Figure 15. St Bathans Post Office.

5.3 ENGINEERING COMMENTS

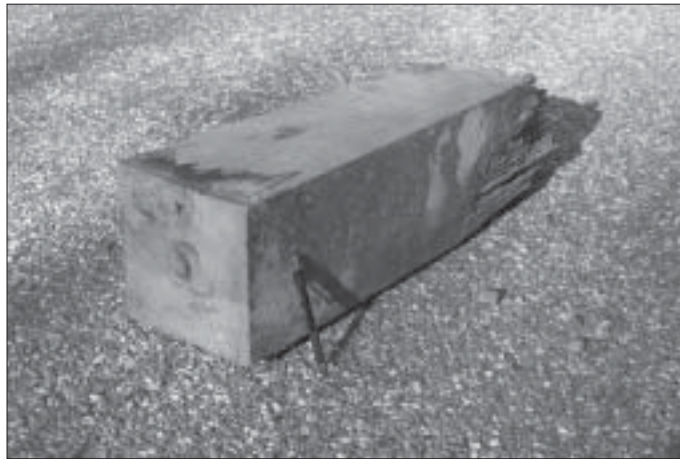
Figure 16. Example of timber pile replaced during 2000 levelling works.

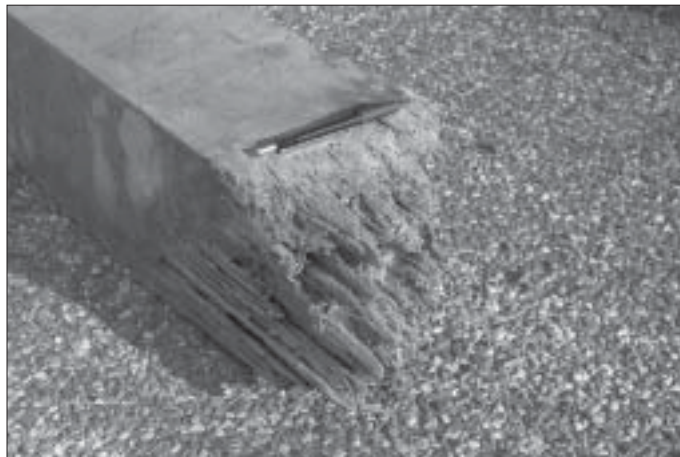
Figure 17. Timber pile shown in Fig. 16 above. Note severe rot at contact with ground.

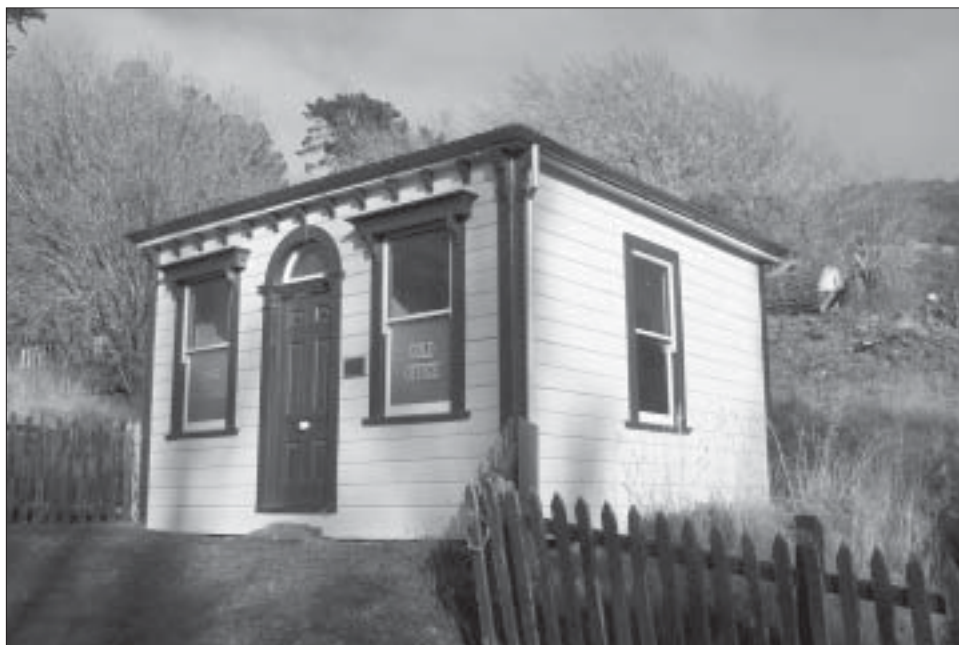
6.3 ENGINEERING COMMENT

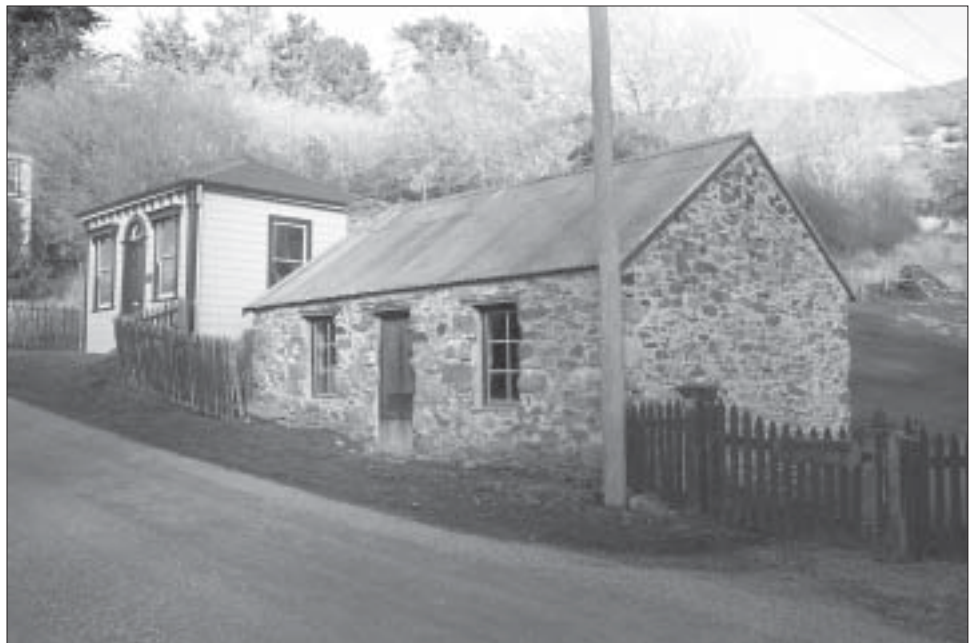
⁵ This is a relative descriptor, placing the condition of the cottage between that of the Post Office and Gold Office, which are in very good condition, and the Public Hall, which is in poor condition.

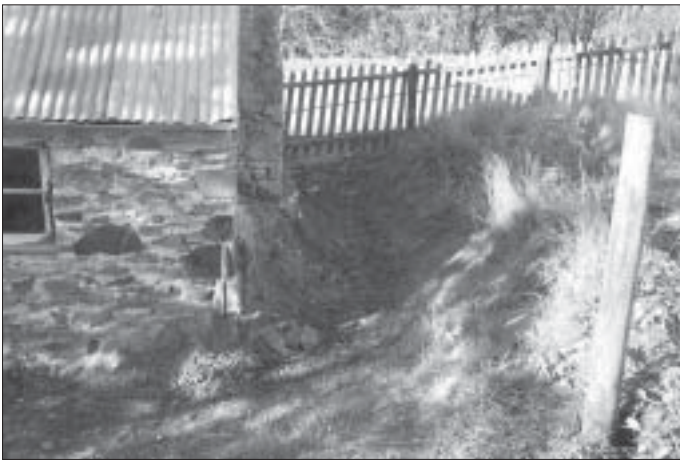
Figure 20. Trench alongside left-hand (as viewed from the road) wall. This view is from the rear of the cottage.

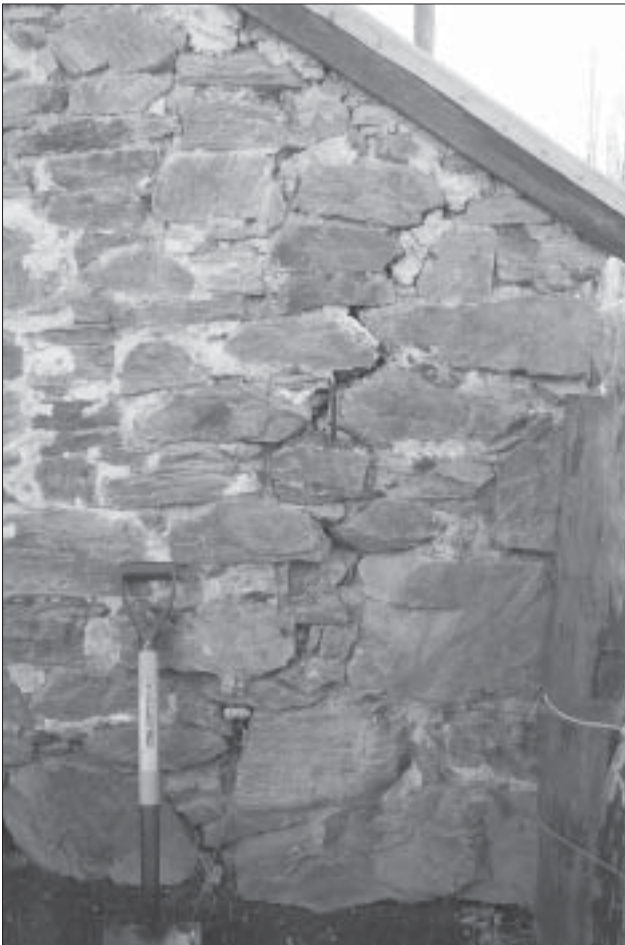
Figure 21. Severe cracking in left-hand wall.

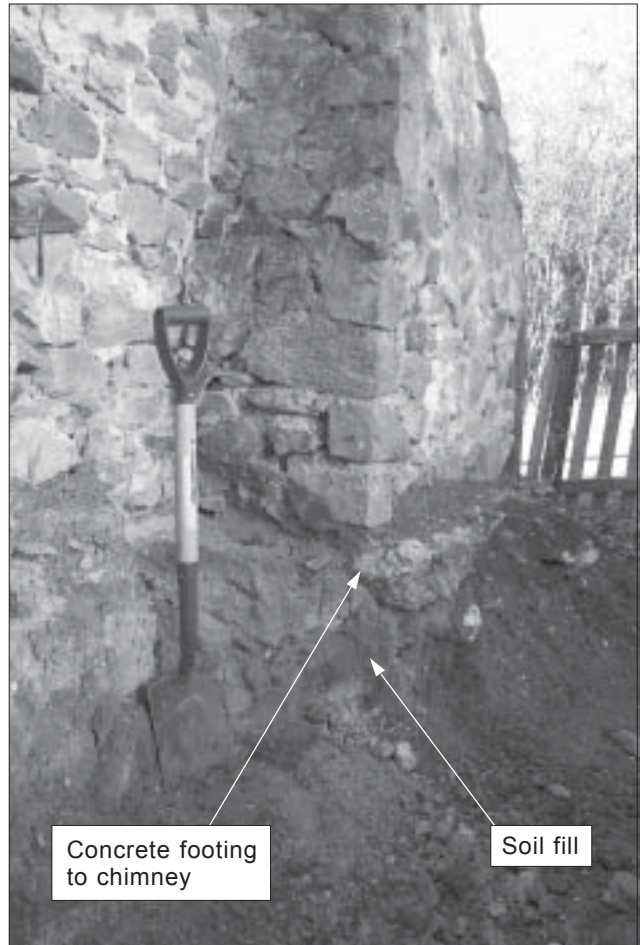
Figure 22. Recent soil removal on left-hand (uphill) side has relieved earth pressure on the wall, but undermined the footing to the chimney.

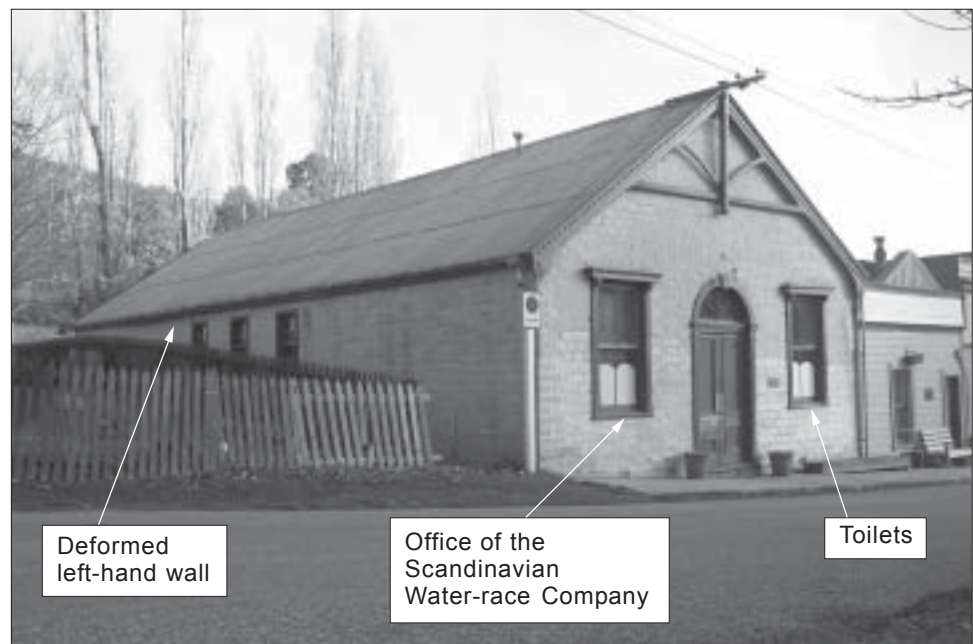
Figure 23. The Public Hall.

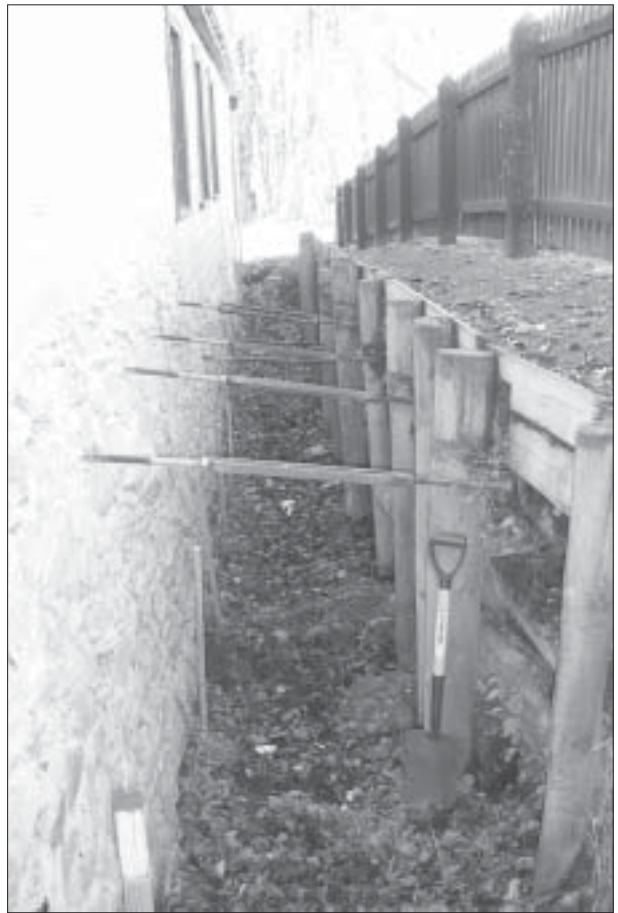
Note: It is evident that deformation and instability of the left-hand wall were on-going concerns prior to 1993.

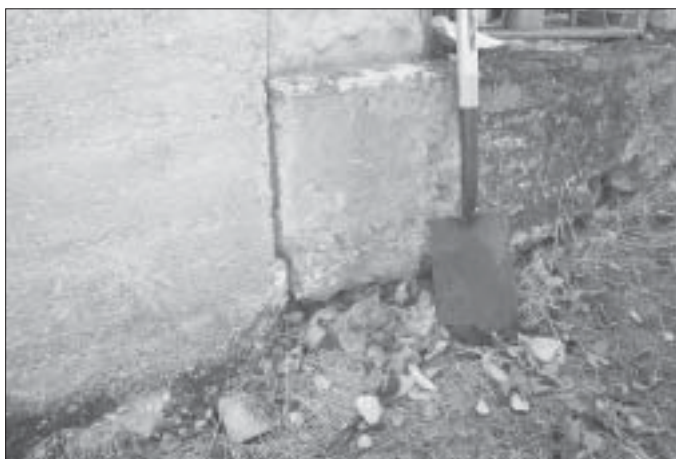
Figure 25. Rear right-hand storeroom. Failure of 'recent' concrete foundations cast at ground surface.

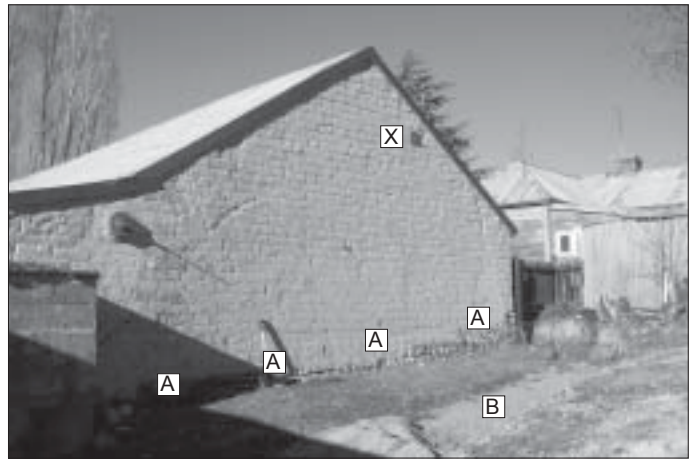
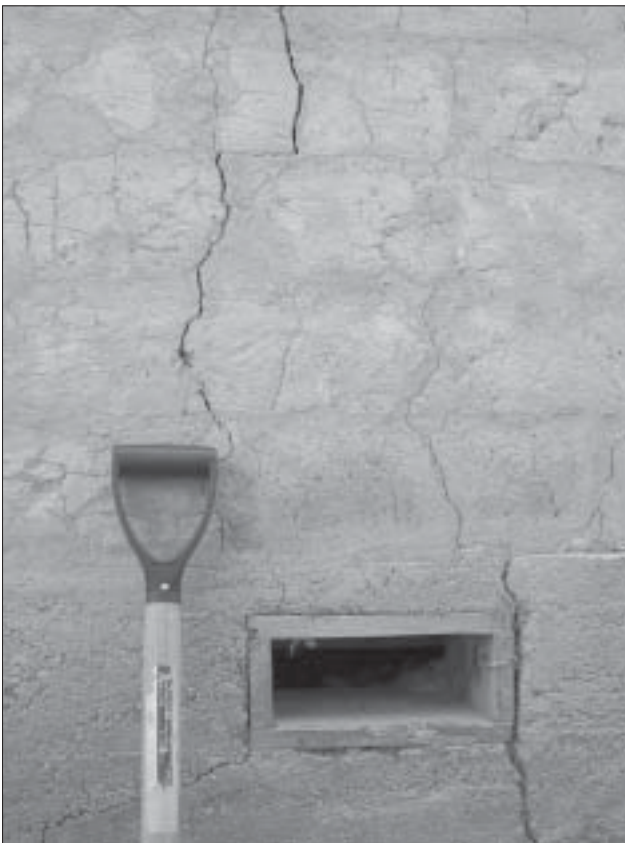
Figure 27. Rear right-hand corner of hall. Note severe cracking of concrete underpinning.

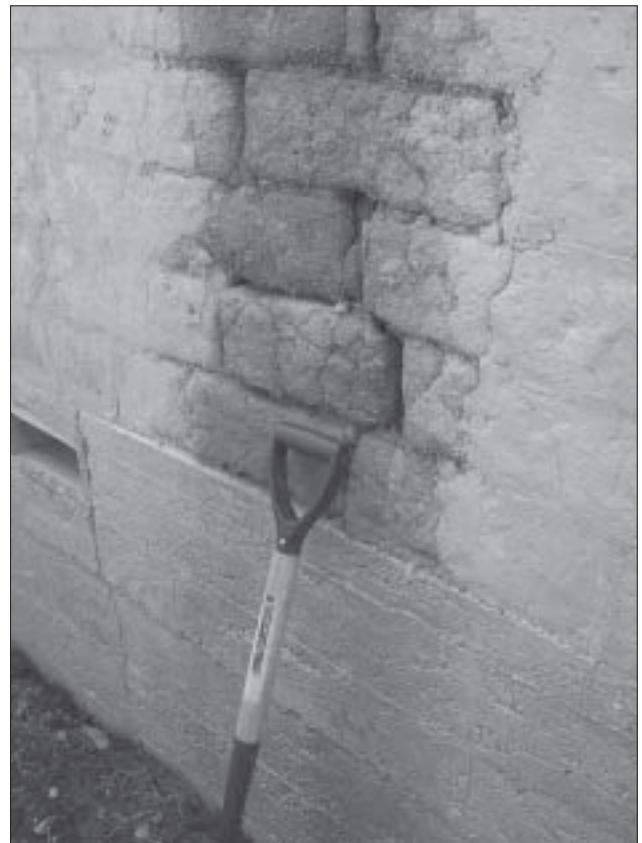
Figure 28. Severe erosion of brickwork and mortar from leaking spouting.

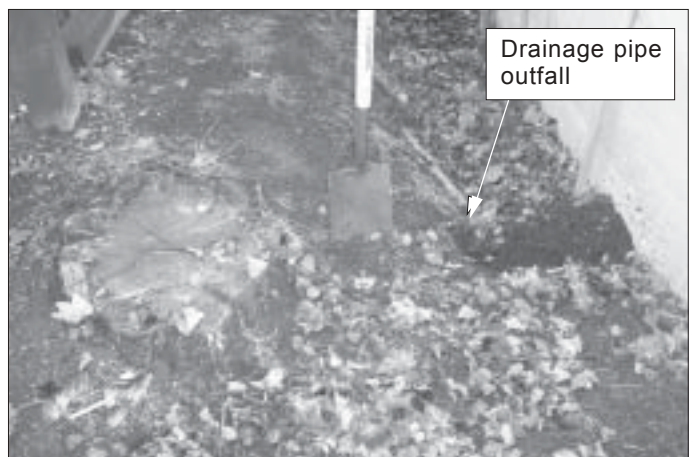
Figure 30. Tie-rod system inside the Scandinavian Water-race Company (SWC) office—view of front wall.

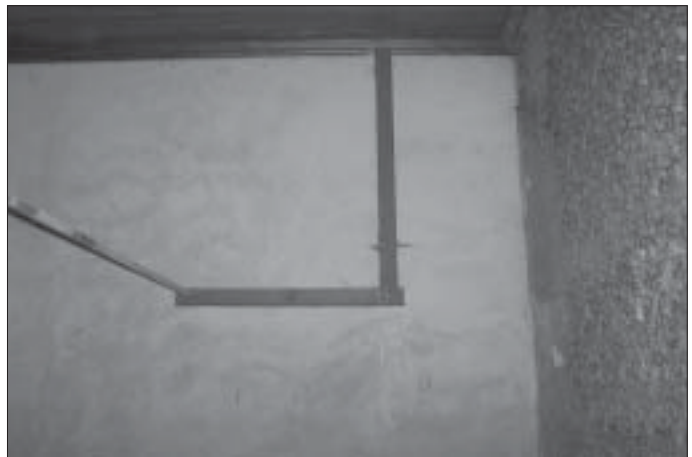
8.3 ENGINEERING COMMENT

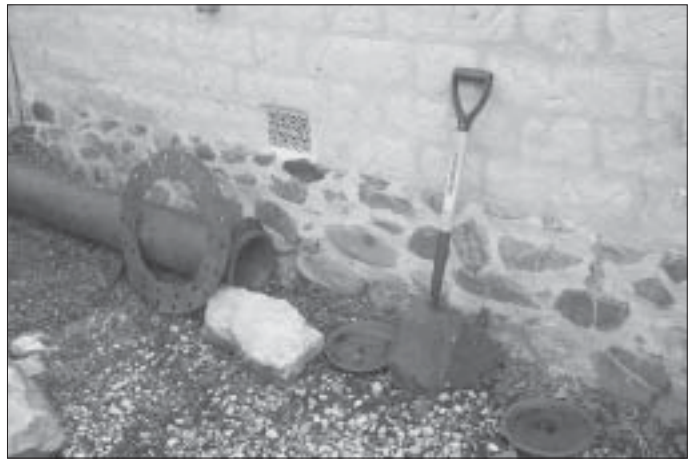
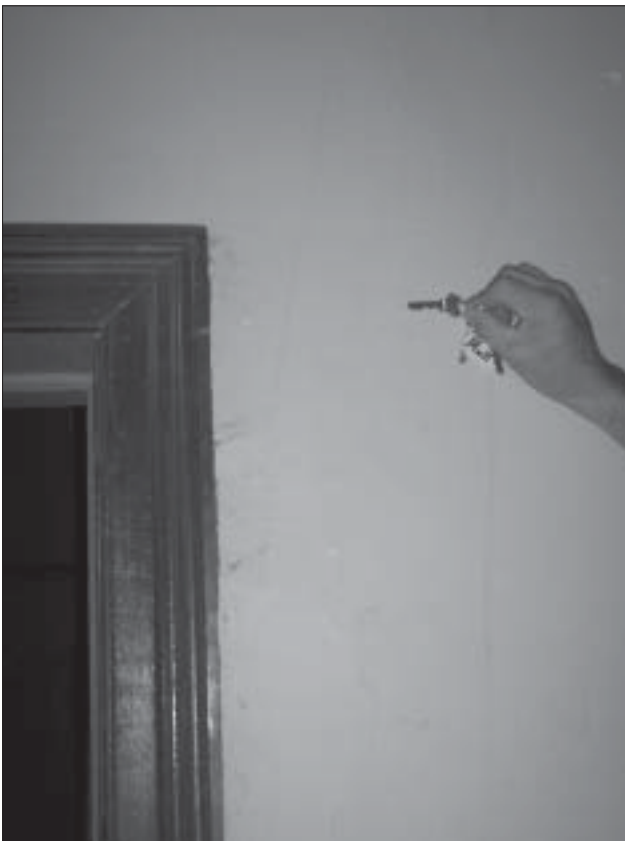
Figure 33. Re-plastering work adjacent to door to SWC office.

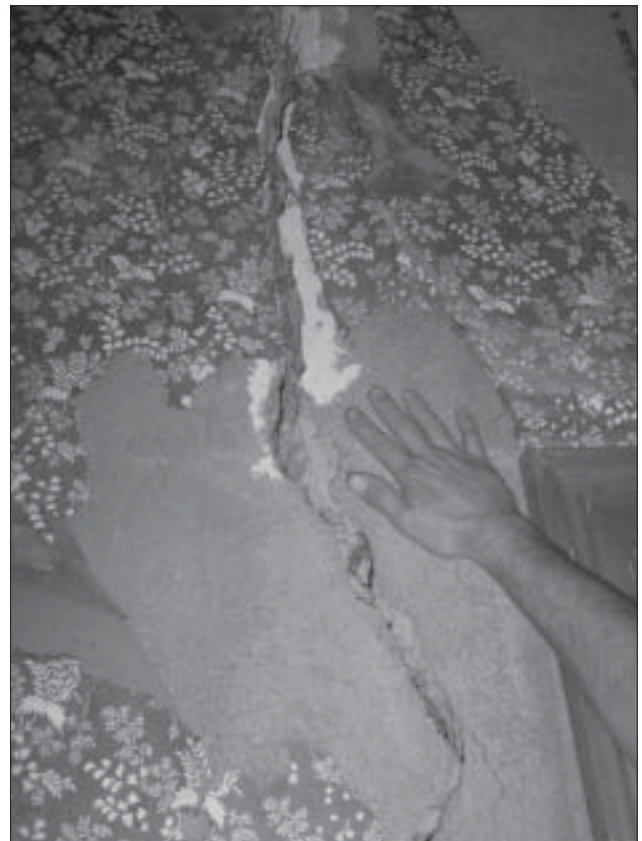
Figure 34. View of re-plastered crack shown in Fig. 33 from inside SWC office.

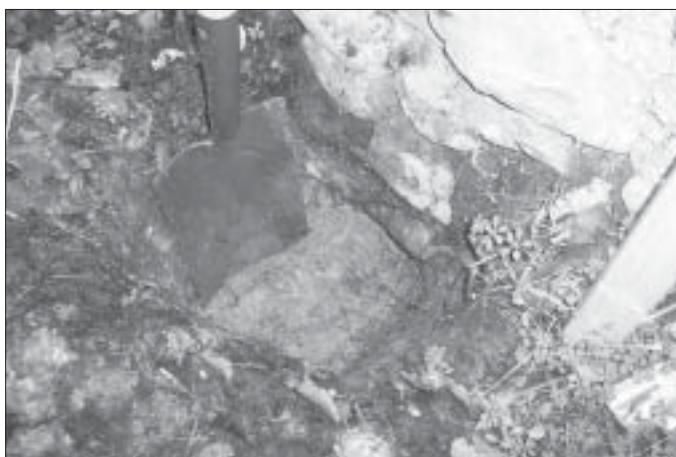
Figure 35. Pit excavated mid-way along foot of left-hand side wall. The ground is very wet.

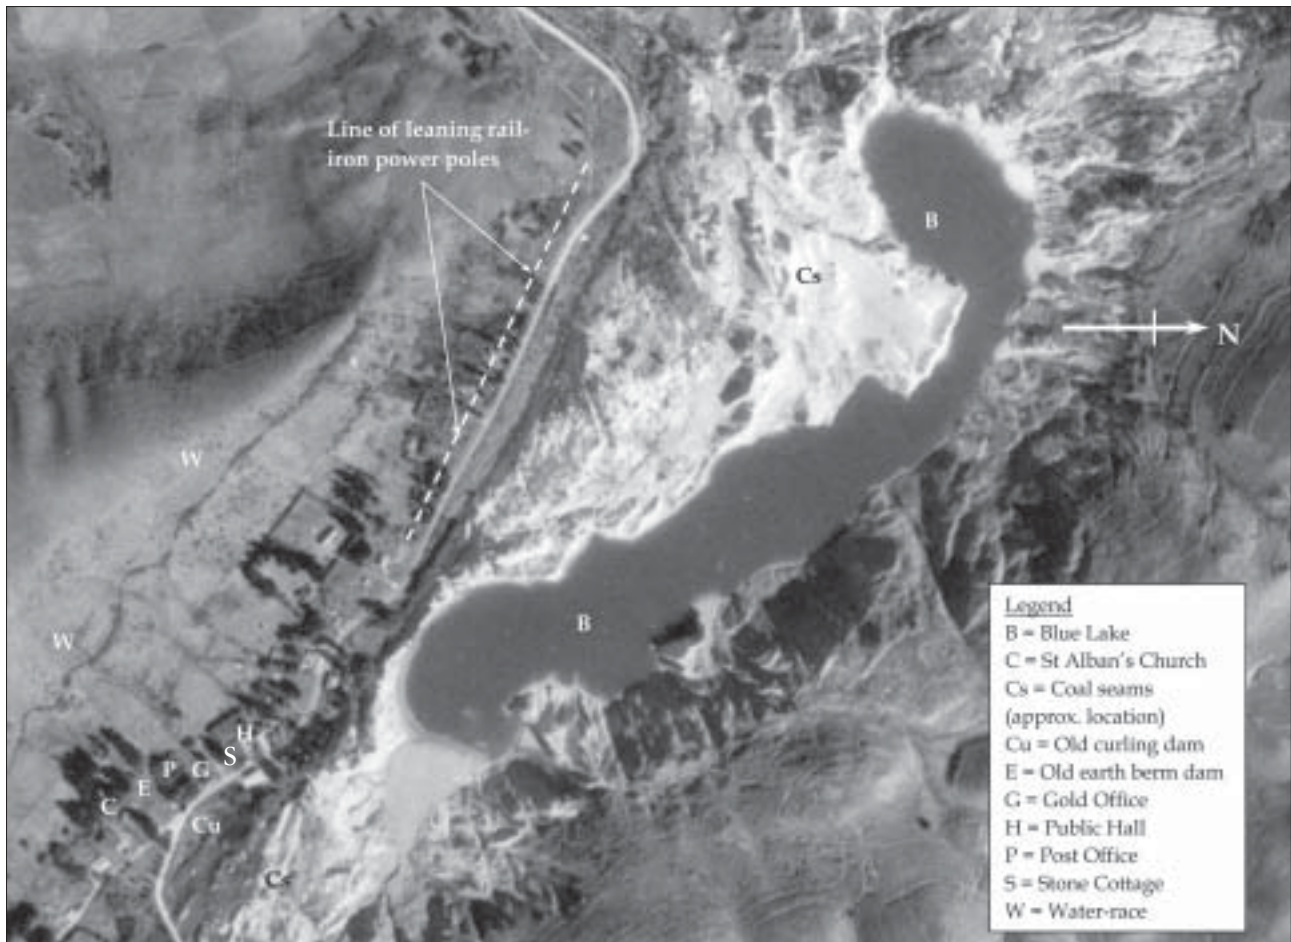
LOCATION PLAN FOR ST BATHANS (AERIAL PHOTO DATED MARCH 1959)

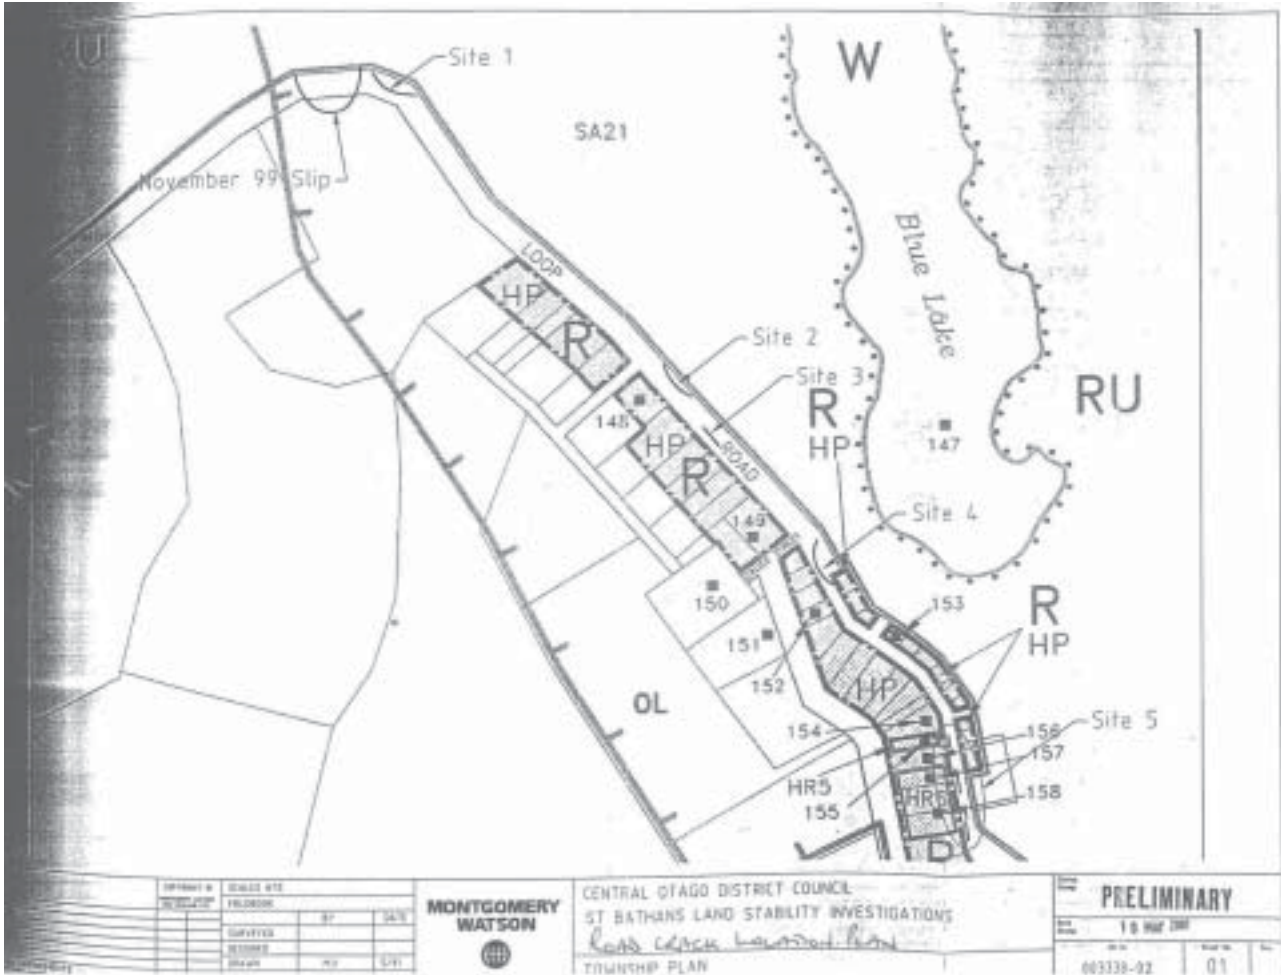
ROAD CRACK LOCATION PLAN FOR ST BATHANS
