# Historic buildings appraisal, St Bathans, Otago

Post Office, Bank of New South Wales' Gold Office,  
Stone Cottage and Public Hall

DOC SCIENCE INTERNAL SERIES 185

Nick Harwood and Phil Woodmansey

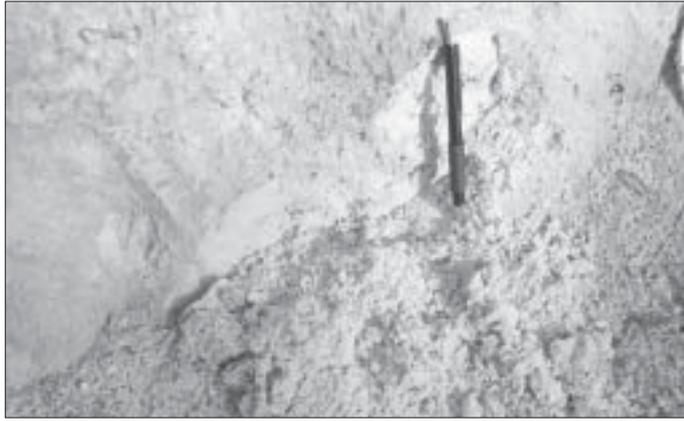
A low cutting behind the private residence between the Public Hall and Stone Cottage exhibits a high variability in shallow soil conditions. Similar conditions probably prevail throughout the area occupied by the four subject buildings (Figs 7, 8 & 9). During recent underpinning works at the hall, non-engineered fill and topsoil was encountered under the hall's foundations (Hadley & Robinson, 2003a).

Figure 7. Exposure in cutting of medium-dense, fine-to-medium sand.

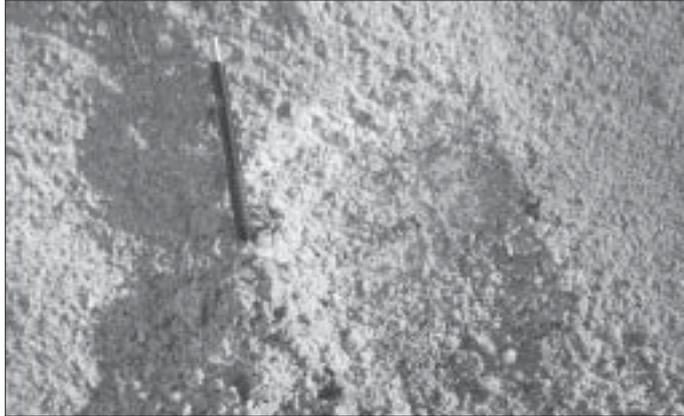
Figure 8. Exposure in cutting of dense, angular, sandy gravel.

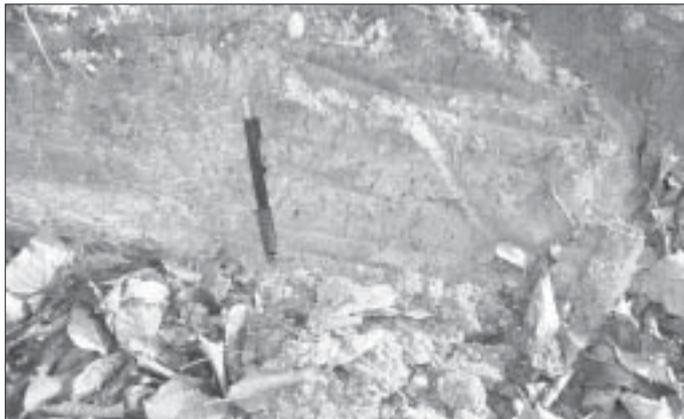
Figure 9. Exposure in cutting of firm-stiff clay/silt.

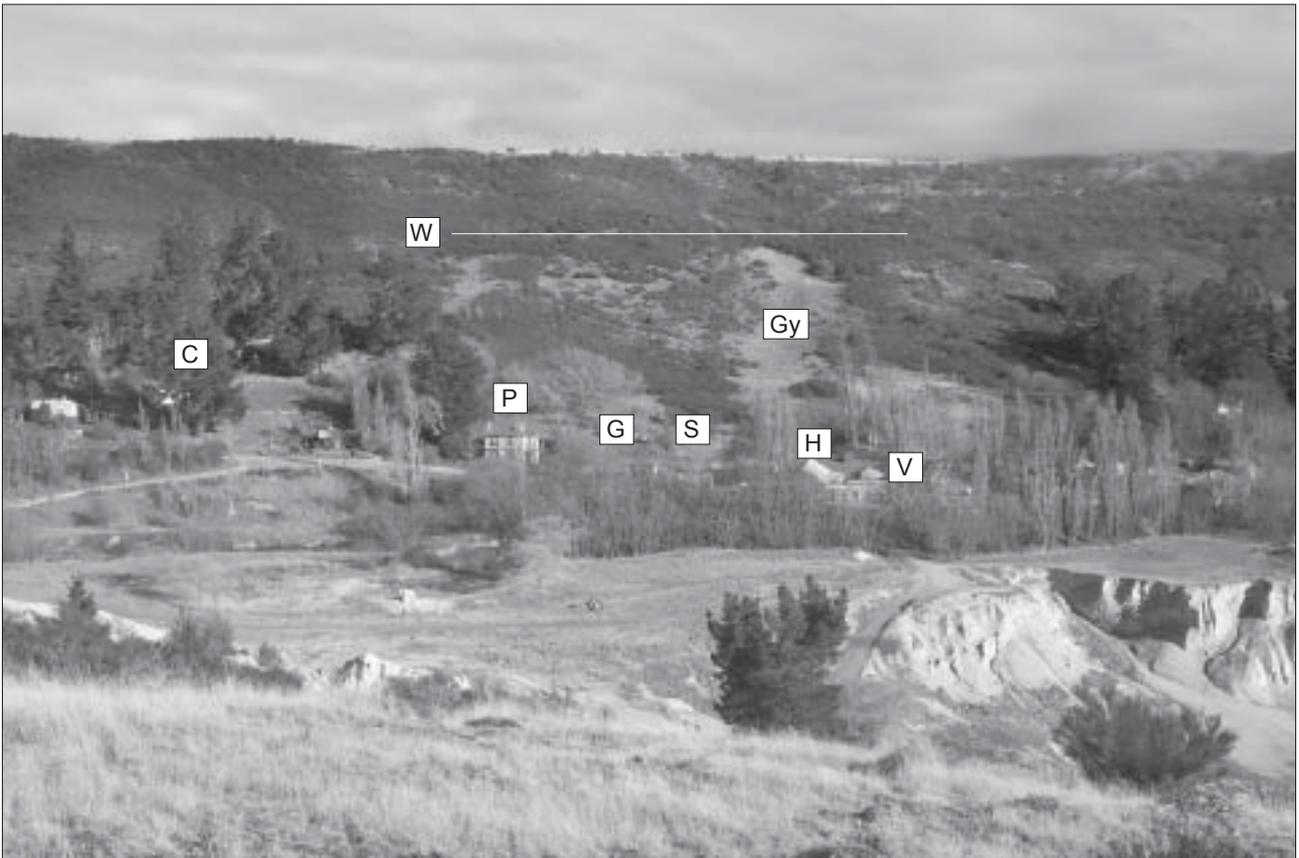
Generally, the hillside rises to the west of the village (and behind the buildings) at a quite steep but uniform slope (c. 25°), although there are almost-flat areas lower down; e.g. the levelled lawn area behind the Hall. The hillside is covered in dense shrub vegetation with some open areas of dense coarse grass. A subdued gully feature is present on the slope above the Hall and has grass cover only (Figs 10 & 11).

Figure 10. View west overlooking St Bathans' main street and the western hillside. C = St Albans' Church (behind trees); P = Post Office; G = Gold Office; S = Stone Cottage; H = Public Hall; V = Vulcan Hotel; W = water race (part only—approximate location); Gy = gully feature.

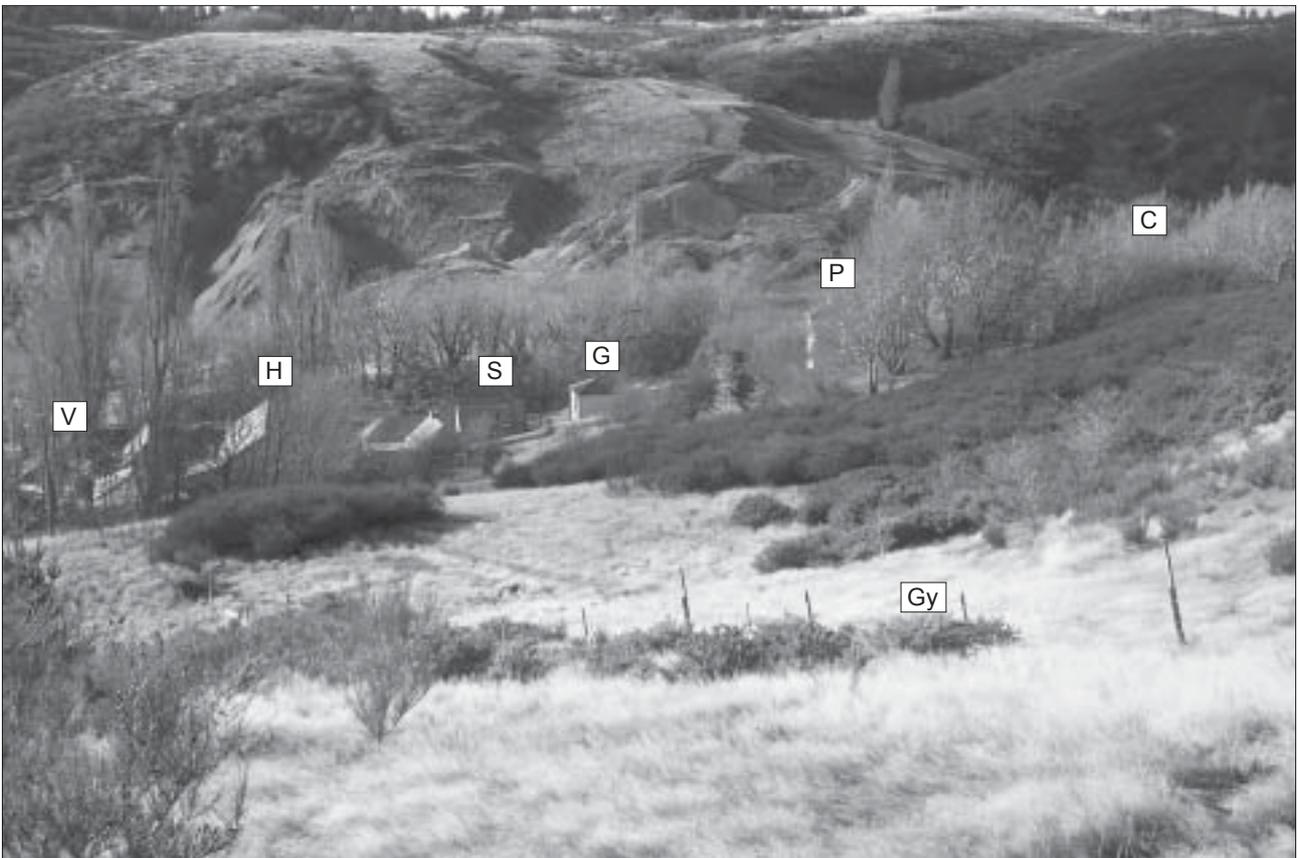
Figure 11. View (looking east) of buildings from the western hillside (labels as in Fig. 10). Water race is up the hill behind the observer.

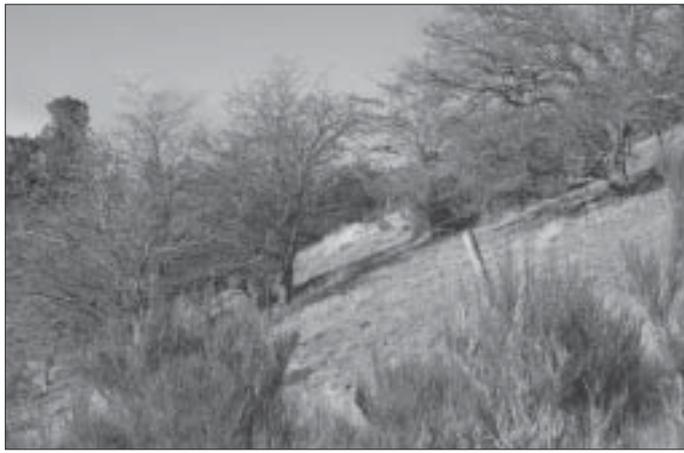
No surface ruptures were observed and there are no signs of recent mass movement. Some trees on the slopes above the subject buildings lean, but many do not (Figs 12–14a).

Figure 12. View across hill slope above subject buildings. Fence post is normal to the c. 25° slope.

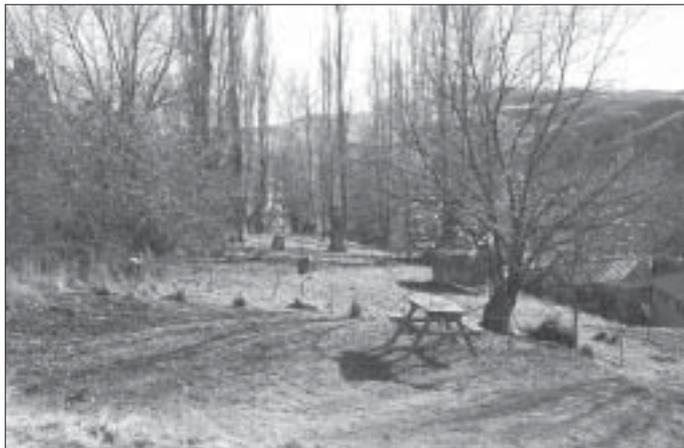
Figure 13. View across 'landscaped' lawn area behind Hall. Note tall vertical (not leaning) poplars in background.

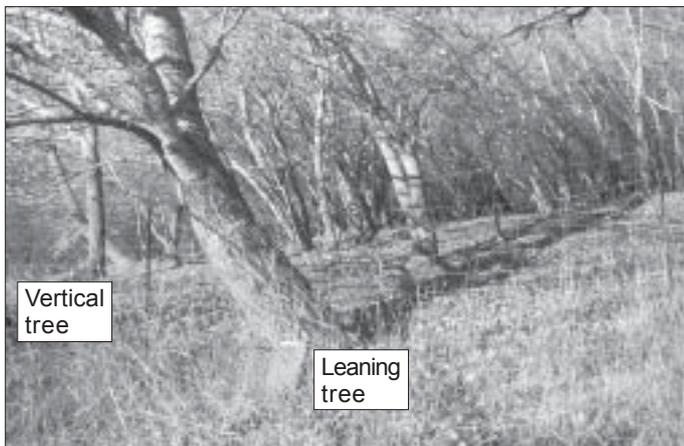
Figure 14a. View across hillside at top of section behind Post Office.

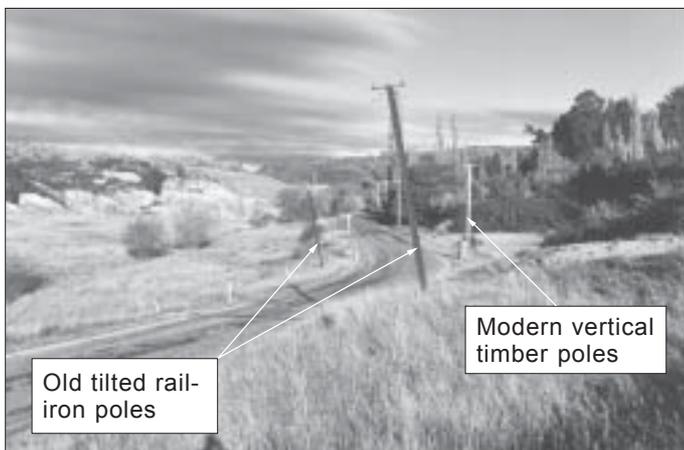
Figure 14b. View south along line of 'old' leaning rail-iron power poles.

The 'modern' power poles that form a line across the slope above the subject buildings show no signs of tilt. Conversely, several disused 'old' rail-iron power poles on the road embankment through the township have a distinct lean.

Any slope movement, indicated by leaning trees or power poles, for example, is primarily attributed to hillside creep, which is a natural, very slow slope movement process. Movement of this nature is usually in the order of a few mm/year, but will vary depending on factors such as slope angle and ground moisture content.
