BUILDING CONDITION APPRAISAL.

Chateau Tongariro Hotel - State Highway 48,
Whakapapa Village, Mount Ruapehu

Prepared for: Department of Conservation

Date: April 2023

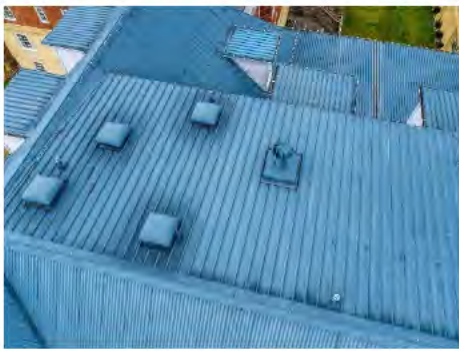
1.5	Main roof	Service and ventilation penetrations	<p>Condition: The service and vent penetrations all appear to have sealant repairs around their perimeter. This will fail under UV light and allow water ingress.</p> <p>Recommended works: The service and vent penetrations should be replaced when the roof sheets are being replaced. This should include back flashings and correct detailing of the penetrations.</p>	●

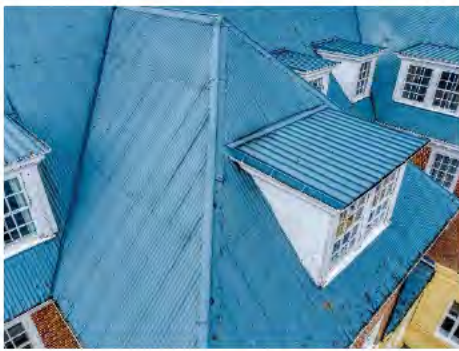
1.8	Main roof	The valleys and hips are formed from folded metal lining to the valleys and folded metal with soft edge to the hips.	<p>Condition: Lifting sections, localised corrosion and loose soft edges were noted over the roof surface.</p> <p>Recommended works: Overhaul the valleys and hips in the immediate term to address any loose soft edges and replace when the roof sheets are being replaced in the medium term.</p>	●

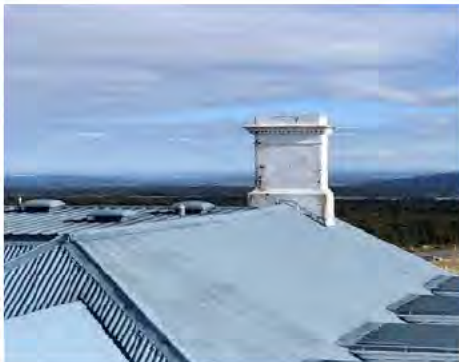
1.12	Chimneys	Main "live" chimney to the front east roof pitch.	<p>Condition: The chimney to the front east is the only "live" chimney. It is in poor condition with cracking noted. It is an unreinforced masonry chimney as per the WSP IEP report.</p> <p>Recommended works: Determine remedial works required once the DSA is completed. Unreinforced masonry chimneys are a potential hazard in an earthquake event. Provisionally allow for seismic strengthening.</p>	●

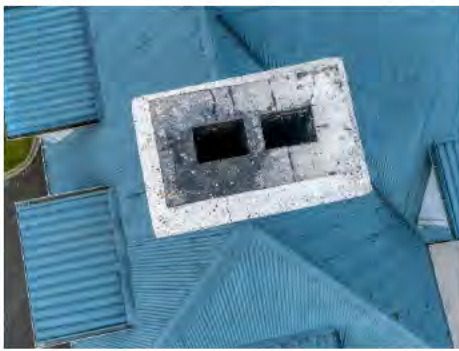
1.14	Chimneys	Main "live" chimney to the front east roof pitch.	As above – note cracking	●

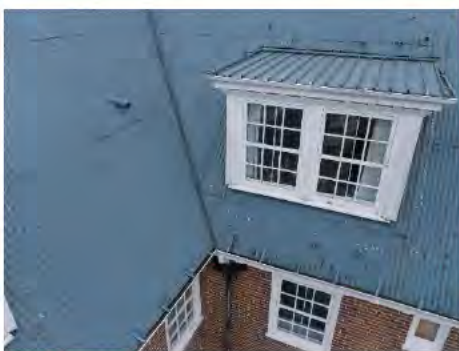
1.15	Dormer windows to original roof	All roof pitches include dormers windows. The dormer roofs are finished with trough section metal roof sheets with perimeter metal gutters. The dormer side are lined with a sheet material however we cannot identify if this is metal or an ACM sheet. The windows are original painted timber.	<p>Condition: The dormer roof sheets are in poor condition with corrosion noted and suffering from a lack of maintenance.</p> <p>Recommended works: The dormer roof sheets to be replaced when the roof sheets are being replaced in the medium term.</p> <p><i>Refer to Window section of this report for additional comments on remedial works to the dormers.</i></p>	●

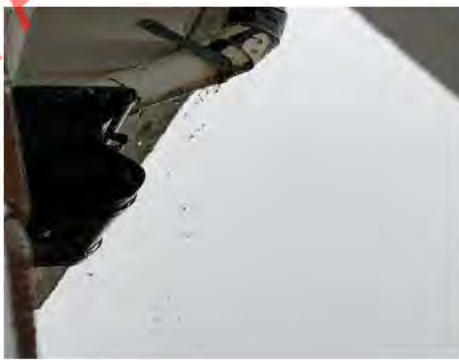
Ref.	Element	Description	Comments on condition/recommended works	Priority	Photograph
1.22	Main roof - rainwater goods.	Overflowing connector pipe	As above – note overflowing/leaking connector pipe	●

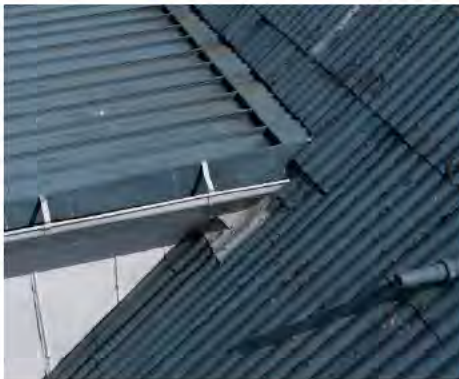
1.24	Main roof	External repair at gutter/roof sheet junction	As above – note silver coloured repair at gutter/roof junction	●

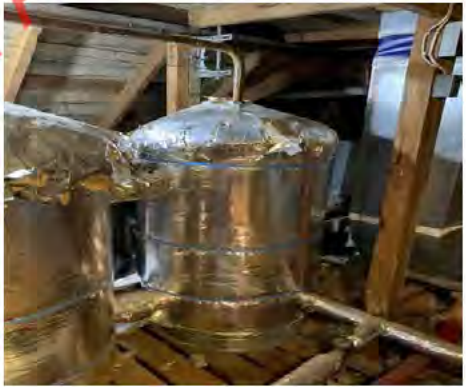
Ref.	Element	Description	Comments on condition/recommended works	Priority	Photograph
1.28	Main roof	Roof space services	<p>Condition: The services and water tanks within the roof space are not seismically restrained.</p> <p>Recommended works: Allow to seismically restrain all services within the roof space.</p>	●

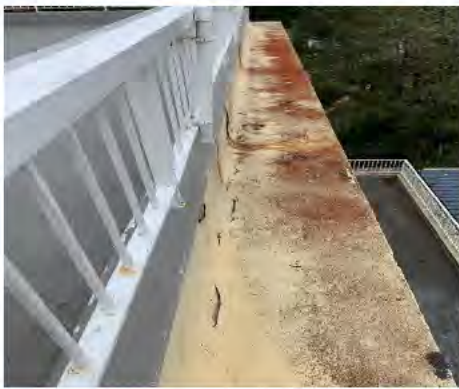
2.8	Perimeter edge capping	Perimeter edge capping	<p>Condition: The external side of the perimeter wall top capping has a paint/waterproof membrane finish which has failed, deteriorated and cracked.</p> <p>Recommended works: Replace the perimeter wall capping with a new waterproof membrane (or continue the liquid applied membrane over the parapet wall) with suitable cap detail.</p>	●

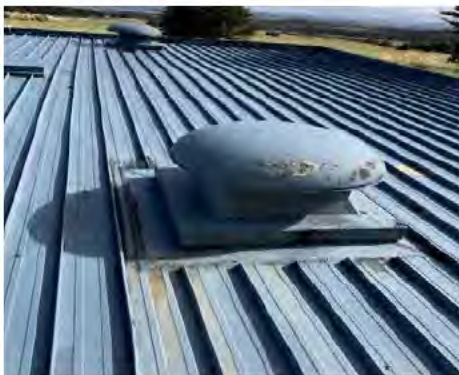
3.4	Corrosion to roof vent	Service penetration flashing detailing	<p>Condition: Close up of corrosion to the vent flashing.</p> <p>Recommended works: Provide a suitable back flashing to the service vents when the roof sheets are being replaced.</p>	●

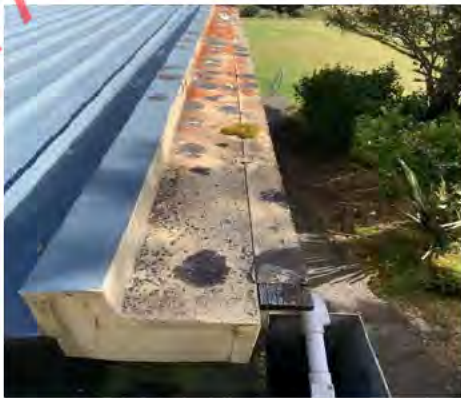
3.6	Roof perimeter detail together with additional flashing	Perimeter detail membrane debonded and lifting.	<p>Condition: The flashing to the perimeter edge detail has debonded from the substrate.</p> <p>Recommended works: Correctly detail the perimeter edge when the roof is replaced.</p>	●

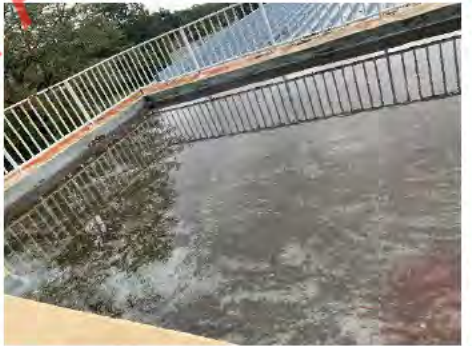
4.3	Original podium roof	Vegetation growth	<p>Condition: Vegetation growth was noted where the membrane has failed and cracks have developed.</p> <p>Recommended works: Remove all vegetation growth prior to replacing the membrane.</p>	●

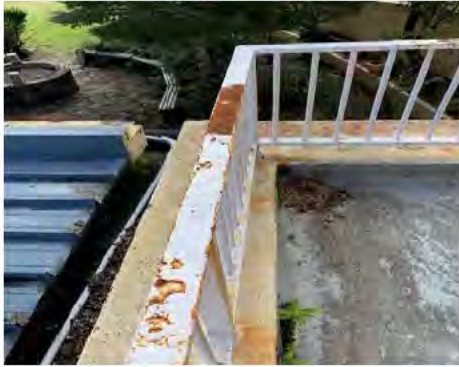
4.7	Original podium roof	Metal handrail/column connection	<p>Condition: The handrail fixing to the concrete column is missing or has been removed.</p> <p>Recommended works: Make good the handrail/column junction.</p>	●

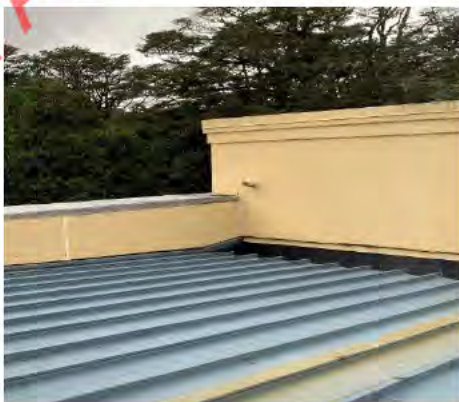
7.29	Rear canopy roof	As above	<p>Condition: The metal roof sheets are in poor condition with localised corrosion and damage noted particularly along the bottom edge.</p> <p>Recommended works: In the immediate term the corrosion should be spot treated to prevent further deterioration.</p>	●

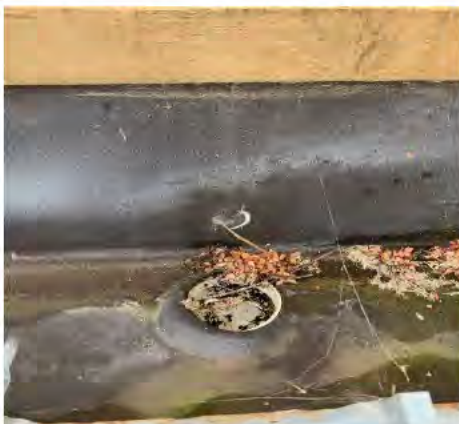
7.32	Parapet gutter	Overflow outlet incorrectly formed.	<p>Condition: One overflow outlet has not been completed and the hole has been incorrectly formed. This will limit the overflow capacity from the roof.</p> <p>Recommended works: The membrane to be correctly detailed to form an overflow outlet.</p>	●

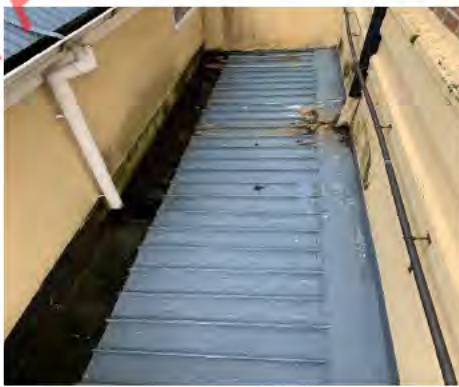
7.34	Void space between the original building and extension	Downpipe	<p>Condition: A downpipe was noted to be blocked with debris and it also discharges directly onto an apron flashing which is not good practice.</p> <p>Recommended works: The downpipe should be cleaned out to leave free flowing and checked/cleaned annually.</p>	●

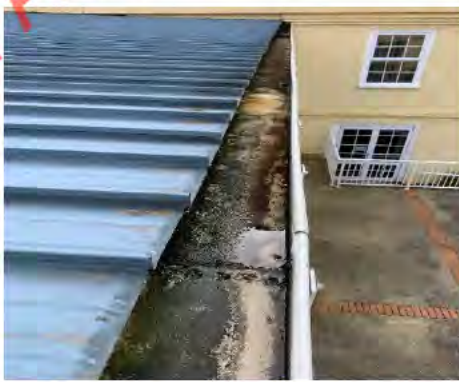
8.9	Dining atrium roof	Downpipes	<p>Condition: The uPVC downpipes discharged directly onto the roof sheet below. This is not good practise as it can lead to concentrated water flow causing premature deterioration.</p> <p>Recommended works: In the immediate term the downpipe should be extended into the lower gutter.</p>	●

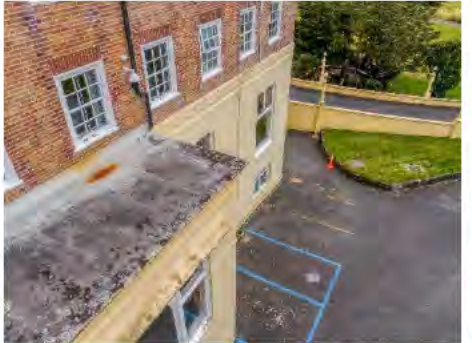
11.4	Flat roof over Ruapehu feature window	As above	<p>Condition: Brown rust staining was noted on the membrane. This appears to be originating from the leaking gutter directly above as shown in the photo.</p> <p>Recommended works: In the immediate term the leaking gutter above should be repaired and the rust stain carefully cleaned, bearing in mind it is likely to be an ACM, prior to the re application of a solar reflective paint.</p>	●

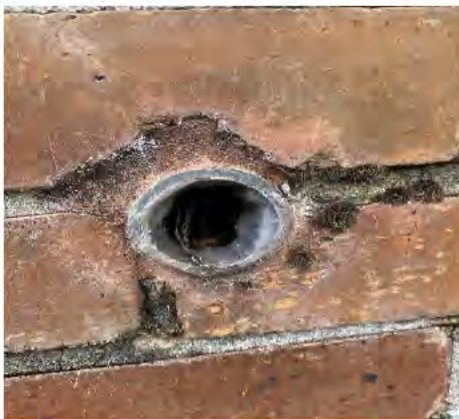
12.18	Brickwork	Damaged and missing pointing to the front corner of the original building	<p>Condition: The mortar pointing to a number of corners was noted to be worn or missing.</p> <p>Recommended works: Repoint missing pointing as found necessary.</p>	●

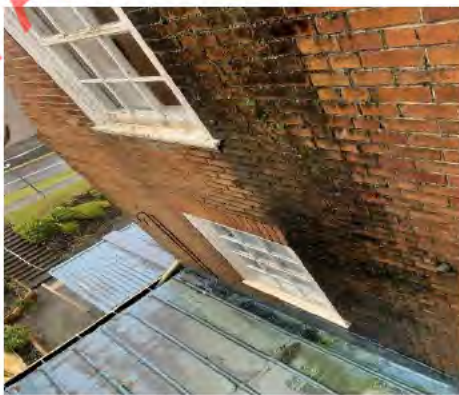
12.23	Brickwork	The brickwork at the junction of the original building and 2005 extension has not been sealed or a suitable flashing provided.	<p>Condition: There is an unsealed vertical gap which is allowing bird entry and possible water ingress.</p> <p>Recommended works: The vertical gap should be flashed or sealed with a flexible sealant material to allow for movement along this line.</p>	●

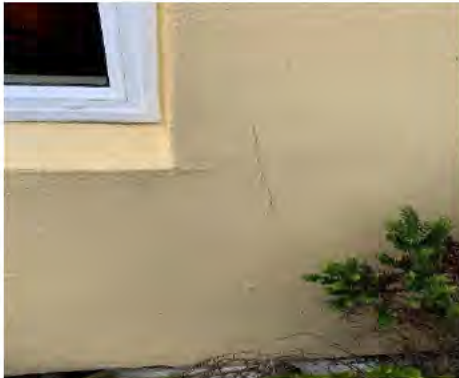
12.42	West elevation	Ground clearance	<p>Condition: The polystyrene cladding has been brought down to ground level with limited clearance provided. This can allow water to wick into the cladding and prevent drainage along the bottom edge.</p> <p>Recommended works: In the immediate term remove stones and other materials to create ground clearance to the cladding.</p>	●

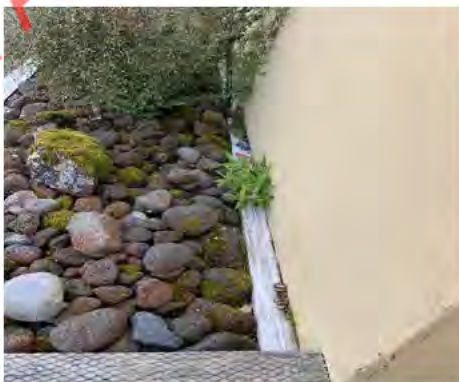
12.44	1955 workshop extension	The West elevation forms the workshop at the entrance to the basement level facilities.	<p>Condition: The paint finish to these elevations is in poor condition. Planters have been created along the elevation which can cause moisture ingress internally.</p> <p>Recommended works: Consideration to be given to removing the planters and making good the affected wall surfaces.</p>	●

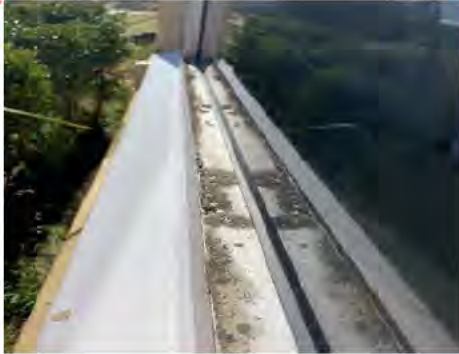
13.2	Tongariro Room windows	Conference room windowsill flashing detail	<p>Condition: The external windowsill detail has also been incorrectly installed which is preventing water draining correctly. Moss growth and damaged paint finish was noted confirming the presence of moisture over a long period of time.</p> <p>Recommended works: The windowsill detail should be reinstalled correctly to prevent future water damage.</p>	●

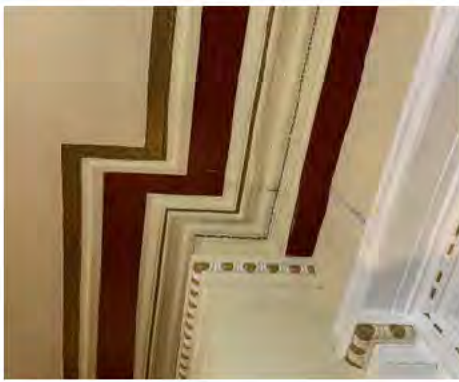
15.20	Internal ceiling	Water damage internally above Ruapehu Room and Ngauruhoe Room windows.	<p>Condition: As previously mentioned under the Elevation section of this report, water ingress is occurring from the Juliet balconies externally.</p> <p>Recommended works: Once the Juliet balconies have been repaired and water ingress abated the internal cornice and walls to be made good and re decorated.</p>	●
