GeoSolve Ref: 160318.01  
14 February 2018

## Preliminary Geotechnical Hazards Assessment Murcott Burn, Te Anau-Milford Highway

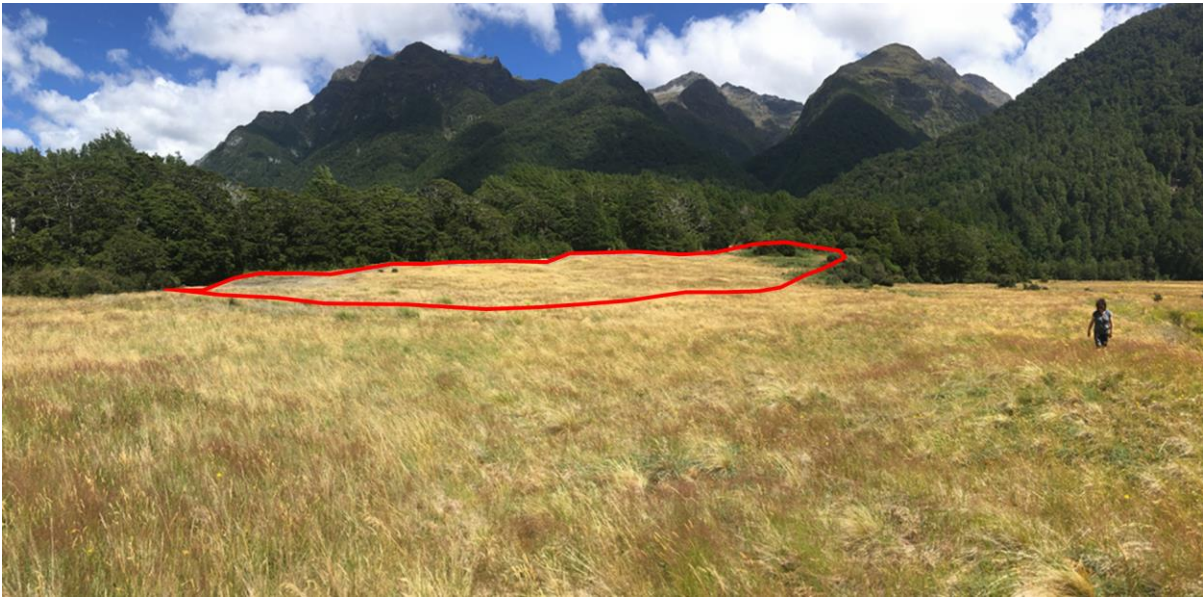
The proposed development site is situated on an isolated terrace elevated above a broad alluvial floodplain of the Eglinton River West Branch to the north. The main flow of the Eglinton River bends around the site to the west and borders the base of the steep terrace slopes on its western and southern sides. The terrace surface slopes gradually towards the northeast and grades into the sub-horizontal alluvial surface of the Eglinton River floodplain (Photo 1).

Photo 1. Site photo looking southwest from the Eglinton River floodplain towards the proposed development site along the bush edge, outlined in red. Murcott Burn is located on the skyline centre of image.

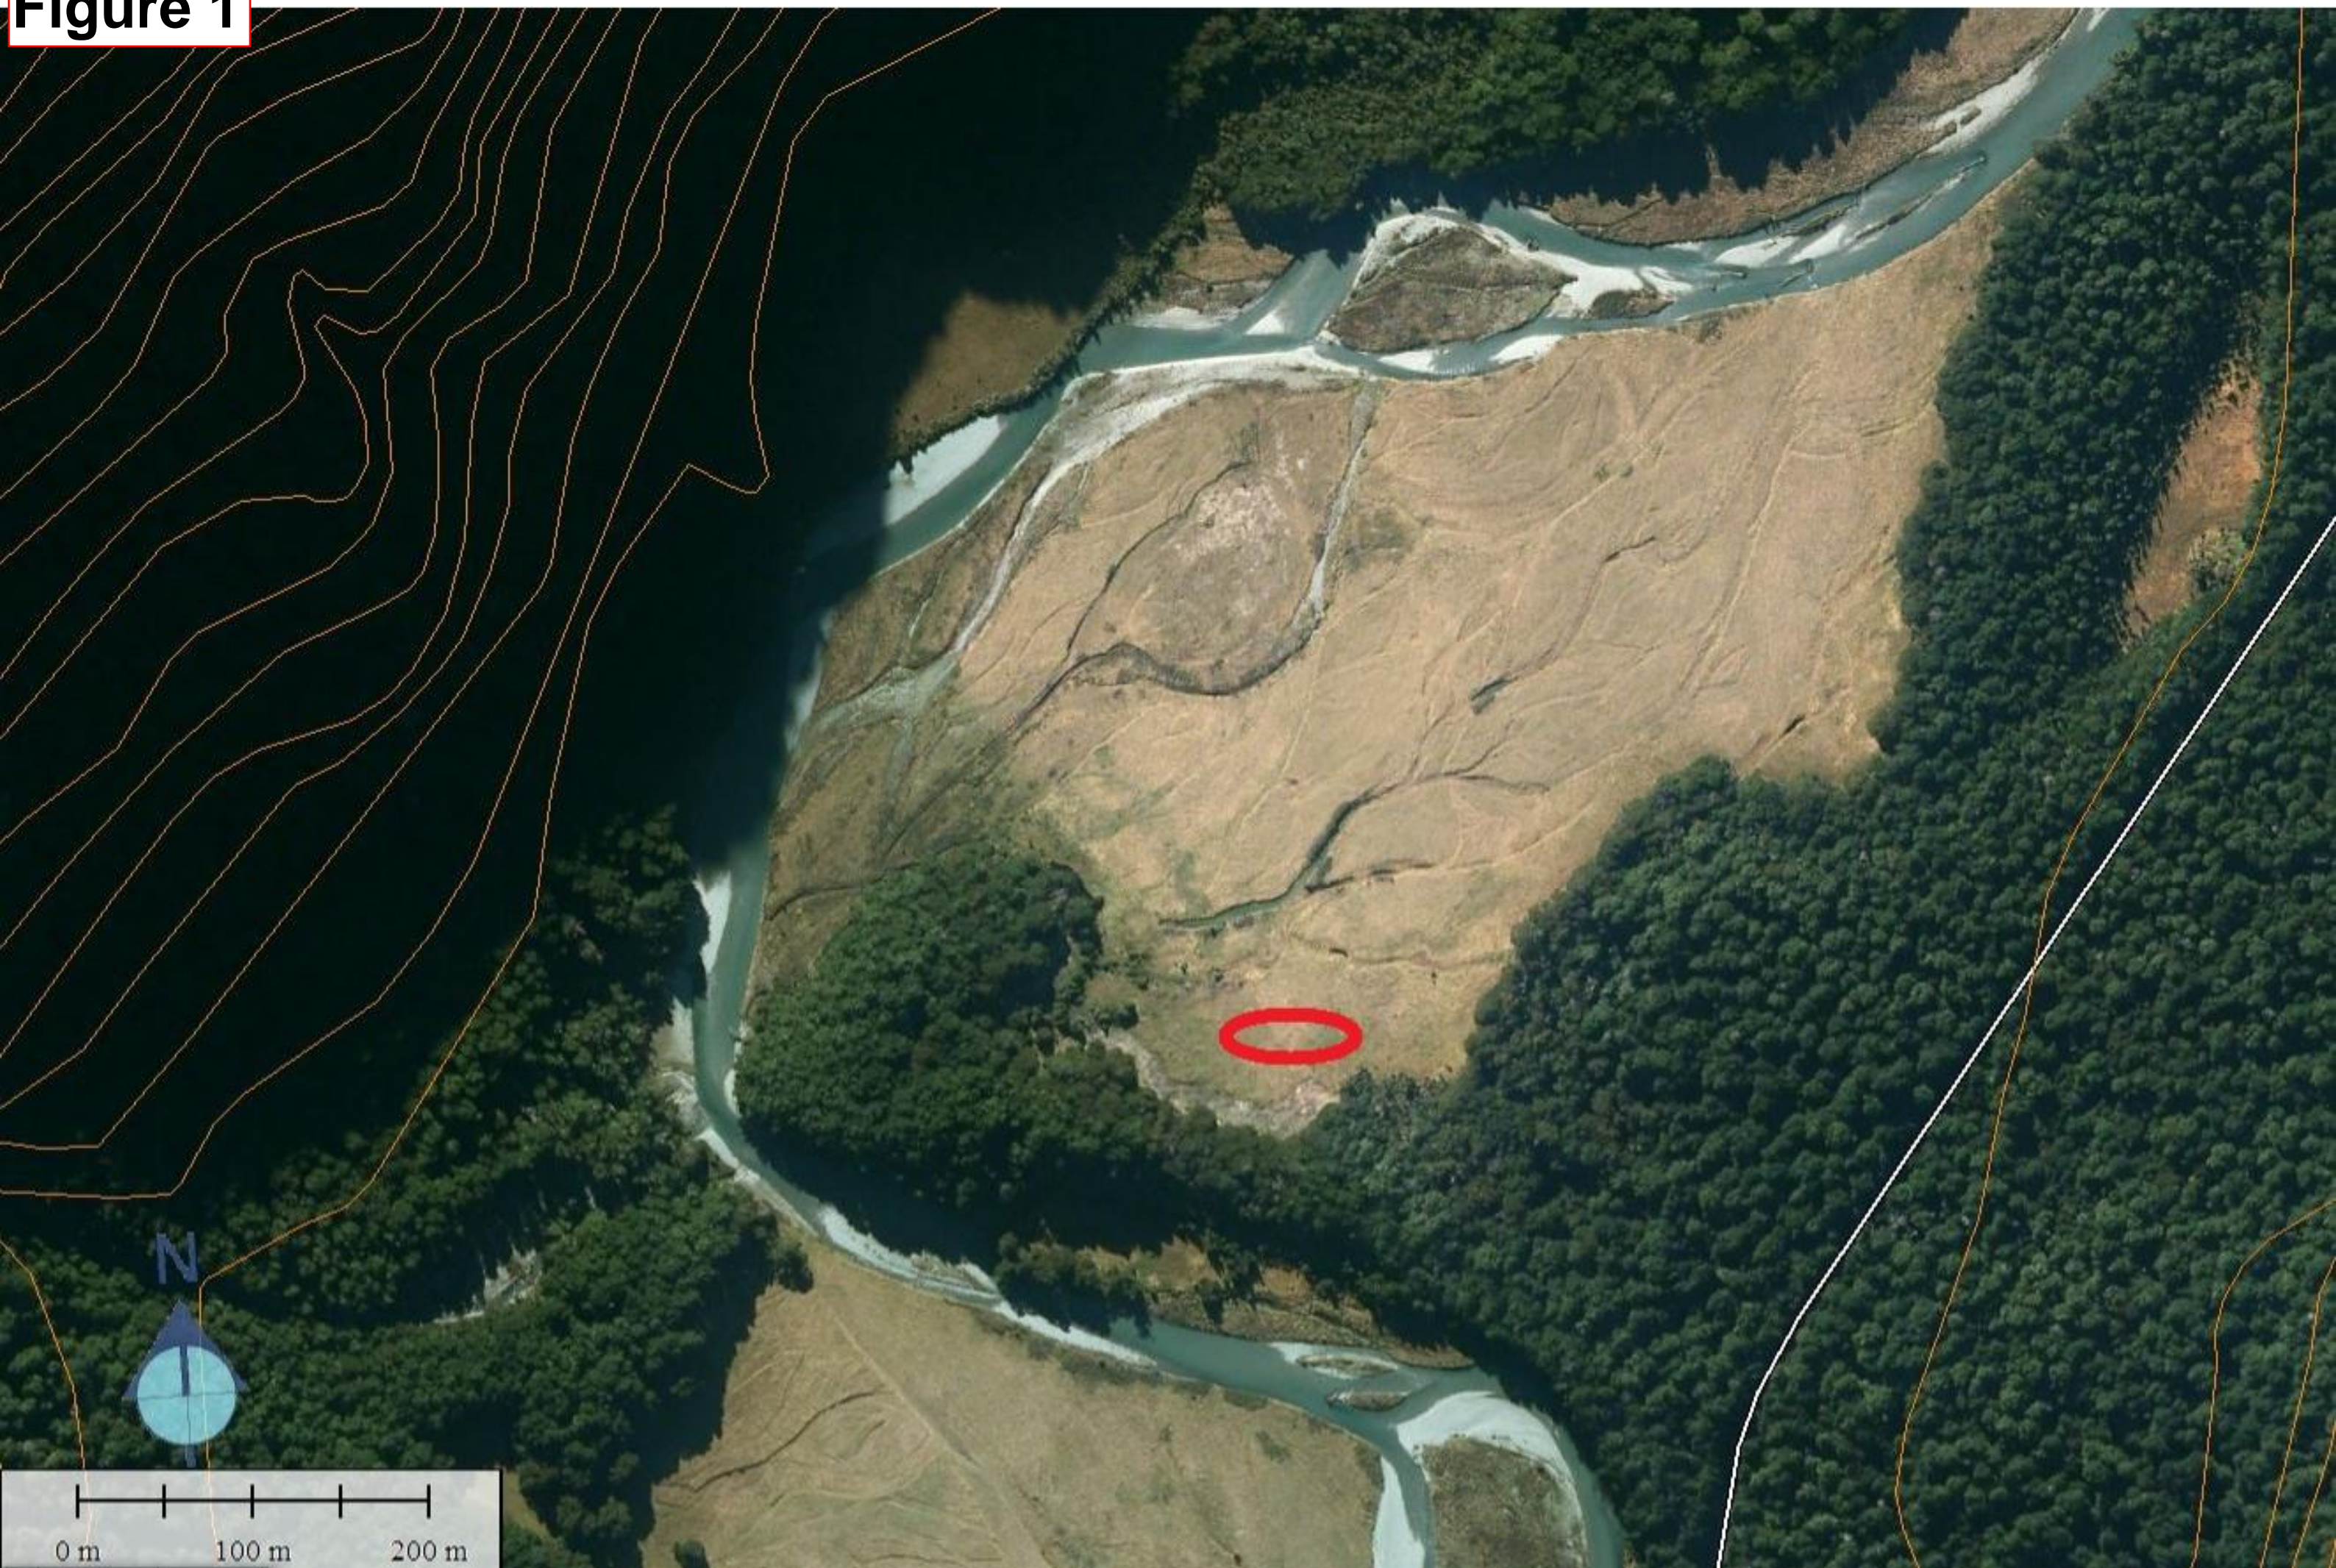
**Figure 1**

Numerous flood overflow channels from the Eglinton River dissect the broad floodplain to the north of the site. These overflow channels reach the base of the terrace on the southern end of the floodplain and deflect around the elevated terrace to the west back towards the main flow of the Eglinton River. The flood overflow channels were observed to be active and showed signs of recent activity including scoured banks and ponding of water.

Figure 1 in the attachments section shows the general position of the proposed development (circled in red) in relation to the Eglinton River West Branch and the surrounding floodplain.

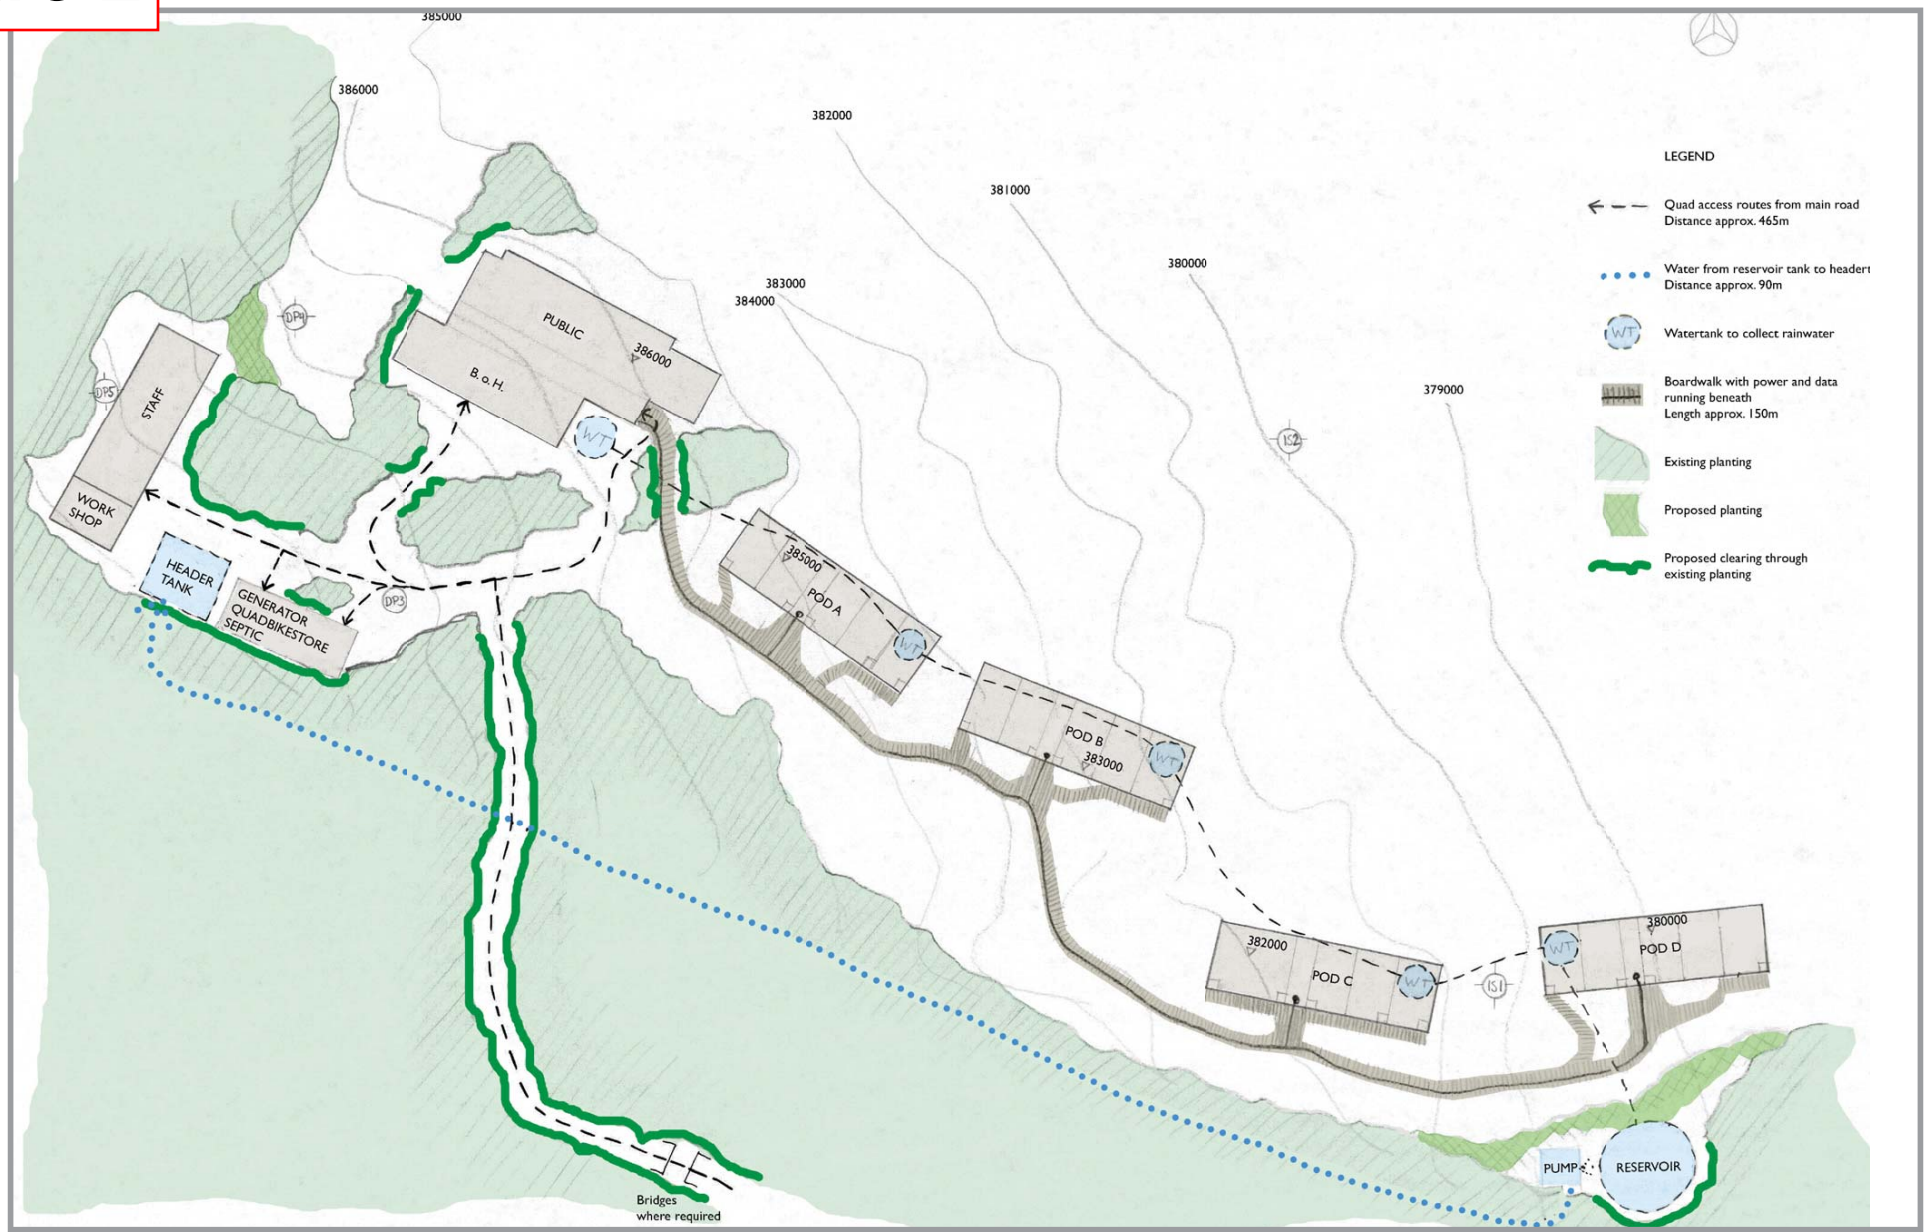
# Figure 2

Concept design plans and site survey plans provided to GeoSolve indicate that accommodation Pod D, located on the eastern extent of the development site will only have approximately 0.5 to 1.0 m of clearance above the adjacent floodplain. Accommodation

Pod D coincides with the least elevated part of the site. The Eglinton River West Branch is expected to carry large volumes of water during periods of high rainfall and the site is situated downstream from a significant bend in the river. Therefore, specific engineering considerations such as elevated floor levels, bunding or relocation of the structure will be required for Pod D at detailed design stage. Therefore, a flood hazard rating of 1-2 has been adopted for this site.

Figure 2 in the attachments section shows site topography overlaid with concept plans of the proposed development.

Regardless of the building floor levels, there may be access difficulties in a major flood which may affect emergency procedures. Therefore, establishment of a robust flood management plan to provide for early and safe evacuation is recommended to mitigate safety risks.
