File Ref:		Permission No:	107380-OTH
Inspection Date:	16/11/2023		
Persons Present:	Department of Conservation Rangers, Nataalia Lunson Community, and Warren Geraghty Heritage and Visitor.		
	Lincoln Smith Terra Firma Mining Limited Managing Director Terra Firma Mining New Zealand.

SECTION 1: DESCRIPTION OF OCCUPATION

Location 2: 29261 - No.8 Level Portal Pad

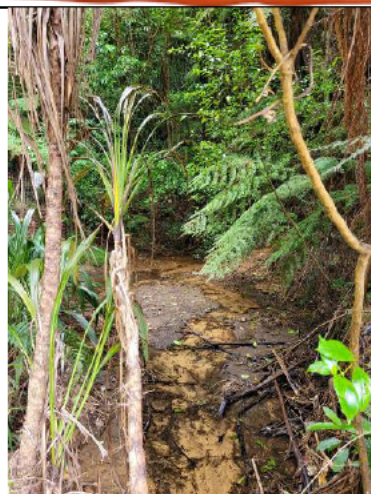
Are buffer zones from waterways in place?	Y			In some places this appears adequate in other areas it is not. This open stream is next to the mine entrance. Access to the stream is protected by a fence. A culvert runs underneath the path. The amount of water in the area is more significantly noticeable once entering the mine.

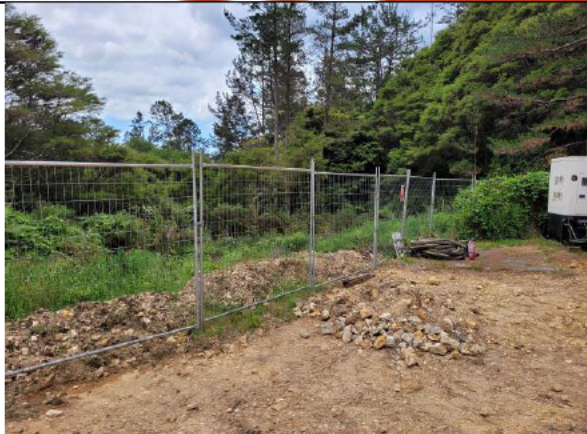
<p>This requires technical advice. Settling ponds are below in the gully behind the fenced area. We did not enter this area during this visit.</p>
Are adequate sediment controls in place?		NA	This requires technical advice and assessment. Efforts are evident towards mitigating surface flooding.
Is water discharge of an acceptable standard?		NA	This requires technical advice and assessment. Water testing has not been included in this visit.
Are access tracks/batter slopes stable & free from erosion?		NA	<p>I did not see purposeful mitigation against erosion risks. An open structure was visible and accessible. It appears to be used as a convenient storage cave.</p>

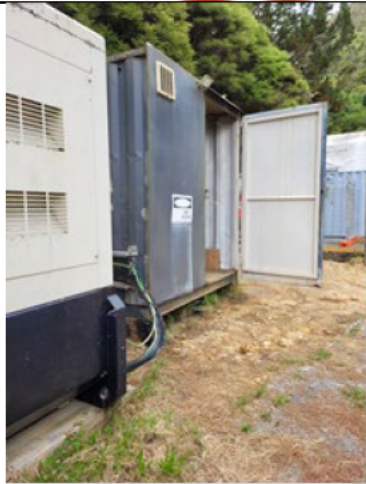
Are fire precautions in place?	Y			Many fire extinguishers are on site, but some were passed their expiry dates. New fire extinguishers are secured on the container doors to be easily available when doors are opened during work hours. Previously they were hung outside but were recently being interfered with people breaking through the security fenced site.	
Is waste material (e.g. drums, grease cartridges) being removed?		N		We were informed that the site is still being cleared and re-established as fit for purpose.	
Is the site free of rubbish?		N			
Is fuel storage & refuelling adequate?				This is to be audited by work safe	
Are the special conditions in the AA being adequately met?			N/A	This is not an AA inspection

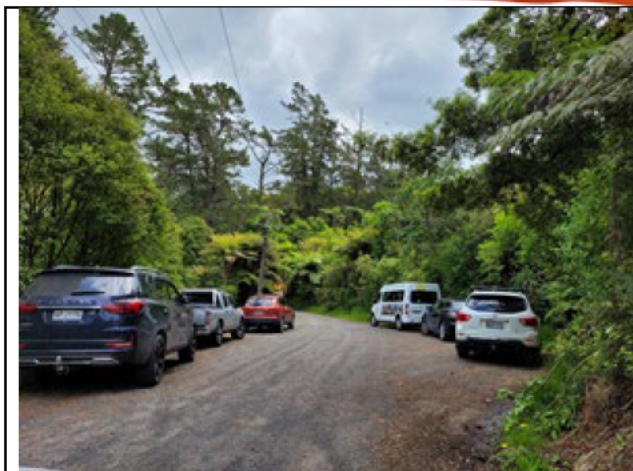
This is the entrance/start of No.8 Level Access Rd. This is where public park to start their walk up the road onto Karangahake. The carpark is beneath a Kauri grove.

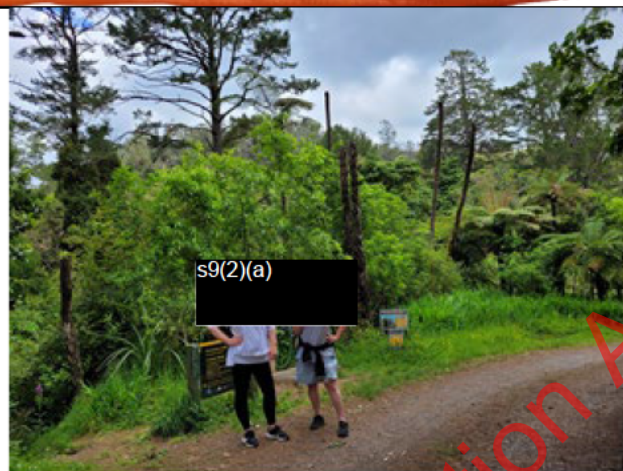
No.8 level access Rd is a public walkway. These are two teachers scoping for a school trip event. Behind them is a basic kauri wash station for shoes.

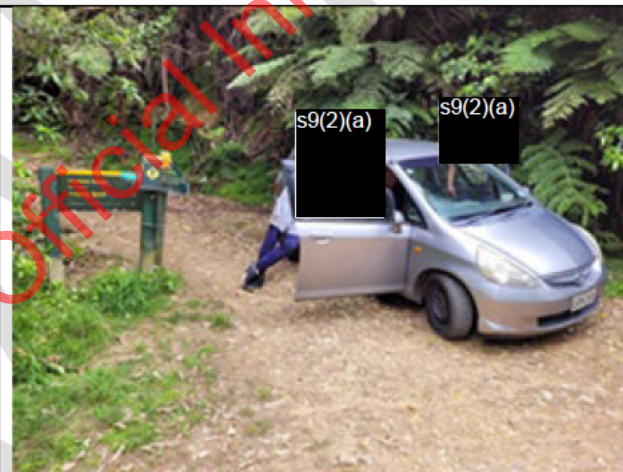
These three individuals have been identified as illegally mining beneath the No.8 Portal Pad. Strange behaviours of individuals are a common occurrence. The area is still attractive to gold mining hopefuls.

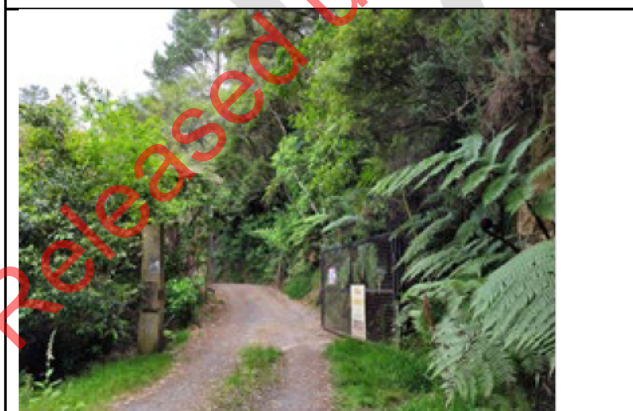
Security gate entrance into the No.8 Level pod. Note the change in the state of the road.

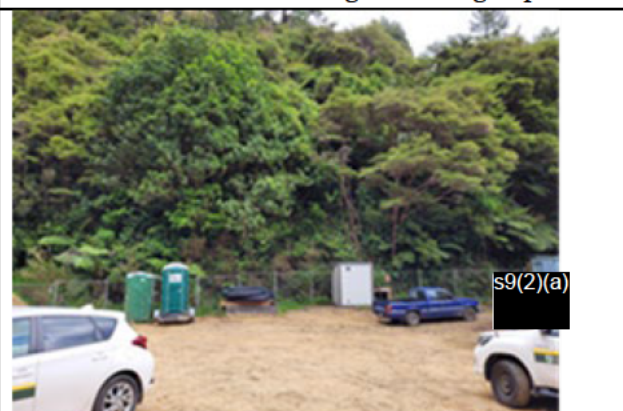
The blue ute is parked facing the gate entrance. During our visit the two teachers I meet on the way up, walked in casually looking for the walking track. Two green Portaloo's, but only one is useable.

A repeated one-off easement for this activity is not eligible. I recommend assessing the legal implications of structures on the site. The site is being prepared by the concessionaire to go into action prior to any approval. I recommend any progress in activity should require more than basic amenities such as a port-a-loo. I did not note any running water for drinking or showering.

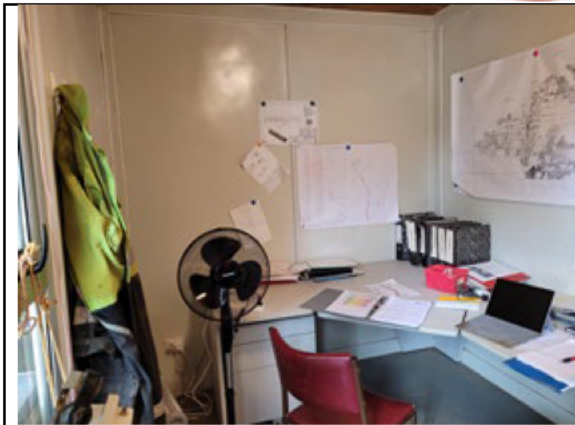
This pod is for the surface controller. On the desk are all the safety plan protocols, including maps and phone contacts.

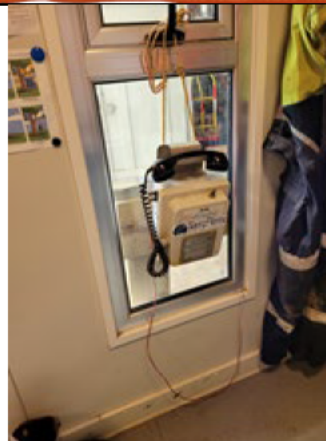
This phone is directly connected to the under-ground mine. Emergency contacts and PPE are instantly accessible.

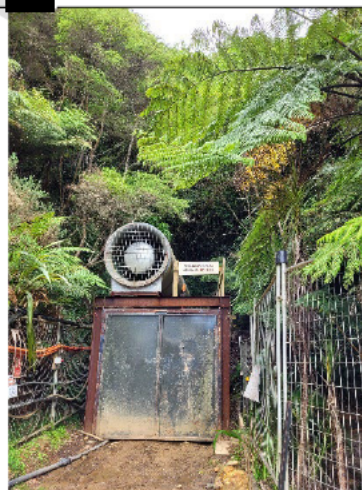
On top of the mine entrance sits the fan. Behind in the distance a waterfall can be heard.

Two diesel engines on site driving a generator and an underground ventilation blower. Requested that the exhausts be turned to exit inward to the earth floor site away from the steep scrub covered site peripheral. Also suggest that a nighttime spark arrestor observation be carried out at a time when/if the operation is in full swing.
