**AN ARCHAEOLOGICAL INSPECTION AND UPDATE OF THE  
PREVIOUSLY RECORDED ARCHAEOLOGICAL SITES ON  
MOTUOPAO ISLAND,  
TE PAKI**

Prepared for  
**Department of Conservation**  
**Northland Conservancy**  
**Kaitia Area Office**

By  
James Robinson MA (Hons)  
Archaeologist

November 2006

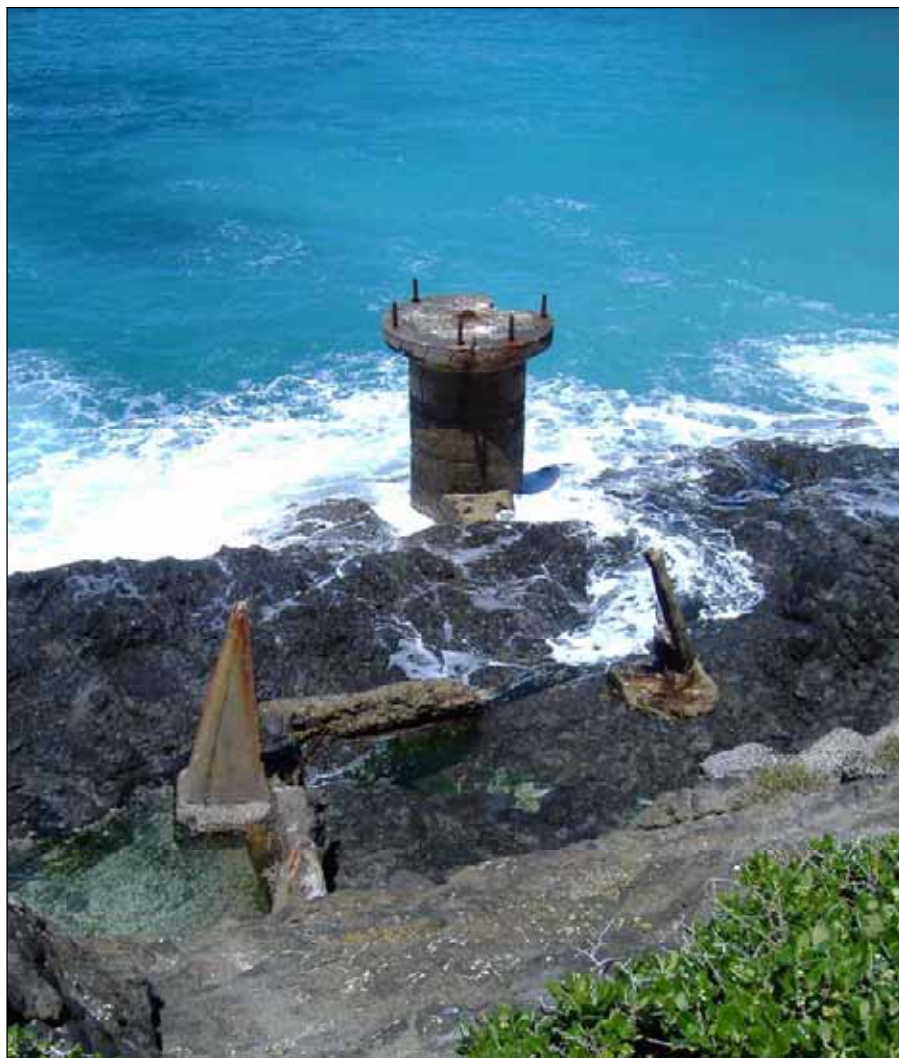
*View from the end of the lighthouse settlement tramway, looking east towards the second crane gantry constructed sometime after 1902 [LH2]*

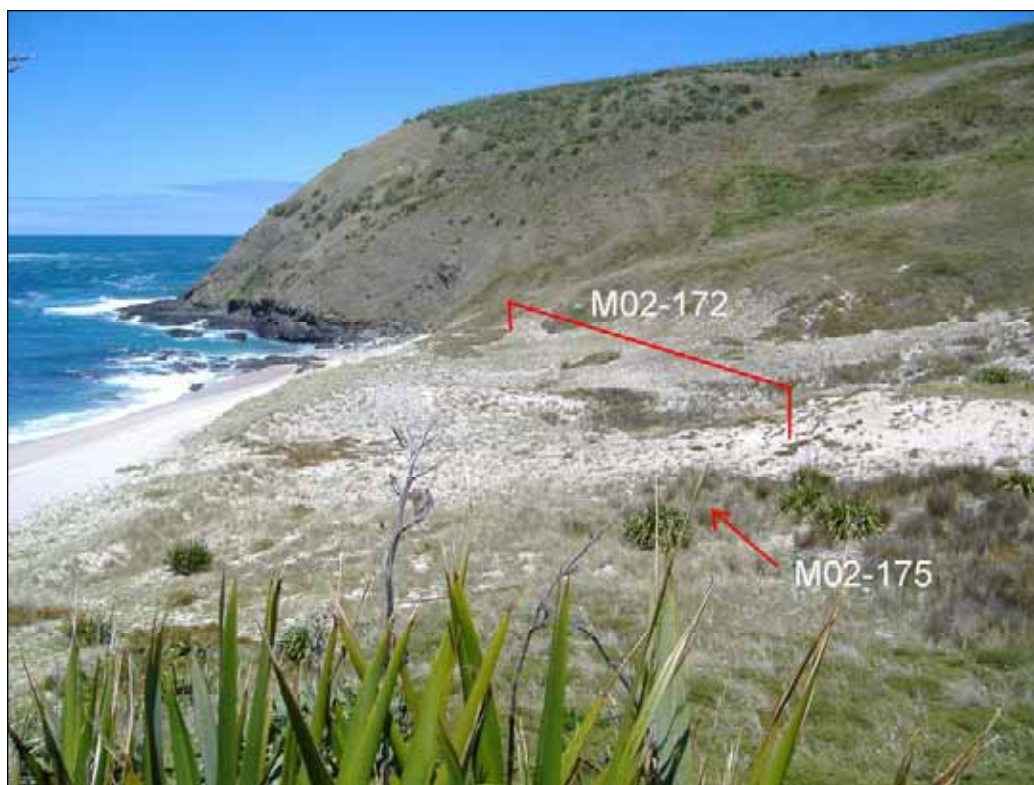
Plate 1: Relocated midden site M02-172 [P1] and stone heap site M02-175 [P4]

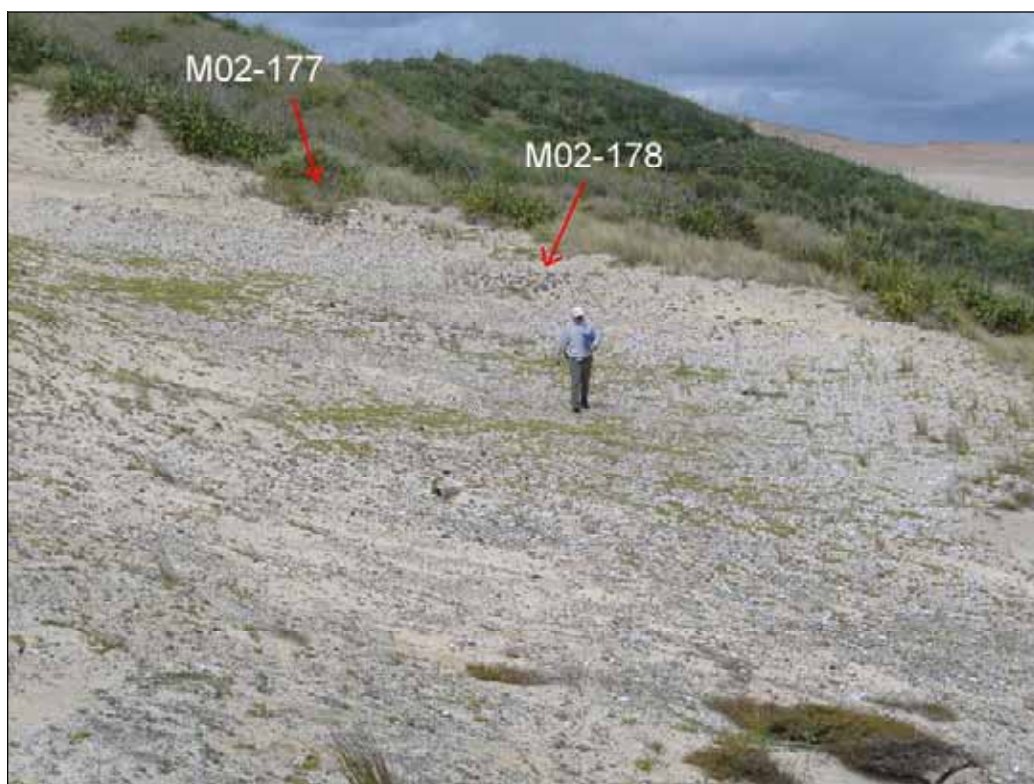
Plate 2: From hangi site M02-176 [P5] destroyed by erosion, looking east to the intact hangi sites M02-177 [P6] and M02-178 [P7].

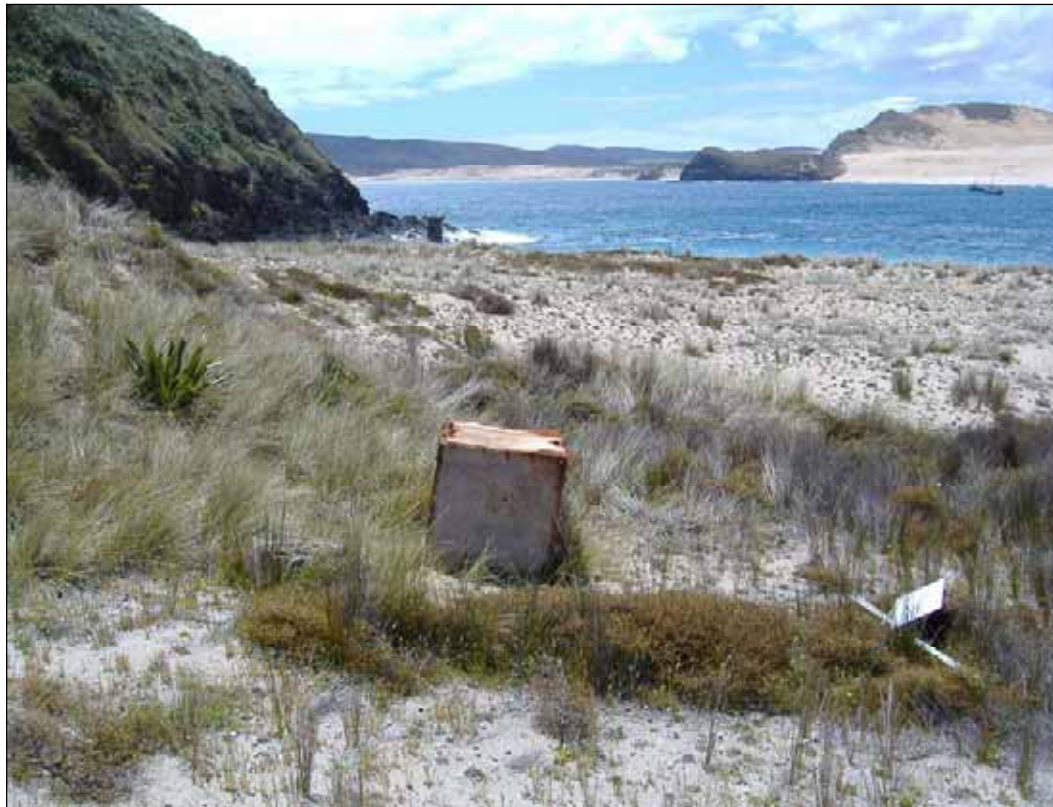
Plate 4: Square metal water tank looking towards the tramway gantry [LH21].

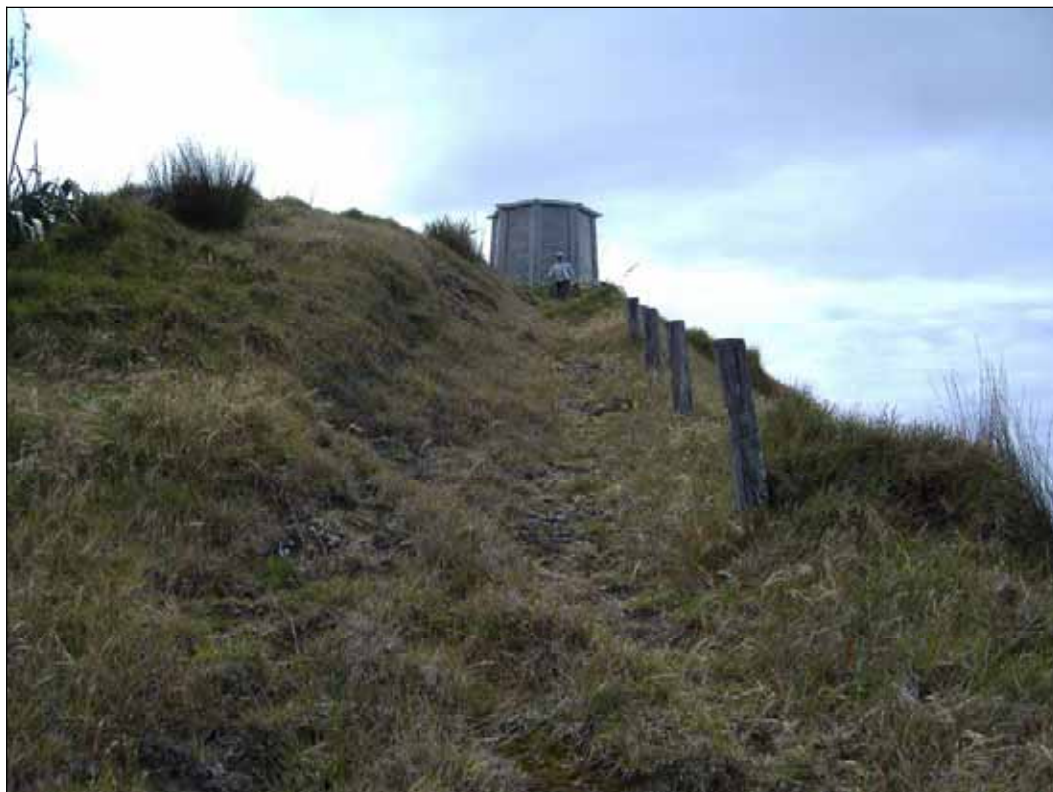
Plate 5: Looking north to the light tower [LH1] from the zigzag path [LH29].

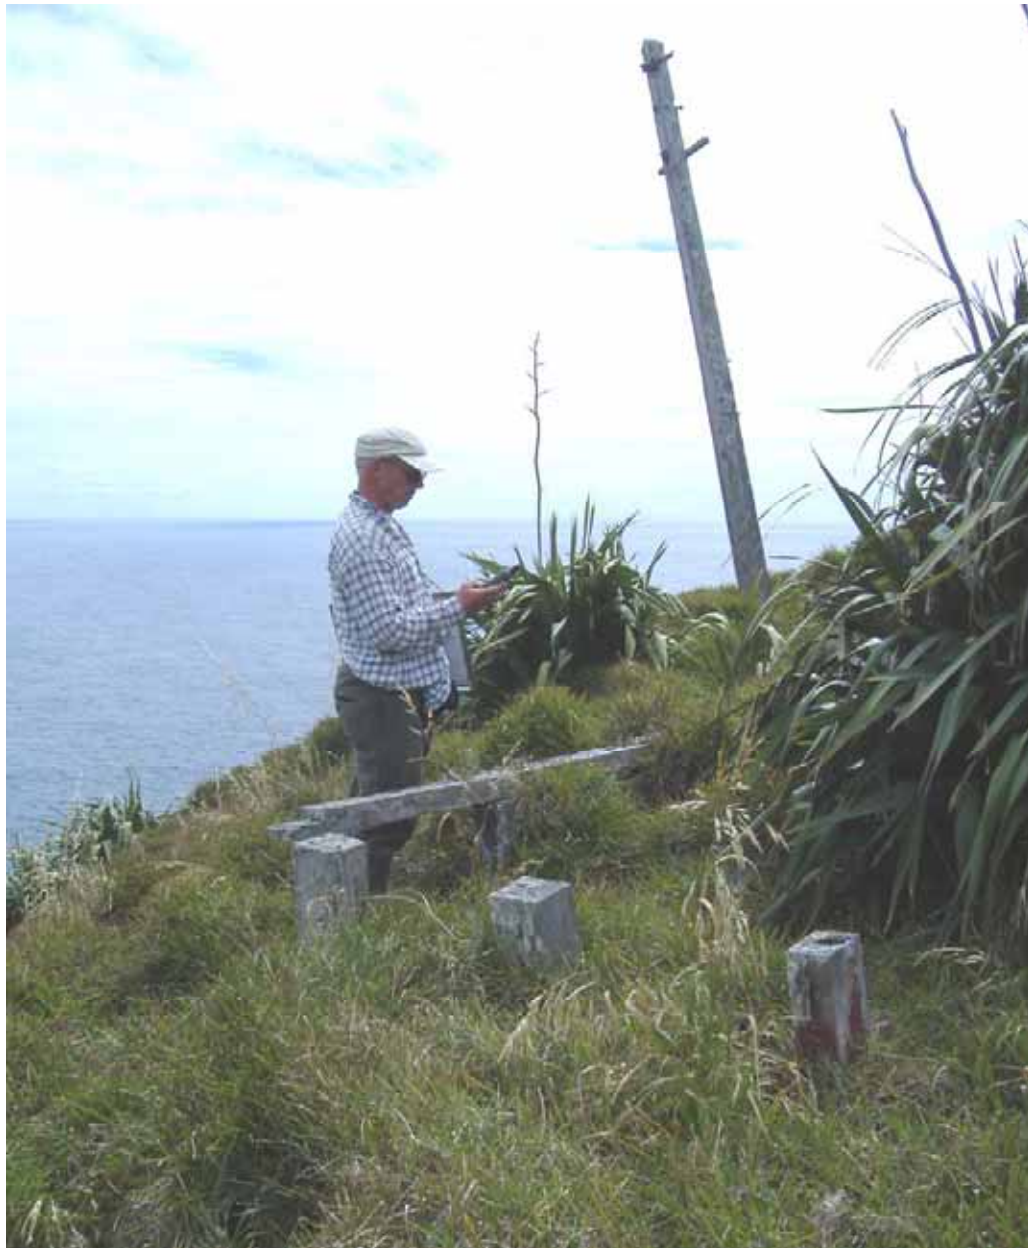
Plate 6: At the lighthouse looking west from the storehouse pile foundations [LH14] to the telegraph pole [LH1]

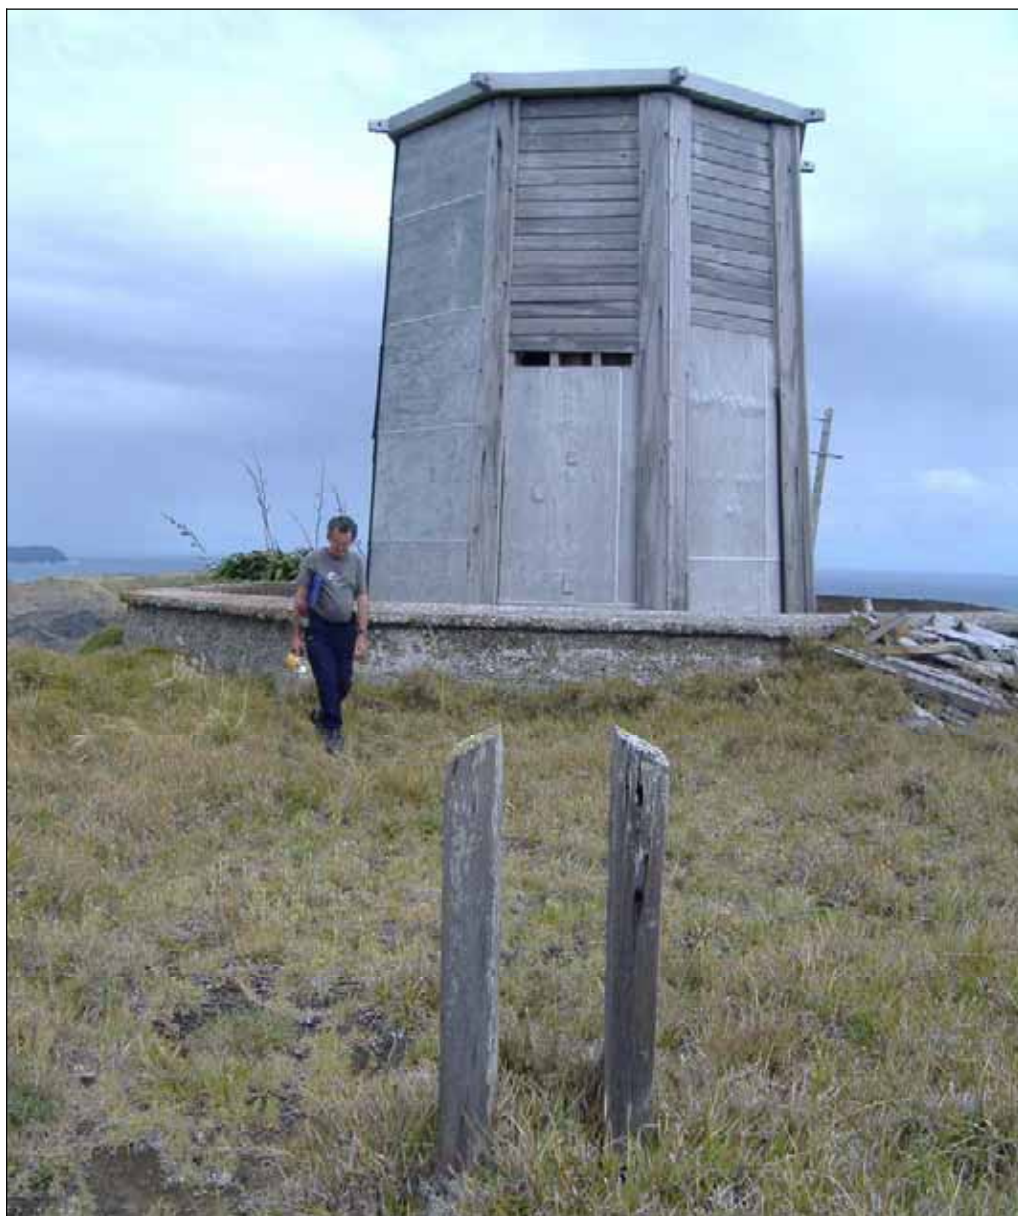
Plate 7: Looking south from the footing of the telegraph or weather mast [LH15] past the light tower [LH1], down the west coast to Scott Pt.
