Lessons Learnt 001

Installation of a fish ramp and baffles to restore fish passage at a perched culvert

Culvert

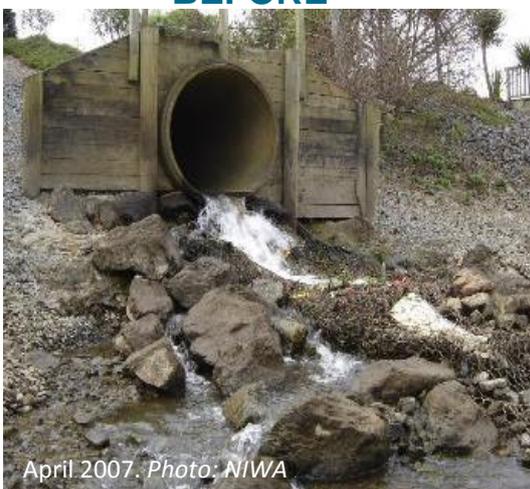
BEFORE

Several indigenous fish species were excluded from Bankwood Stream, Hamilton, by a perched concrete culvert (1.5 m diameter; 73.8 m length; gradient 0.3–2.55°). The culvert had not been built to facilitate fish passage, and as such the barrel water velocities were too high to permit upstream passage for swimming fish, such as inanga (*Galaxias maculatus*) and common smelt (*Retropinna retropinna*), and the outlet had become perched.

April 2007. Photo: NIWA

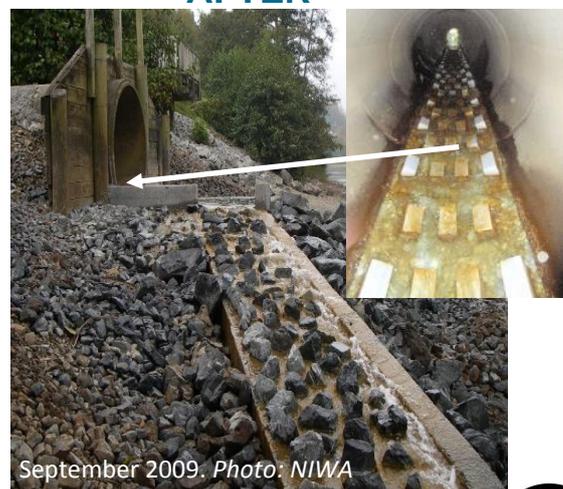
AFTER

September 2009. Photo: NIWA

* Improvement rating: 4/5 – Improved upstream and downstream passage for expected species.

We initially installed a fish ramp at the outlet of the pipe culvert. The ramp was made of concrete, embedded with cobbles and angled horizontally (5°). A receiving pool (approximately 2 m x 2 m) was installed at the top of the ramp. The final built ramp was 16 m long and 0.9 m wide, with a slope of 5.7°.

Thirty-six UV stabilized polyethylene spoiler baffle sheets (2 x 0.9 m; Rotational Plastics Ltd.), with baffles (0.25 x 0.10 x 0.12 m) spaced 0.10 m apart laterally and 0.25 m longitudinally, were secured to the culvert base with 5 mm Dynabolts™ and 20 mm stainless steel washers. Baffles were configured in alternating offset rows of 3–4 baffles.

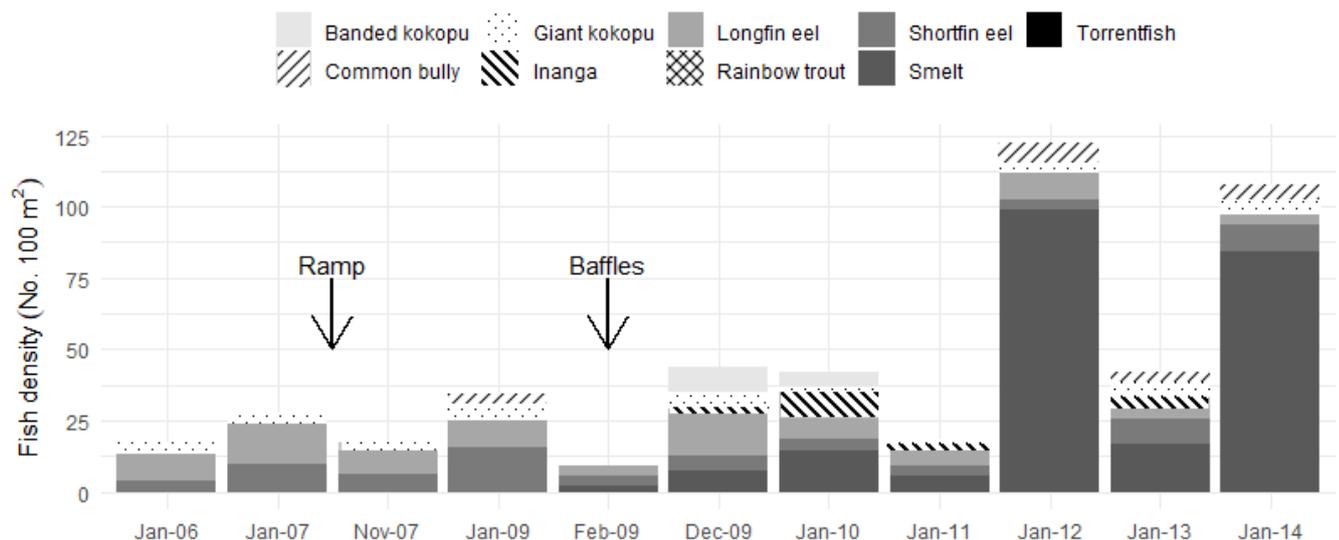
Monitoring showed that installation of a ramp allowed common bully and torrentfish passage upstream, and the ramp and baffles enabled juvenile banded kokopu, smelt, inanga and torrentfish to migrate upstream (Figure 1). Follow-up surveys since 2010 have shown that both smelt and inanga have continued to be present. We undertook quantitative electrofishing annually in January in two 50 m² reaches upstream of the culvert, and a few supplementary surveys were also carried out around the time the fixes were installed.

Figure 1. Results of fish community monitoring before and after ramp and baffle installation upstream of the culvert over time.
