Lessons Learnt 006

Fish passage facilitation by increasing flow and mussel spat rope installation on a dam spillway

October 2019 V2

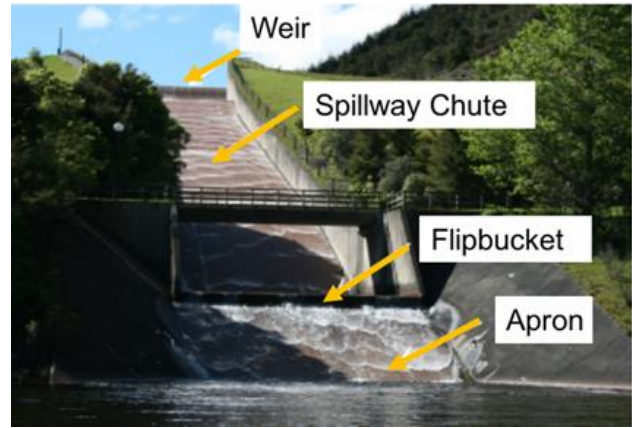
- Very long and steep spillway, which creates a barrier or diminishes upstream fish passage.
- Lack of wetted margins and rest areas for migrating fish during high flow.
- Lack of flow / no flow on the spillway at times during juvenile eel and whitebait migration season.
- High water temperatures in and around the Maitai Dam due to stagnant water.
- Flip Bucket drying out during low lake levels.

Figure 1. The Maitai Dam with weir, spillway, flip bucket and apron.

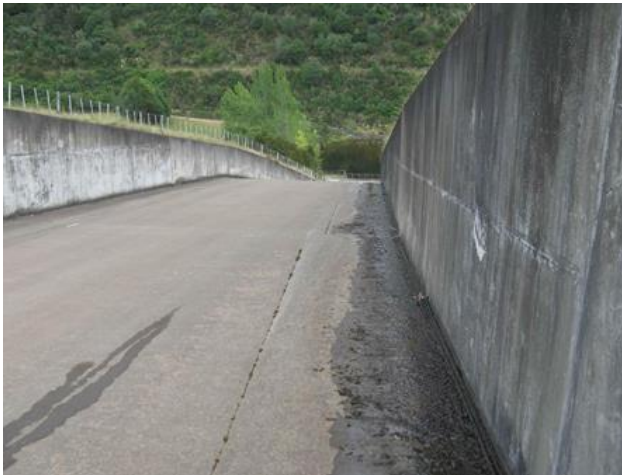
Figure 2. We installed the pump at the shady side of the spillway to ensure permanent water flow down the spillway and apron.

- Installation of a pump (Figure 2) to deliver water (capacity = 3.5 L/s) from the reservoir to the spillway crest at times when the reservoir water level is too low for spilling to occur. This ensures continuous flow down the spillway during summer migration periods.

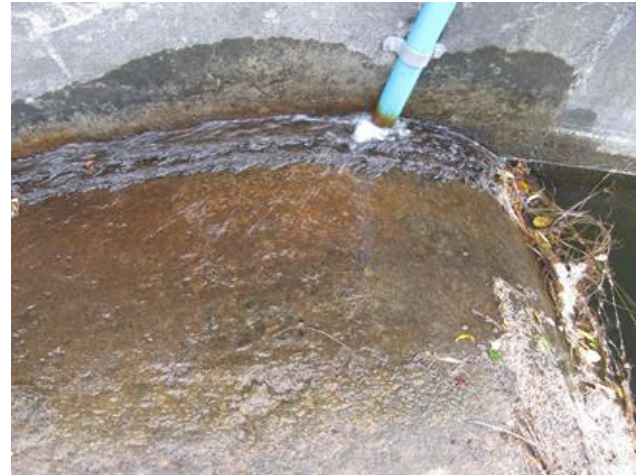
Figure 3. Mussel spat ropes installed at the shady side of the dam where the pump provides water to facilitate upstream passage of juvenile eels and kōaro.

- Plugging the drainage outlets in the flip bucket with rubber bungs to maintain the pool that usually forms in this bucket when spilling occurs.
- Installation of 'Xmas Tree'¹ mussel spat ropes (Figure 3) down the total length of the spillway (i.e. 151 m) and downstream of the flip bucket, adjacent to the true right spillway wall, to provide additional cover as well as resting and climbing opportunities for migratory fish. Two spat ropes side by side were installed with approx. 100 mm between them.

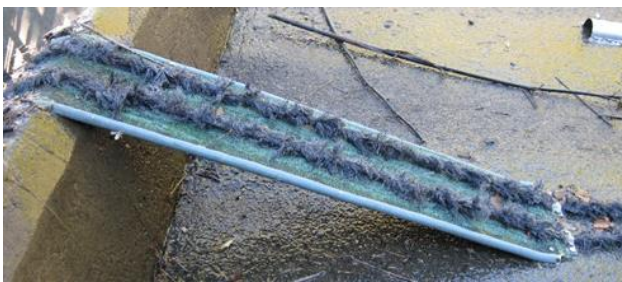
Figure 4. An aluminium ramp with astroturf lining and two mussel spat ropes installed to assist fish passage from the very beginning of the long climb ahead.

- Installation of a short ramp (i.e. aluminium ramp with astroturf lining and two mussel spat ropes) from the lip of the flip bucket to the spillway apron below, to allow climbing fish to avoid the steep transition into the flip bucket (Figure 4).

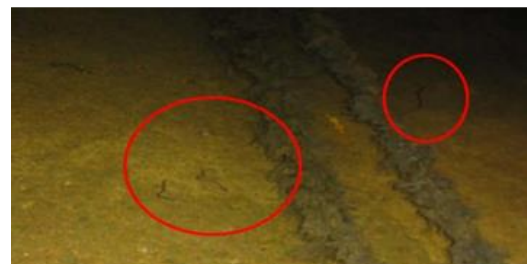
Figure 5: Resting juvenile eels are using mussel spat ropes for cover in the flip bucket.

The spat rope was being used for cover by resting elvers, particularly in the flip bucket pool (Figure 5), but also on the spillway. The spat rope was also observed being used by a few elvers to assist in climbing the spillway; most of the climbing occurred in the wetted splash zone on the spillway, away from the spat ropes.
