# Lessons Learnt 10

## Mussel spat rope and rubber apron remediation of Tōtaranui Road culverts.

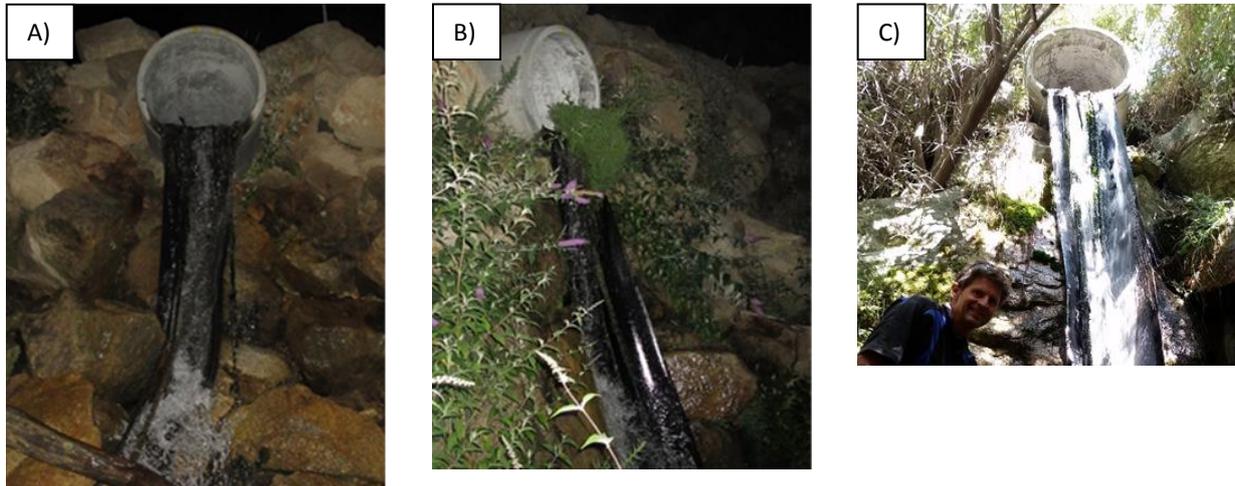
Due to cost restraints, culverts, which overhung the stabilising rock rip rap of the road embankments, were installed instead of bridges. The newly installed culverts formed a complete barrier to fish passage with a 6-8 m vertical fall and a 0.3-0.5 m horizontal undercut (Figure 1).

The aim of the remediation work was to reconnect the downstream and upstream habitat for climbing fish species at three culverts perched by over 6 m (see Figure 1). The objective was to enable fish to access good quality native bush habitat upstream of the culverts.

**Figure 1: Examples of the retrofitted culverts with rubber apron and mussel spat rope on Tōtaranui and Awaroa Roads, Abel Tasman National Park in 2014. A) Culvert 9, B) Culvert 18, C) Culvert 31. (Photos: Tasman District Council)**

In February 2013, we retrofitted the culverts with mussel spat rope and rubber aprons to allow fish to climb up the vertical drop. We attached mussel spat rope at the inlet of the culvert and all the way through to the stream below. The aprons were attached to the outlet of the culvert.

This remediation took c. 1.5 person hours to complete and cost less than \$40 in fixings, with all other materials being donated. Six strands of spat rope were used through each culvert, attached to the culvert with bolts, and extended just beyond the downstream end of the apron (a total length of 32 m of spat rope for culvert 18).

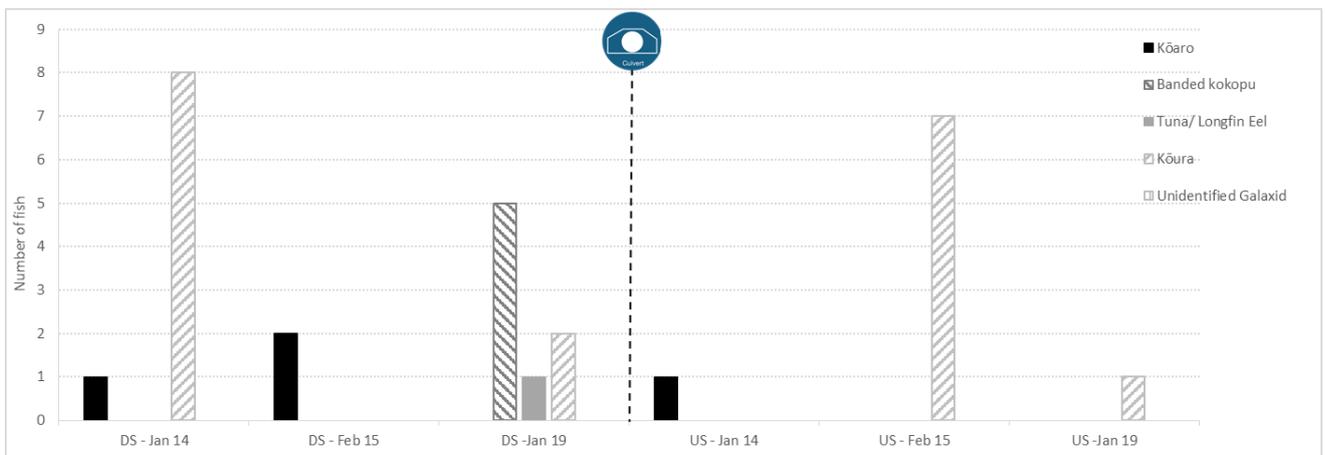
**Figure 2: Number of fish for each species present upstream (US) and downstream (DS) of Culvert 9 in 2014, 2015 and 2019.**

3. The one situation where no fish were found upstream of culvert 9 appears to be due to the rip-rap rock protection and the water flowing between the rock and not on the surface (i.e. downstream of the culvert). High numbers of fish were observed in the stream below this rock rip rap but none above it or upstream of the culvert. This suggests that the rock rip rap is at fault. It would be useful to install a longer apron to extend over the rock work and then sample again after a spring upstream migration.

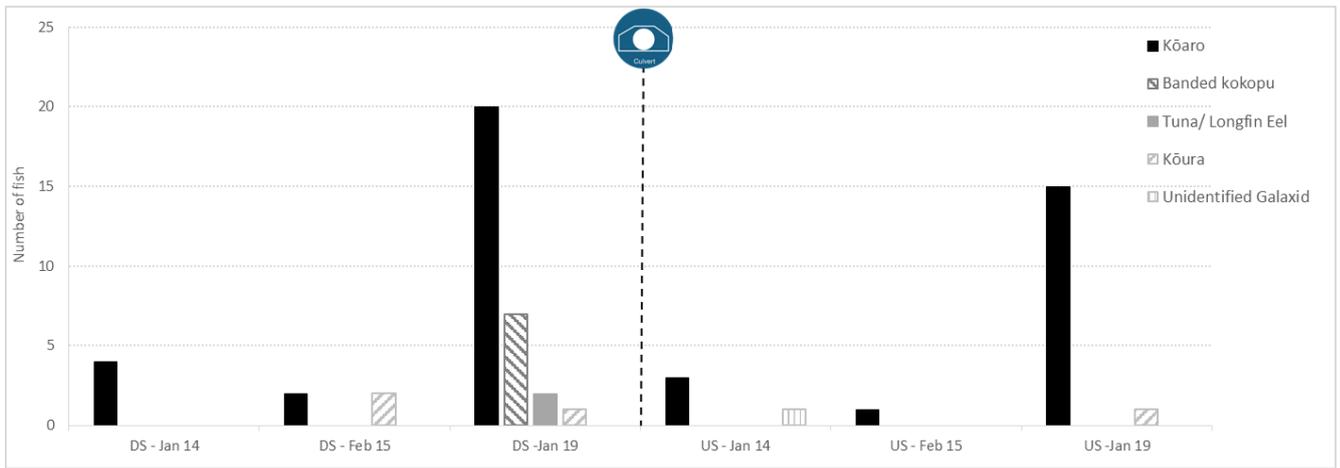
- Juvenile kōaro were observed upstream and downstream of culverts 18 and 31, during all sampling years.
- Kōaro ranged between 50-110 mm in length in 2014 and 2015, whereas in 2019 there was a larger range of sizes with maximum lengths reaching up to 180 mm.
- Tuna were found upstream of Culvert 31 in 2015 and 2019.
- Upstream and downstream of culverts 18 overall fish abundance increased dramatically in 2019.
- At culvert 9, kōaro were observed in low numbers both upstream and downstream, but only in 2014. No fish were seen upstream of culvert 9 in the 2015 and 2019 surveys.
- As expected, no other fish species were found during sampling.

**Figure 3: Number of fish for each species present upstream (US) and downstream (DS) of Culvert 18 in 2014, 2015 and 2019.**

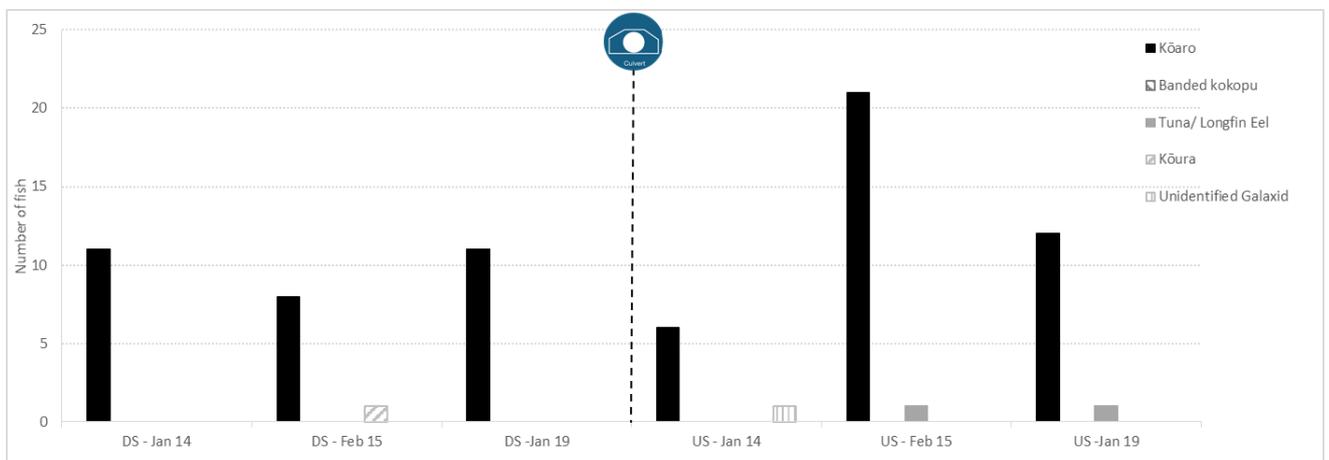
**Figure 3: Number of fish for each species present upstream (US) and downstream (DS) of Culvert 31 in 2014, 2015 and 2019.**
