ARTILLERY CAMP ADMINISTRATION BAY MOTUTAPU ISLAND

A HERITAGE ASSESSMENT

Prepared for the
Department of Conservation

By
Dave Pearson Architects Limited

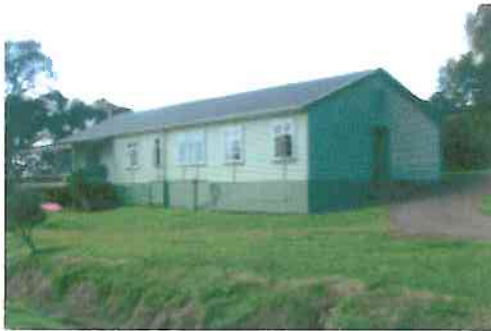
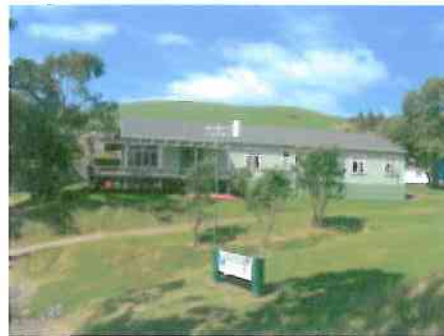
BUILDING 2 – VISITOR LODGE (FORMERLY OFFICERS' QUARTERS)

Description	
Exterior	
Roof	Corrugated steel roof.
Walls	Weatherboards, vertical baseboards.
Joinery	Timber doors & casement windows.
Interior	
Ceilings	Original ceilings - timber T&G.
Walls	Original walls – timber T&G.
Floors	Timber tongue & groove/concrete to shower & toilet areas.
Modifications	
Exterior	
<ul style="list-style-type: none"> • Deck and verandah added to west elevation near north end, also to north elevation. • Doors and windows all changed in same area. • Porch to east elevation roofed over. • Toilet waste added. • Roof replaced, spouting replaced with plastic. 	
Interior	
<ul style="list-style-type: none"> • Lounge area at north end of building relined. • Bench fittings added. • Showers added, also some later partitions & linings 	
Condition	
Exterior	
Roof, walls	Roof & wall areas in reasonable condition.
Joinery:	Joinery in reasonable condition.
Interior	
All surfaces:	Generally good condition.

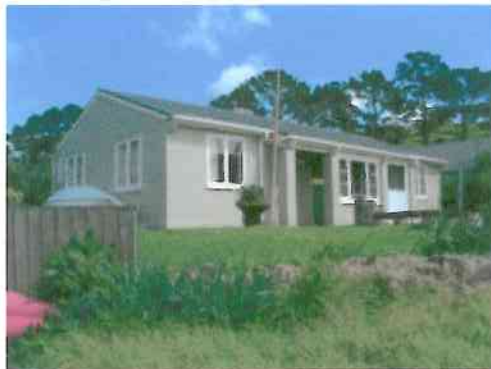
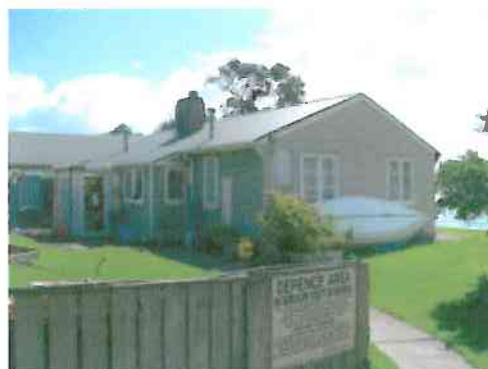
BUILDING 3 – CARETAKER'S DWELLING (FORMERLY OFFICERS' MESS)

Description	
Exterior	
Roof	Corrugated steel roof
Walls	Concrete
Joinery	Timber casement sashes.
Interior	
Ceilings	Softboard/plasterboard
Walls	Plasterboard, hardboard to bathroom area.
Floors	Concrete
Joinery	Ply faced doors
Trim	Timber
Features	Fireplace
Modifications	
Exterior	
<ul style="list-style-type: none"> • Porch to north elevation partly infilled. • Porch added to south elevation. • Roof replaced. • Spouting replaced with plastic. 	
Interior	
<ul style="list-style-type: none"> • Some wall/ceiling linings changed. • Shower toilet not original. • Kitchen bench, pantry installed. • Some finishing trim changed. • Plaster fire surround possibly not original.

Condition	
Exterior	
Roof:	Good condition.
Walls	Walls in good condition.
Joinery:	Paintwork flaking.
Interior	
Ceiling:	All surfaces generally in good condition.
Walls:	
Floor:	
Trim:	
Joinery:	
Assessment of Significance	
<p>Building 3 is unusual with its concrete floor and wall construction. The exterior is essentially in its original form, with only minor alterations. Some relatively minor modifications have been made to the interior. As the former officers' mess, it has considerable significance. There is potential in the future for a recovery of significance.</p> <p>Present overall rating – Considerable</p> <p>Potential rating – Considerable</p>	
Considerable	Original concrete walls, timber window joinery, original internal doors, trim, fireplace.
Some	Chimney, concrete floors, softboard ceiling linings.
Not relevant	Roofing, later internal linings, bathroom and kitchen fixtures & fittings.
Intrusive	Later porch to south elevation, infills to north elevation, plastic spouting.

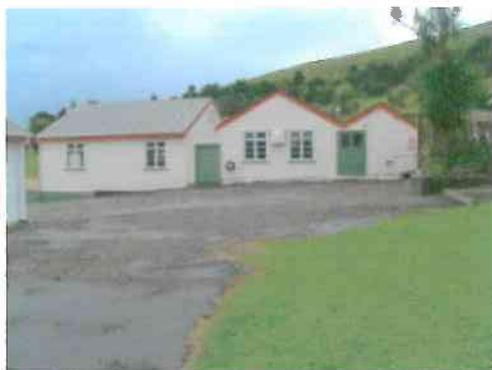
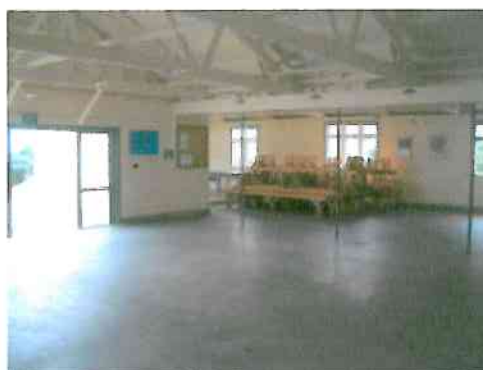
BUILDING 12 -15 – KITCHEN, DINING HALL (FORMERLY WASHUP, COOKHOUSE, COALSTORE, VEGETABLE STORE)

Description	
Exterior	
Roof	Corrugated steel roof
Walls	Weatherboards over timber frame. Timber baseboards.
Joinery	Timber casements, aluminium sliding doors.
Interior	
Roof framing	Timber sarking, purlins on timber trusses.
Ceilings	Plastic faced hardboard in kitchen.
Walls	Tongue and groove linings/hardboard/softboard.
Floors	Concrete/particle board.
Trim	Timber.
Modifications	
<p>The building has been extensively altered over the years. The original drawings describe it as an emergency mobilisation kitchen and the building comprised a kitchen space, off which opened a butchery, a vegetable preparation area, a dry store and what may have been an area in which a refrigerator was located. A lean-to was constructed to the northwest of the kitchen and appears to have contained a basin and a sink. A plan dated 1941 shows an engine room behind the kitchen and behind this again, a coal store. The lean-to may have been extended. An undated but slightly later plan shows an addition to the northeast of the original kitchen. A vegetable locker has been added to the back of the coal store.</p> <p>Further changes have occurred to the building. While some of these undoubtedly occurred when the camp became the outdoor education centre, other changes may have been earlier. Changes known to have taken place include the removal of the northeast wall of the original kitchen (possibly when the addition to the side took place), the removal of the internal partitions from the original kitchen, the infilling of the space between the original kitchen and the coal store (the present kitchen) and the removal of the original lean-to. A concrete floor was poured over the original timber floor.</p> <p>Changes that appear recent include the installation of aluminium sliding doors in the northwest elevation, the construction of a deck along the same side the relining of the present kitchen (formerly the coal store) and the installation of a cool store in what was the vegetable locker. In recent times, a shelter for washing up has been added to the northeast side of the kitchen.</p>

Exterior	
<ul style="list-style-type: none">• Roof replaced.• Spouting replaced with plastic.• Deck and steps added to northwest elevation.• Aluminium joinery added to northwest elevation.• Sash missing from window in northwest wall.• Area between old kitchen and coal store infilled.• Wash up area added to northeast face.• Louvre windows added to kitchen area.• Gas water heaters added to exterior of building.• Fan added to exterior wall.	
Interior	
<ul style="list-style-type: none">• Kitchen. Area relined, fittings added, opening added in northwest wall.• Cool store, freezer area. Area relined, cool room installed.• Dining area. Hardboard wall linings added.• Concrete slab added over original timber floors.	
Condition	
Exterior	
Roof:	Good condition.
Walls	Generally good condition.
Joinery:	Sash missing, northwest wall.
Interior	
Ceiling:	All surfaces generally in reasonable condition.
Walls:	
Floor:

Trim:	
Joinery:	
Assessment of Significance	
<p>The exterior of the kitchen building has been extensively added to and modified over the years. Some of the changes, notably the aluminium joinery detract from the original building. Changes have also occurred to the interior as areas have been relined and fittings have been added. In the dining area, the exposed roof trusses can still be readily seen. In its present form it has some significance. There is potential in the future for a recovery of significance.</p> <p>Present overall rating – Some</p> <p>Potential rating – Considerable</p>	
Considerable	Original timber window joinery. Weatherboards, original facings & trim. Original timber trusses, roof sarking. Original internal T & G linings.
Some	Other original internal linings.
Not relevant	Roofing, timber deck & steps, washing up area Later timber joinery, internal linings, kitchen fittings.
Intrusive	Plastic spouting, aluminium joinery.

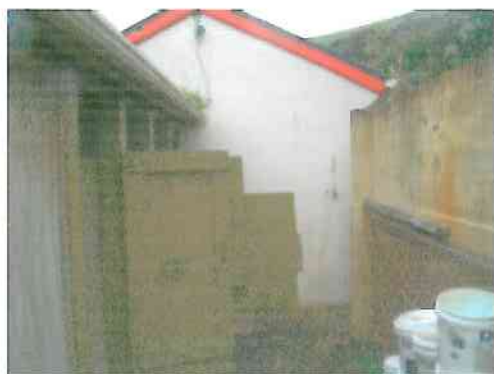
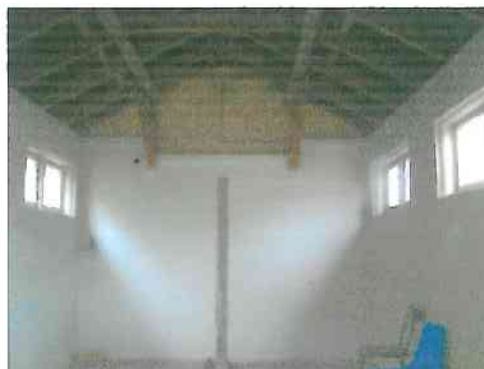
BUILDING 16 – OLD ABLUTION BLOCK (FORMERY SHOWERS, TOILETS)

Description	
Exterior	
Roof	Corrugated steel roof.
Walls	Concrete.
Joinery	Timber casements. Tongue & groove sheathed doors.
Interior	
Roof framing	Timber rafters, purlins.
Ceilings	N/A.
Walls	Concrete.
Floors	Concrete.
Modifications	
Exterior	
<ul style="list-style-type: none"> • Wall above urinal extended. • Some doors to toilet area removed and replaced with ply sheathing. • Roof replaced, spouting replaced with plastic. • Plastic services added. 	
Interior	
<ul style="list-style-type: none"> • Partitions to showers & toilets removed. 	
Condition	
Exterior	
Roof:	Roof in reasonable condition.
Spouting:	Weeds growing in spouting.
Walls:	Hole broken through wall, southeast elevation for service pipes.
Joinery:	One window sash missing. Paintwork flaking from joinery.
Interior	
All surfaces:	Generally reasonable condition.

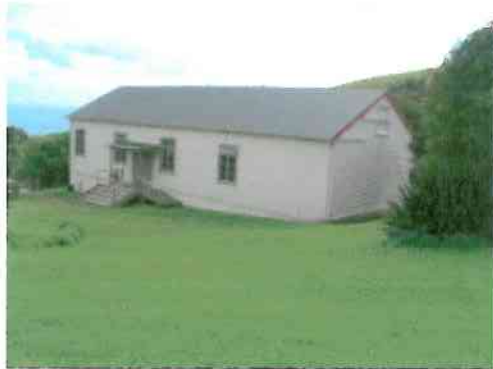
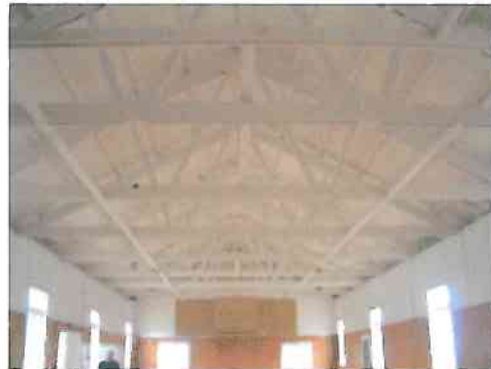
BUILDING 17 – GYMNASIUM (FORMERLY RECREATION HALL)

Description	
Exterior	
Roof	Corrugated steel roof
Walls	Weatherboards over timber frame. Fibre-cement sheathing to northwest wall.
Joinery	Fibre-cement base. Timber casements
Interior	
Roof framing	Timber sarking, purlins on timber trusses.
Ceilings	N/A
Walls	Particleboard to lower section.
Floors	Particleboard over original tongue & groove.
Trim	Timber.
Modifications	
Exterior	<ul style="list-style-type: none"> • Roof replaced. • Spouting replaced with plastic. • Canopy, steps, ramp added to southwest elevation. • Doors to southwest elevation probably original but resheathed. • External timber framing added to southeast elevation to support interior climbing frame. • Door nearest east corner of northeast elevation probably original but hinges changed. • Second door added on northeast elevation. • Northwest wall resheathed with fibre-cement. • External timber framing added to northwest elevation to support basketball hoop. • Fibre-cement base sheathing added.

Interior	<ul style="list-style-type: none"> • Floor overlaid with particleboard. • Particleboard added to lower section of walls. • Lining to upper section of walls possibly not original. • Basketball hoops, climbing wall added.

Condition	
Exterior	
Roof:	Good condition.
Walls	Generally good condition.
Joinery:	Sash missing, northeast wall.
Interior	
Ceiling:	All surfaces generally in good condition.
Walls:	
Floor:	
Trim:	
Joinery:	
Assessment of Significance	
The exterior of building 17 is generally in its original form, although the steps and canopy have been added to the southwest elevation and the northwest elevation has been resheathed. Changes have occurred to the interior as original linings have been overlaid with particleboard. The original construction with the exposed roof trusses can still be readily seen. As the former recreational hall it has considerable significance. There is potential in the future for a recovery of significance.	
Present overall rating – Considerable	
Potential rating – Considerable	
Considerable	Original timber window joinery, original doors. Weatherboards, vent in end wall, original facings & trim. Original timber trusses, roof sarking.

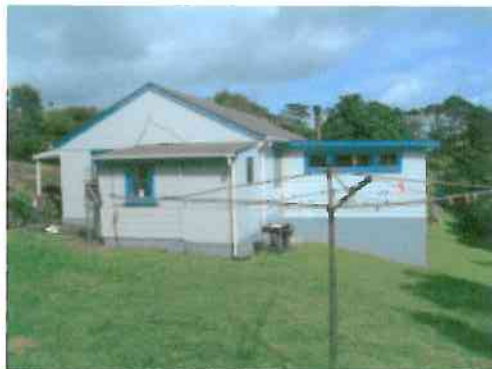
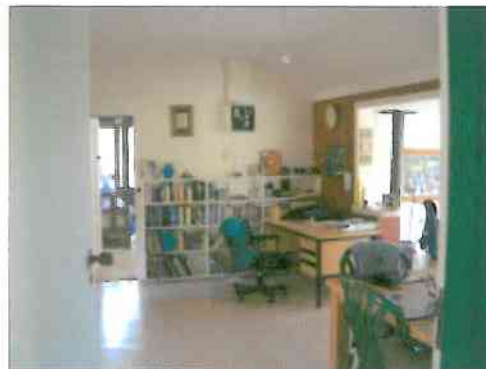
BUILDING 18 – TEACHER'S DWELLING (FORMELY HOSPITAL)

Description	
Exterior	
Roof	Corrugated steel roof
Walls	Concrete (original section) Fibre-cement (addition)
Joinery	Timber casements
Interior	
Ceilings	Softboard (original section)
Walls	Softboard (original section) Hardboard (bathroom)
Floors	Concrete (original section) Timber (extensions)
Joinery	Ply faced doors
Trim	Timber
Modifications	
Exterior	<ul style="list-style-type: none"> • Canopy added to south elevation. • Early lean-to added to east elevation. Later extended. • Living room and deck added to north elevation. • Roof replaced. • Spouting replaced with plastic.
Interior	<ul style="list-style-type: none"> • Kitchen installed. • Opening added through to new living room. • Door to bedroom probably not original. • Switchboard added.

Condition	
Exterior	
Roof:	Good condition.
Walls	Rust stains by living room extension. Elsewhere walls in good condition.
Joinery:	Paintwork flaking.
Interior	
Ceiling:	All surfaces generally in good condition.
Walls:	
Floor:	
Trim:	
Joinery:	
Assessment of Significance Building 18 is unusual with its concrete floor and wall construction. The original form of the exterior can still be readily seen, despite various additions. Some relatively minor modifications have been made to the interior. As the former hospital, it has considerable significance. There is potential in the future for a recovery of significance. Present overall rating – Considerable Potential rating – Considerable	
Considerable	Original concrete walls, timber window joinery, original internal doors, trim. Concrete floors, softboard ceilings & wall linings, earlier lean-to. Roofing, later canopy to south elevation, later internal fixtures & fittings. Later additions, deck, plastic spouting.

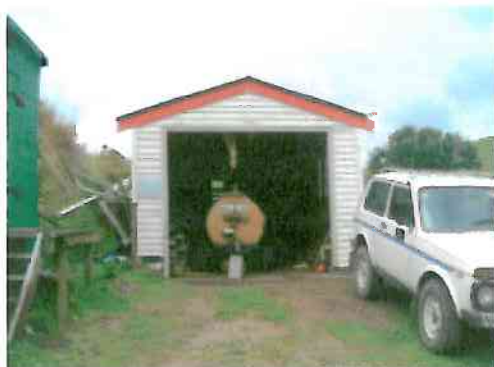
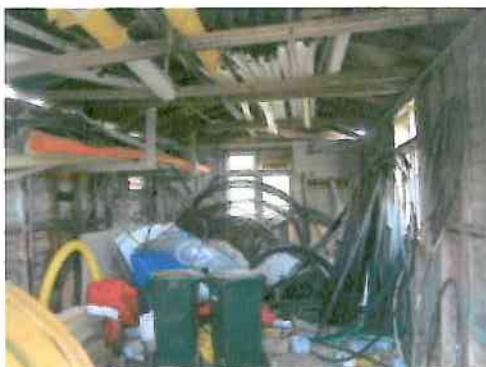
BUILDING 21 – TRACTOR SHED (FORMERLY CARPENTER, POWER STATION)

Description	
Exterior	
Roof	Corrugated steel roof
Walls	Weatherboards on timber framing.
Joinery	Timber casements
Interior	
Roof framing	Timber rafters
Ceilings	N/A
Walls	N/A
Floors	Concrete
Modifications	
Exterior	
<ul style="list-style-type: none"> • Windows in west wall nearest north wall possibly reused from elsewhere (sashes upside down). • North wall reframed. • Some weatherboards to east wall replaced. • Door in west wall not original. • Spouting replaced with plastic. 	
Condition	
Exterior	
Roof:	Some rust evident in underside of sheets. Roof partly lifted and barge flashing at south end loose.
Walls:	Extensive decay and borer in weatherboards. Walls bowed, particularly east wall.
Joinery:	Paint flaking to window joinery. Door in west wall extensively decayed. Rust stains by living room extension. Elsewhere walls in good condition. Paintwork flaking.
Interior	
Roof & wall framing:	Extensive borer in rafters & one rafter split Rafters and top plates separating.

The tractor shed was formerly the carpenter's shop and power station. It is a simple building with a shallow pitched roof and weatherboard walls. It has some significance as part of the overall Administration Bay complex. It is in poor condition.

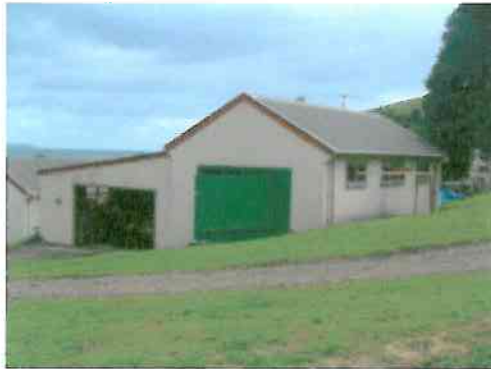
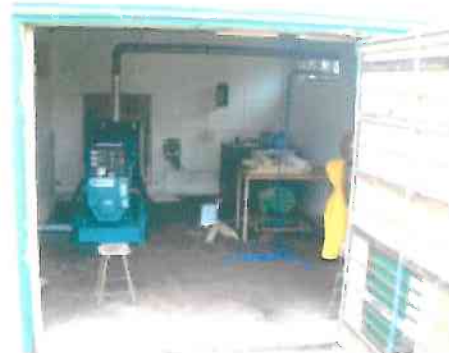
BUILDING 22 – GENERATOR SHED/PROPAGATION UNIT (FORMERLY MOTOR TRANSPORT WORKSHOP)

Description	
Exterior	
Roof	Corrugated steel roof
Walls	Concrete (original section)
Joinery	Timber casements
Interior	
Roof framing	Timber rafters, purlins.
Ceilings	N/A
Walls	Later timber framed wall
Floors	Concrete
Modifications	
Exterior	
<ul style="list-style-type: none"> • Original opening infilled, northeast wall. Door with louvre, porch added. • Glass from windows, southeast wall, removed, replaced with wire netting. Flue extended through window. • Door to southwest elevation changed. • Propagating shed, store added, northwest elevation. • Roof replaced, spouting replaced with plastic. 	
Interior	
<ul style="list-style-type: none"> • Timber wall added to partition off drying room, lined with fireproof board in generator room. • Ceiling added in drying room. • Switchboards added in generator room. 	
Condition	
Exterior	
Roof, walls:	Roof & walls in reasonable condition.
Joinery:	Sashes damaged when glass removed and wire netting installed.

Services:	Rusting cast iron pipe at east corner.
Interior	
Roof framing:	Generally good condition.
Interior linings:	Good condition.

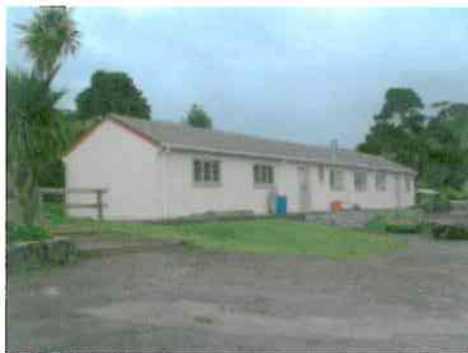
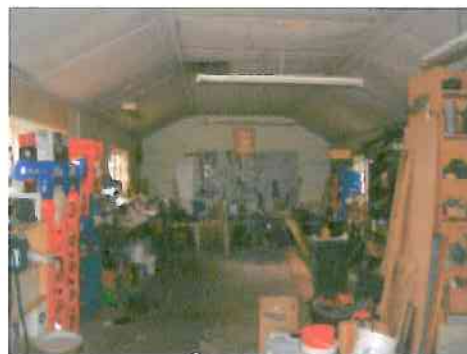
BUILDING 23 – WORKSHOP & FLAT (FORMERLY QUARTERMASTER STORE)

Description	
Exterior	
Roof	Corrugated steel roof.
Walls	Concrete.
Joinery	Timber casements. Tongue & groove sheathed doors.
Interior	
Ceilings	Softboard
Walls	Hardboard on later timber framed wall
Floors	Timber tongue & groove
Modifications	
Exterior	<ul style="list-style-type: none"> • Louvre window added to northwest elevation. • Louvres added to toilet windows, southeast elevation. • Canopy over doors, southeast elevation probably added. • Gas cylinder housing, plastic pipework added, southeast elevation. • Roof replaced, spouting replaced with plastic.
Interior	<ul style="list-style-type: none"> • Timber wall added to partition off staff area. Toilet, shower facilities added.
Condition	
Exterior	
Roof, walls:	Roof & walls in reasonable condition.
Joinery:	Glazing bar missing from one window.
Interior	
All surfaces:	Generally good condition.
Assessment of Significance	
<p>The exterior form of the workshop is generally original with only minor modifications having been carried out. The interior has been modified to provide staff facilities. As the former quartermaster store, it has considerable significance.</p> <p>Present overall rating – Considerable</p> <p>Potential rating – Considerable</p>

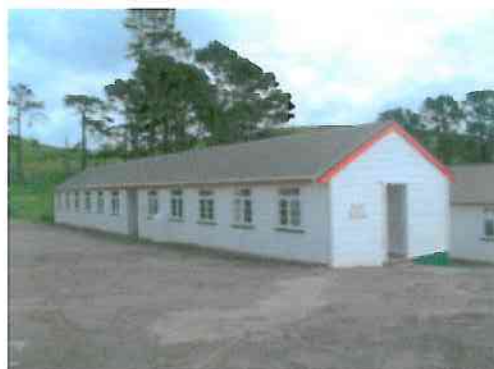
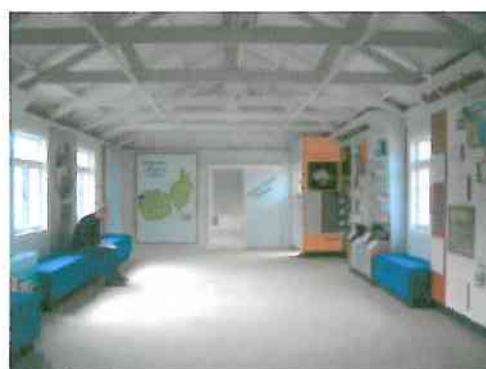
BUILDING 24 – STUDY CENTRE (FORMERLY SERGEANTS' QUARTERS)

Description	
Exterior	
Roof	Corrugated steel roof.
Walls	Weatherboards, timber baseboards.
Joinery	Timber doors & casement windows.
Interior	
Roof structure	Timber sarking , purlins on timber trusses.
Ceilings	N/A
Walls	Plasterboard above T&G timber dado.
Floors	Timber tongue & groove
Modifications	
Exterior	<ul style="list-style-type: none"> • Door off porch at northeast end infilled. • Porch infilled, northwest elevation. • Chimney removed, southeast elevation. • Roof replaced, spouting replaced with plastic.
Interior	<ul style="list-style-type: none"> • Partition seating added for AV theatre. • Displays added. • Later partitions, doors added in cooks' quarters. • Shower, toilet facilities added.
Condition	
Exterior	
Roof, walls:	Roof & walls in reasonable condition.
Joinery:	Joinery in reasonable condition.
Interior	
All surfaces:	Generally good condition.

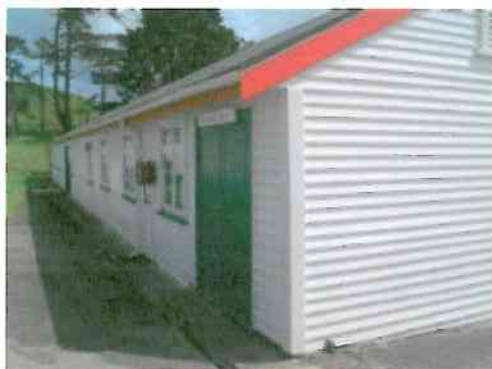
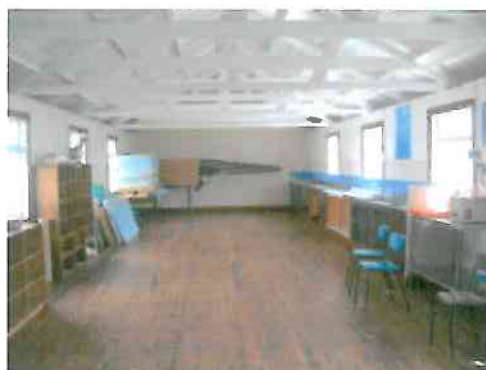
BUILDING 25 – DISCOVERY, OFFICE (FORMERLY MEN'S QUARTERS)

Description	
Exterior	
Roof	Corrugated steel roof.
Walls	Weatherboards, timber baseboards.
Joinery	Timber doors & casement windows.
Interior	
Roof structure	Timber sarking, purlins on timber trusses.
Ceilings	N/A
Walls	Plasterboard above T&G timber dado.
Floors	Timber tongue & groove
Modifications	
Exterior	
<ul style="list-style-type: none"> • Some doors changed (now have plain panels). • Some windows, doors possibly repositioned. • Fire hose reel added • Roof replaced, spouting replaced with plastic. 	
Interior	
<ul style="list-style-type: none"> • Store at southwest end partitioned off. • Partitions added in office area. • Resource room at northeast end partitioned off. • Bench fittings added in resource room. • Sprinkler pipes added. 	
Condition	
Exterior	
Roof, walls:	Roof & walls in reasonable condition.
Joinery:	Joinery in reasonable condition.
Interior	
All surfaces:	Generally good condition.

The exterior form of the building is generally original with only minor modifications having been carried out, including the replacement of some doors and the possible repositioning of some joinery. The interior has been modified with additional walls and fittings. As the former men's quarters, it has considerable significance.

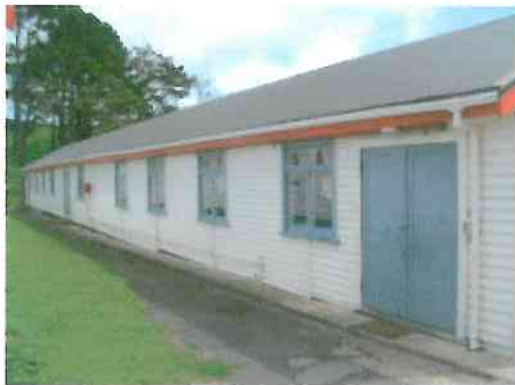
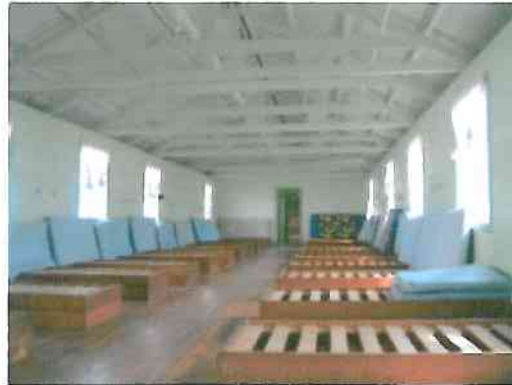
BUILDING 26 – DORMITORY 4 (FORMERLY MEN'S QUARTERS)

Description	
Exterior	
Roof	Corrugated steel roof.
Walls	Weatherboards, timber baseboards.
Joinery	Timber doors & casement windows.
Interior	
Roof structure	Timber sarking, purlins on timber trusses.
Ceilings	N/A
Walls	Plasterboard above T&G timber dado.
Floors	Timber tongue & groove
Modifications	
Exterior	<ul style="list-style-type: none"> • 2 sets of doors to southeast elevation replaced. • Fire hose reel added • Roof replaced, spouting replaced with plastic. • Window spacing varies, possibly indicative of changes. • Exterior sprinklers added.
Interior	<ul style="list-style-type: none"> • Partitions added in central section (some possibly from military days). • Sprinkler pipes added.
Condition	
Exterior	
Roof	Roof in reasonable condition.
Walls:	Some paintwork flaking. Some baseboards loose.
Joinery:	Joinery in reasonable condition.
Interior	
All surfaces:	Generally good condition.

The exterior form of the building is generally original with only minor modifications having been carried out, including the replacement of some doors and the possible repositioning of some joinery. The interior has been modified with the insertion of additional walls. As the former men's quarters, it has considerable significance.

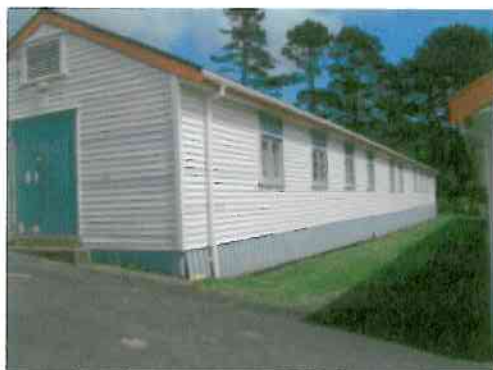
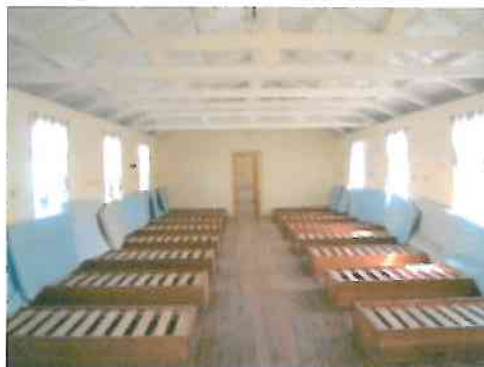
BUILDING 27 – DORMITORY 3 (FORMERLY MEN'S QUARTERS)

Description	
Exterior	
Roof	Corrugated steel roof.
Walls	Weatherboards, timber baseboards.
Joinery	Timber doors & casement windows.
Interior	
Roof structure	Timber sarking, purlins on timber trusses.
Ceilings	N/A
Walls	Plasterboard above T&G timber dado.
Floors	Timber tongue & groove
Modifications	
Exterior	<ul style="list-style-type: none"> • Door positions at each end probably not original. • Doors not original. • Fire hose reel added. • Doorway to southeast elevation infilled and window added. • Roof replaced, spouting replaced with plastic. • Window spacing varies, possibly indicative of changes.
Interior	<ul style="list-style-type: none"> • Partitions added in central section (some possibly from military days). • Sprinkler pipes added.
Condition	
Exterior	
Roof	Roof in reasonable condition.
Walls:	Some paintwork flaking. Some baseboards loose.
Joinery:	Joinery in reasonable condition.
Interior	
All surfaces:	Generally good condition.

The exterior form of the building is generally original with only minor modifications having been carried out, including the replacement of some doors and likely repositioning of some joinery. The interior has been modified with the insertion of additional walls. As the former men's quarters, it has considerable significance.

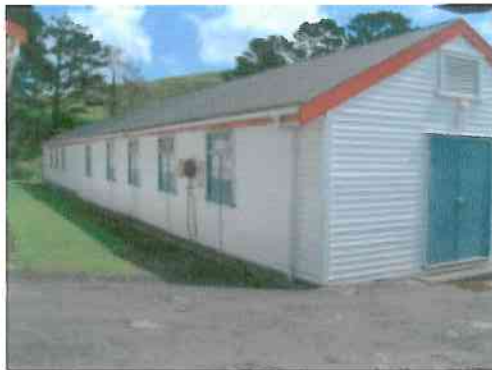
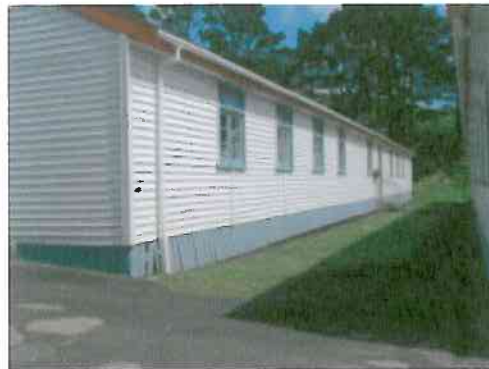
BUILDING 28 – DORMITORY 2 (FORMERLY MEN'S & WACs' QUARTERS)

Description	
Exterior	
Roof	Corrugated steel roof.
Walls	Weatherboards, timber baseboards.
Joinery	Timber doors & casement windows.
Interior	
Roof structure	Timber sarking, purlins on timber trusses.
Ceilings	N/A
Walls	Plasterboard above T&G timber dado.
Floors	Timber tongue & groove
Modifications	
Exterior	
<ul style="list-style-type: none"> • Door on southeast wall infilled, (Door on northwest wall remains – differs from buildings 26, 27, but possibly original configuration). • Door locations at each end probably not original. • Doors not original. • Fire hose reel added. • Window spacing varies along walls and between sides, possibly indicative of changes. • Roof replaced, spouting replaced with plastic. 	
Interior	
<ul style="list-style-type: none"> • Partitions added in central section. Layout varies from buildings 26 & 27. • Some partitions removed. • Sprinkler pipes added. 	
Condition	
Exterior	
Roof	Roof in reasonable condition.

Walls:	Some paintwork flaking. Some baseboards loose.
Joinery:	Joinery in reasonable condition.
Interior	
All surfaces:	Generally good condition.

The exterior form of the building is generally original with only minor modifications having been carried out, including the replacement of some doors and the likely repositioning of some joinery. The interior has been modified with the insertion of additional walls. As the former men's and WAC's quarters, it has considerable significance.

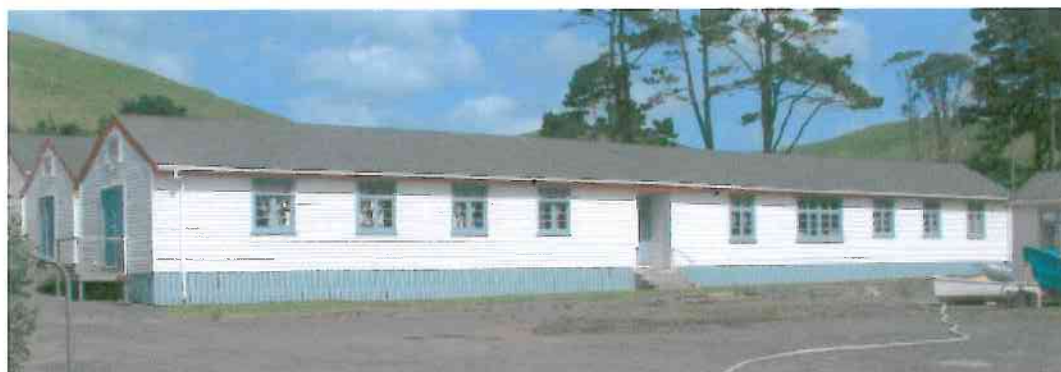
BUILDING 29 – DORMITORY 1 (FORMERLY DORMITORY)

Description	
Exterior	
Roof	Corrugated steel roof.
Walls	Weatherboards, timber baseboards.
Joinery	Timber doors & casement windows.
Interior	
Roof structure	Timber sarking, purlins on timber trusses.
Ceilings	T&G in central section.
Walls	Plasterboard above T&G timber dado.
Floors	Timber tongue & groove. Concrete in central section.
Modifications	
Exterior	<ul style="list-style-type: none"> • Door added in southeast wall. • Earlier doors in southwest end infilled. • Doors added in northeast end. • Fire hose reel added. • Some windows on northwest wall differ (different heights, 2 fanlights above casements as against single fanlight elsewhere, also 2 windows adjacent each other). • Roof replaced, spouting replaced with plastic. • Ramp added at northeast end.
Interior	<ul style="list-style-type: none"> • Additional partitions added at southwest end. • Additional partitions also in central section. • Sprinkler pipes added.

Condition	
Exterior	
Roof	Roof in reasonable condition.
Walls:	Some paintwork flaking.
Joinery:	Joinery in reasonable condition.
Interior	
All surfaces:	Generally good condition.

The exterior form of the building is generally original with only minor modifications having been carried out, including the replacement of some doors and the likely repositioning or replacement of some joinery. The interior has been modified with the insertion of additional walls. As a former dormitory, it has considerable significance.
