# Maintenance of buildings and structures in Macetown Reserve, Central Otago

John B. Gray

DOC RESEARCH & DEVELOPMENT SERIES 250

Conservation Architect, 567 George Street, Dunedin North,  
Dunedin 9016, New Zealand  
Email: [john@oakleygray.co.nz](mailto:john@oakleygray.co.nz)

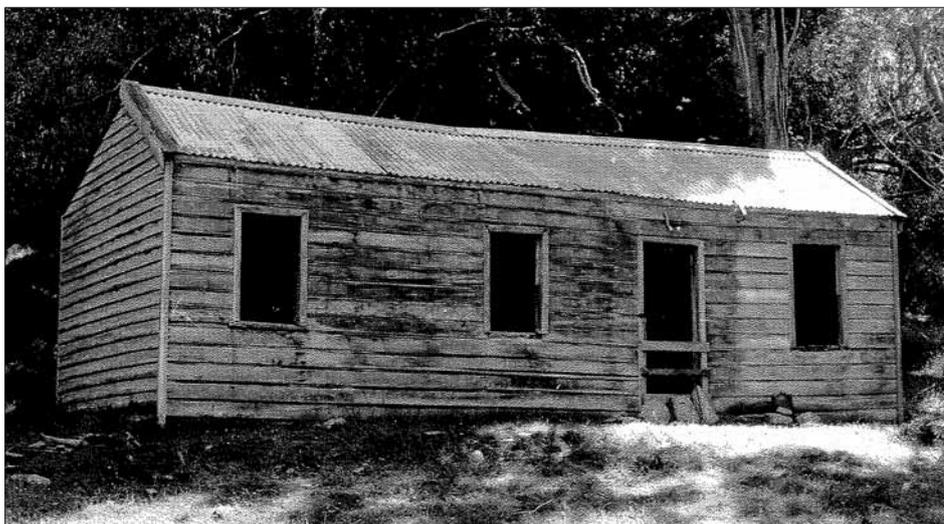
Figure 1. The front (north wall) of the un-named timber building as it was in the late 1970s. The window on the left (east end) replaces a former door.

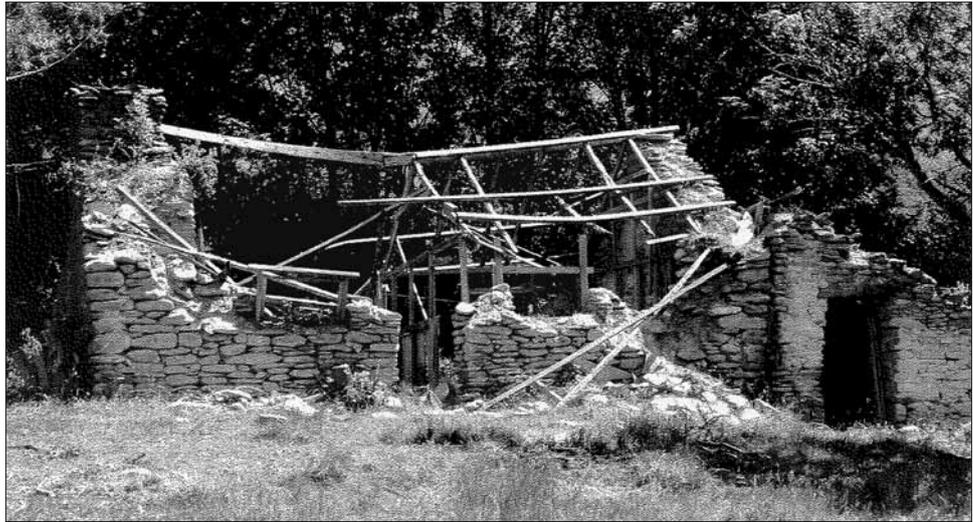
The cottage is in reasonable condition (see Petchey 2002: fig. 8), having been extensively reconstructed from a reasonably intact, but dilapidated and substantially roofless ruin in 1979 (Figs 2 and 3). Unfortunately the reconstruction of the stonework made extensive use of Portland cement in the mortar mix, which detracts from what was otherwise a good piece of workmanship.

Figure 2. Front (north) elevation of Needham's cottage prior to restoration in the late 1970s.  
<sup>2</sup>Photo: L&S records from DOC files.

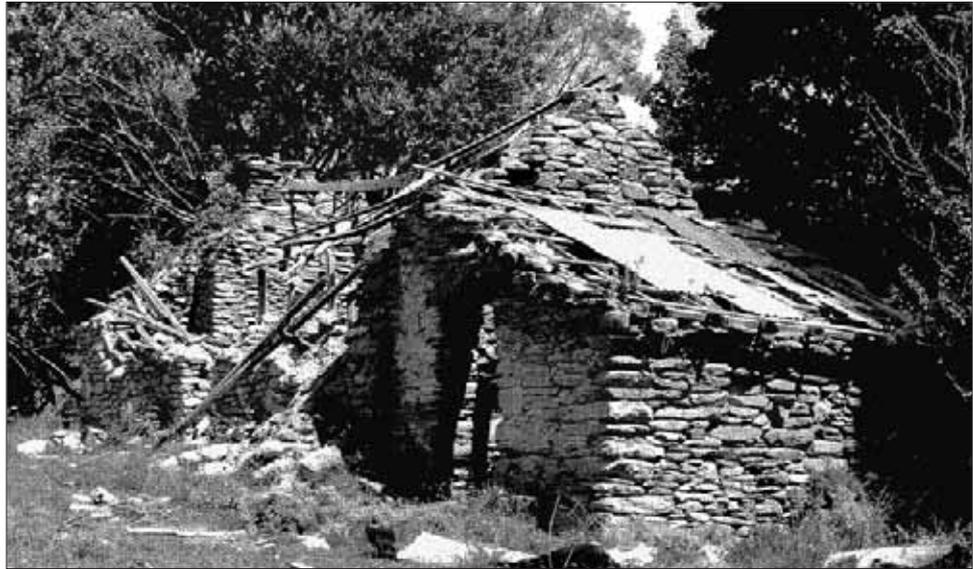
Figure 3. Needham's cottage from the west, prior to restoration in the late 1970s.  
<sup>2</sup>Photo: L&S records from DOC files.

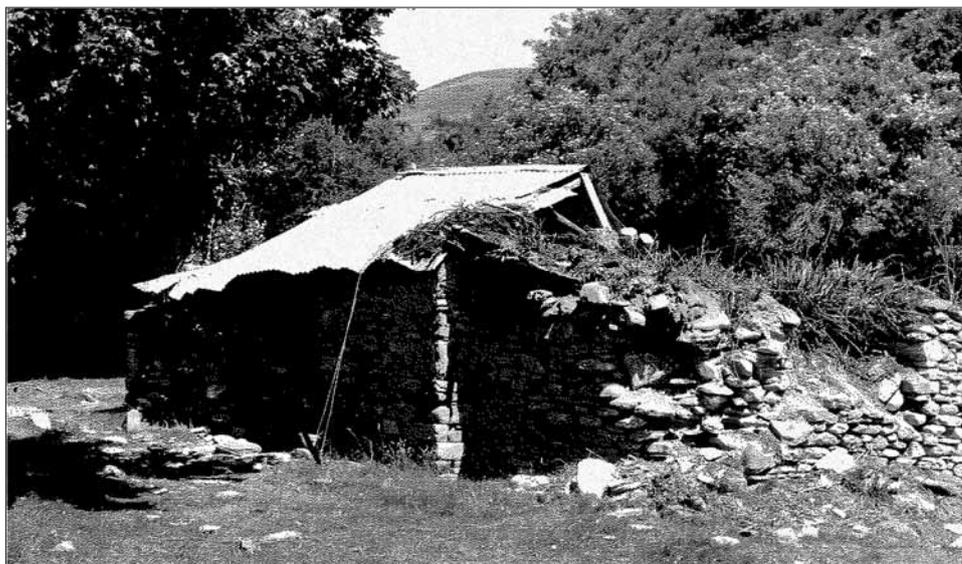
Figure 4. The Bakehouse (from the northwest) in the late 1970s, showing the front (north) elevation on the left. The large stone filling a hole at the near end of the front wall may be obscuring an oven entrance. Note the shelf-like stone below the hole.  
<sup>2</sup>Photo: L&S records from DOC files.

west-side structure has been extensively rebuilt. This probably occurred during the 1979 work.

One of the series of photographs (Figs 4-9) taken during the restoration process of 1979 shows the west-side structure already rebuilt but work not yet started on the east-side structure. Figures 5 and 6 indicate that the door may not have been originally located where it presently is (see Fig. 8), which adds further doubt about the authenticity of the rebuild of the probable ovens area.
