SCIENCE AND RESEARCH INTERNAL REPORT NO.47

ROSS ISLAND HISTORIC HUTS:

**Report on Archaeological and restoration work
and future management considerations**

**Event K281 1988-89
for the Antarctic Heritage Trust**

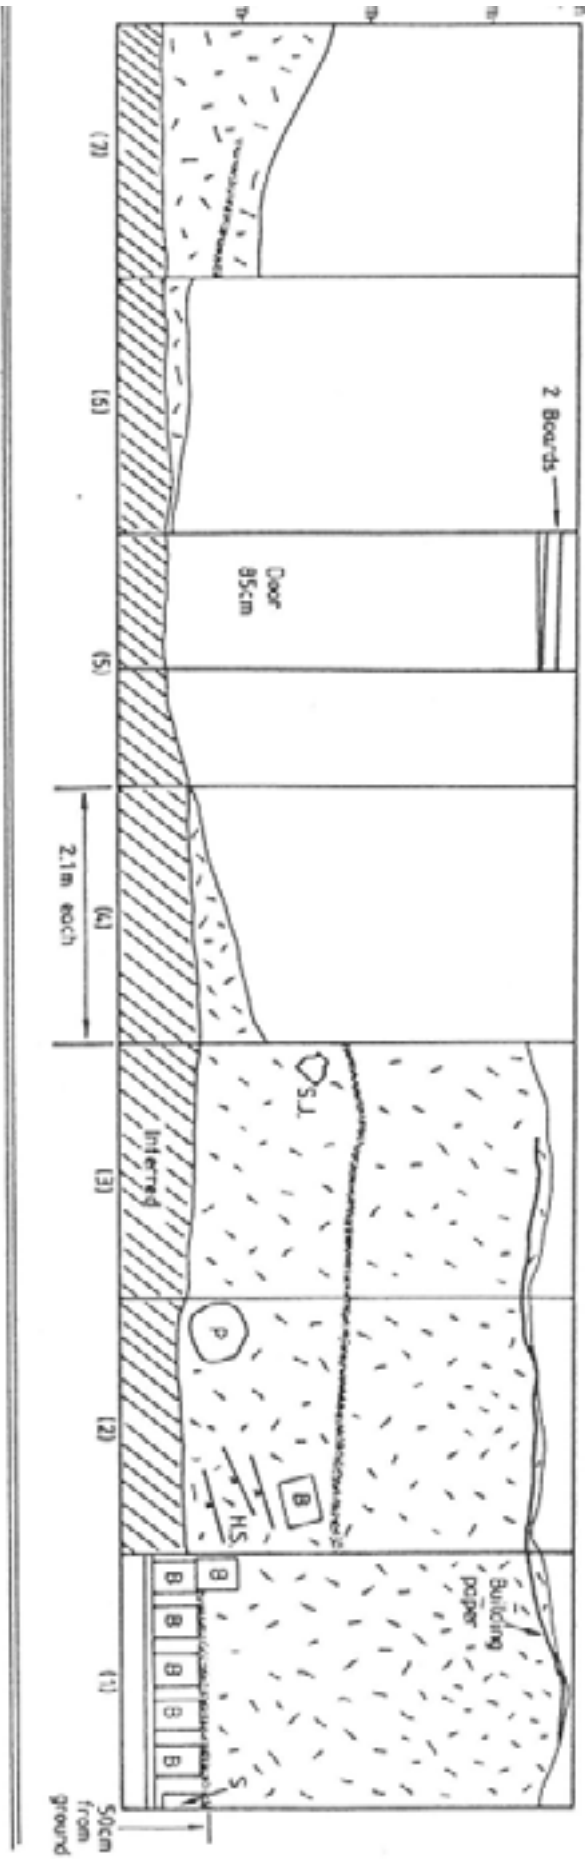
FIG. 1

The removal of the front wall of the stables enabled visual observation of the ice masses and some indication of their formation. This information and the amount of ice in each bay prior to the excavation is depicted in Fig. 1. The 2cm thick horizon of manure and fodder (at 1m height) through bays 2 & 3 is attributed to wind eddies lifting the material from adjacent bays and depositing it on the ice in bays 2 & 3 where it subsequently was covered with further ice and snow. This also probably accounts for a similar horizon which covered the butter boxes in bay 1. The butter boxes had been uncovered previously, but in the absence of adequate weatherproofing had again been ice bound.

The numbering of the bays (1-7 from west to east) follows the precedent set by Burton and Sutton-Pratt (1977) and others. In summary bays 1-3 were virtually full to the roof with solid ice (ca.36 cu. metres), bay 4 contained c. 2 cu.m of frozen meltwater, bay 5 was virtually clear, bay 6 contained only a token amount, and bay 7 contained ca. 4 cu. m, most of which was on the seaward side. With the exception of bay 7, there is little doubt that the majority of the ice formation in recent years has been from egress of meltwater into the stables rather than ice formed from wind driven snow. When we arrived at the site, meltwater was constantly dripping into the stables from thawing snow on the roofs of the main hut, the cold porch, and the stables itself.

CAPE EVANS STABLES - FRONT WALL
SECTION SHOWING ICE PROFILE BEFORE EXCAVATION
(WALL REMOVED)

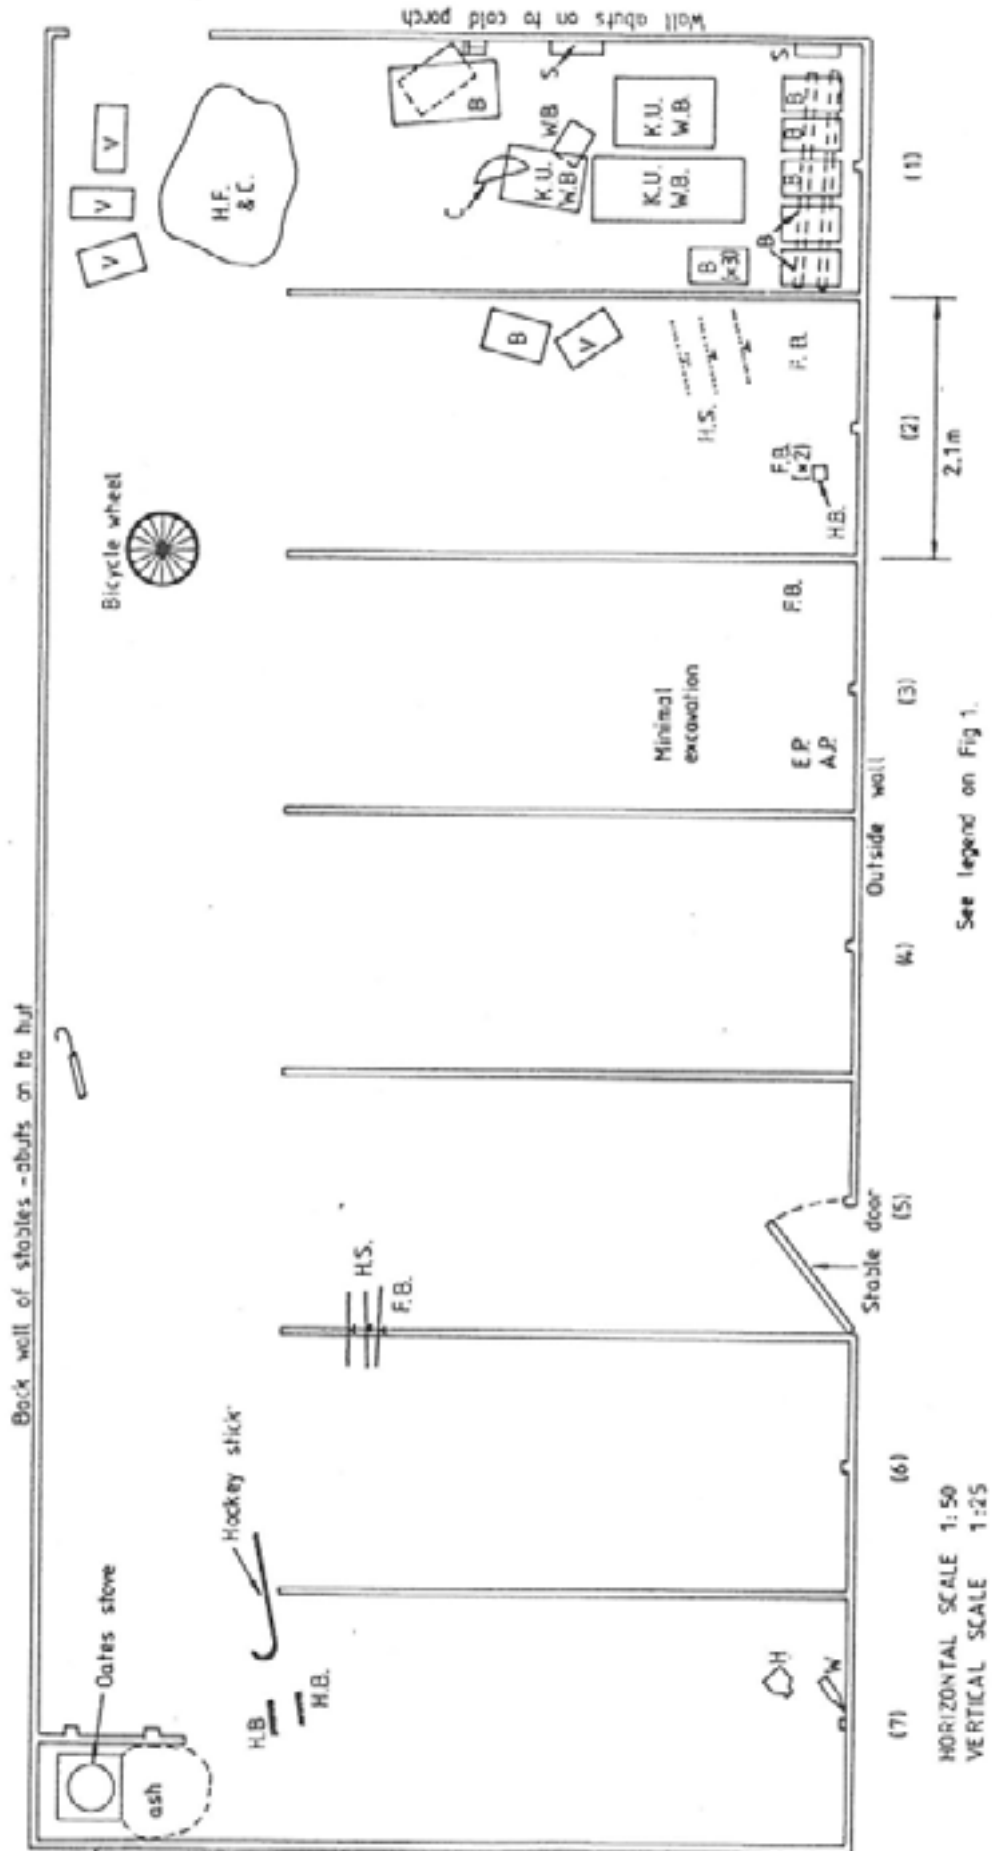
FIG 2

CAPE EVANS STABLES - FLOOR PLAN SHOWING POSITIONS OF EXPOSED ARTEFACTS

Bay 1 was virtually full to the roof with frozen meltwater and snow-ice. On the western side meltwater had flowed through the door into the adjoining cold porch forming a sloping ice mass over one metre high and two metres long. By the end of the field season this bay had been cleared of ice (ca. 12 cu. m.) leaving the basal 40 cm which contains numerous artefacts. Their position is depicted in Fig.2. In terms of the number and variety of artefacts uncovered this season, this bay proved to be the most productive, but due to lack of time most of the exposed items are still firmly frozen in-situ. An sheet of orange canvas nailed across the 'door' and along the wall between bays 1 & 2 was exposed. As it is faintly marked 'NZR' it obviously post-dates 1960 and was presumably erected by early caretakers in an attempt to contain the snow and ice build-up.

The most notable items uncovered in bay 1 were as follows: 9 unopened boxes of N.Z. butter (see App. 2 for details & discussion), 3 wooden boxes containing miscellaneous kettles, pots, an aluminium? casserole dish lid, and other kitchen utensils, an ice axe, two wooden rimmed fine mesh sieves, a small wooden box (c.17 x 17 x 12cm), a wooden box marked "Balloon. To Be Taken South", an area of human excrement (the Ross Sea party's latrine, D. Harrowfield pers. comm.), and three unopened venesta provision cases. In terms of placement five of the butter boxes were sitting on two planks which appear to be supported by at least two more butter boxes. The three cases of kitchen utensils are notable for their disarray. The utensils appear to have been 'thrown' into the boxes which in turn appear to have been 'dumped' in the stables.

Bay 2 Ca. 50% of the ice in bay 2 had been removed by the end of the field season, leaving c. 1m depth remaining over the whole bay. Excavation proceeded on two fronts. Ice was removed from the front of the stables exposing a canvas fodder bag (containing oats and chaff), 3 wooden artefacts of unknown use (possibly 'spacers' for dog sled harness; 4 more were found in the rafters in the same bay), a N.Z. butter box (see App. 2), and an unopened plywood provision case. Both boxes lay at haphazard angles within the ice mass suggesting they had been placed there, probably by people excavating in bay 1 in the past. Excavating in the eastern side of the bay revealed two more canvas fodder bags, a rolled-up hock bandage, and the five penguin carcasses (4 Adelies and 1 Emperor). The penguins may have been acquired and stored there for food or research purposes. Once the penguins were encountered no further excavation was done in the vicinity. Excavation also proceeded progressively westwards along the stable corridor, from bay 5 to bay 2. At the conclusion of the field season, the upper metre of sterile ice had been removed exposing the mule name 'Rani' on the rear wall and a badly rusting cycle wheel. The latter is off Griffith-Taylor's bicycle (D Harrowfield pers. comm.). It is difficult to fathom how the wheel got to be where it is (it is now exposed but still ice-bound). Possibly it was hanging on the stable wall and has fallen and become incorporated into the ice mass, although there is no less likelihood that it was placed there in more recent times during the course of ice removal.
