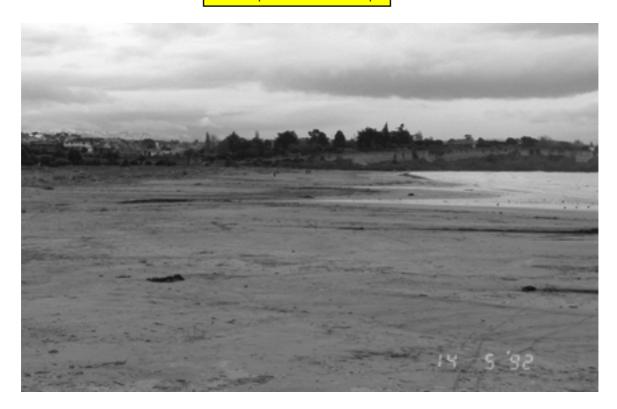
Plate 14 Site 103, Caroline Bay, Timaru, 14 May 1992, rated 30. This sandy beach site, while exhibiting accretion, is low-lying, inundated by storm wave run-up and experiences high fluctuations.

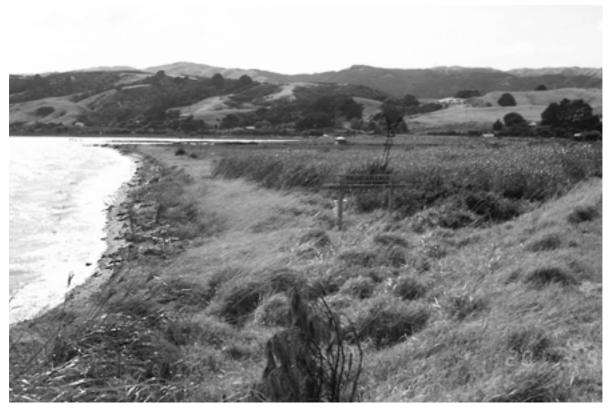
Plate 15 The head of Pauatahanui Inlet, Site 39, Pauatahanui Wildlife Management Reserve, Wellington, 20 March 1992, rated 26. This low-lying shelly gravel ridge backed by a saltmarsh is found within sheltered estuarine conditions which contribute to low levels of storm wave runup and very small short-term fluctuations.

These sites exhibit moderate rates of erosion or accretion, low to moderate short-term fluctuations, moderate to high elevations and may be composed of a variety of types. (Plates 15, 16, and 17)

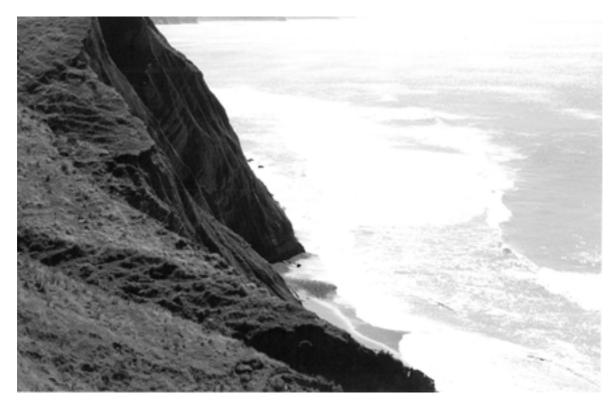
Plate 16 Looking north of Site 13, high cliffs north of the Kaiwhata River, Wairarapa, east coast, 11 March 1992, rated 26. This site is characterised by eroding, steep gradient, high cliffs composed of mudstones which are susceptible to large slumps resulting in the retreat of the cliff top by over 30 m.

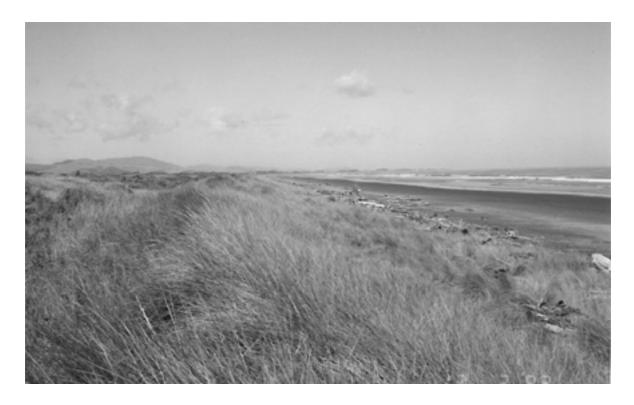
Plate 17 Looking south of Site 23, Te Horo beach, Kapiti Coast, 13 March 1992, rated 25. This accreting sandy beach has a low foredune that has not been overtopped by recorded storm wave run-up levels, but does experience high short-term fluctuations.

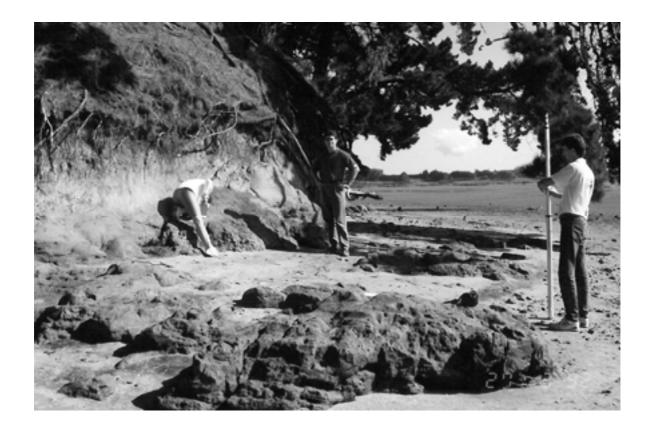
Low sensitivity areas exhibit a wide range of rock types but are generally characterised by moderate to high elevations, are not susceptible to overtopping by storm wave run-up and may be accreting or eroding at very low to low rates. (Plates 18 and 19)

Plate 18 Photo taken 27 March 1992 of Site 48, Waipipi Wharf Rd, Manakau Harbour, Franklin District, rated 19. the low rating reflects the moderate elevation, low storm wave run-up (due to its sheltered nature), and the steep gradient of the soft rock, Pliocene sand cliffs. The site experiences small short-term fluctuations and a low erosion rate.

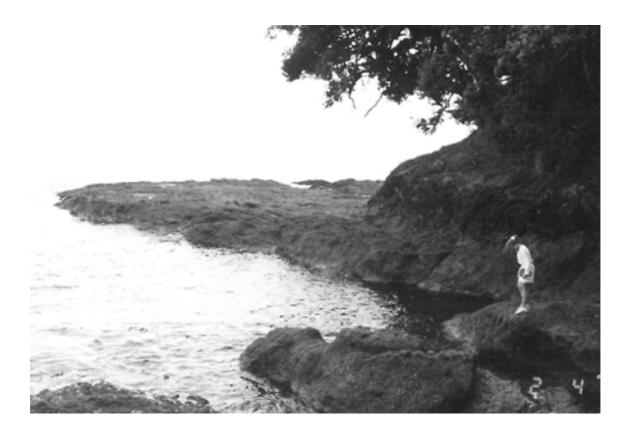
Plate 19 Photo taken 2 April 1992 of Site 71, Whanarua Bay, Eastern Bay of Plenty, rated 14. Whanarua Bay is composed of steep greywacke hard rock and platforms, which are eroding very slowly and are not to slumps or fluctuations.

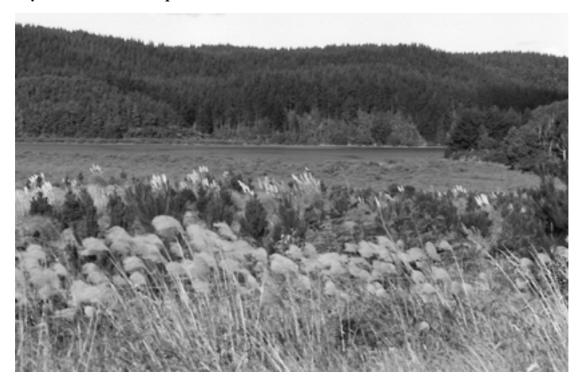
These sites are typically characterised by high elevations, steep gradients, very hard rock composition, very low erosion rates and no short-term fluctuations. (Plates 20 and 21)

Plate 20 Photo taken 4 April 1992 looking east at Site 96, Whangamata upper harbour, Coromandel, rated 11. This area rates very low owing to its steep, hard rock nature, and its situation within the sheltered confines of the Whangamata Harbour. It is not susceptible to inundation by storm wave run-up or short-term fluctuations or failures.
