Restoration of riffle habitat in the Ōtākaro/Avon River

In 2013–15 the Ōtākaro/Avon River in Christchurch underwent in-river and riparian restoration as part of the wider Te Papa Ōtākaro Avon River Precinct (ARP) project. The ARP was part of the rebuild following earthquakes in 2010/11.

Overall, works were undertaken along a 3.2 km stretch of the 14 km long Ōtākaro/Avon River. This case study focuses on the 70 m section at Montreal St.

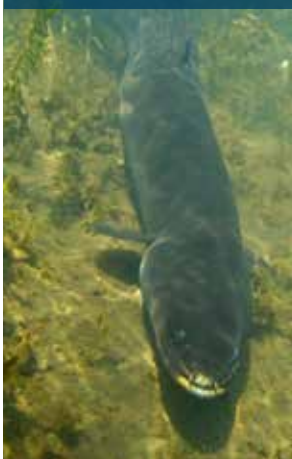
Longfin eels present, but lacked quality habitat

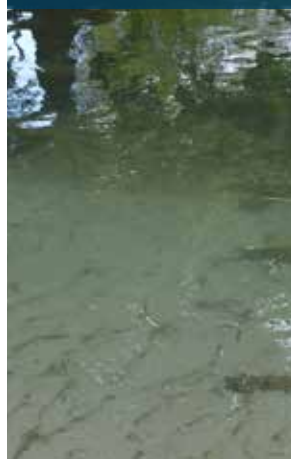
Lots of smothering fine sediment & liquifaction

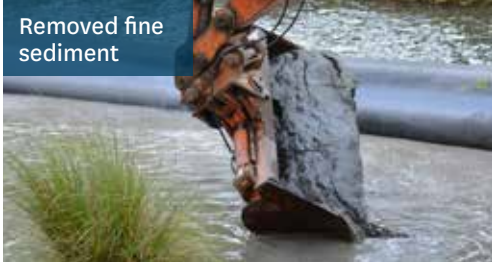
1.

Removed fine sediment

Removed excess fine sediment from the riverbed. This included existing silt and liquefaction from earthquake activity. All sediment was loaded into a truck and removed from the site.

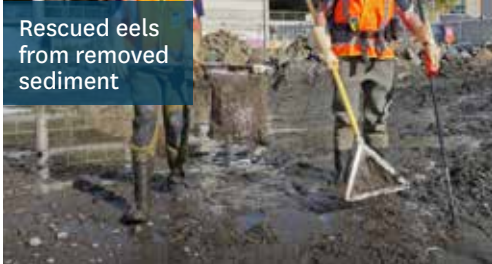
2.

Rescued eels from removed sediment

This site was too deep to use electrofishing in-river before works began, but fish were rescued from the excavated sediment piles. Shallower sections of the river were electrofished to remove fish prior to any works taking place.

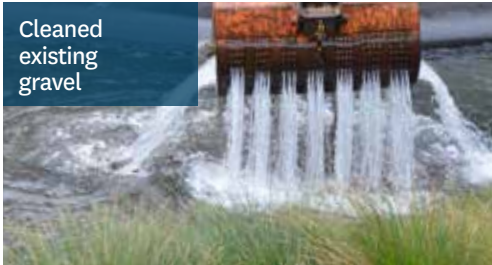
3.

Cleaned existing gravel

Gravel substrate was cleaned onsite to remove embedded fine sediment. A purpose-built digger sieve (riddle bucket) was developed to clean gravels to a depth of 1 m.

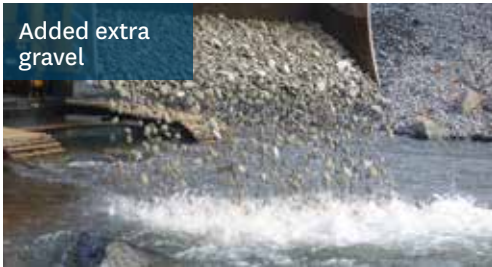
4.

Added extra gravel

The riverbed was built up by constructing a buried weir of larger boulders covered by a cobble/gravel ramp. This increased the channel gradient and supplemented the freshly cleaned gravels already present.

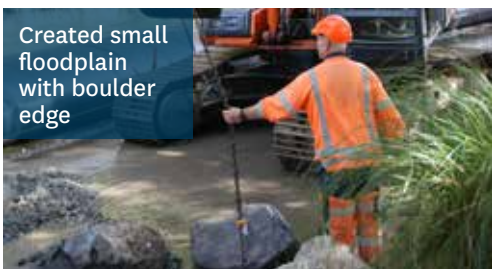
5.

Created small floodplain with boulder edge

A small floodplain was created by building a boulder edge into the channel and backfilling with a mix of soil and gravels. Fish habitat was created by the rough boulder edge, gaps formed between/under boulders, and by adding additional boulder clusters/eel caves in front.

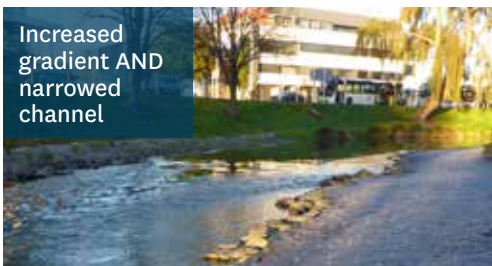
6.

Increased gradient AND narrowed channel

The channel was narrowed and gradient increased to create a fast riffle habitat. Faster flow keeps fine sediment suspended while an upstream pond area acts as a deposition area. The new riffle habitat is suitable for a range of native fish including juvenile longfin eels.

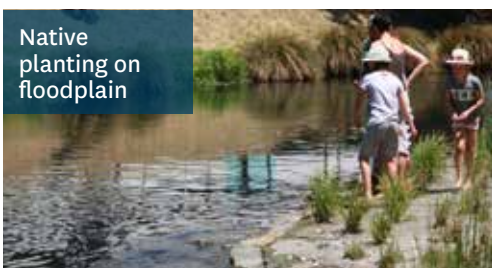
7.

Native planting on floodplain

The small floodplains were planted with low-stature native plants suited to the conditions. The low height of the small floodplains and plants helped to keep a low/neutral effect on flood levels – an important consideration for urban catchments.
