Date: 6 May 2026

Subject: Waimata Gemstone Bay Options Paper

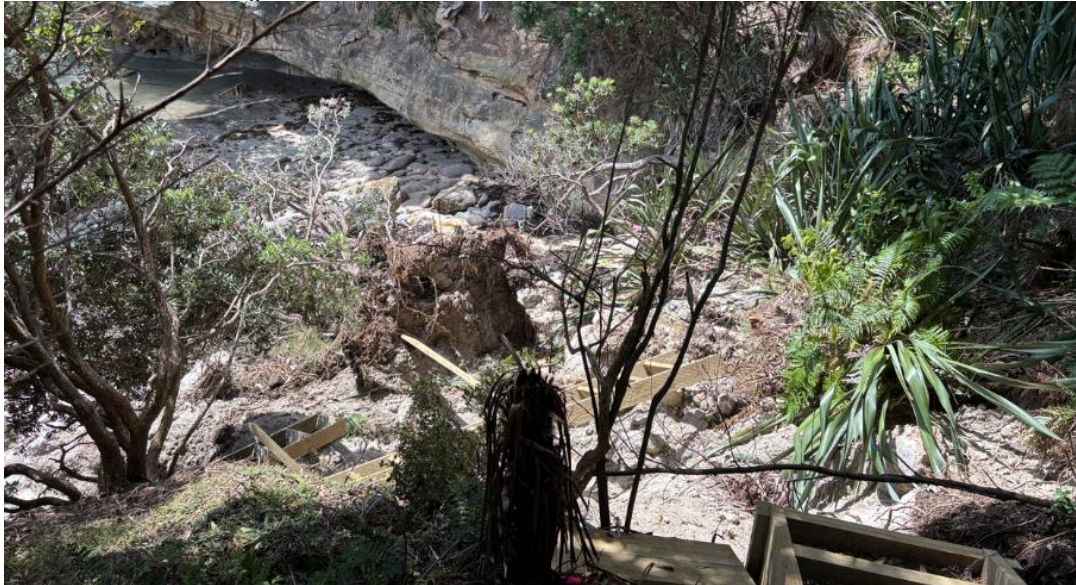
Landslide and track damage: Photo DOC

17. Table 1 shows the decision-making process flow chart³ used to guide this assessment. The first step was to understand the risk/damage.
18. District staff along with geotechnical experts undertook damage assessments in early February 2026. The new access track was damaged by the January 2026 storm with one landslide undermining several stair sections near the bay. Geotechnical experts noted the headscarp of the landslide appeared to be approximately 10m above the bay and approximately 5m wide. Although this is likely to be erosion of surface material small slips around this landslide could continue as the headscarp regresses and settles down and while vegetation re-establishes.

19. Damage assessments confirmed ongoing erosion, and coastal scour had undermined the shallow stair foundations and will continue to impact the site over time. The site sits within unstable, bouldery colluvium and is subject to continued coastal surge risks.

20. This site damage was assessed as major, requiring funding beyond the District baseline and specialised project management to rebuild⁴.
21. The next step of the assessment is to consider visitor site criteria, importance of the site and climate change and natural hazard risk modelling.

28. The preferred option is to permanently remove the damaged stairs and spur track to restore the site to nature - recognising ongoing instability, repeated loss of infrastructure, no feasible alternative route, and the need to use limited funding effectively. It is recommended to consult with key stakeholders and to inform the public, to guide the final decision paper.
