Subject: Waimata Gemstone Bay Options Paper

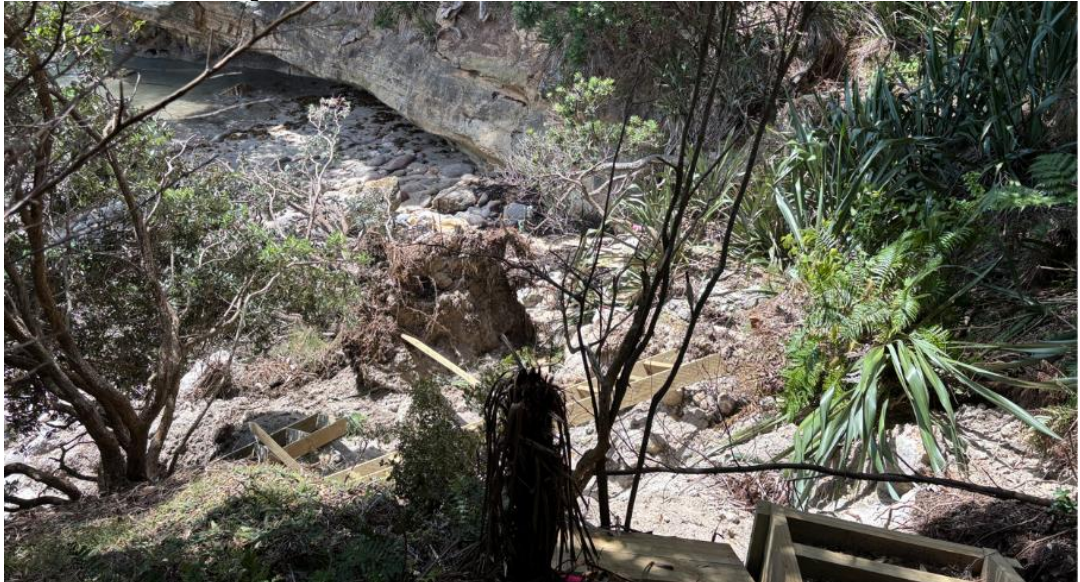
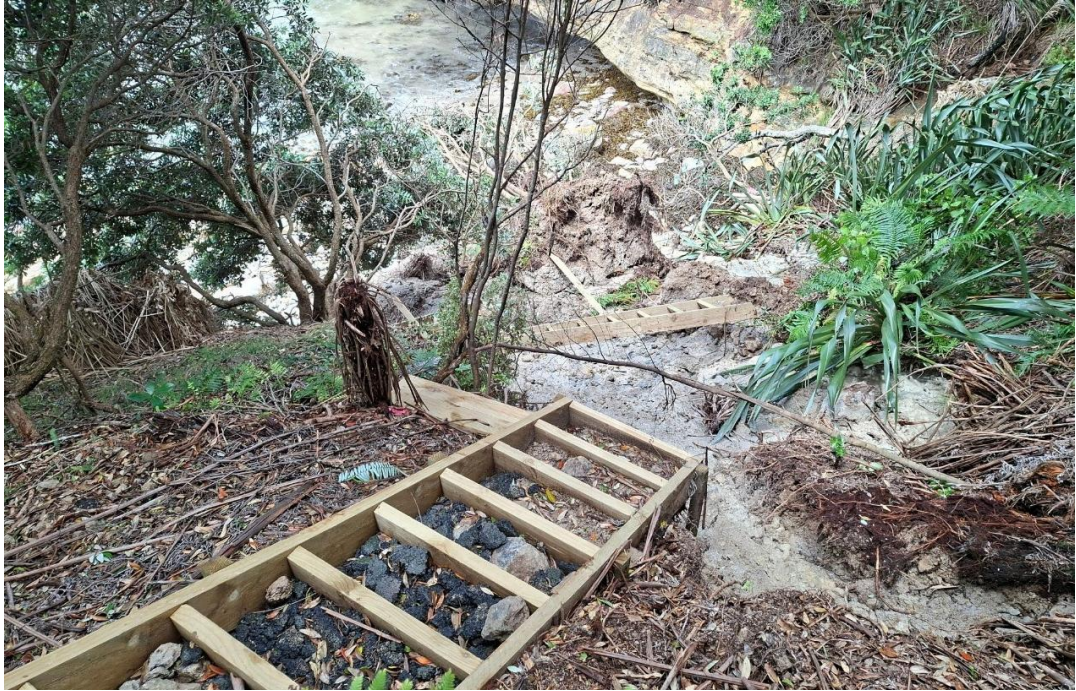
17. Table 1 shows the decision-making process flow chart³ used to guide this assessment. The first step was to understand the risk/damage.
18. District staff along with geotechnical experts undertook damage assessments in early February 2026. The new access track was damaged by the January 2026 storm with one landslide undermining several stair sections near the bay. Geotechnical experts noted the headscarp of the landslide appeared to be approximately 10m above the bay and approximately 5m wide. Although this is likely to be erosion of surface material small slips around this landslide could continue as the headscarp regresses and settles down and while vegetation re-establishes.

19. Damage assessments confirmed ongoing erosion, and coastal scour had undermined the shallow stair foundations and will continue to impact the site over time. The site sits within unstable, bouldery colluvium and is subject to continued coastal surge risks.

Landslide and track damage: Photo DOC

20. This site damage was assessed as major, requiring funding beyond the District baseline and specialised project management to rebuild⁴.
21. The next step of the assessment is to consider visitor site criteria, importance of the site and climate change and natural hazard risk modelling.

28. The preferred option is to permanently remove the damaged stairs and spur track to restore the site to nature - recognising ongoing instability, repeated loss of infrastructure, no feasible alternative route, and the need to use limited funding effectively. It is recommended to consult with key stakeholders and to inform the public, to guide the final decision paper.
