Archaeological survey of the Arrow River and Macetown, Otago

Peter Petchey

Department of Conservation
Te Papa Atawhai

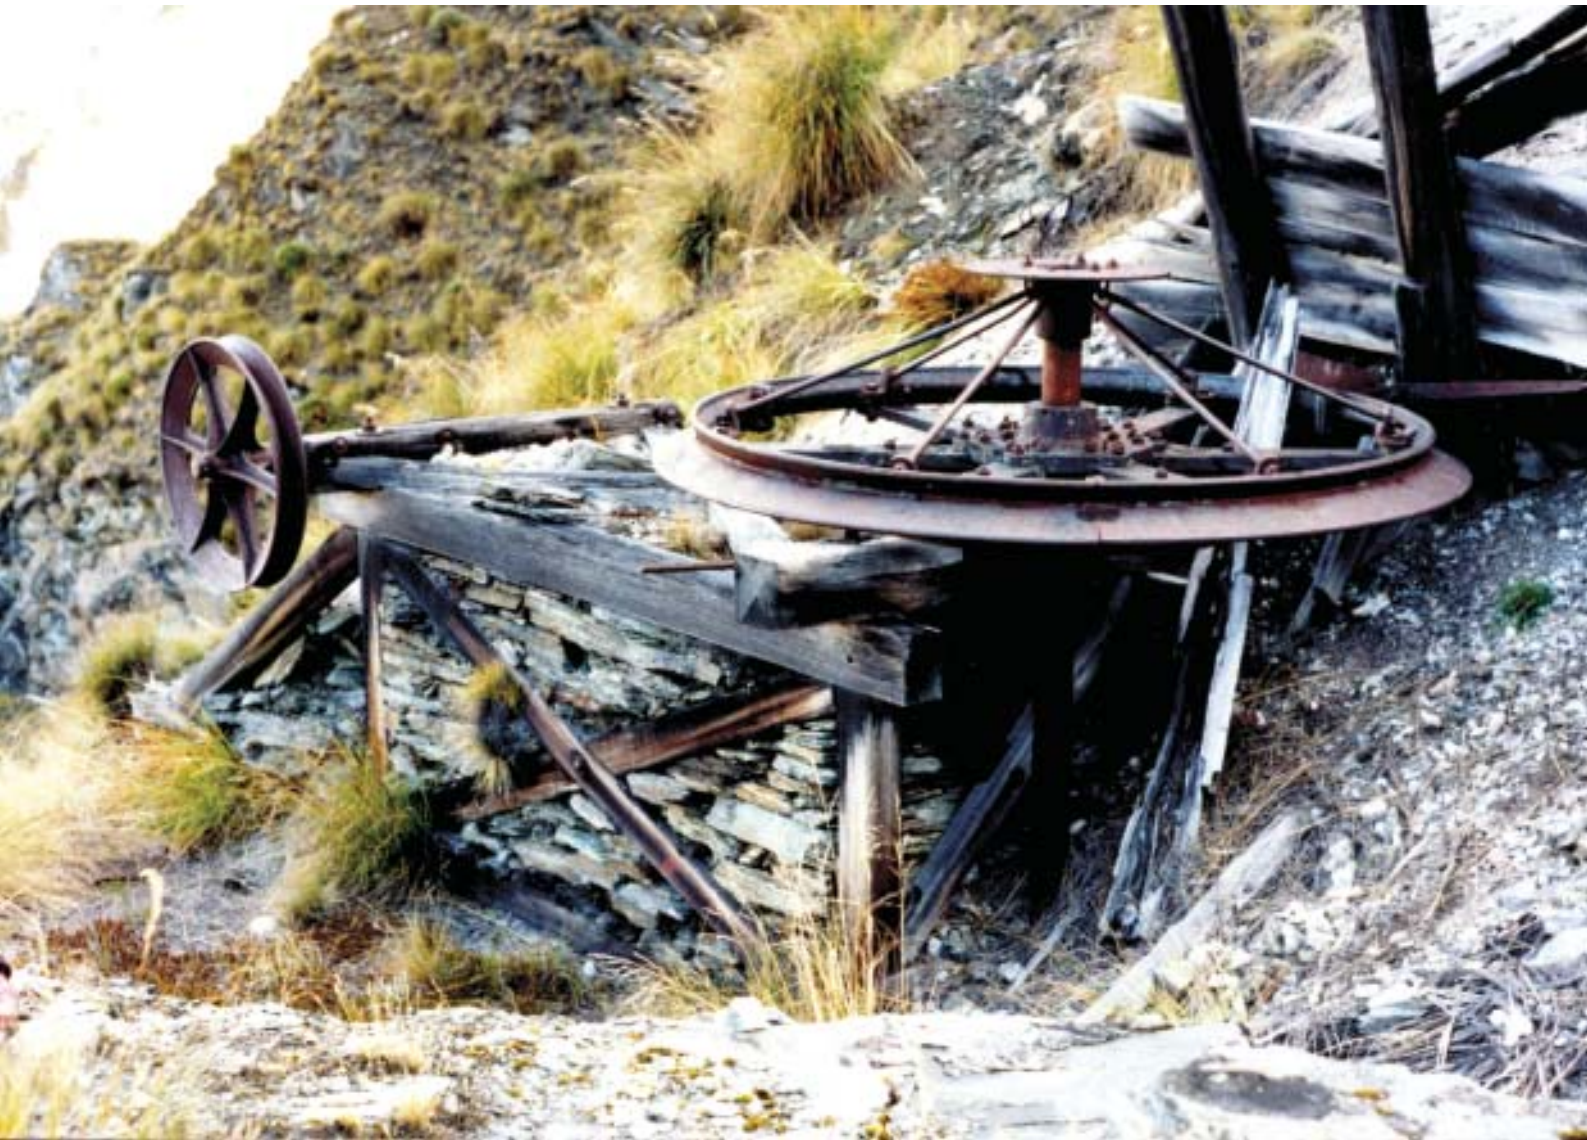
Cover photograph

The All Nations aerial cableway and return wheel. *Photo: P. Petchey.*

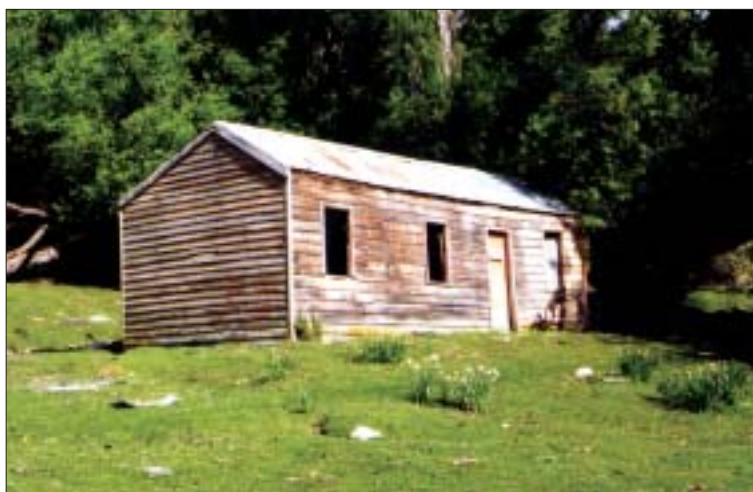
Figure 7. The last remaining timber building at Macetown. Note the clumps of flowering daffodils.
Photo: P. Petchey.

On the left (southwest of the road) is the only remaining timber building in the township (Fig. 7, and 'H' on Map 1, pp. 10-11). Its history is unknown. Beside this building, past some old gnarled willows, are several house and hut sites, the largest of which has the daffodil pathway mentioned above. There are several other hut sites, the remains of an orchard, and a stone wall fronting the road. On the other side of the road (northeast) from the wooden building is a large area of ground sluicing. Fifty metres past the stone wall just mentioned there is a small square stone structure set immediately above and southwest of the road. It is in good condition, although the roof is missing.

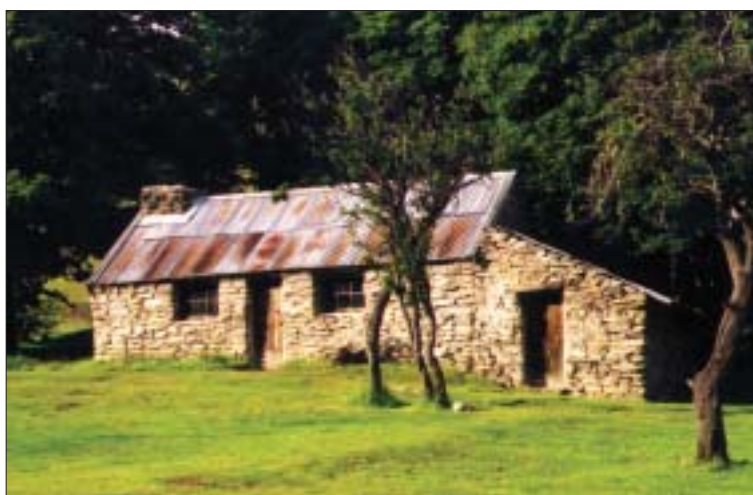
Figure 8. Joseph Needham's cottage. This building was restored by the former Department of Lands and Survey.
Photo: P. Petchey.

Two hundred and fifty metres further on, on a terrace below and to the northeast of the road, is Needham's cottage (Fig. 8, and 'G' on Map 1). Joseph Needham was the schoolmaster at Macetown from 1879 until 1889, after which he stayed in Macetown goldmining (Beaton 1971: 54). The cottage was substantially rebuilt by the Department of Lands and Survey c. 1979.

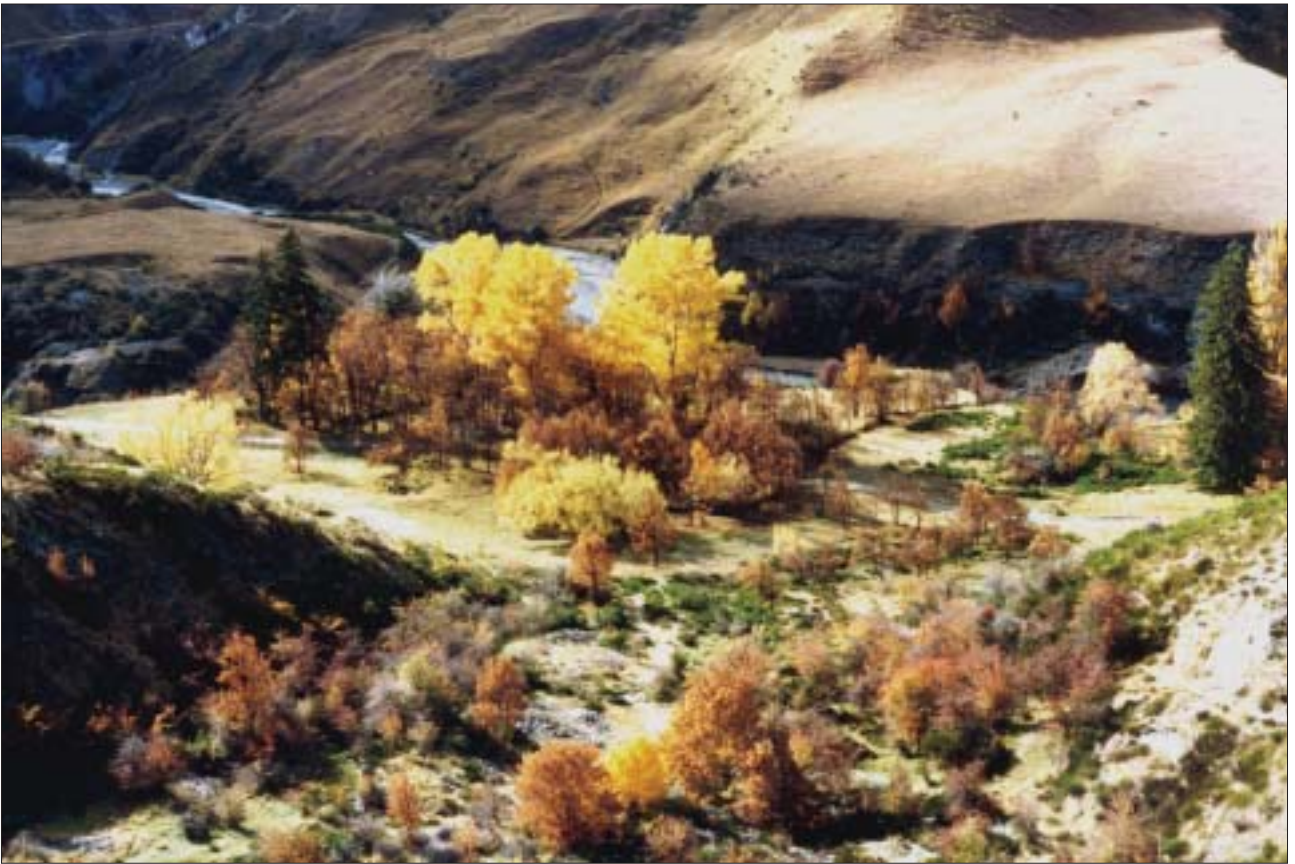
Figure 11. Part of the western end of Macetown in autumn. Numerous low stone walls and lines of revetment mark out long-disappeared gardens and house sites amongst the trees.
Photo: P. Petchey.

A number of other house, hut, and business sites and access lanes are scattered on either side of the road as one continues along. Revetted banks and remains of gardens mark several of these just past the small stream (Fig. 11). The road then drops down a cutting towards the Rich Burn, where the track branches.

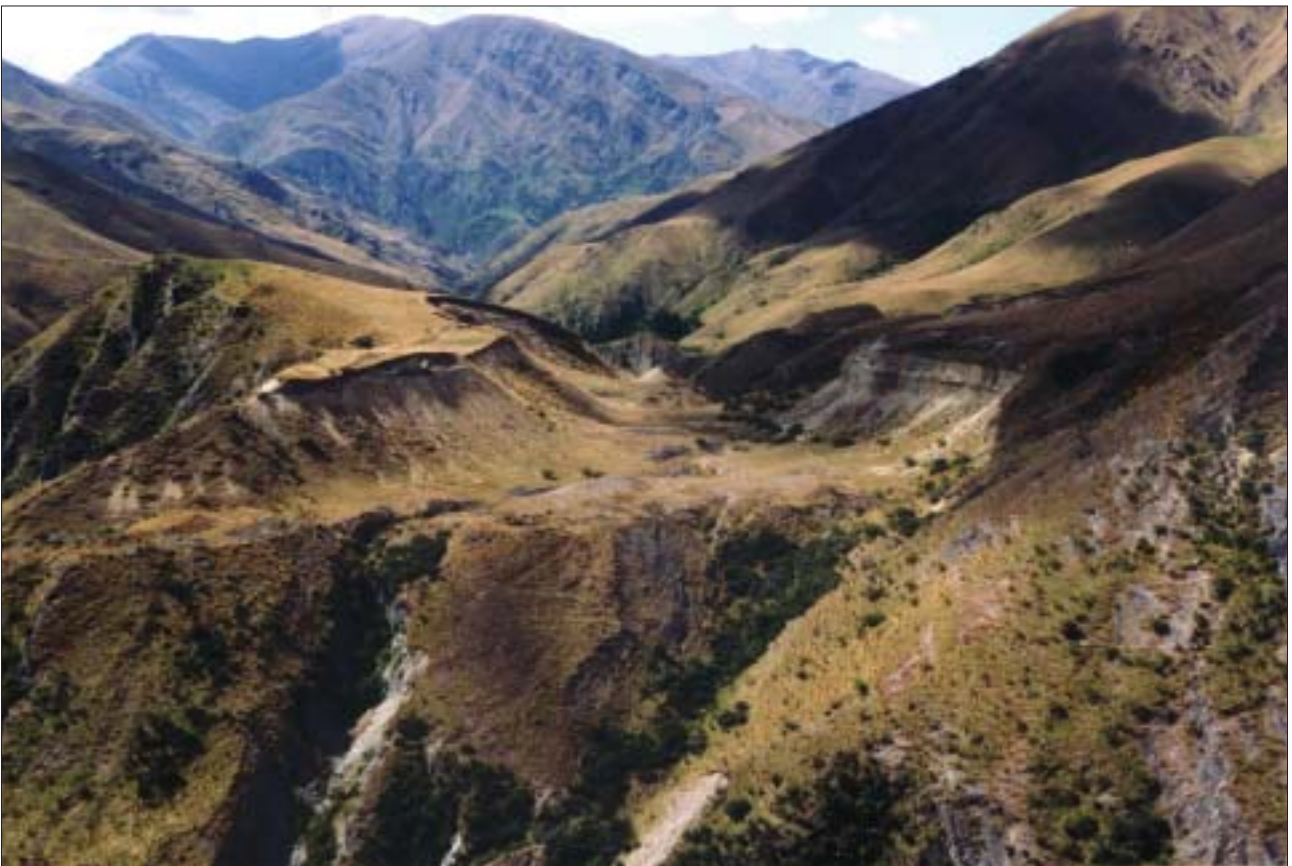
Figure 13. A 'hidden valley' hydraulic sluicing scar. Not visible from the road (to the left and below), this valley was sluiced from the hillside. The cut is between 110 and 200 m wide (see Map 2, p. 18, the northernmost of the two areas marked 'J'). *Photo: P. Petchey.*

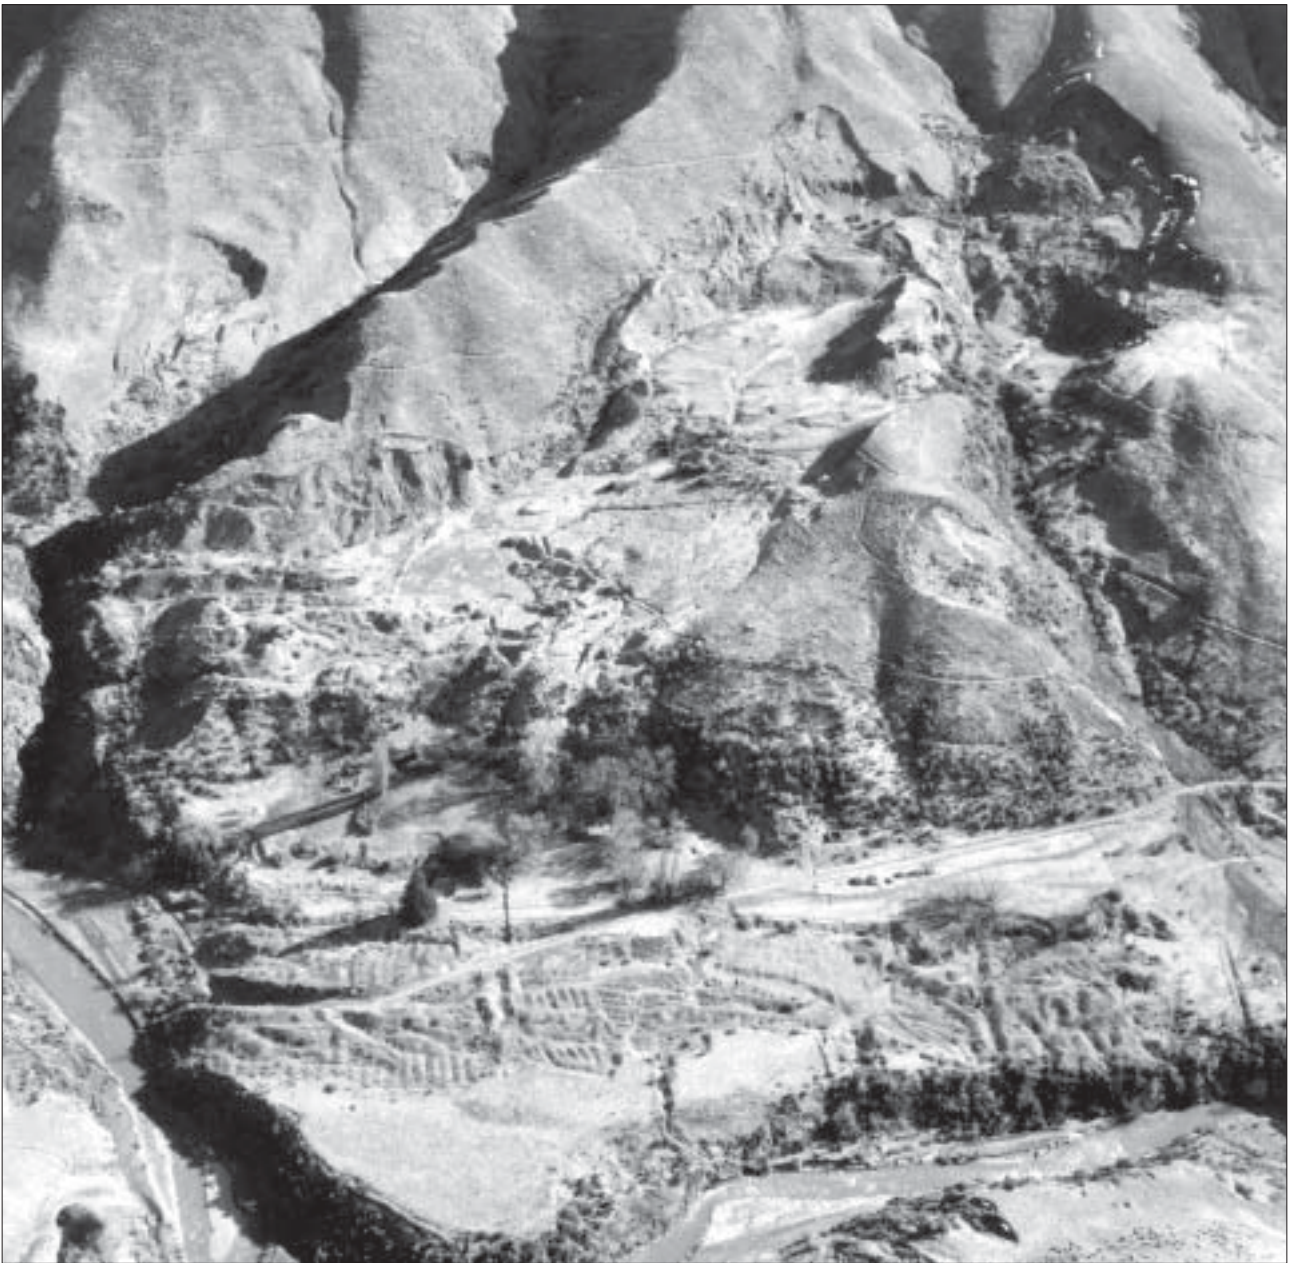
Figure 14. An oblique aerial view (looking southwest) of the southern end of Macetown. High on the hillside is a hydraulic sluicing scar (J on Map 1, pp. 10-11), with the tailrace leading off to the left cut through earlier ground sluicing tailings (K on Map 1). The 'tracks' that appear to follow hillside contours are the remains of supply and head races. Below, several building sites and Macetown's surviving timber building (H on Map 1) are located in the trees, with the regular patterns of hand-stacked ground sluicing tailings on the flat in the foreground (K on Map 1).
Photo: K. Jones, Department of Conservation, Wellington.

There is some pattern to site location, with ground sluicing areas dominating the low- to mid-altitude sites, and hydraulic sluicing sites often found higher up the hillsides. In several places at Macetown there is clear evidence of the progression of mining, with hydraulic sluicing cutting through earlier ground sluicing sites lower down the hillsides (Fig. 14).

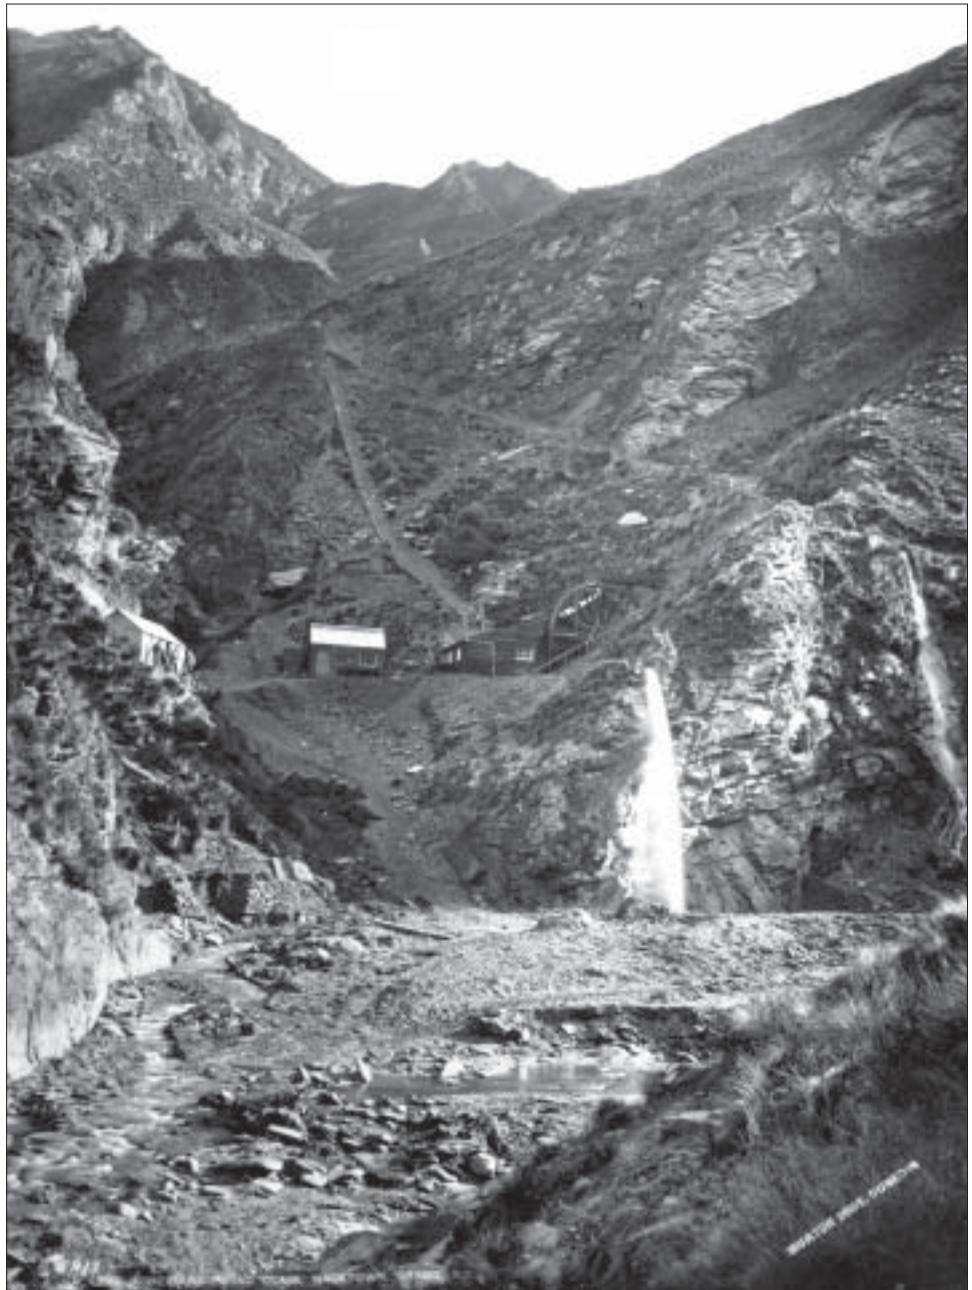
Figure 15. The second Homeward Bound Battery. The tramway can be seen leading from the mine on the hill above. Water from a race powered the mill and the waste water flowed via a waterfall into the Rich Burn.

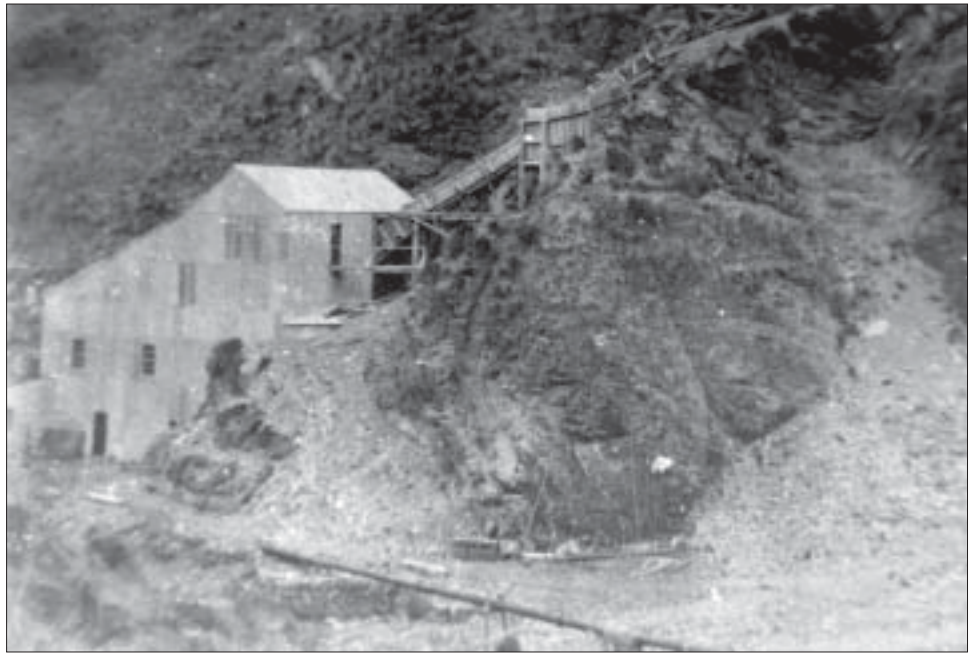
Figure 16. Third Homeward Bound Battery, date unknown.
Photo: Lakes District Museum, Arrowsmith.

This is the third Homeward Bound Battery, moved to the site from Waipori in 1910. It is a ten-stamp mill, manufactured by the Sandycroft Foundry of Chester, England. The heavy frame timbers still bear the marks cut into them to aid reassembly. Extensive stabilisation and timber preservation work has recently been carried out on the structure, including the construction of a roof. Scattered around are various items of battery plant, including a berdan and a

The battery was originally housed in an iron and timber battery shed, of which nothing now remains. Contemporary photographs show it complete (Fig. 16), and at a later date when the iron had been stripped away (Fig. 17).

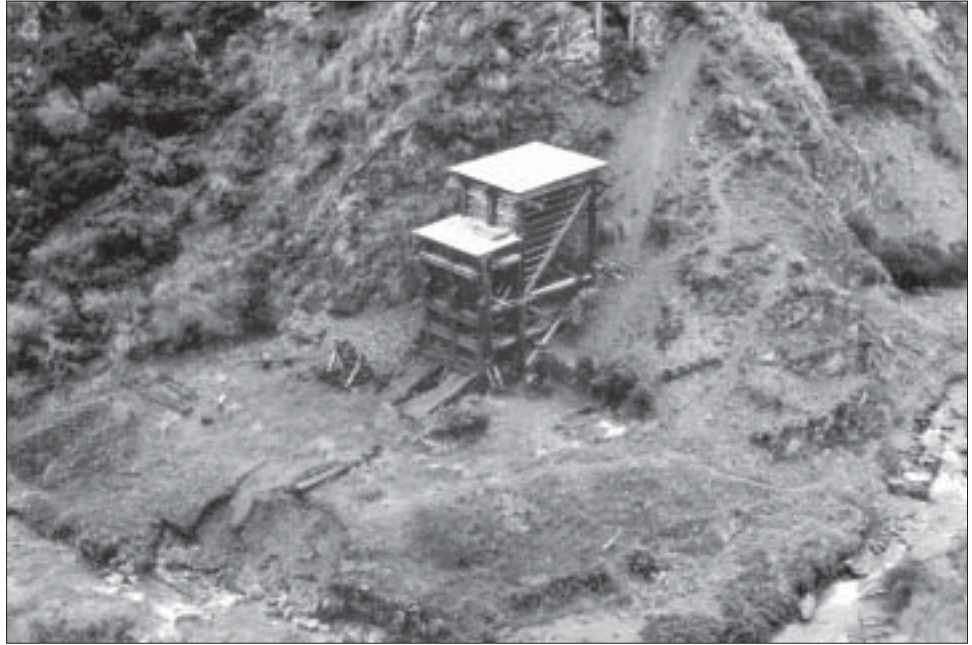
Figure 19. The remains of the third Homeward Bound Battery (ex OPQ). The roof on the structure is a recent addition to slow down the deterioration of the timbers. The berdan is in its correct position, but the camshaft and Wilfley table have been dismantled.
Photo: P. Petchey.

disassembled Wilfley concentrating table. A jaw rock crusher is sitting in the battery structure, although it was originally mounted to the rear and above the mill.

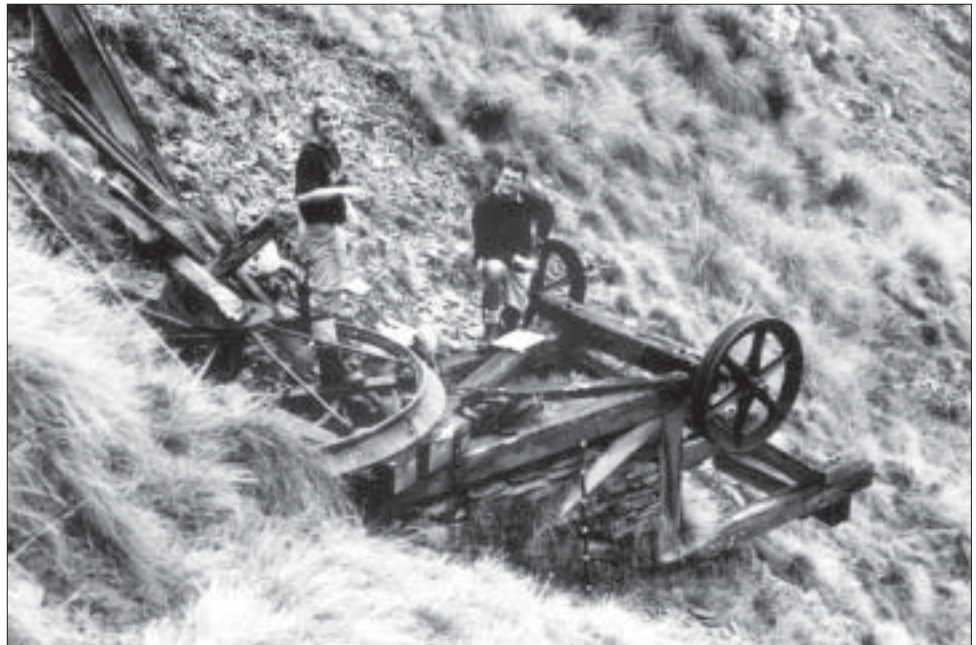
Figure 20. The Homeward Bound aerial cableway top return wheel.
Photo: K. Jones, Department of Conservation, Wellington

It is very similar to the Homeward Bound top return wheel (see Fig. 20), which was built at the same time by the same company, New Zealand Consolidated Mines (Limited), presumably using the same plans and parts.

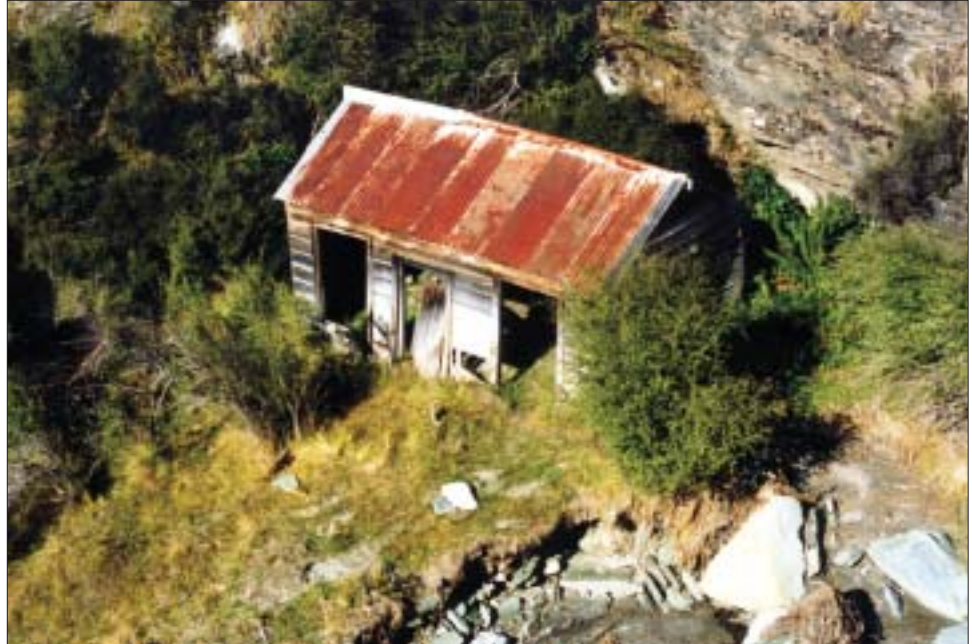
Figure 21. The surviving building at the Sunrise Battery site.
Photo: P. Petchey.

The mine office is located just upstream of the battery site (Fig. 21). It is a small weatherboard building with a corrugated iron roof. Floods have regularly washed through it and gravel has accumulated around and in the building so that the ground level is now at the base of the windows.

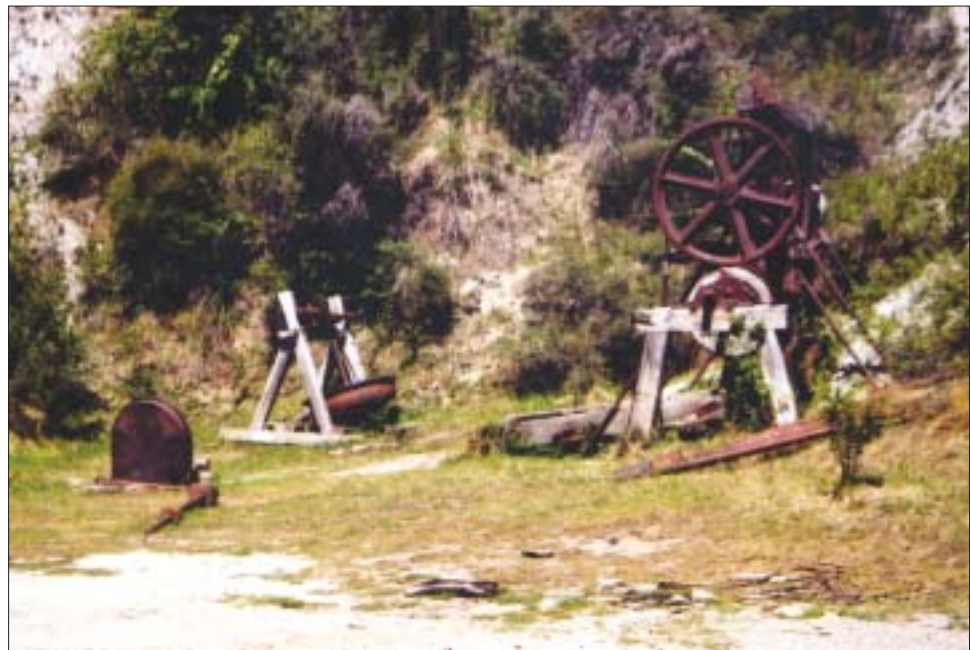
Figure 22. Anderson's Battery site.
Photo: P. Petchey.

The track up Scanlan's Gully starts at Anderson's Battery site (Figs 22 and 23; 'A' on Map 3, p. 24).

The battery is iron-framed, and is the only one of its kind in Otago. Built as a ten-stamp battery (two sets of five stamps), one set of stamper shafts has been removed, and the shafts are presently lying on the ground beside the structure. The battery was powered by a Pelton wheel, which has been removed since the 1970s, although the iron casing for the wheel remains. The berdan, used for fine

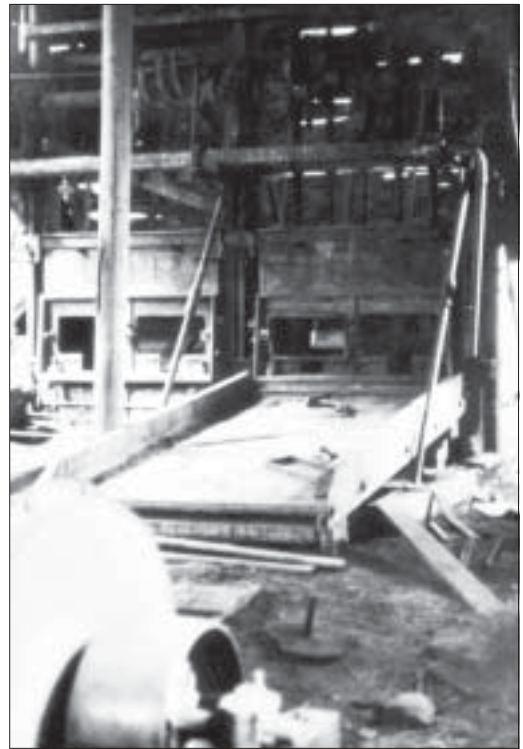
Figure 24. Anderson's Battery in January 1967. The battery shed stood until the 1970s. Since then, the decay of the machinery that remained on the site has been rapid.

grinding, is still in situ in line with the end of the stamper camshaft, from which it was driven via a canvas belt. The battery and equipment stands in the open, although the battery shed survived until the 1970s (Fig. 24). Photographs show it as a weatherboard building with an iron roof. Exposure to the elements is causing decay of the remaining timber elements (berdan frame, battery tables and pulleys), with noticeable deterioration between 1993 and 2000.

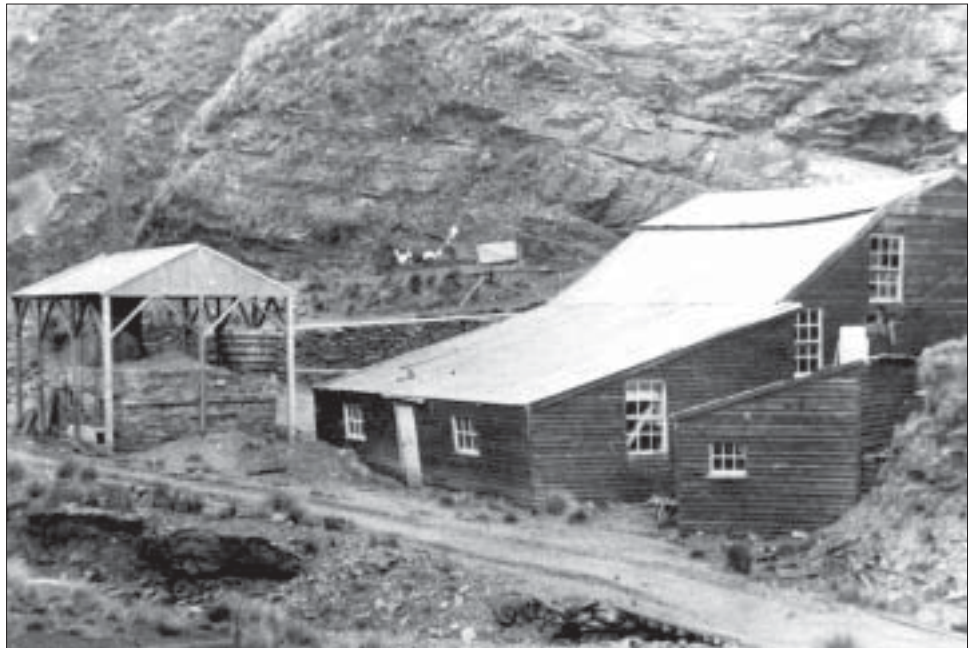
Figure 25. Tipperary Battery c. 1900. The furnace can be seen under the open-sided shelter to the left of the building housing the battery.
Photo: Lakes District Museum, Arrowsmith.

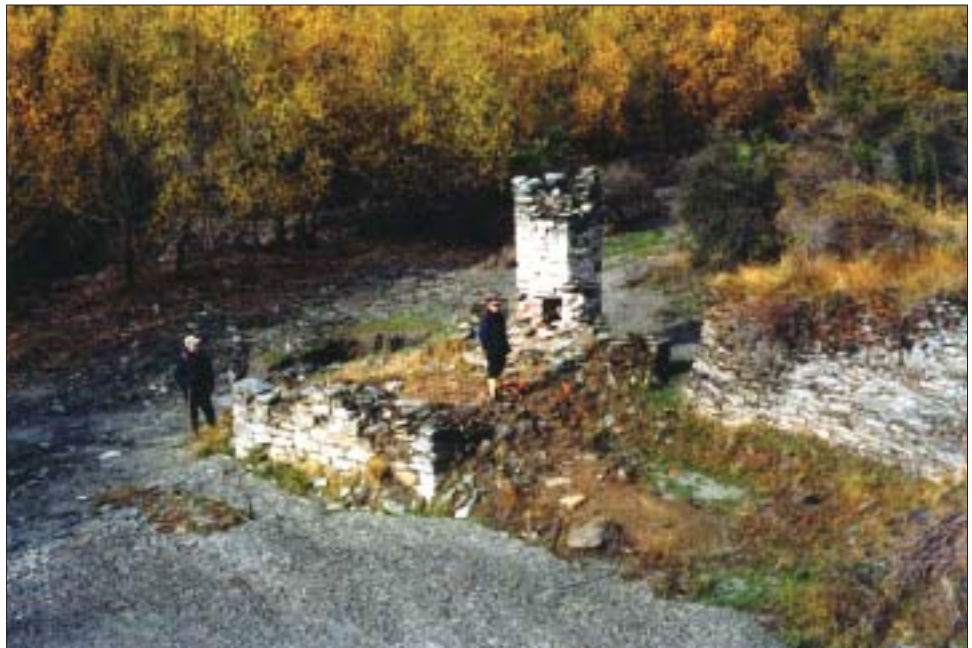
Figure 26. The Tipperary furnace. The gravel was deposited around the structure by floods in 1999.
Photo: P. Petchey.

The Tipperary Battery site and furnace are located about 500 m up the gully, on the true left of the stream (Figs 25, 26 & 27, and 'L' on Map 3, p. 24). Floods in November 1999 badly damaged the site, depositing a thick layer of gravel and washing away the old stream banks. No machinery remains on site. There is a revetted embankment, which was probably where the ore was fed down into the stampers. The stone furnace, located beside the battery site, is still partly standing, although the stonework is becoming increasingly decrepit.

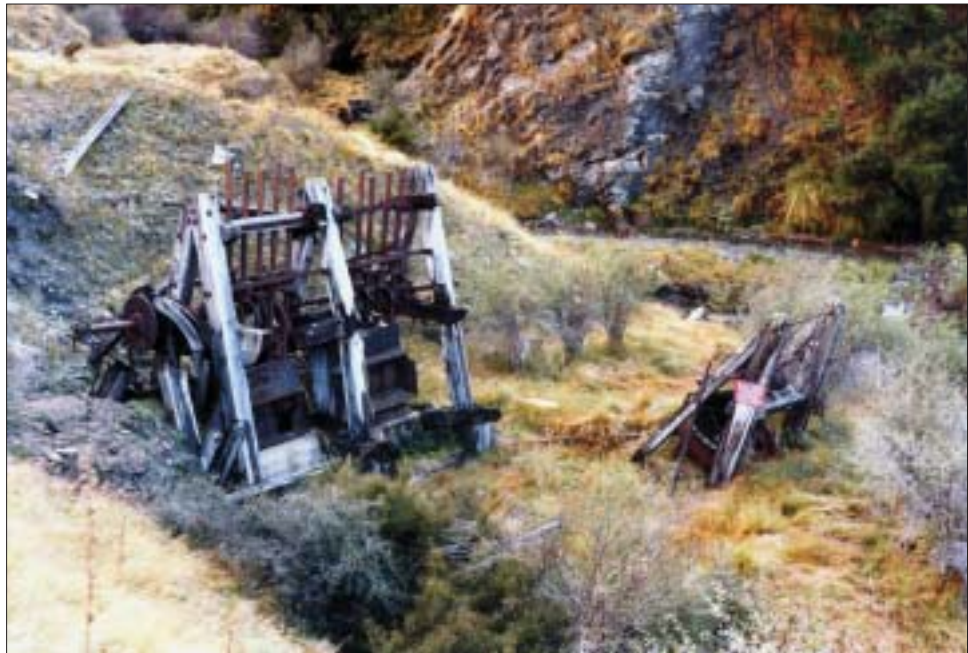
Figure 28. The United Goldfields Battery.
Photo: P. Petchey.

Four hundred metres further on are the United Goldfields Battery and an associated building terrace (Fig. 28 and 'Q' on Maps 3 and 4). The battery is intact, but is becoming quite decrepit. A small slip has come down behind the battery, while the stream is eroding the ground in front of the structure. The battery is unusual in that it has concrete foundations, timber being more commonly used. This may be related to its relatively late date of construction (1910).

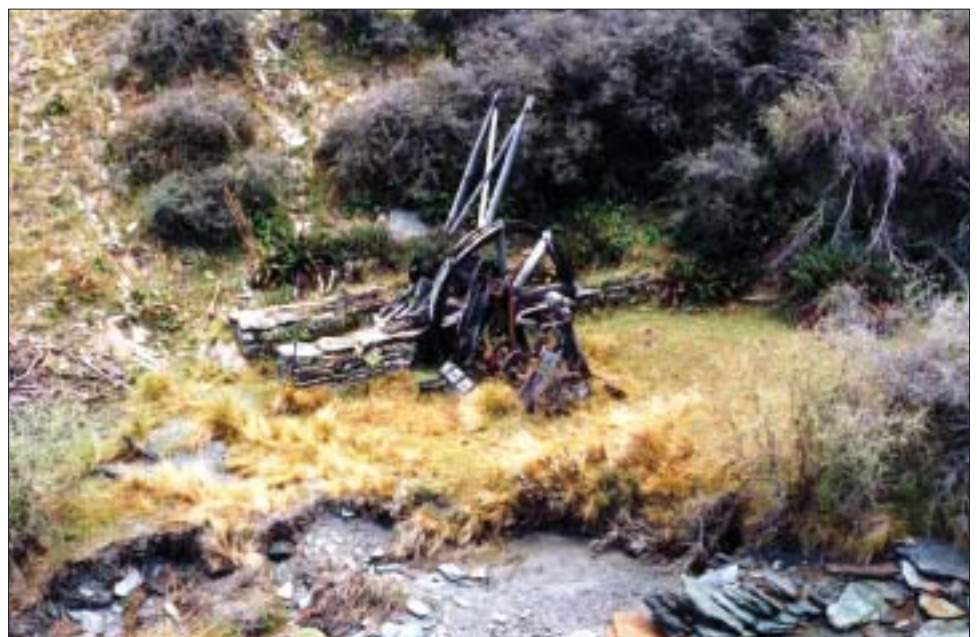
Figure 30. All Nations
Battery.
Photo: P. Petchey.

The site of the All Nations Battery (Fig. 29) is on the true right bank of Sylvia Creek. It consists of the remains of the battery and water wheel, although these are quite decrepit (Fig. 30 and 'R' on Maps 3 and 4). The head race is clearly defined, meeting with Sylvia Creek a short distance upstream, past the site of an old smithy on the opposite bank.

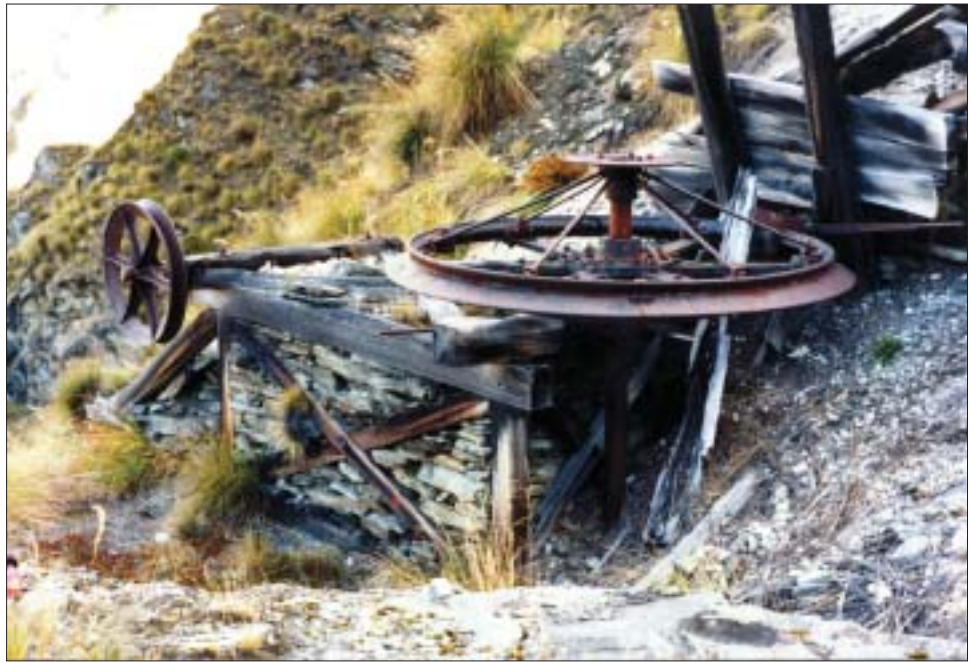
Figure 33. The All Nations aerial cableway top return wheel. Note the similarity to the Homeward Bound wheel (Fig. 20).
 Photo: P. Petchey.

At Skytown, the track first leads to the intact top return wheel of the aerial cableway and the partially collapsed quartz hopper, which is still full of quartz (Figs 33 & 34). The return wheel structure is in very good condition, although one cable guide wheel is missing.

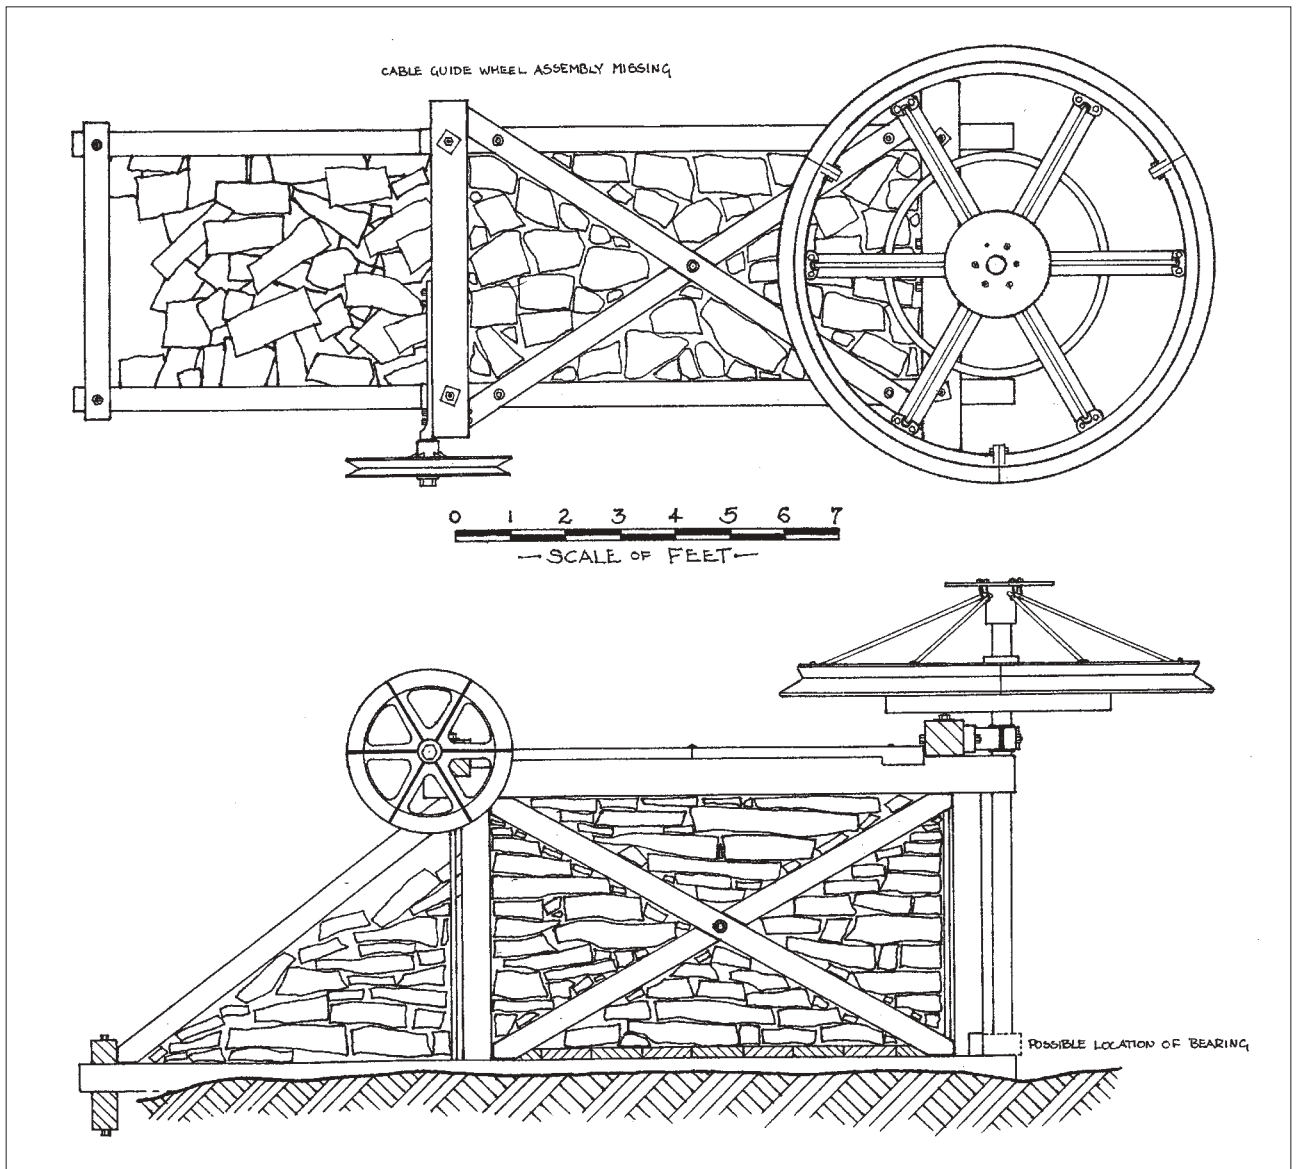
Figure 34. All Nations cableway top return wheel. Drawn by P. Petchey from sketch and measurements made in the field by K. Jones and from photographs. This structure is very similar to the Homeward Bound return wheel, which was built by the same company at the same time. Note that one guide wheel is missing.

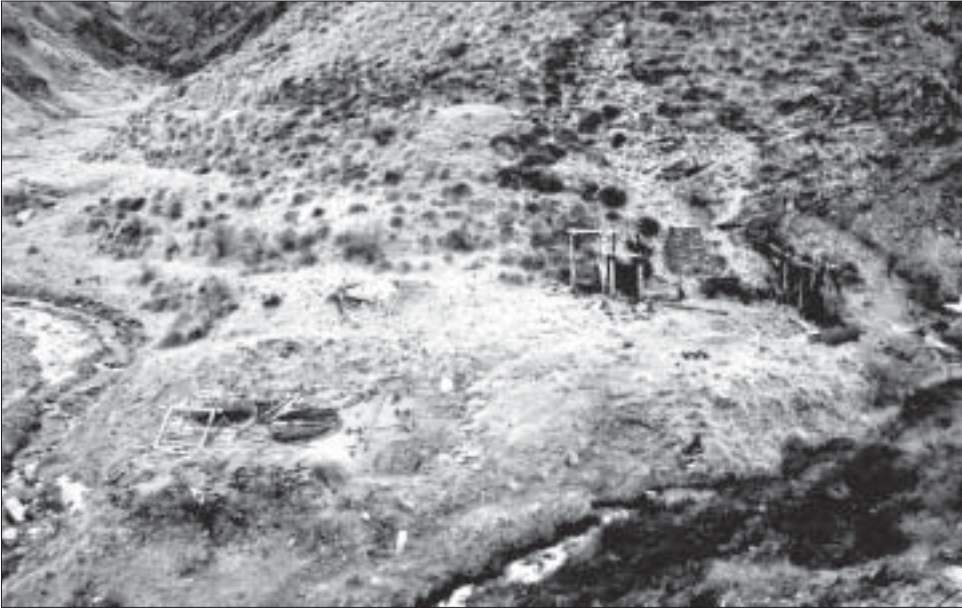
Figure 39. Maryborough/
Premier Battery site from the
northeast. On the left are the
cyanide tanks, and to the
right the remains of the
stamper frames and the water
wheel frame. The Rich Burn
runs in from the right, and
Sawyers Creek is on the left.
Photo: P. Petchey.

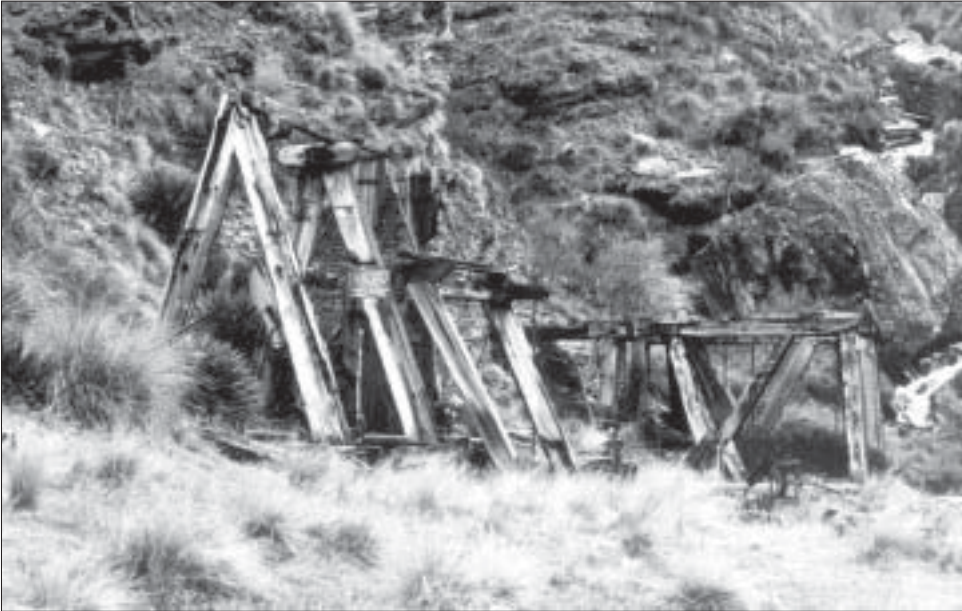
Figure 40. Maryborough/
Premier Battery stand and
water wheel race supporting
structure from the southeast.
*Photo: K. Jones, Department
of Conservation, Wellington.*

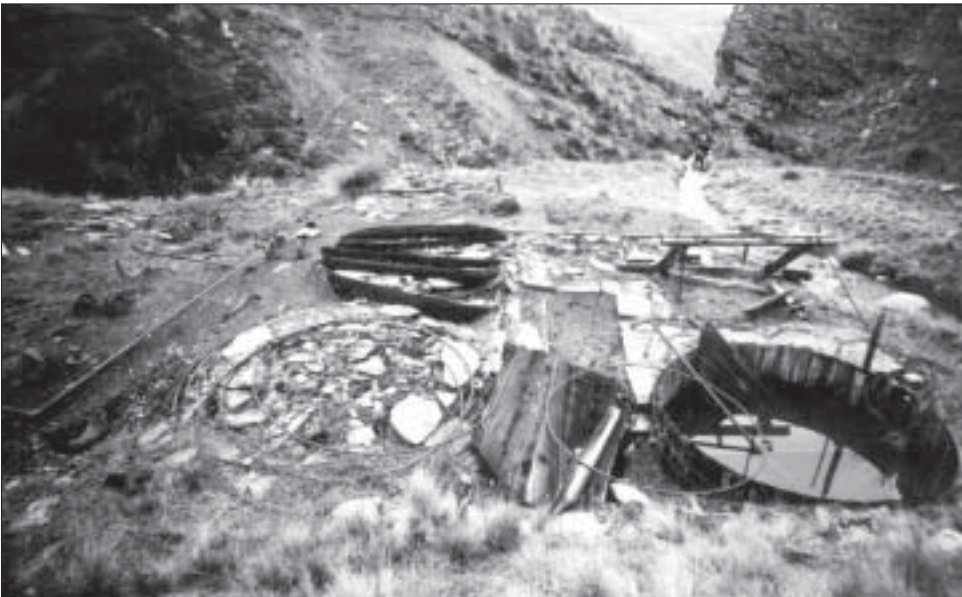
Figure 41. Maryborough/
Premier Battery cyanide vats
from the west.
*Photo: K. Jones, Department
of Conservation, Wellington.*

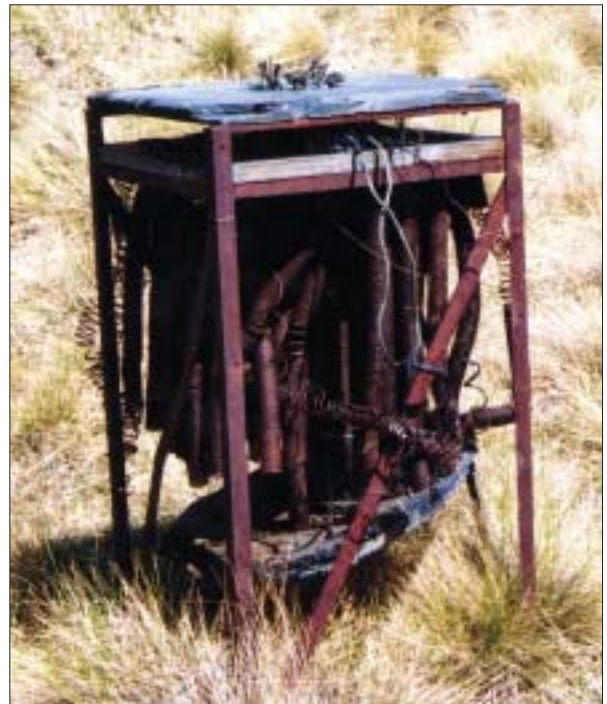
Figure 42. Variable resistance controller for the Premier Mine generator.
Photo: P. Petchey.

There are also a large number of mine infrastructure remains. From the battery, a tramway formation runs up the true left of the gully to the remains of the ore hopper. From the top of the ore hopper an upper tramway runs across the top of a very large mullock heap towards the Premier Mine adit ('X' on Map 4). The mullock heap has a flattened top, and was obviously an important industrial activity area. Various items of ironwork are still scattered about, including a cast iron generator bed. On the gully floor below the heap there are numerous iron trolley wheel sets, an iron winding drum, and a variable resistance controller for the mine generator (Fig. 42).

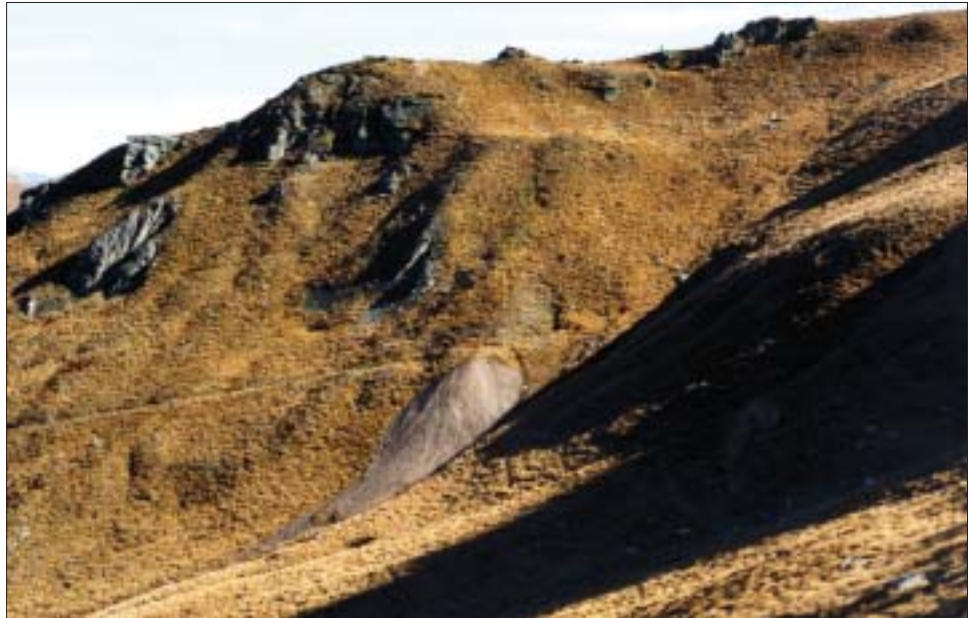
Figure 43. The Sunrise Mine on Advance Peak, nearly a mile high. The mullock heap and steep benched track are clear. The shadow of Advance Peak is thrown across the slope in the autumn sun.
Photo: P. Petchey.

About half way up the mountain the track again branches. The right-hand branch goes around to the Sunrise Mine, where the mullock heap and two hut sites are located (Figs 43 and 45 and 'Sm' on Map 5). Above the adit mouth (caved in) are several prospect pits. To reach the other mines on the Peak one can either follow these pits over the ridge, or one can go back down the track and then up to the mines. The former is much quicker.

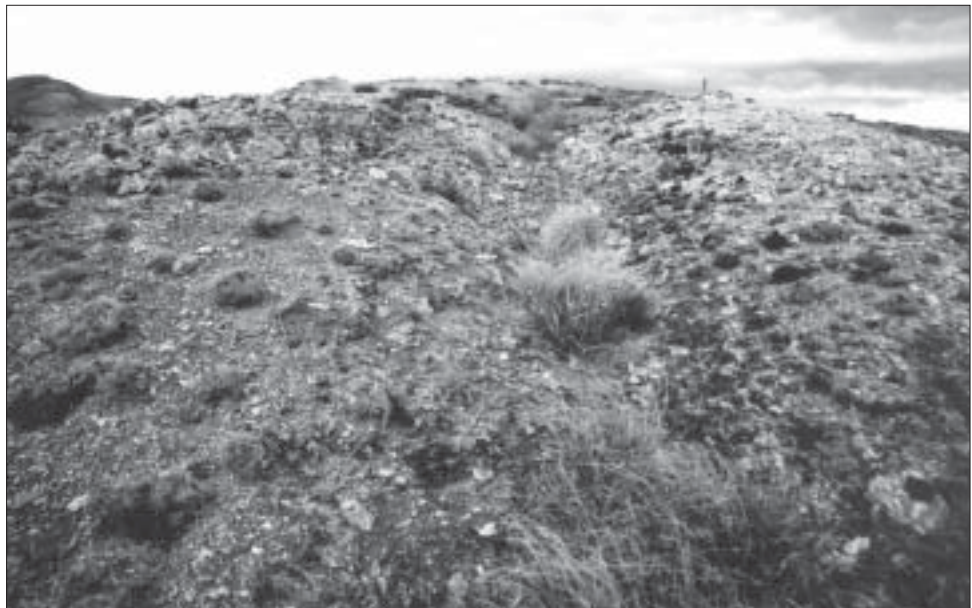
Figure 44. Prospect trench on the ridge top of Advance Peak.
Photo: K. Jones, Department of Conservation, Wellington.

Following the main track to the top ridge, it is easy to turn to the east (right) and climb to the summit of Advance Peak. To the west the track passes close to several large pits and mullock heaps and a prospect trench (Fig. 44) right on the ridge top. From the ridge one can look down into the Shotover Valley, another important historic goldmining area.
