Archaeological survey of the Arrow River and Macetown, Otago

Peter Petchey

Department of Conservation
Te Papa Atawhai

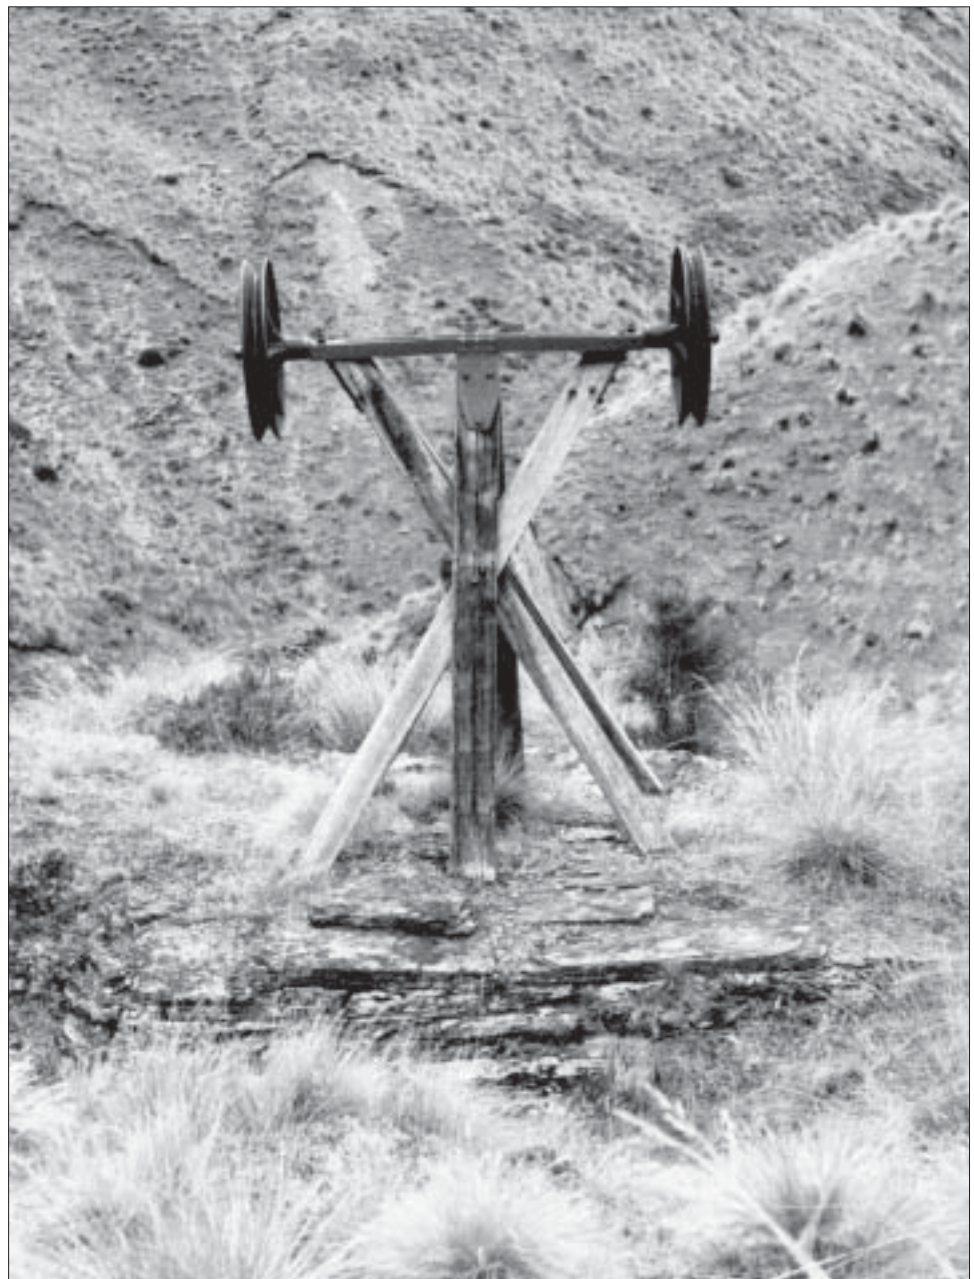
An aerial cableway pylon,
Homeward Bound
cableway
(see Section 7.9.1).
Photograph: P. Petchey.
