### 10.1.3 Tin workings

NZAA Site No. D49/48

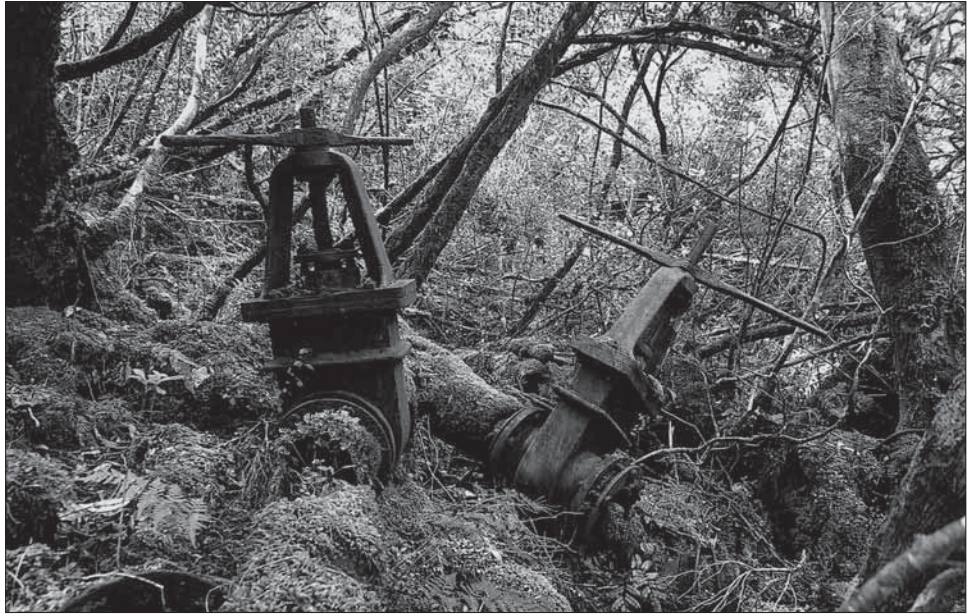
Figure 16. Two screw (gate) valves at the end of the main pipeline, Site D49/41.  
*Photo: P. Petchey.*

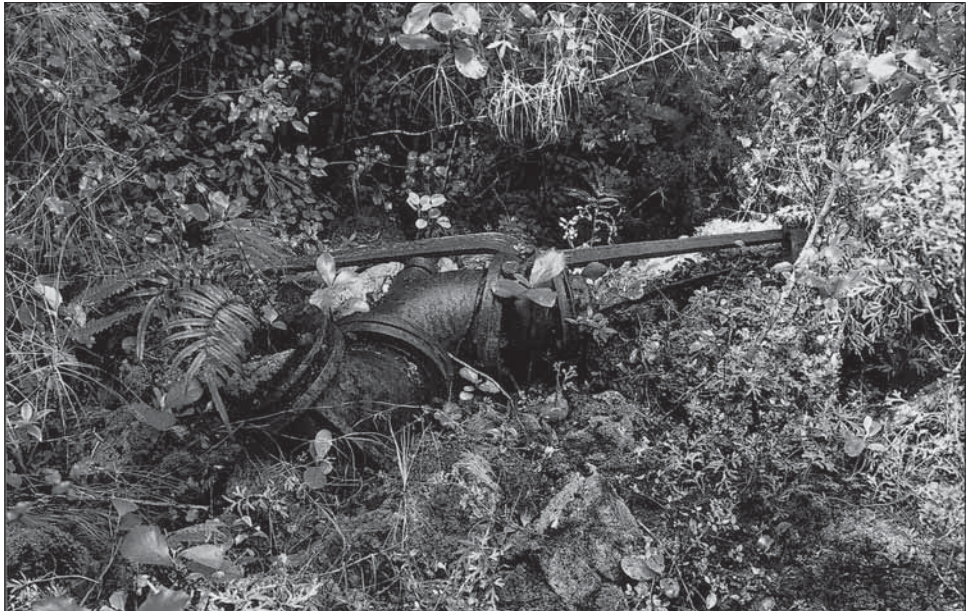
Figure 17. Hydraulic sluicing monitor lying amongst tailings, Site D49/41.  
*Photo: P. Petchey.*

Hydraulic sluicing certainly was used by the 1912-17 tin mining company, as evidenced by the equipment on site. That company acquired an ordinary prospecting licence for the claim in 1912.
