4. Waikato

Waikato fortifications fall into two groups: Māori and Pākehā works associated with the invasion and fighting of 1863 and 1864, and Pākehā frontier works of the next 20 years. Most date from the 1863–64 Waikato War, which was the most important single campaign of the New Zealand Wars in terms of fighting forces involved and its role in deciding the overall outcome. Fighting began on 12 July 1863 when British troops crossed the Mangatawhiri River near Pokeno to Māori land, and ended at the Battle of Orakau of 31 March – 2 April 1864, near the Puniu River, which was afterwards the boundary of Pākehā settlement until 1881.

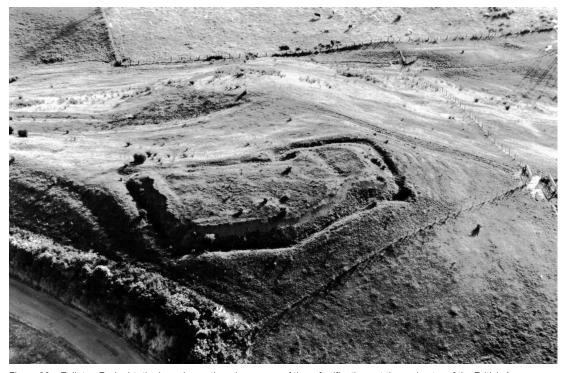
S12/204 (2692000E 6435200N); N48/192; recorded 1979, updates 1999, 2000, 2004; also Koheroa Redoubt; Fig. 28.

Irregular earthwork redoubt of internal area c. 40×20 m with two interior levels. Perimeter mostly without flanking defence. The unusual form depends on available hill-top land, and/or earthworks of the earlier pā on the site.

Under pasture; good condition, some erosion of scarps through slumping and stock damage; fossicking has been reported.

Figure 28. Eglinton Redoubt: the irregular earthwork was one of three fortifications at the perimeter of the British Army camp put up south of Mangatawhiri River at the start of the July 1863 invasion of the Waikato. *Photo: N. Prickett, 1992.*

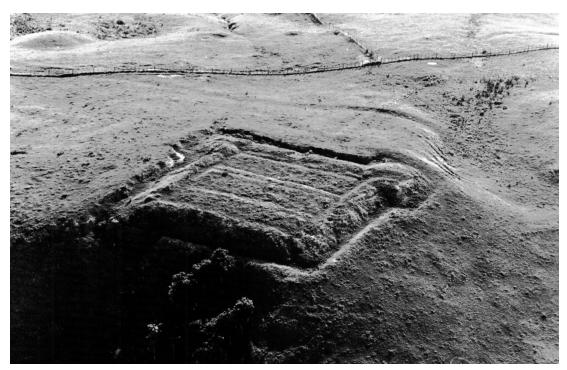
S12/30 (2710950E 6442700N); N48/7; recorded 1967, update 1989; Fig. 29.

Earthwork redoubt with bastion defence at three corners covering all sides; square interior $c. 30 \times 30 m$, with three terraces separated by small scarps and drains; stone platform on one terrace; outside are stone paths and other stone works.

Under pasture; stock erosion; unusual and detailed archaeology within and outside the redoubt.

Figure 29. Esk Redoubt. Photo: N. Prickett, 1992.

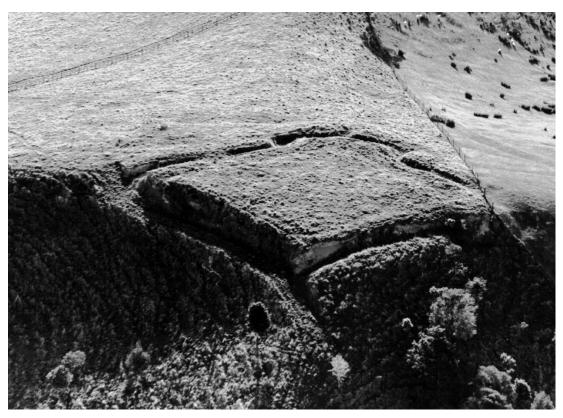
Earthwork redoubt c. 30×30 m, with bastions at three corners covering all four sides (Auckland Historical Society 1993: 34–35).

Under pasture; good condition except for defences on the southeast side now largely destroyed by a farm road.

Fig. 33. Surrey Redoubt. Photo: N. Prickett, 1992.

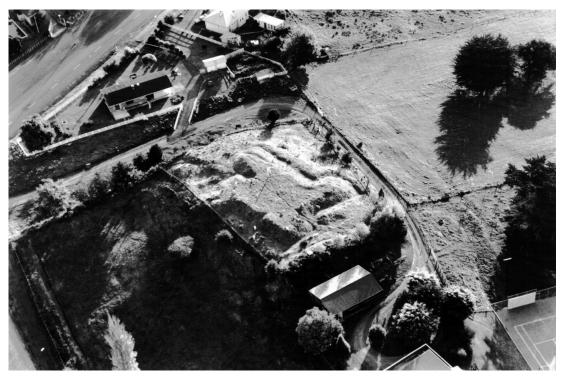
Rectangular earthwork redoubt of 20×15 m internal dimensions, with four bastions, and a 1.5 m high scarp to the external ditch which is 1 m up on the outer side and 4 m wide at the top.

Good condition under grass; earthworks extend outside historic reserve to adjacent land.

Figure 34. Te Wheoro's Redoubt, Rangiriri, is on the ridge formerly occupied by the line of Māori defences. *Photo: N. Prickett,* 1992

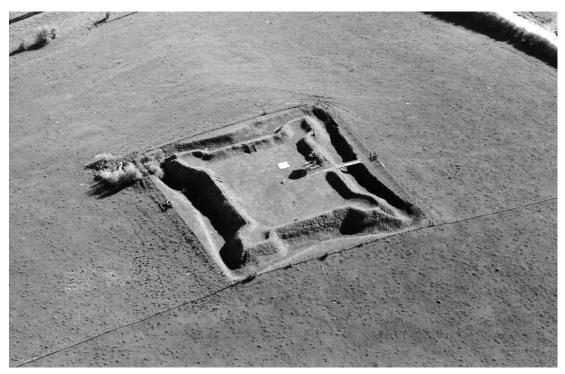
Rectangular earthwork 33 × 22 m, on the summit of a low but commanding hill; an unusual New Zealand form with bastions at four corners covering all sides from both adjacent angles.

In good order under grass in historic reserve, low bracken on earthworks; repaired 1994.

Figure 36. Alexandra Redoubt, Pirongia: bastions at four corners cover each side from both adjacent angles. *Photo: Kees Sprengers, Waikato Museum Te Whare Taonga o Waikato, Ref. No M542-26 (1980).*

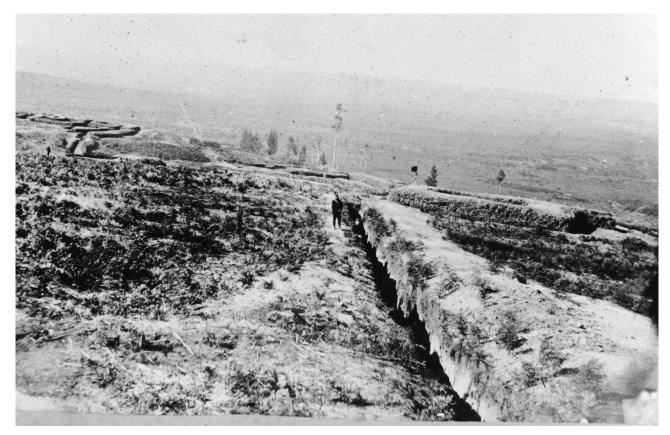
The largest continuous earthwork fortification and outstanding barrier work of the New Zealand Wars, comprising c. 1 km of rifle trenches connecting six strong points.

The site is now largely destroyed by farming, key areas have been built on in recent years. Little is now visible; significant subsurface remains likely of such a major earthwork.

Figure 37. Paterangi: the largest continuous barrier pā of the New Zealand Wars included nine strong points, two of them shown here at right and left distance, with rifle trenches between. Photo: M. Higginson (attributed), Auckland Museum album 510, p. 6.

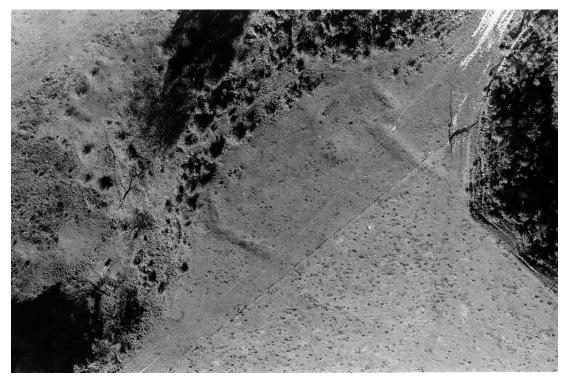
Figure 38. Te Rore redoubt on left bank of Waipa River. Earthworks are destroyed to the right of the fence. *Photo: Kees Sprengers, Waikato Museum Te Whare Taonga o Waikato, Ref. No M538-7 (1980).*

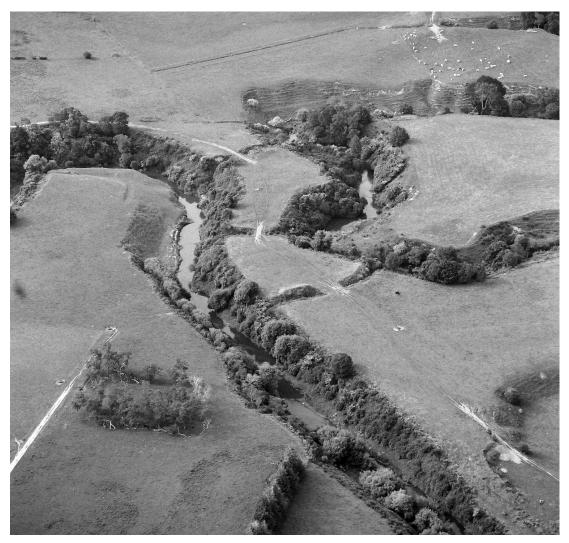
Fig. 39. Waiari: three trenches across the river bend are the defences of Waiari pā; Waiari Redoubt is on the other side of the Mangapiko Stream under trees at lower left. *Photo: K.L. Jones, 2004.*

Rectangular redoubt, c. 40×35 m internal dimensions, with rounded bastion defence at two corners covering all sides.

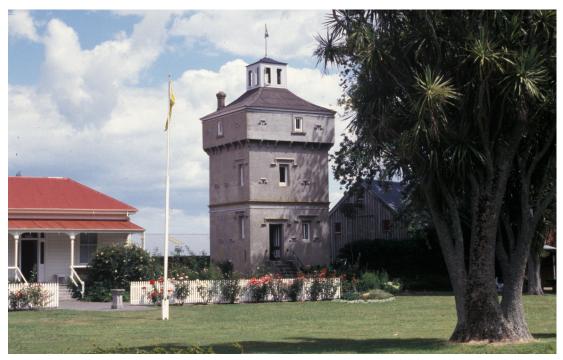
Figure 40. Firth's Tower, Matamata: built 1881–82 as a look-out and refuge on J.C. Firth's 23,000 ha Matamata Estate. *Photo: N. Prickett. 2001.*

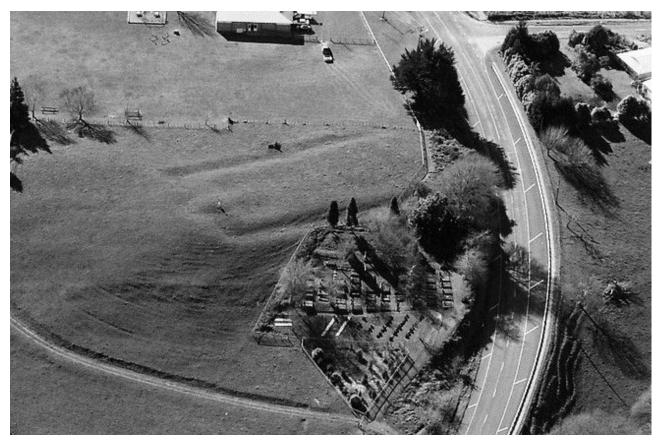
Rectangular redoubt c. 75×30 m; defensive projection from the centre of west end. A 1943 aerial photograph (836/47) shows a flanking angle at the east end.

Good condition under grass; east end now destroyed.

Figure 41. Ohaupo Redoubt, from the south, Ohaupo Road (SH3) at right. Photo: K.L. Jones, 2004.

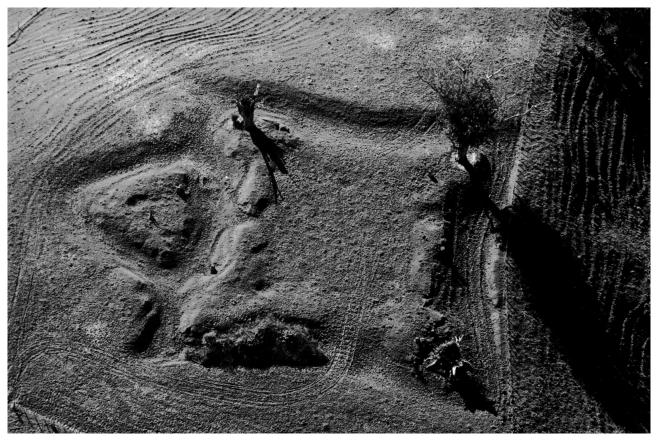
Figure 44. Rotoorangi Redoubt: unusual 'star' form for 1873 work with 'ravelin' outwork protecting the entry. *Photo: Kees Sprengers, Waikato Museum Te Whare Taonga o Waikato, Ref. No M581-1 (1980).*
