Whanganui River Estuary

Broad Scale Habitat Mapping 2008/09

Department of
Conservation

June
2009

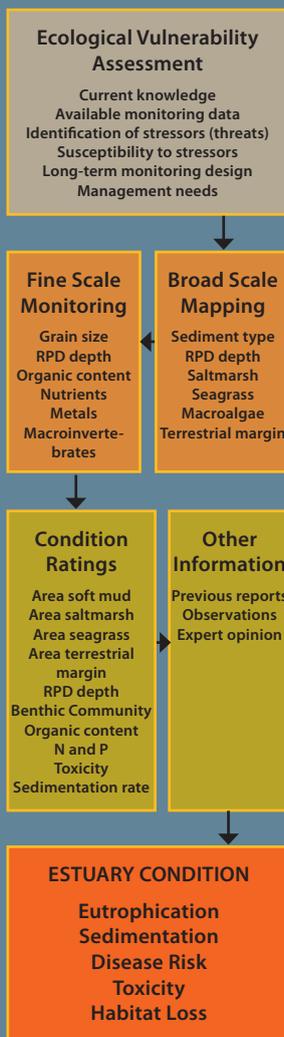
Figure 1. Typical approach to evaluating the condition and risks to estuarine habitats.

Typical approach to evaluating the condition and risks to estuarine habitats

Developing an understanding of the condition and risks to estuarine habitats is critical to their effective management, and typically follows the approach summarised in Figure 1. In recognition of the large size of the Whanganui River Estuary, its national significance (for bird habitat), regional significance for botanical values (Fechney et al. 1990), important fish breeding areas (Strickland et al. 1982), and the limited information on the types of habitats present and their existing condition, the Department of Conservation (DOC) contracted Wriggle Coastal Management to undertake the broad scale habitat mapping of the lower estuary using the National Estuary Monitoring Protocol (EMP) (Robertson et al. 2002) plus recent extensions (see Tables 1 and 3). EMP results can be compared with estuaries throughout NZ monitored using the same method.
