Mitigating Incidental Captures of Fur Seals in Trawl Fisheries

A REPORT COMMISSIONED BY
DEPARTMENT OF CONSERVATION

Project MIT 2006/09

SEPTEMBER 2009

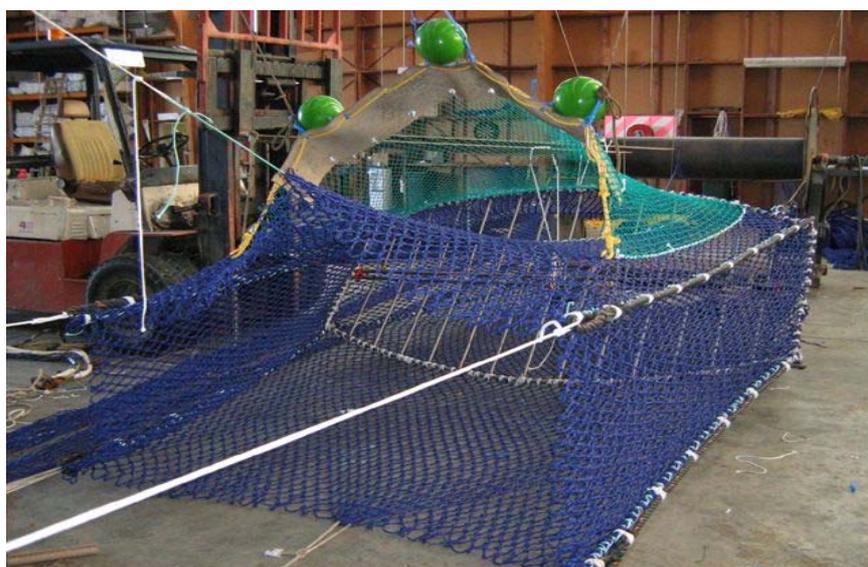
Figure 2: SED during construction at Motueka Nets Ltd, Nelson, 2008

The SED was constructed by Motueka Nets Ltd, a leading trawl manufacturing and repair company in Nelson (Figure 2). Motueka Nets have been heavily involved in the design and testing of the sea lion SLED design and construction from its inception.

The SED was built to general SLED design specifications and with a two panel grid. The bar spacing however was 17 cm (inside measurement) compared to 23 cm for sea lion exclusion, but the escape hole remained the same size as a 1.0 m wide base and 1.2 m long triangle. The grid was fitted into a 150 mesh round, four panel lengthener designed to fit directly into *FV Taimania's* trawl net. More information on the SED can be seen in Appendix 3.

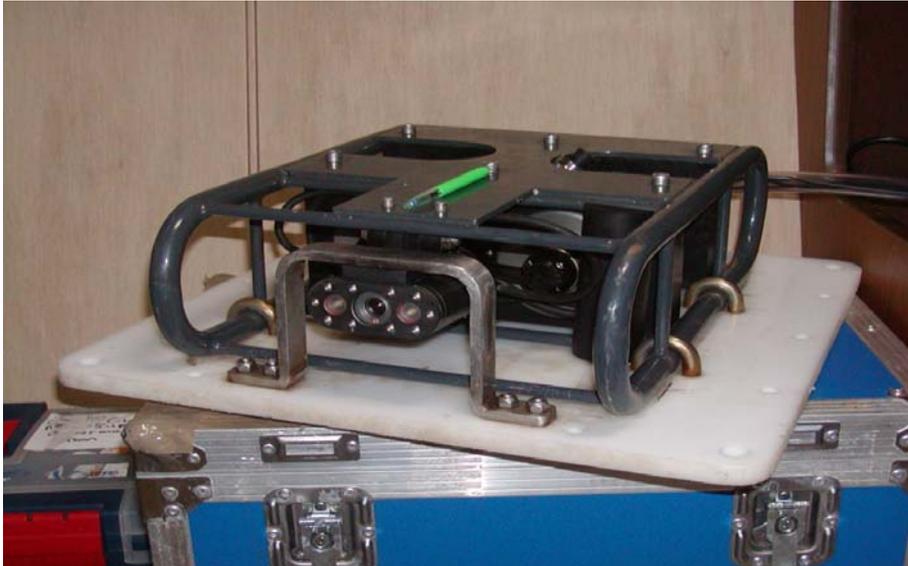
Figure 5: Trittech Seacorder white light camera. The Teflon base board and stainless protection bar were added to improve usability and protection. Ball point pen lying on top provides scale.

Observation of the SED under operating conditions during the second sea trial used a Tritech Seacorder white light camera (see Figure 5, specification Appendix 6). This system has been used for work in the New Zealand SQU 6T trawl fishery (see Middleton, & Banks, 2008) and has proven to be relatively robust and reliable. As it was available, the OS camera was also taken to sea as a contingency in the event of failure of the Seacorder unit.

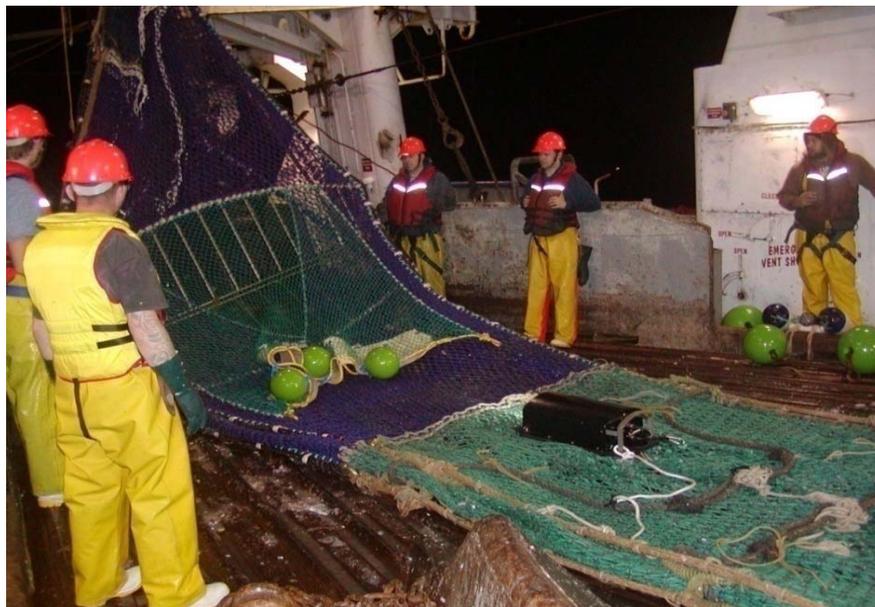
Figure 7: Ocean Systems camera fitted on the trawl ready for deployment. Camera light can be seen operating, *FV Taimania*, September 2008

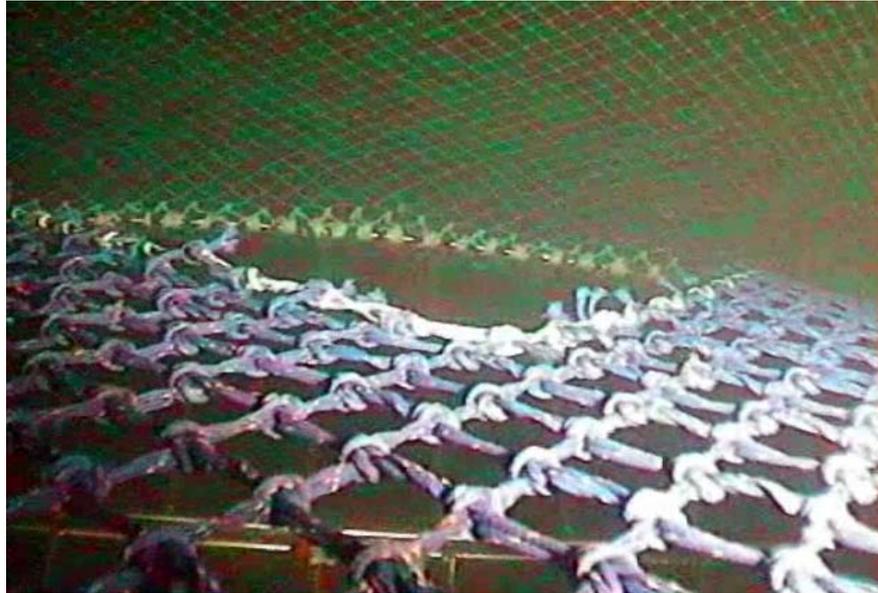
Figure 8: SED in operation during initial trials in Cook Strait, 2008. View of escape hole from apex looking aft towards top of grid frame. Netting meshes in hood and SED lengthener are assuming proper shape. Centre of grid where the two sections join is visible inside the lengthener, bottom of picture.

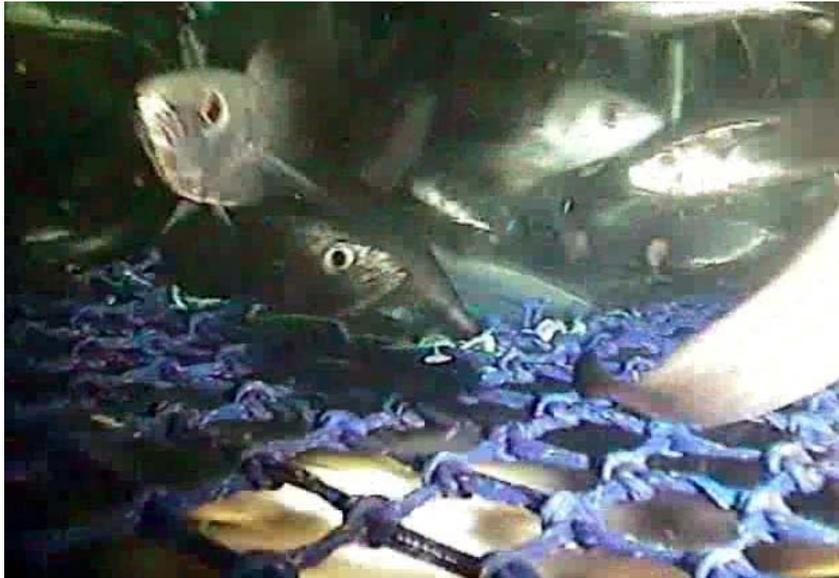
Figure 9: Hoki swimming freely from escape hole of SED during high catch rates achieved during initial trials, Cook Strait, 2008

Depending on fish levels passing through the SED, water flow appeared to change through the SED escape hole and hood. Whereas when there was little or no fish entering the lengthener, it appeared that water flowed into the SED escape hole or at least across it and passed out the back of the hood. Some fish could be seen held against the lower hood netting by this flow. When large amounts of fish enter the SED this flow appeared to stop and the hood area had little or no flow. During this type of event large numbers of fish were observed escaping from the SED as demonstrated in the video still image (Figure 9). While the grid was not observed to completely block up, the top section of the grid became congested when fish filled the escape hole and the hood area.

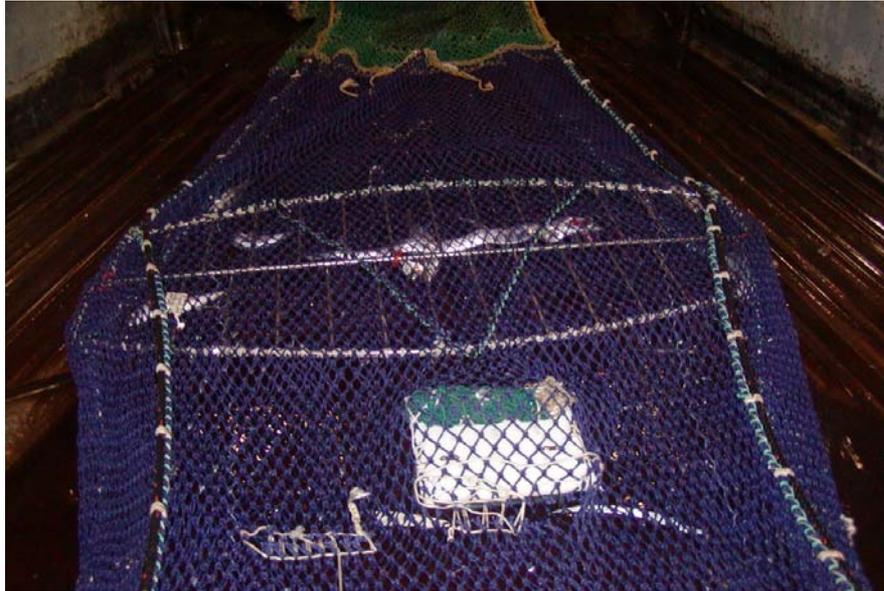
Figure 14: SED on deck after haul. A single frostfish (*L. caudatus*) is still retained across the bars. The placement position of the camera close to the apex of the closed escape hole and within the lengthener can be clearly seen, April, 2009

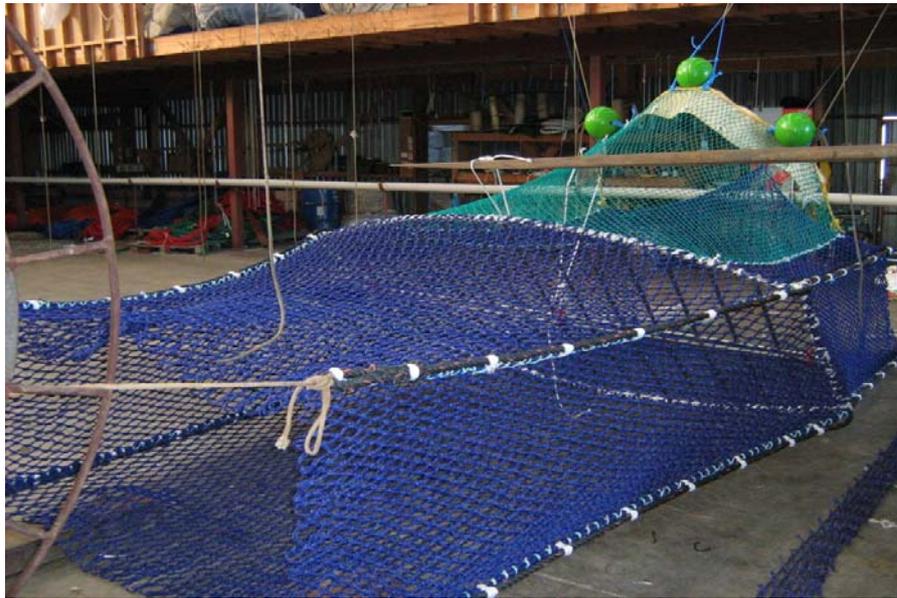
Figure 16: SED viewed from behind, final lengthener and codends attach at end closest to observer.

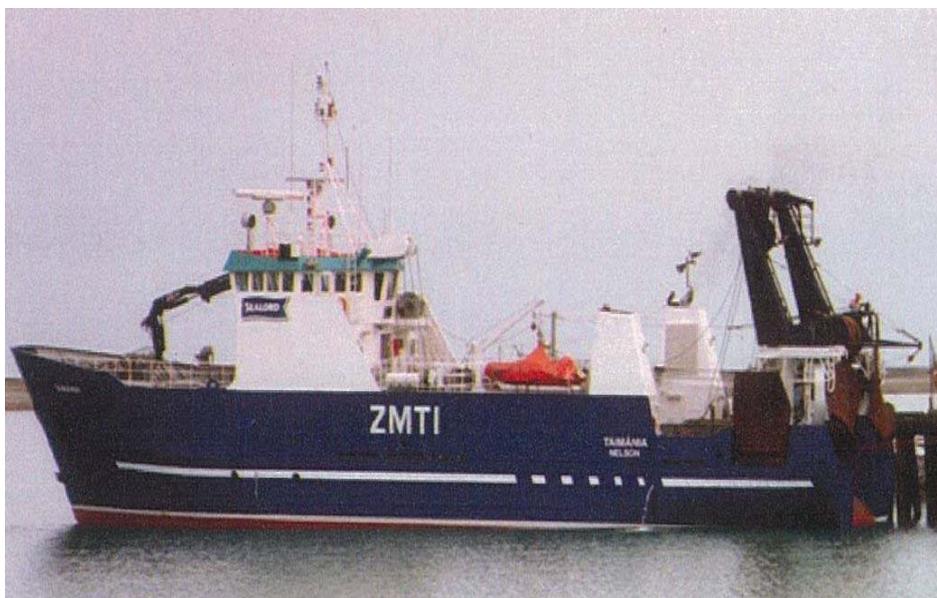
FV Taimania

Fresh fish stern trawler:

- 43 m length overall
- 2500 horsepower
- 798 gross registered tonnes

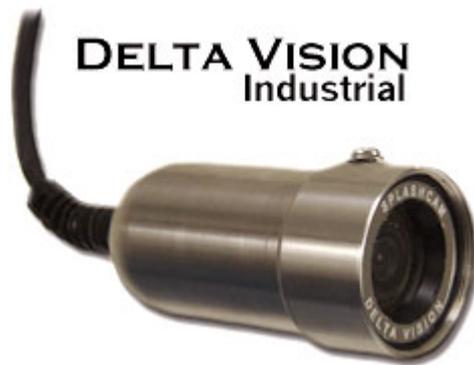
Video Platform

- Pressure Bottle 4"x18" (rated 2500 m)
- Delta Vision Colour Camera
- Mustek (PVR – H140) video recorder
- Portable 1500 m Led Lamp
- NI – MH 9 AH battery
- Video recorder and battery stored into the pressure bottle

Delta Vision Industrial Colour Camera Features:

- 420 TV lines of resolution
- Low light operation - (0.5 lux) without LED's engaged
- Virtually indestructible stainless steel camera housing
- Military grade umbilical cable – 700 lb. BS – 250 lb. Working
- Switchable internal ultra bright LED's for illumination
- Recessed lens Borsolite lens
- Camera field of view 75°
- Image NTSC composite video
- Lens: 3.6 mm
- Iris: electronic
- Operating temp: -10 to 55°
- Input volts: 12 VCD
- Current consumption: 270 MA
- Visibility 6 m in clear water

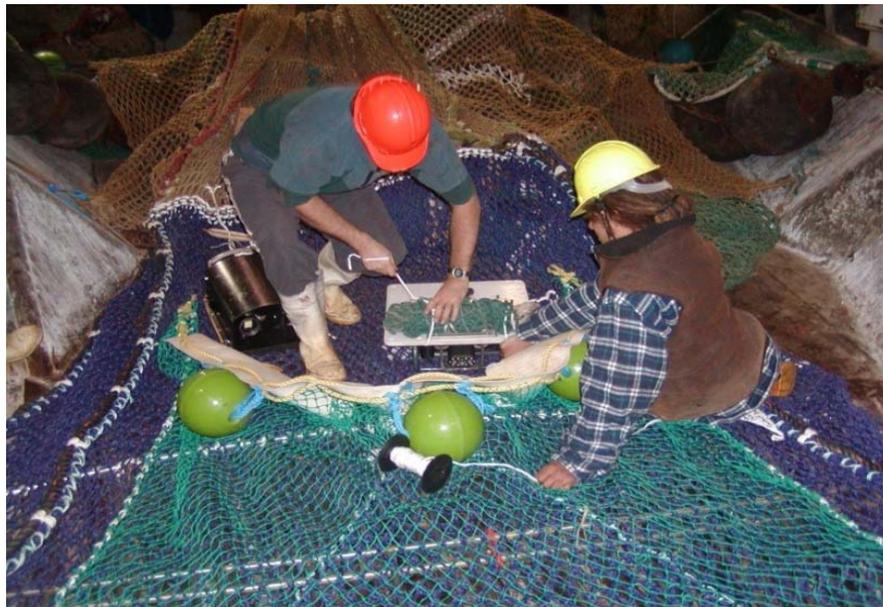
Figure 1: Deck crew fitting the cameras to the SED with netting packing to improve field of view, *FV Taimania*, April 2009

Both units were tied to the top of the mesh inside the SED lengthener. The cameras were tilted down 15 degrees to view the centre of the grid and on the Trittech unit (as it was fitted closer to the grid) we also fitted netting packing to the camera board as packing to give another 15 degrees downward angle (Figures 1 and 2).

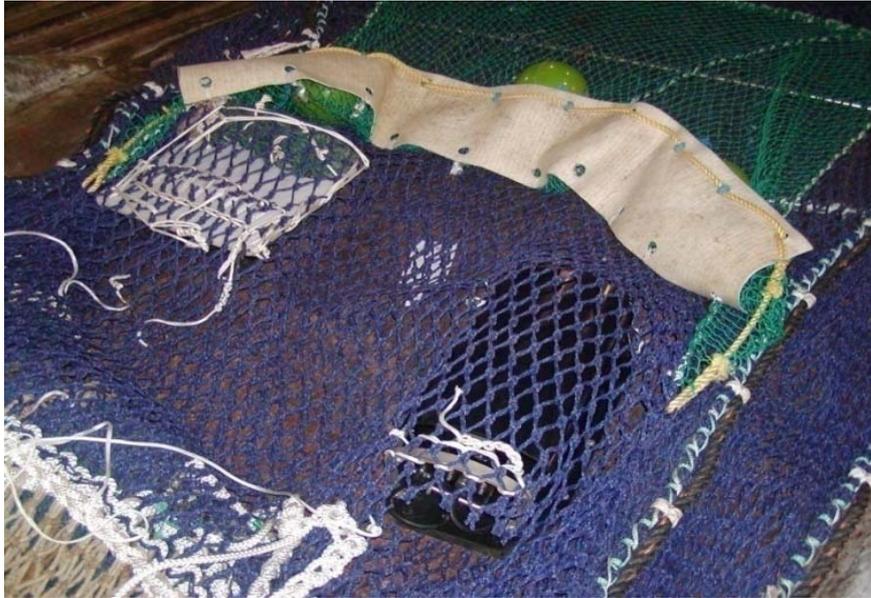
Figure 2: Both cameras fitted inside the SED lengthener, *FV Taimania*, April 2009

The two cameras were installed into the body of the SED lengthener. On the port side the Ocean System's unit was fitted 1.5 m from the top of the grid and on the starboard side the Trittech unit fitted 1 m back from the top of the grid.

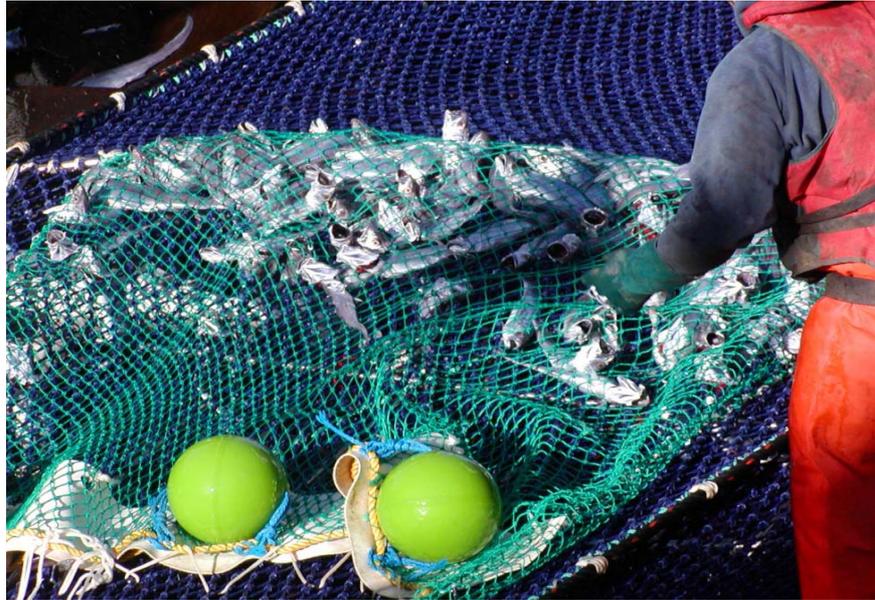
Figure 3: Some small hoki escaping from lengthener were retained in the hood *FV Taimania*, April 2009

The hood is full of hoki; it is because the escape hole is stitched up so small fish getting out of the lengthener are getting caught in the smaller mesh of the hood (Figure 3). This has occurred every tow, so decide to let crew cut hood/kite off.
