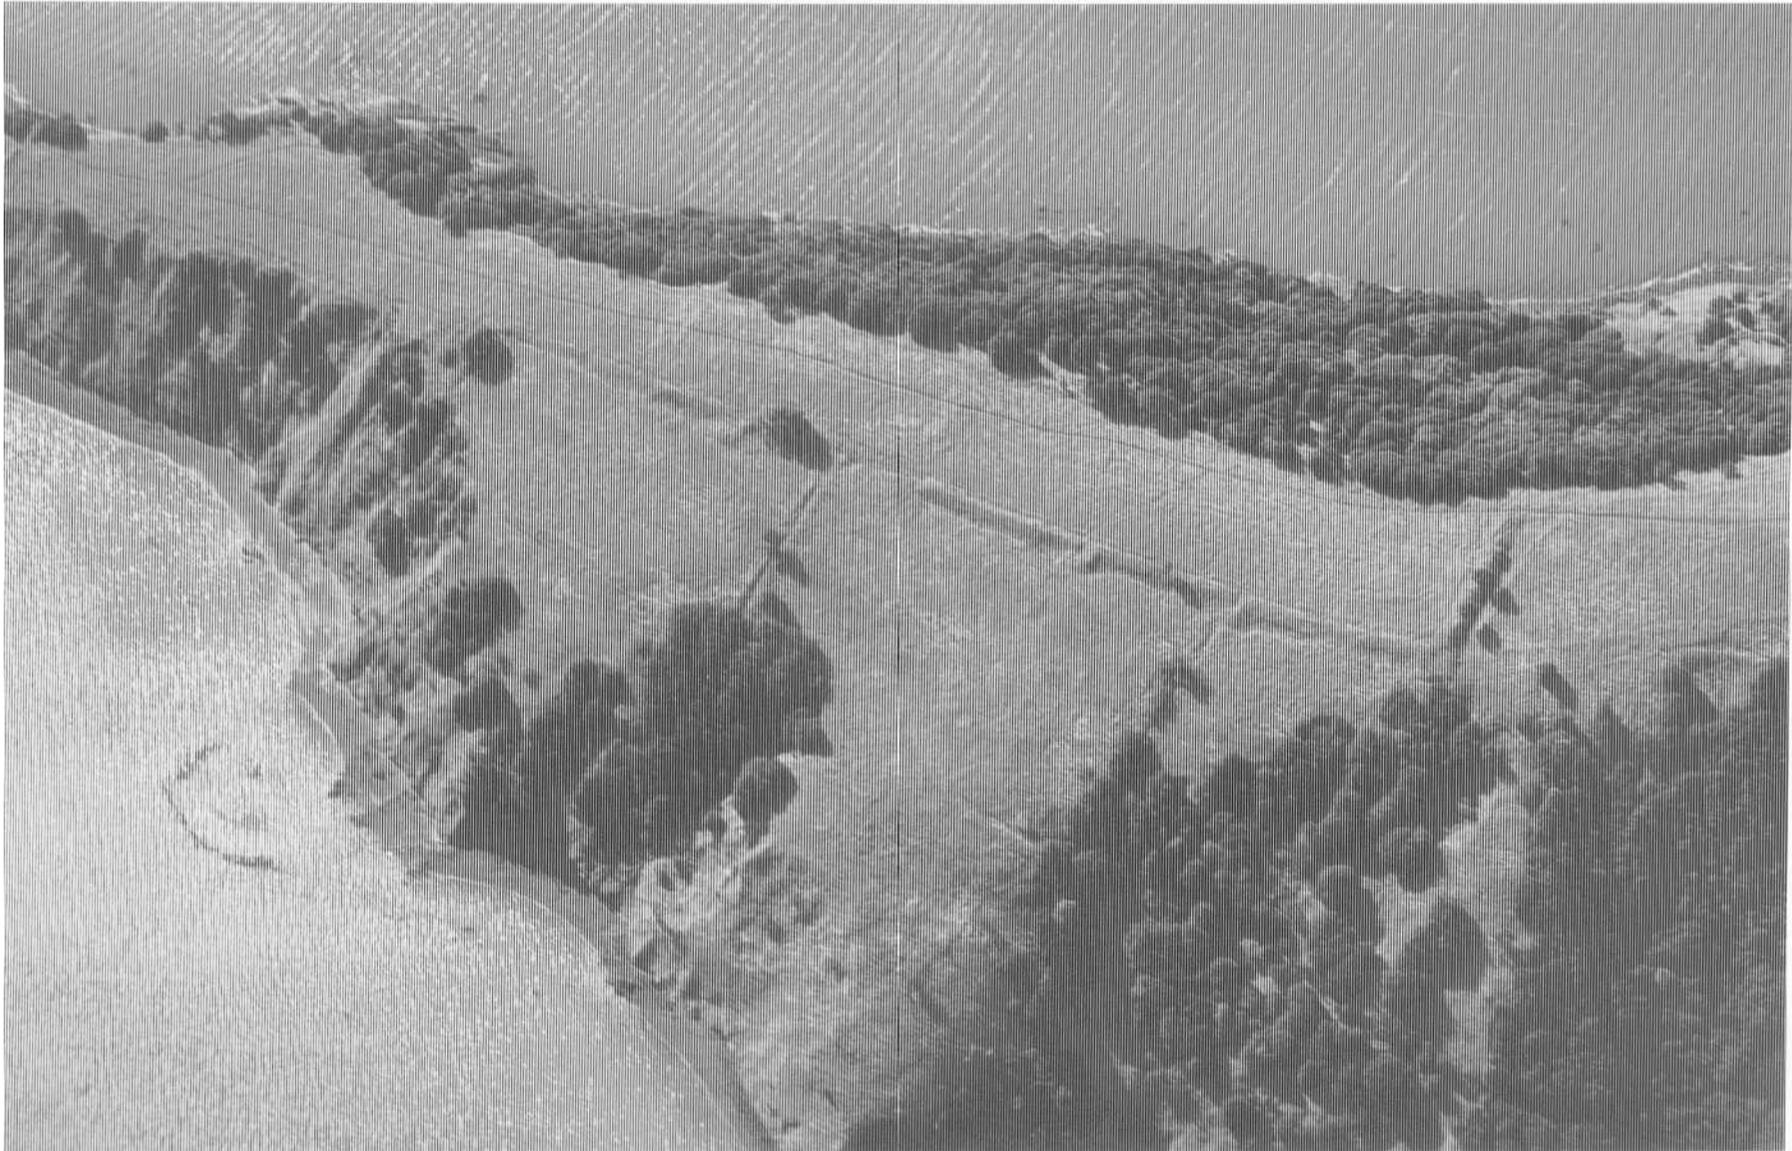
Figure 37 Onawe, from the south-west, showing the two main rectangular defensive enclosures, and the "communication trenches" (running towards the camera viewpoint). There is a further transverse ditch out of picture on the narrowing ridge to left. Since this photograph was taken (August 1991) there has been some slumping on the faces at far left. At top is the kanuka forest of the eastern flank.

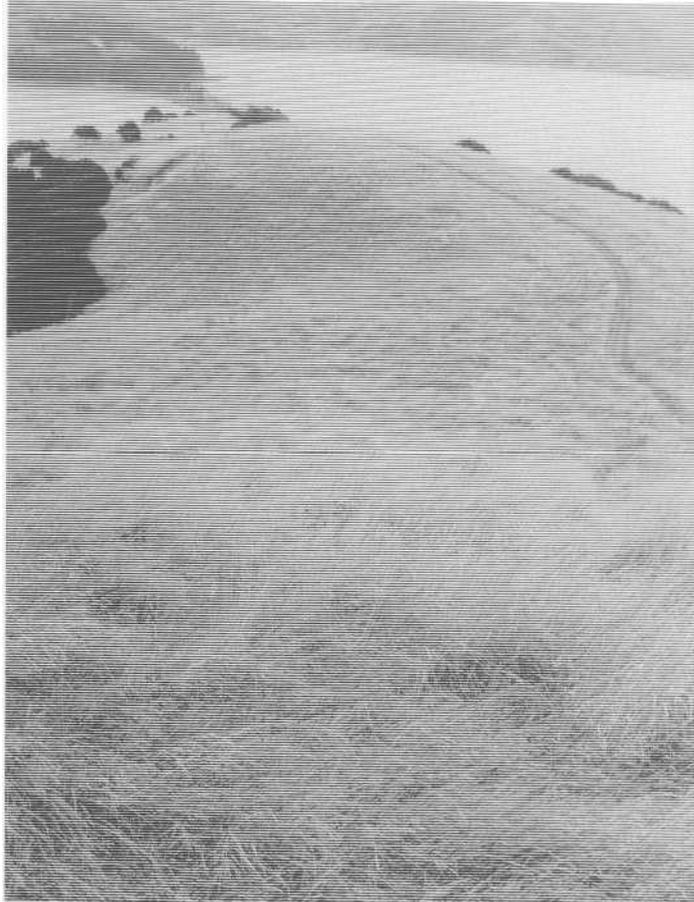
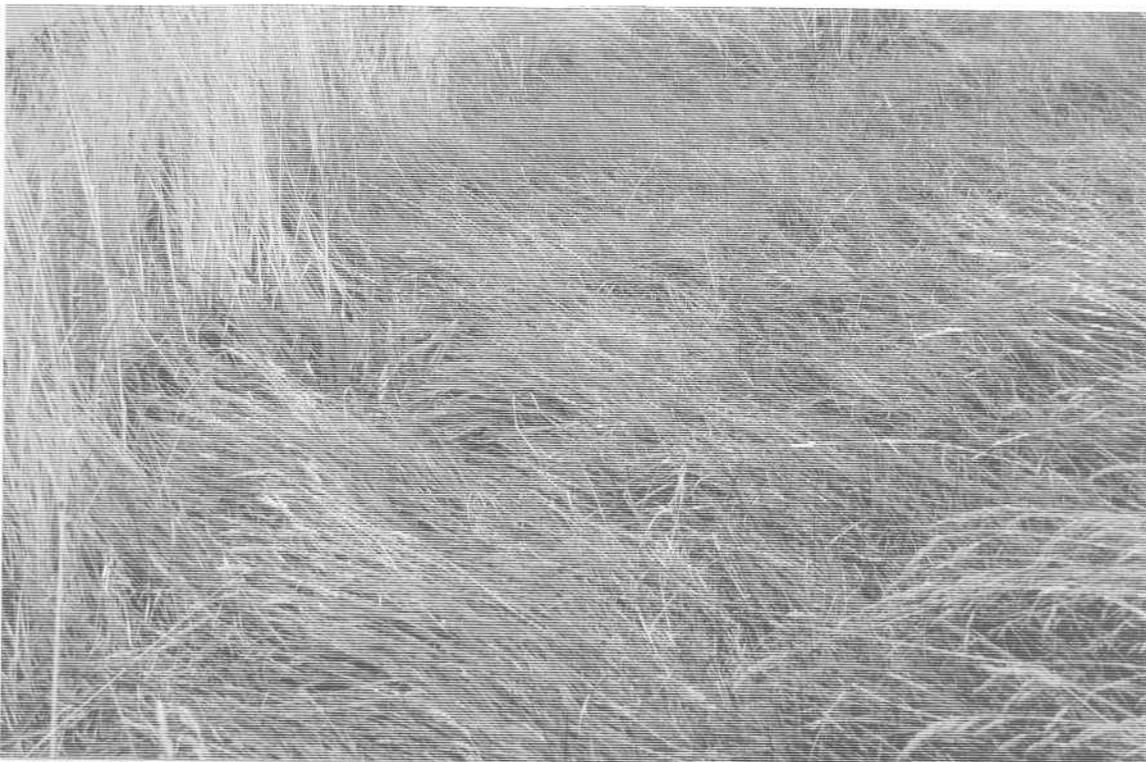
Figure 38(a), (b) Onāwe, growth of *Ehrharta stipoides* into formerly cocksfoot dominated tallgrass sward: (a) distant view of pa from the south, *E. stipoides*, in foreground; (b) *E. stipoides* sward with cocksfoot at left.

spreading and replacing the cocksfoot (Fig. 38(a), (b)). The knoll showed green at the date of our visit (31 March) because of this species dominating the exotic grasses. The replacement of exotic grass by this species in the absence of stock disturbance has been seen elsewhere (Motutapu Island), and is regarded as a significant natural process that assists pā protection and visitor appreciation.

On the ridge crest, the native grasses could be encouraged by thinning the exotics, gathering seed from pātītī *E. stipoides* and oversowing (see appendix 1), or deliberate planting of nursery-reared plugs. Patio should do well in partial shade under the eastern kanuka fringe.
