# Lahars from Mount Ruapehu – mitigation and management

**Harry J.R. Keys**

Dept of Conservation (DOC)  
Private Bag, Turangi  
New Zealand  
hkeys@doc.govt.nz

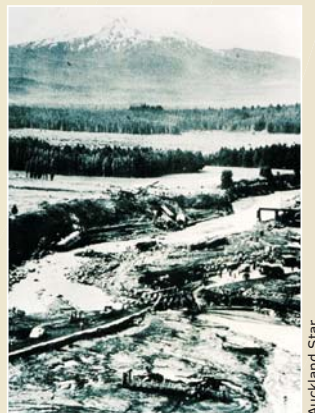
Tangiwai rail disaster caused by bridge collapse during dam-break lahar in 1953.

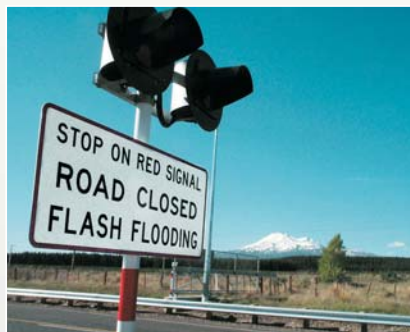
Automatic lights are installed on State Highways 1 and 49.

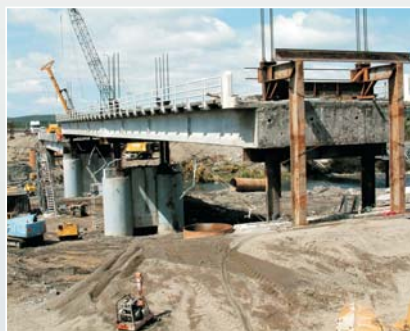
State Highway 49 bridge being raised and strengthened.

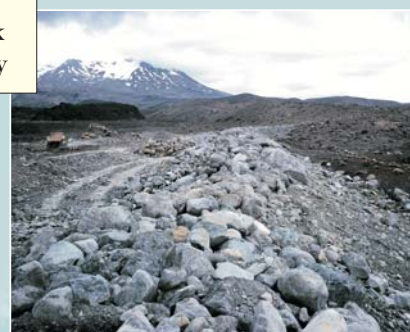
The 300-m-long bund under construction

- A public consultation process with scientific input and risk assessments was carried out.
- A sequence of decisions have been made to reduce risks to manageable residual levels.
- Reliable early warning and emergency response systems have been set up (ERLAWS and EDS).
- A bund to prevent overflow from the Whangaehu lahar path into the Tongariro River headwaters has been constructed.
- Some utility companies have made changes to their assets so that they can withstand lahars, or are isolated from them.
- The Minister of Conservation decided that there would be no intervention at Crater Lake, as engineering at the outlet would provide a short-term solution to only one lahar problem.
- Crater rim deformation is regularly surveyed.
