The Houses

The construction of the three houses for keepers and their families was as essential as the lighthouse itself.

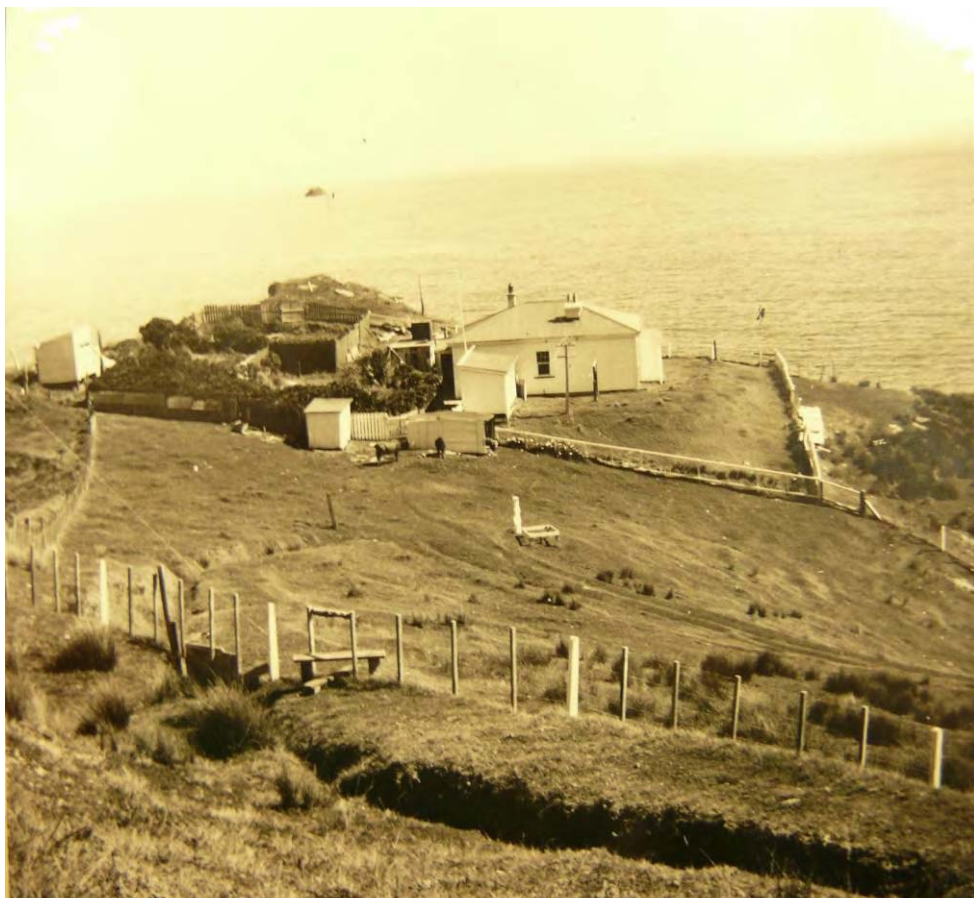
Figure 49 – The principal keeper's house (viewed from the east) with associated gardens and structures.

The first house was positioned on the far west of the station about 46 metres above sea level. The house was assigned to the principal keeper, but no particular features (especially in its early history) distinguished it from the other two. The house continued to shelter the principal keepers, from Robert McIver and family in 1910 to Noel Proebstel and family in 1978.

In addition to the house, the double concrete tanks, and the wash house, the house had an associated cow shed built at the front of the hill. The wash house was also used as the office and post office for the principal keeper for many years. The office remained until a designated office was included in the power house in 1968.¹²⁷

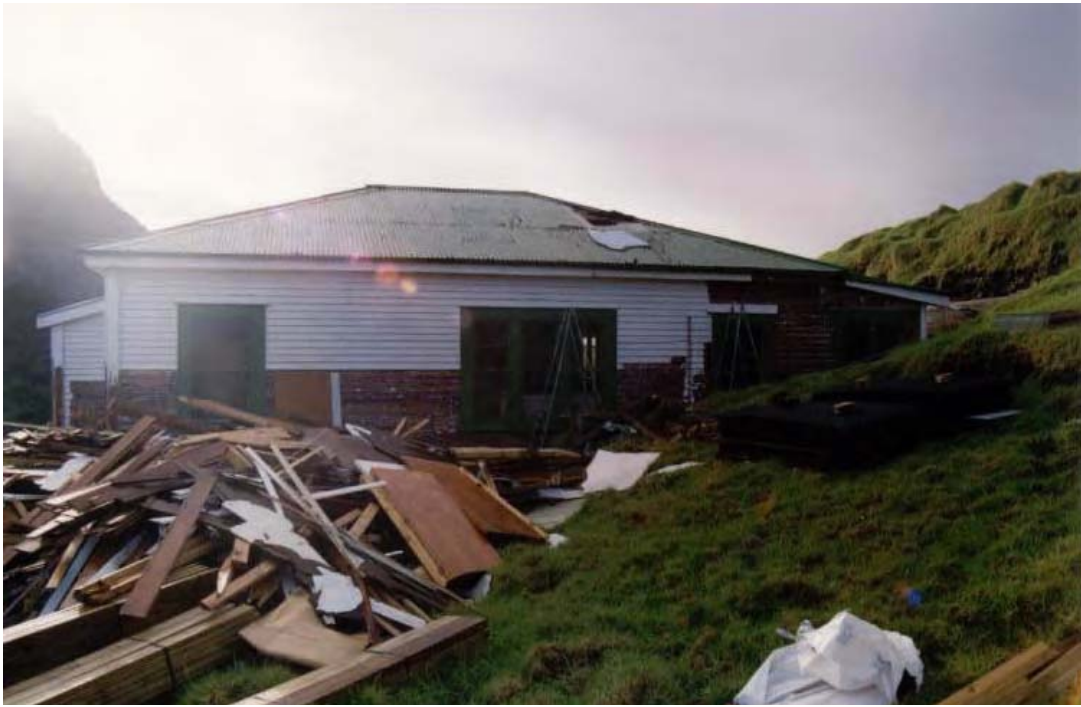
Figure 54 – The hut in the process of being refurbished, 1996.

Eighty-six years later the house was converted into the current Department of Conservation hut, which attracts visitors from all over the world. DOC staff gutted the house to provide a decent number of beds – 23 – for visitors in two large and one small bunk rooms, and allowing for a larger kitchen area at the front of the house and new toilets behind the house. They also painted, varnished the floors and installed gas for the four gas stoves.

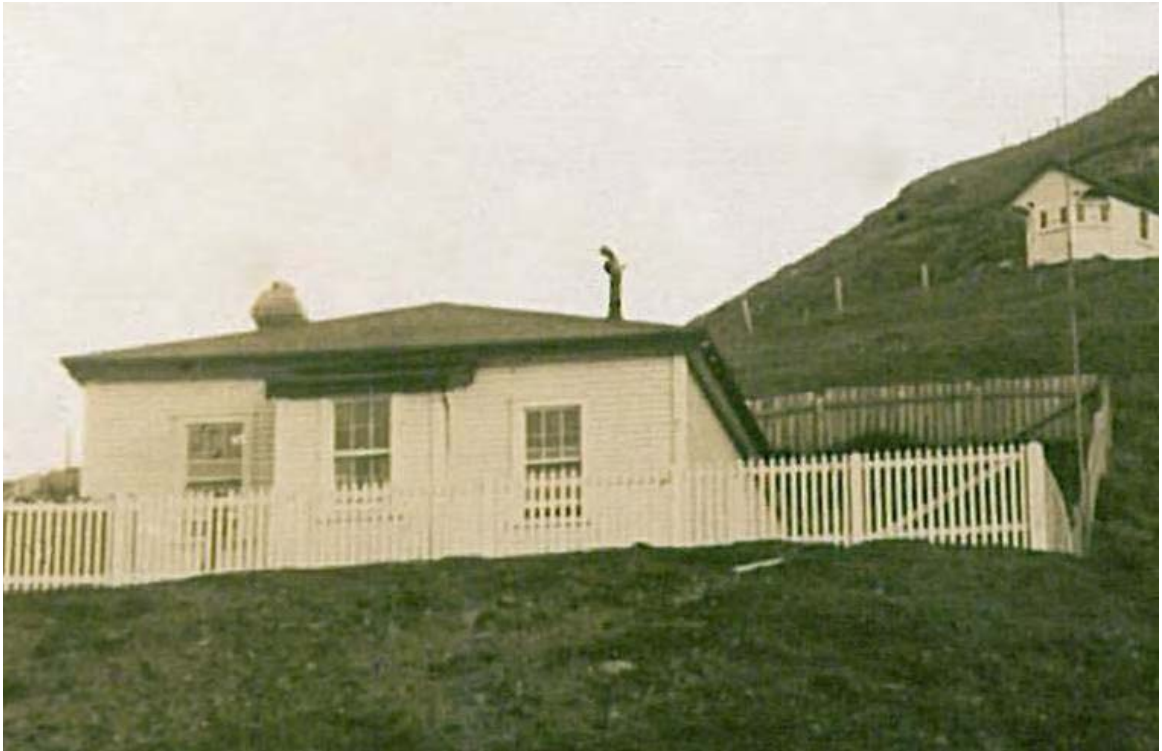
Figure 56 – The front view of the third house with the signal hut in background.
