### **The tramway, landing, associated features and the multiple cranes**

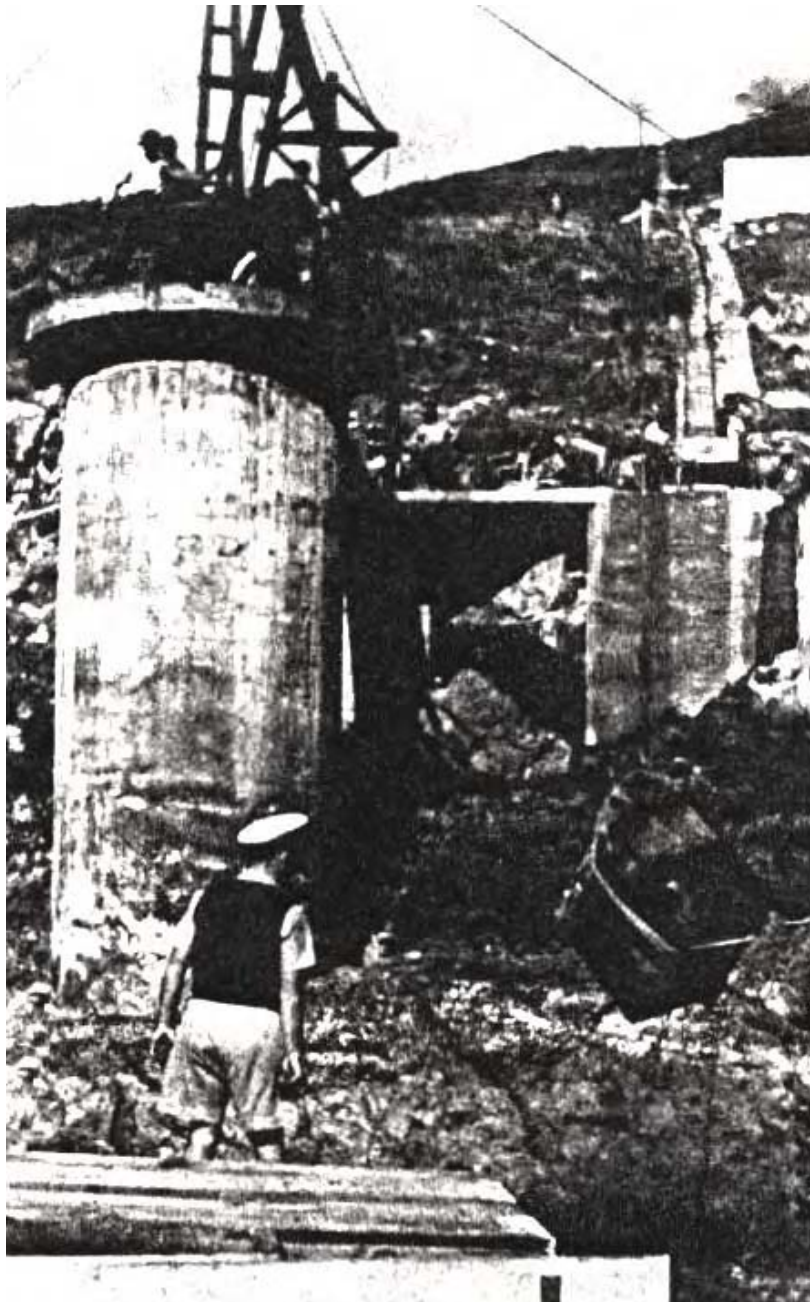
Figure 36 – The view of the gantry from the stores boat during World War 2.

To build the landing, the rock at the top of the platform had to be blasted to create a flat area for unloading and loading goods and materials onto the tram trolley.<sup>111</sup> Few details are available about the actual construction of the concrete and iron pillar which forms the base of the landing.

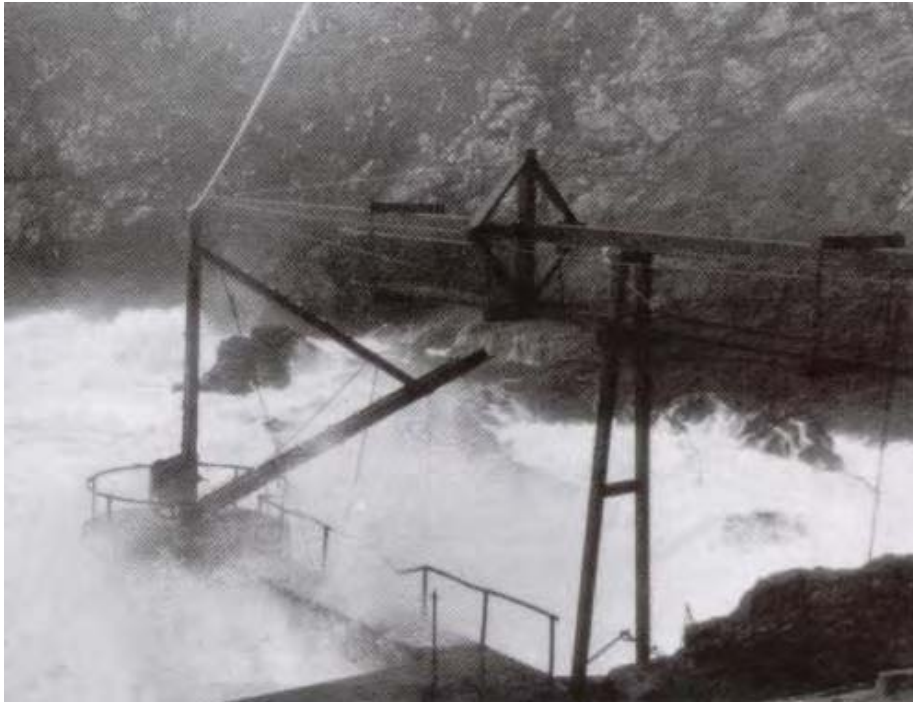
**Figure 37 – The crane during a storm with the barriers removed.**

died.<sup>112</sup> The department's reaction to this accident was to enlarge the landing block and to order the installation of safety barriers to prevent further falls. Permanent barriers were concreted in on the eastern side of the landing, with those on the west being removable. The removable barriers allowed offloading of stores straight onto the block, and the barriers could not be washed away in large swells.

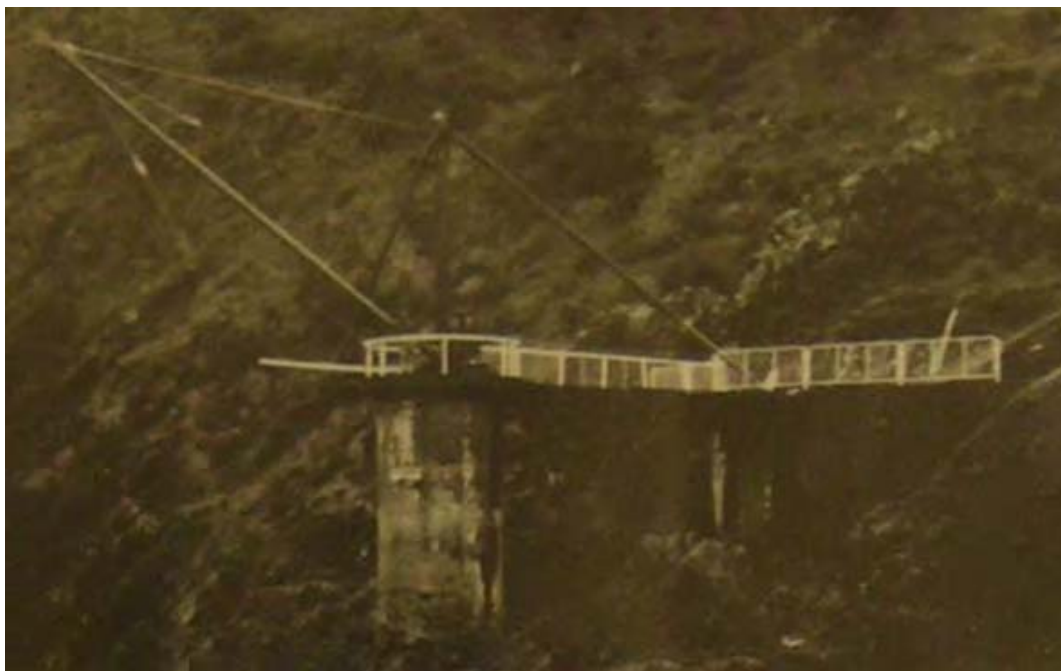
**Figure 38 – The barriers in place in the 1970s.**

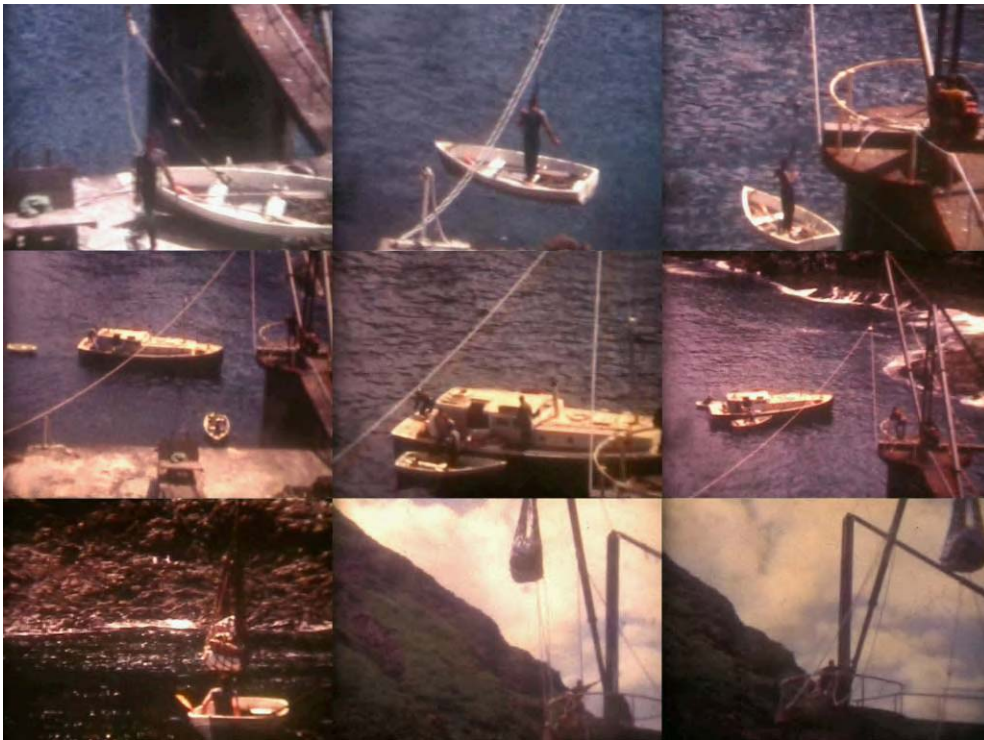
**Figure 39 – The crane under operation, 1960s. Keeper Murray is in the dinghy transferring stores, while keeper Rodda operates the crane.**

The crane was used to move stores, mail, keepers' property, animals, construction materials and other items, from the various boats on to the landing. Figure 39 is a series of pictures illustrating the crane's operation in the 1960s.

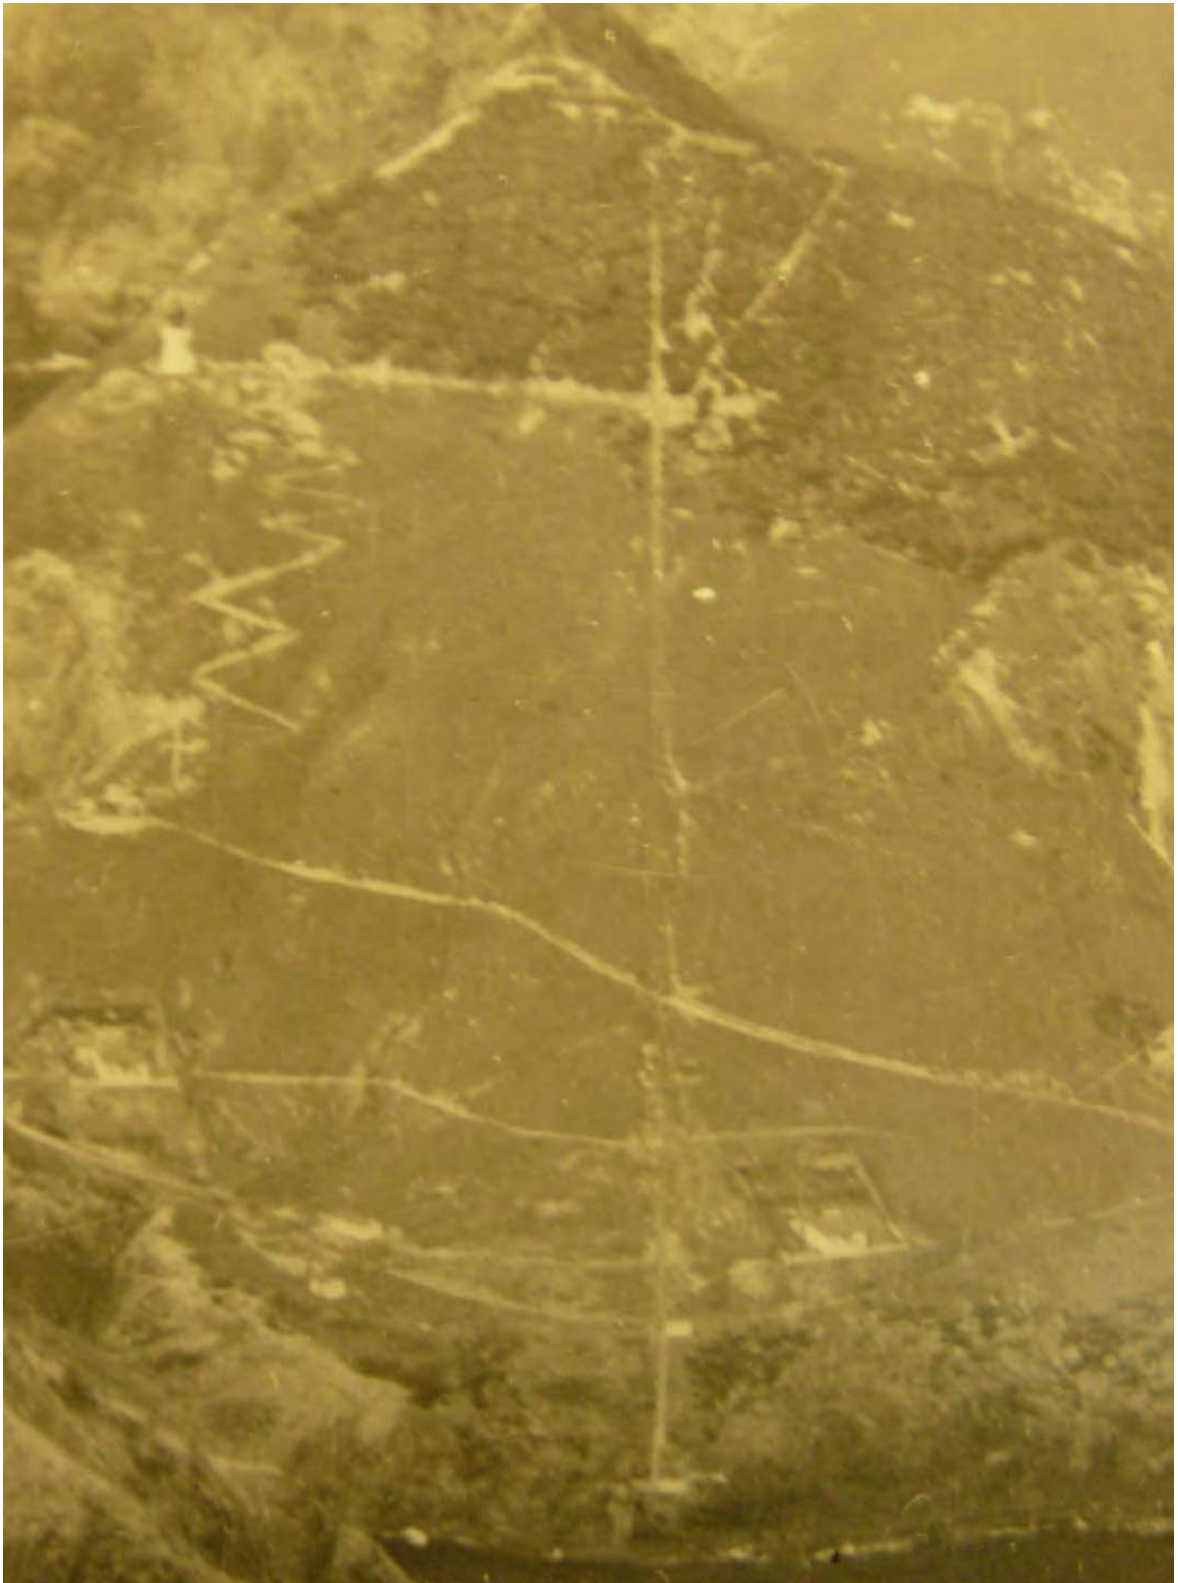
**Figure 40 – The tramway running through the centre of the station — from the landing to the naval radar station.**

The tramway was constructed using concrete and rails and was originally powered by a single horse and whim working from the top of the tramway. A large trolley on a long cable moved goods up and down the tracks. It was later operated using a diesel engine housed in one of the tramway sheds.

During World War 2 the tramline was extended through the manuka scrub up to the ridgeline above the lighthouse. This connected the station's major supply line to the naval station to move supplies up to the Navy personnel. When the naval station was closed the tramline was shortened to its original length.

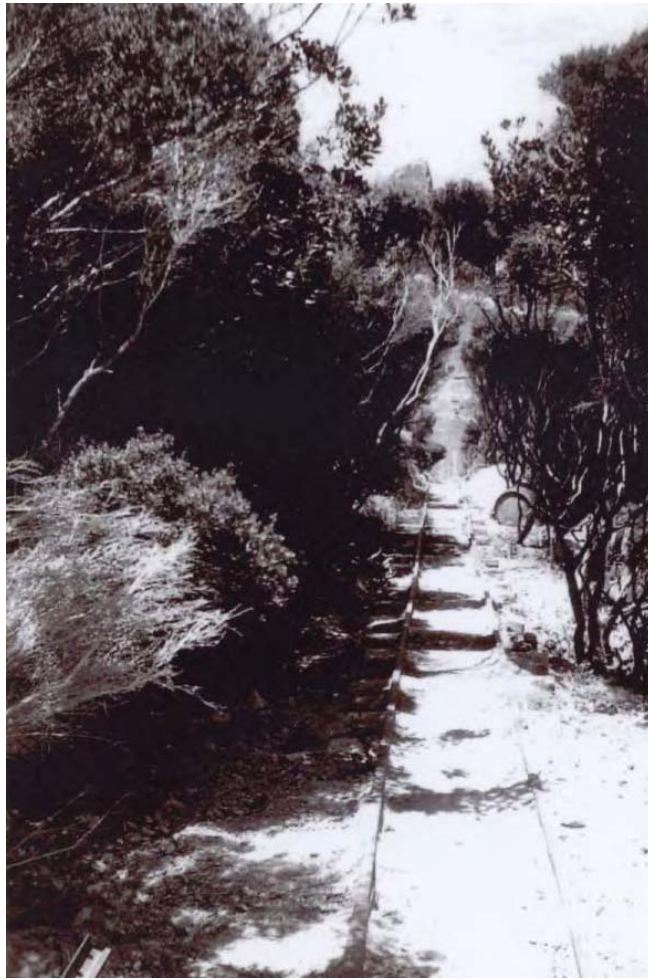
**Figure 41 – A photo from the base of the navy stretch of tramway looking up towards the radar station, World War 2.**

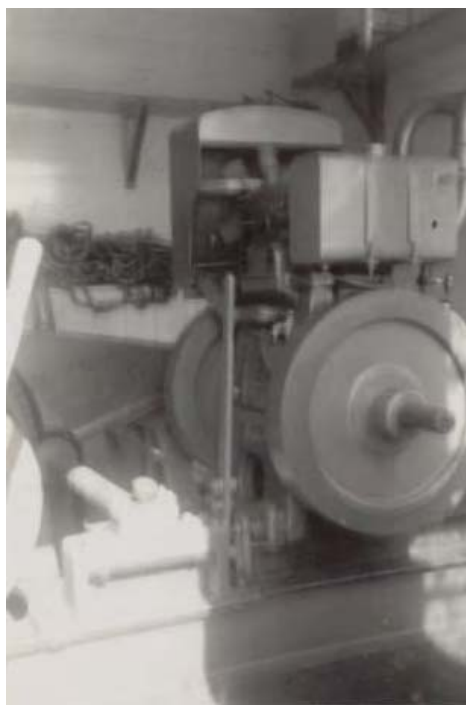
**Figure 42 – The "Giggling Gertie" winch two cylinder Lister diesel engine, used to operate the tramway in 1959.**

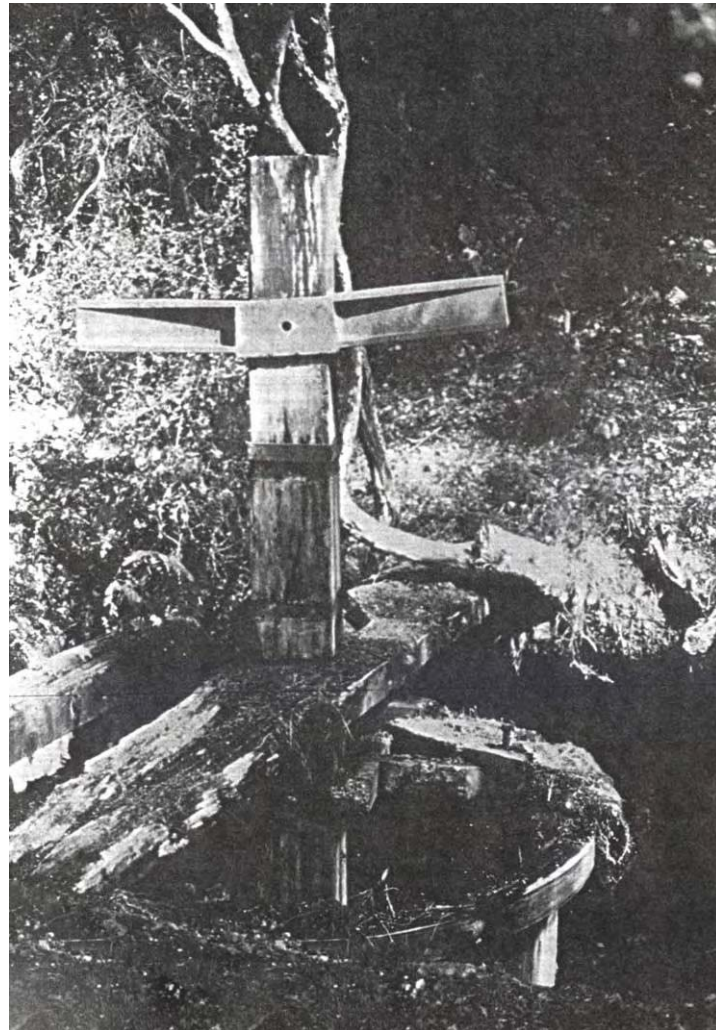
**Figure 43 – The whim during the 1970s.**

*'a large wooden capstan that turned inside an underground housing. Two poles were set into the top of the capstan, a horse harnessed to each pole as they plodded round and round they drew the trolley with the tower sections steadily uphill.'*<sup>115</sup>

A hole was blasted into the rock and the whim was built using Kauri timbers. Horse power pulled the loaded trolley up the long tram and the original horse supplied during the station's construction worked until 1922, when it died from old age.<sup>116</sup> An article published in 1974 by the *Auckland Star* reports that an 8inch horseshoe hanging on the wall indicated the horse was probably a Clydesdale, but whether the shoe belonged to the whim horse is unknown.<sup>117</sup> The whim only ever operated with a single horse though it could operate with two.

A photo from the Proebstel family shows that the whim was largely intact in the 1970s though some of the wood appears to have begun to rot (see Figure 43). In 2008 the capstan is still recognisable in the hole, though the area is surrounded by dense scrub.

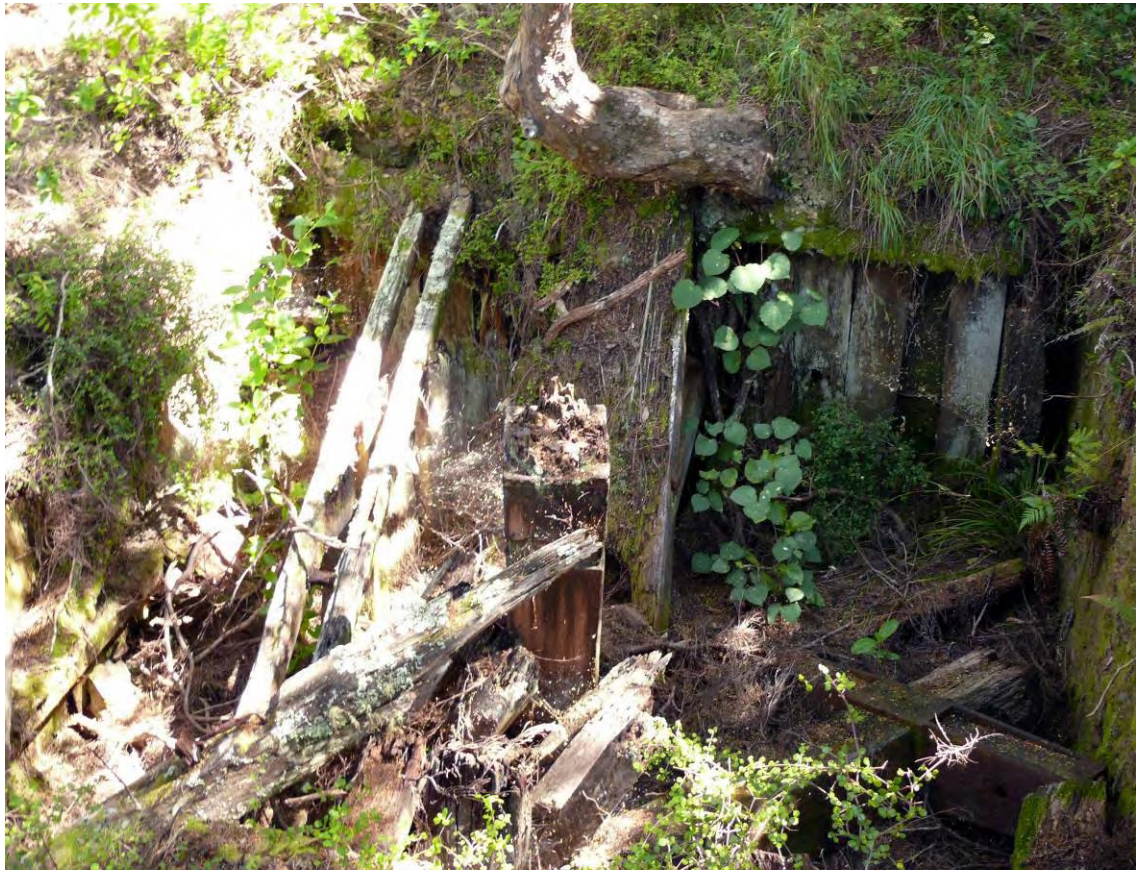
Figure 44 – The cut for the whim in 2007. Note the capstan lying in the bottom right corner.

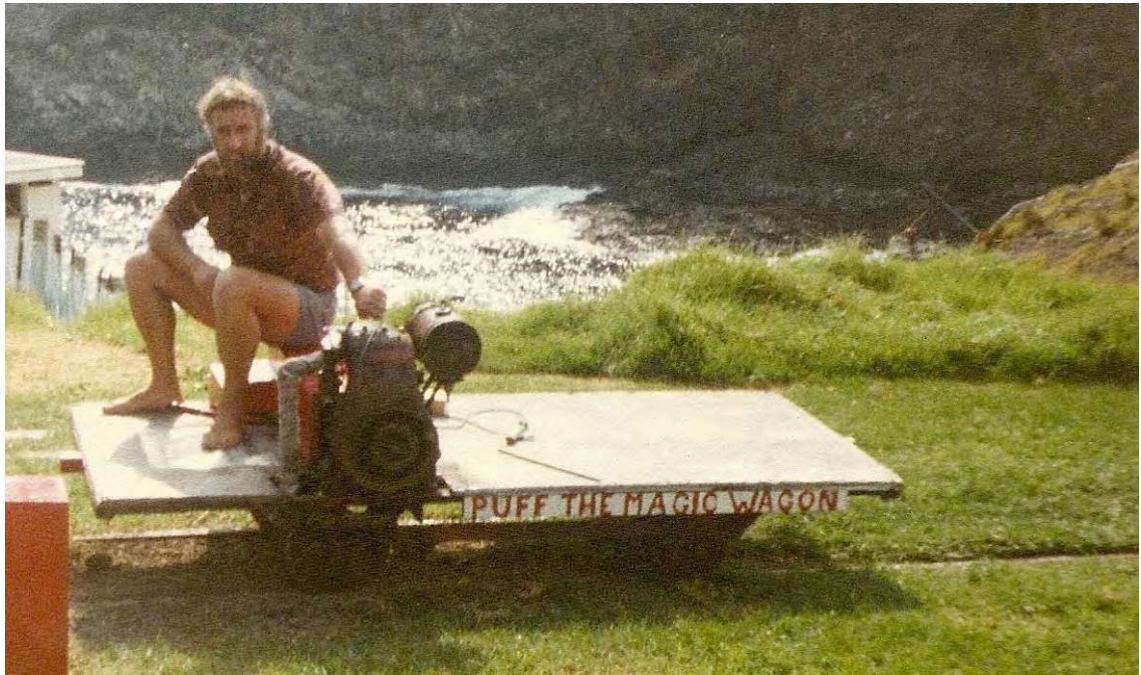
**Figure 46 – Noel Proebstel on the motorised Puff wagon.**

The motorised wagon was used to transport stores from the tramway to the buildings on tracks constructed from the rails no longer needed for the tramway. The wagon was commissioned in the late 1960s and named ‘Puff the Magic Wagon’ by the lighthouse children.
