The Vege Garden with a view

The Schoolhouse

The Signal Hut / Station aka The Port War Signal Station

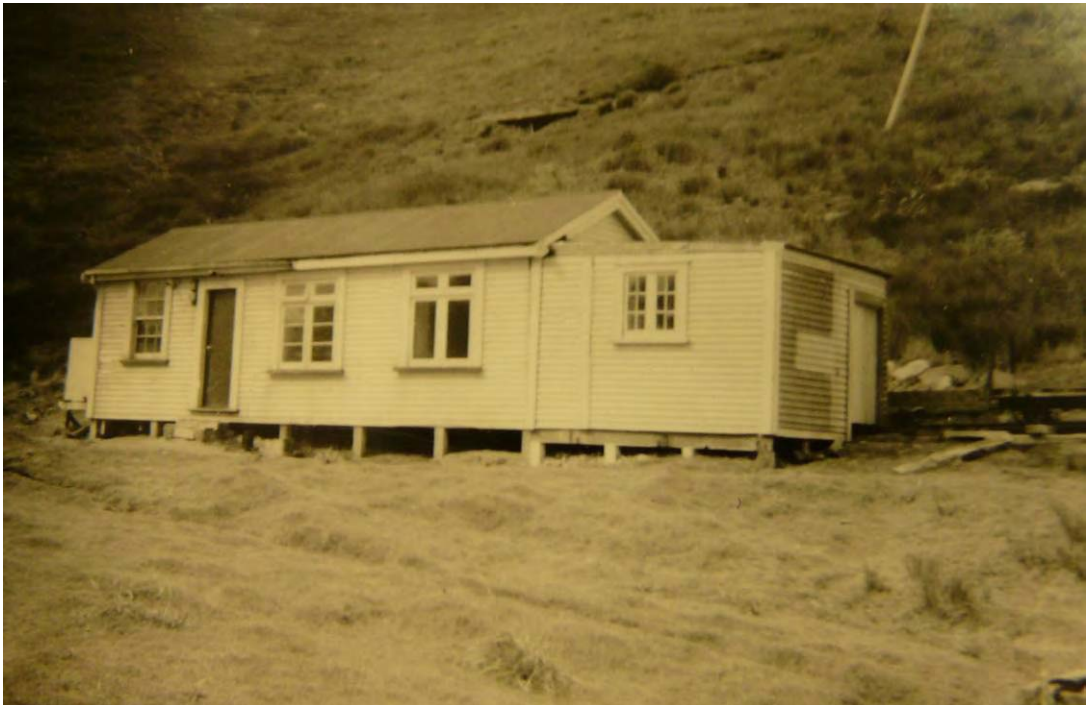
Figure 60 – The schoolhouse after the addition of the extra room.

The school was built in 1909 at the same time as the houses and light tower. It was positioned on the western section of the dip below the third house and was also built from kauri. It was a single room building and was in everyway a stereotypical New Zealand rural school with mixed age classes, blackboards, school desks and students' work wallpapering the walls.

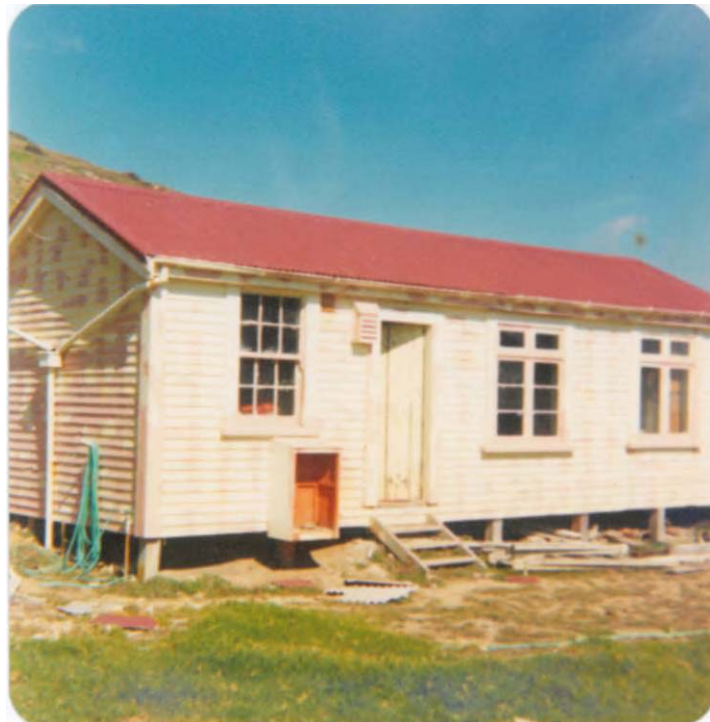
Figure 61 – The schoolhouse in 1978.

If there were fewer than seven primary school aged children the school was closed by the Education Department. In February 1969 the schoolhouse was converted into a workshop, engine room and storage facility.¹³⁸

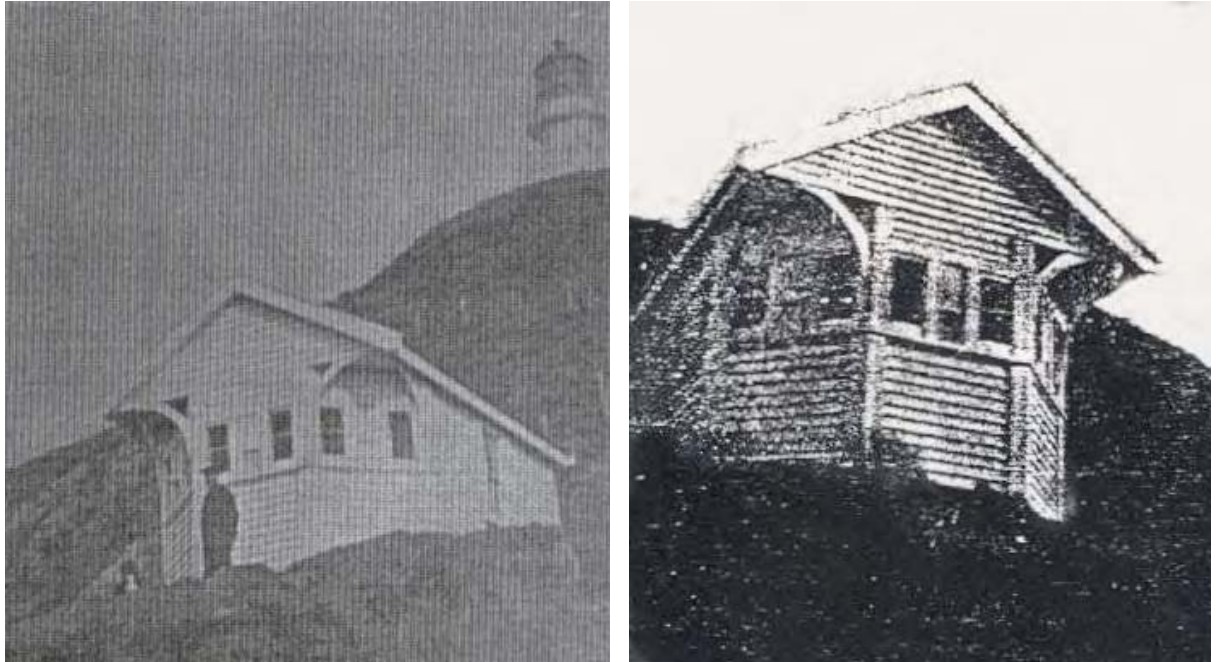
Figure 63 –Both photos show the signal hut before the World War 2 modifications.

The signal hut was originally built by the Marine Department for signalling ships, but also for other activities, including boat building. During World War 2 it was converted to a naval signal station. In 1941 the government approved the establishment of port war signal stations and the conversion happened almost immediately. The building was based on the standard plans from the department (another example being that located at Pencarrow).

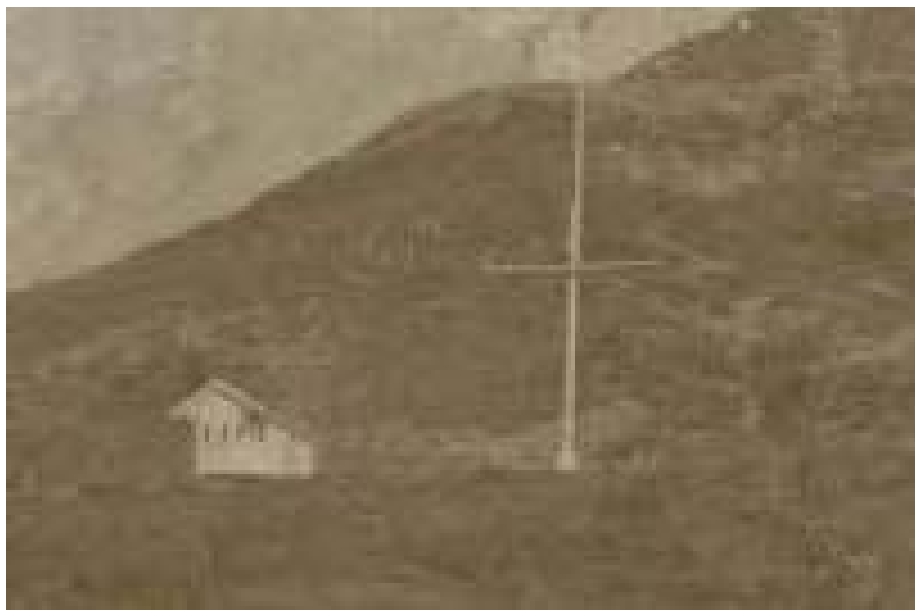
Figure 64 – The signal hut and flagstaff as they were around 1916-20.

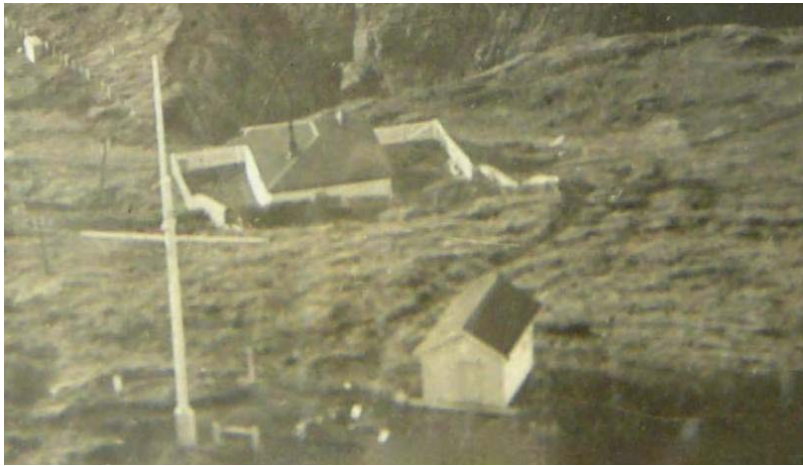
Figure 65 – The signal hut reverse view before modifications.

The signal station was modified in 1941 to accommodate two naval reserves to keep watch over the Bay for the Japanese.

Modifications included:

1. An extension of 5' for a new galley including concrete floor and new concrete chimney, plumbing and painting, etc (£99.13.0).
2. Renovating mess room, removal of partition, replacing windows with double light, lining new extension and installing Miro staves (£43.0.0).
3. Bunk house: line walls and ceilings with Pinex, close up front door and provide 2 additional double windows (£37.0.0).
4. Mast: Overhaul and replace shackles, renew broken halyard stays, etc (£15.17.0).
5. Flag dock: construct as indicated on plan 3'6" high with concrete floor (£51.10.0)

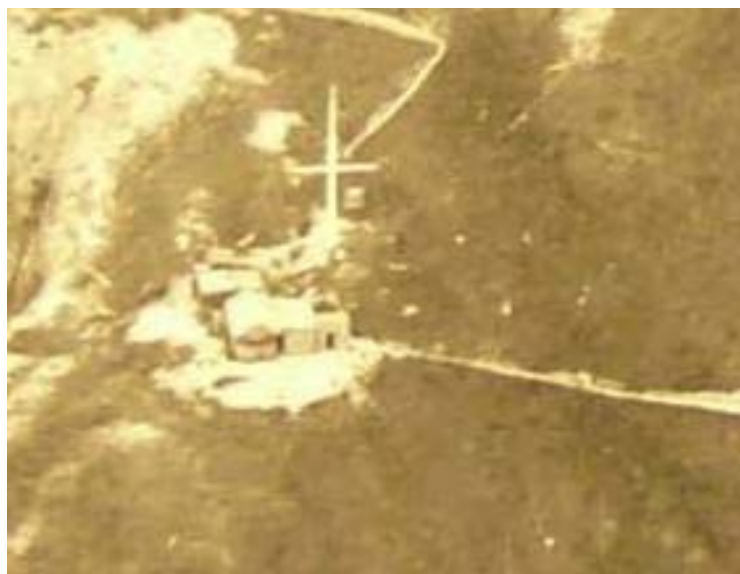
Figure 66 – The signal hut after modifications.

The modifications cost approximately £247.14.0.¹³⁹ They were carried out by two carpenters who worked all day, everyday, and boarded with the keepers.¹⁴⁰ By the time the changes were finished the naval reserves had an operations room, a lounge with bunks on one wall and an extension at the back and an open plan kitchen/dining room with an enamel stove and kerosene fridge.¹⁴¹

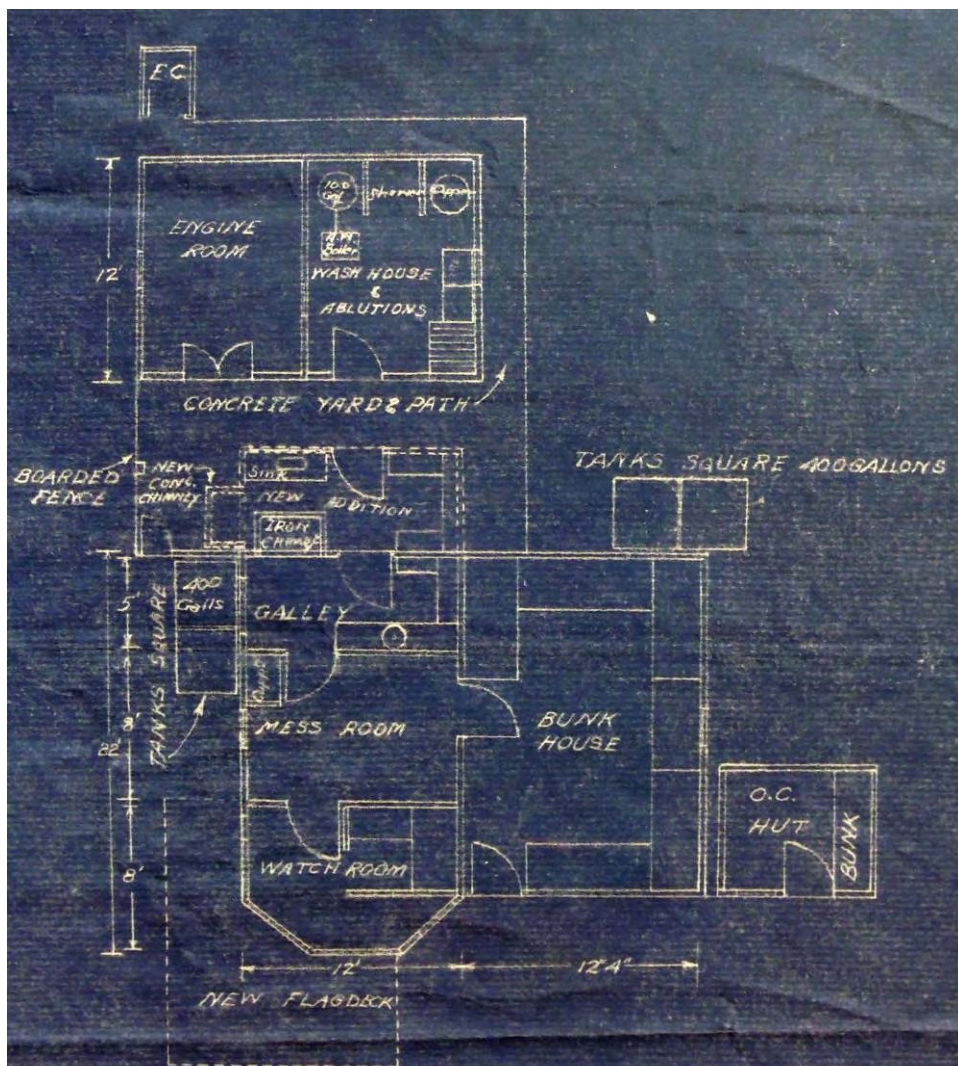
Figure 68 – Plan of the signal station with modifications.

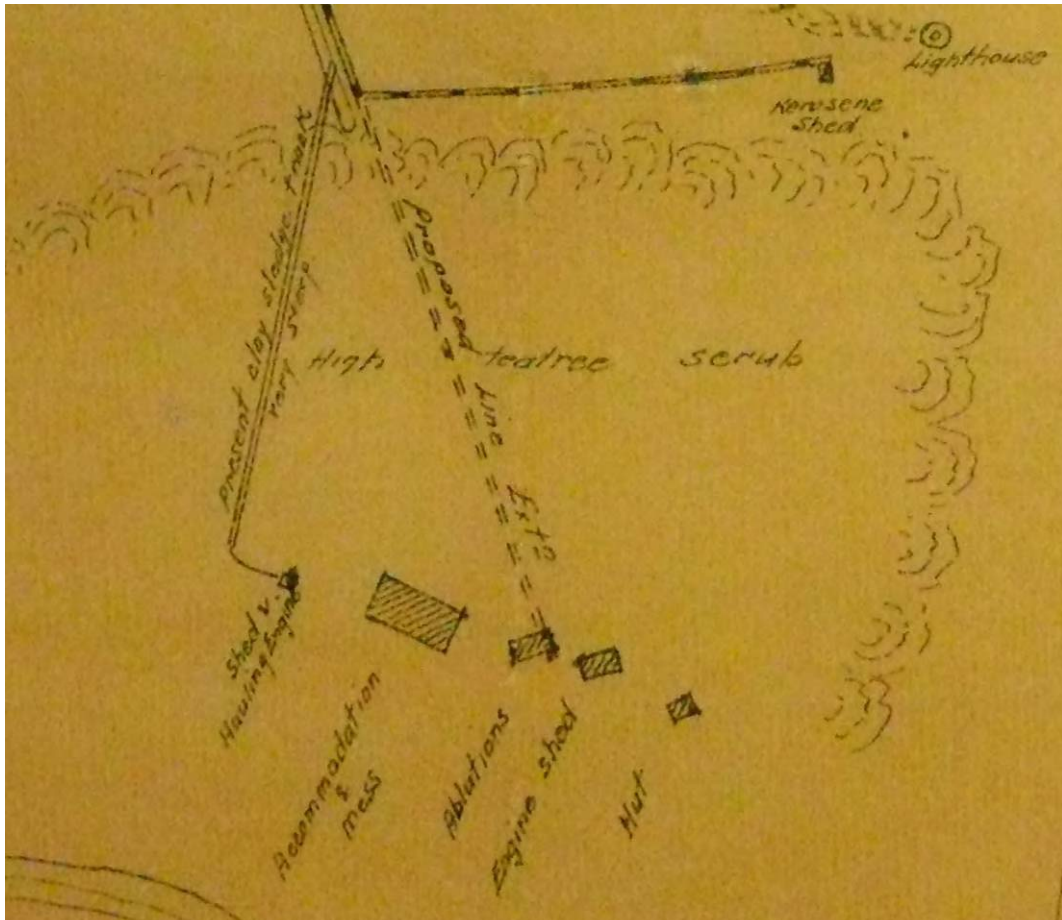
Figure 69 – A sketch plan of the World War 2 structures from 25 February, 1943.

Based on the remains in situ today, and the map shown in Figure 69, the station consisted of five buildings:

1. Shed for tramway hauling engine
2. Accommodation and Mess
3. Ablutions
4. Engine shed
5. Radar hut

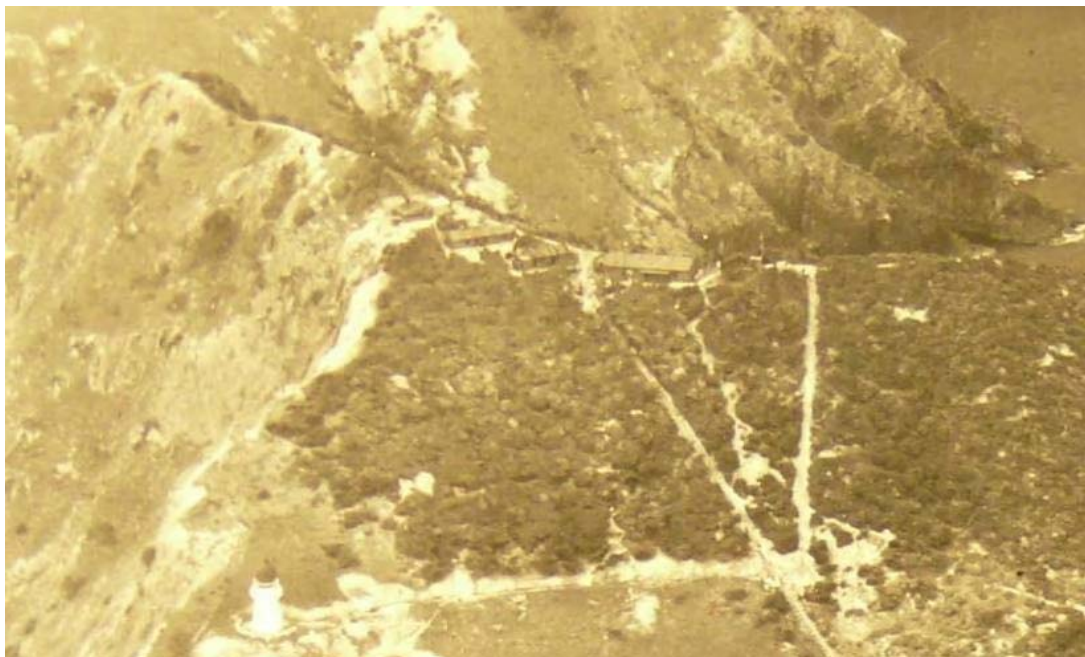
Figure 70 – The Naval Radar station at the top of the ridge.

The naval radar station at the Cape was one of 13 built throughout the country.¹⁴³ Six were constructed on light stations with the Cape Brett station opening in March 1942 (after being approved by Cabinet in July of 1940).¹⁴⁴ The station was manned by naval personnel and run in conjunction with the signal station for a short period of time.

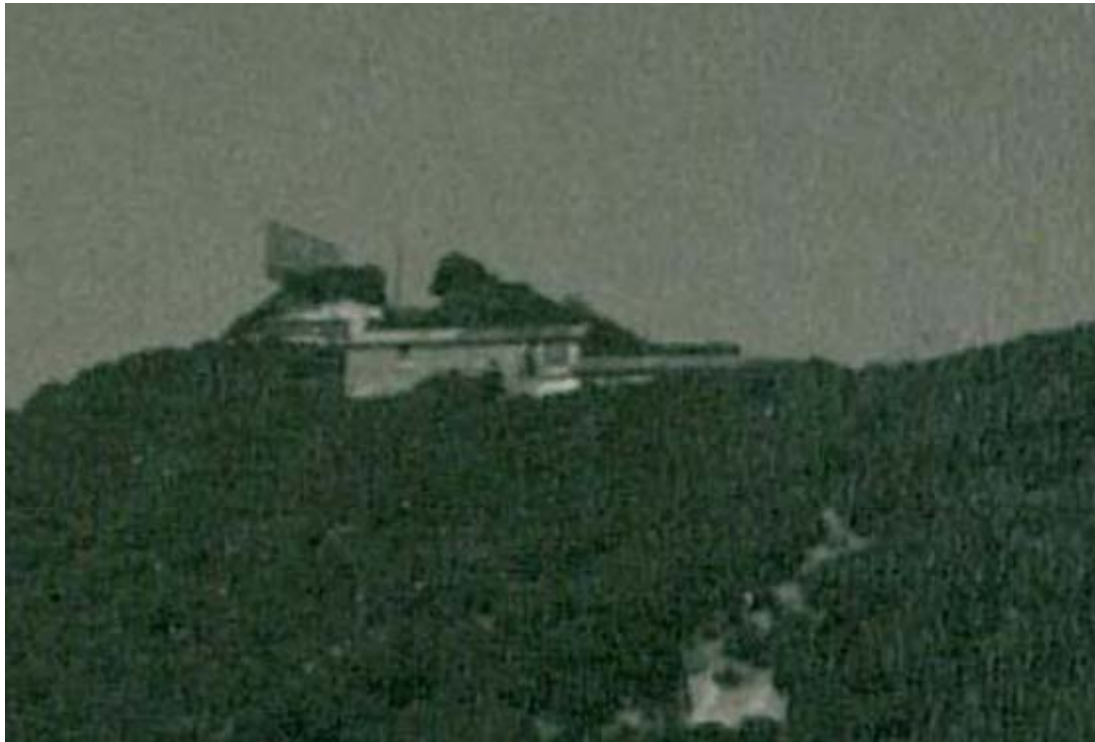
Figure 71 – The Naval Radar station – with the radar poking above the ridgeline.

*'From the base of the lighthouse hill they could see a slow-turning steel structure silhouetted against the skyline [a radar station for tracking shipping]. There are seven or eight naval men there in very comfortable quarters. The workmen dammed the Pig Gully creek and they have flushed toilets with water they pump over. They don't use the signal station any more and have their own diesel engines....It's all very hush-hush.'*¹⁴⁹

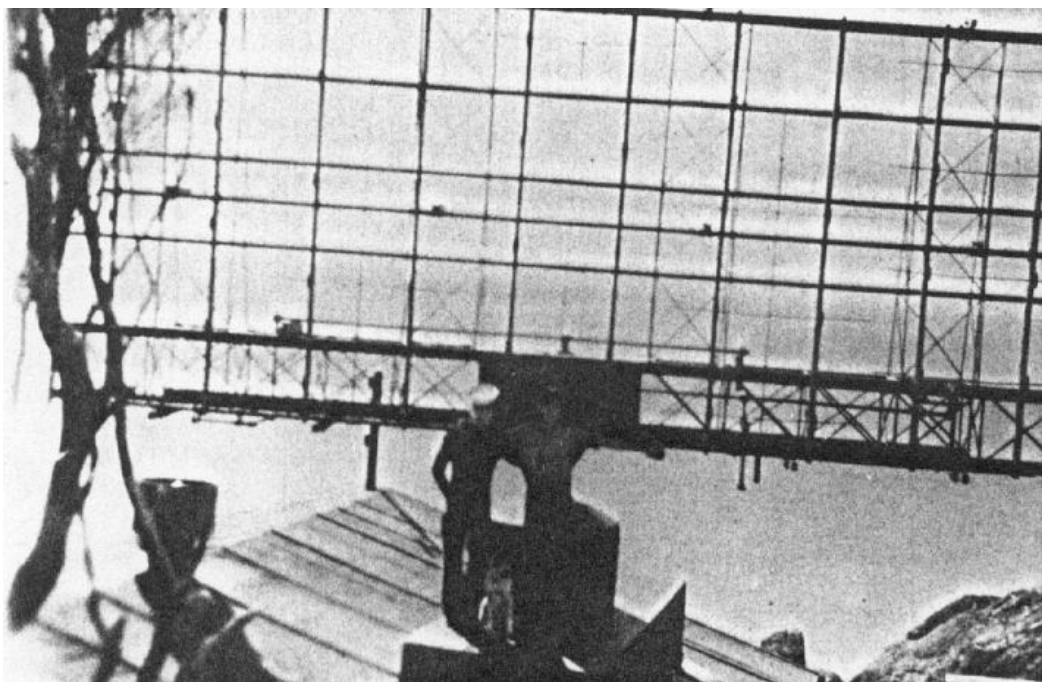
Figure 72 - The radar aerial mounted above the operator's hut.

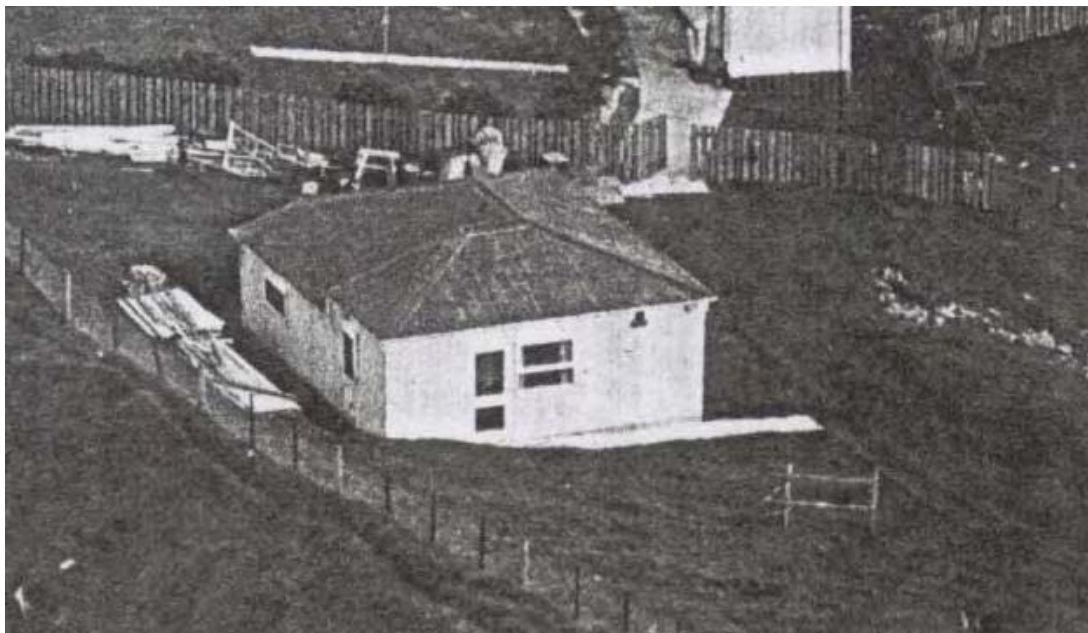
Figure 74 – View of the power house from the northwest.

The last and singularly dedicated building was the power house, built in 1968. It housed the generator, workshop, the book/radio/store room and office.

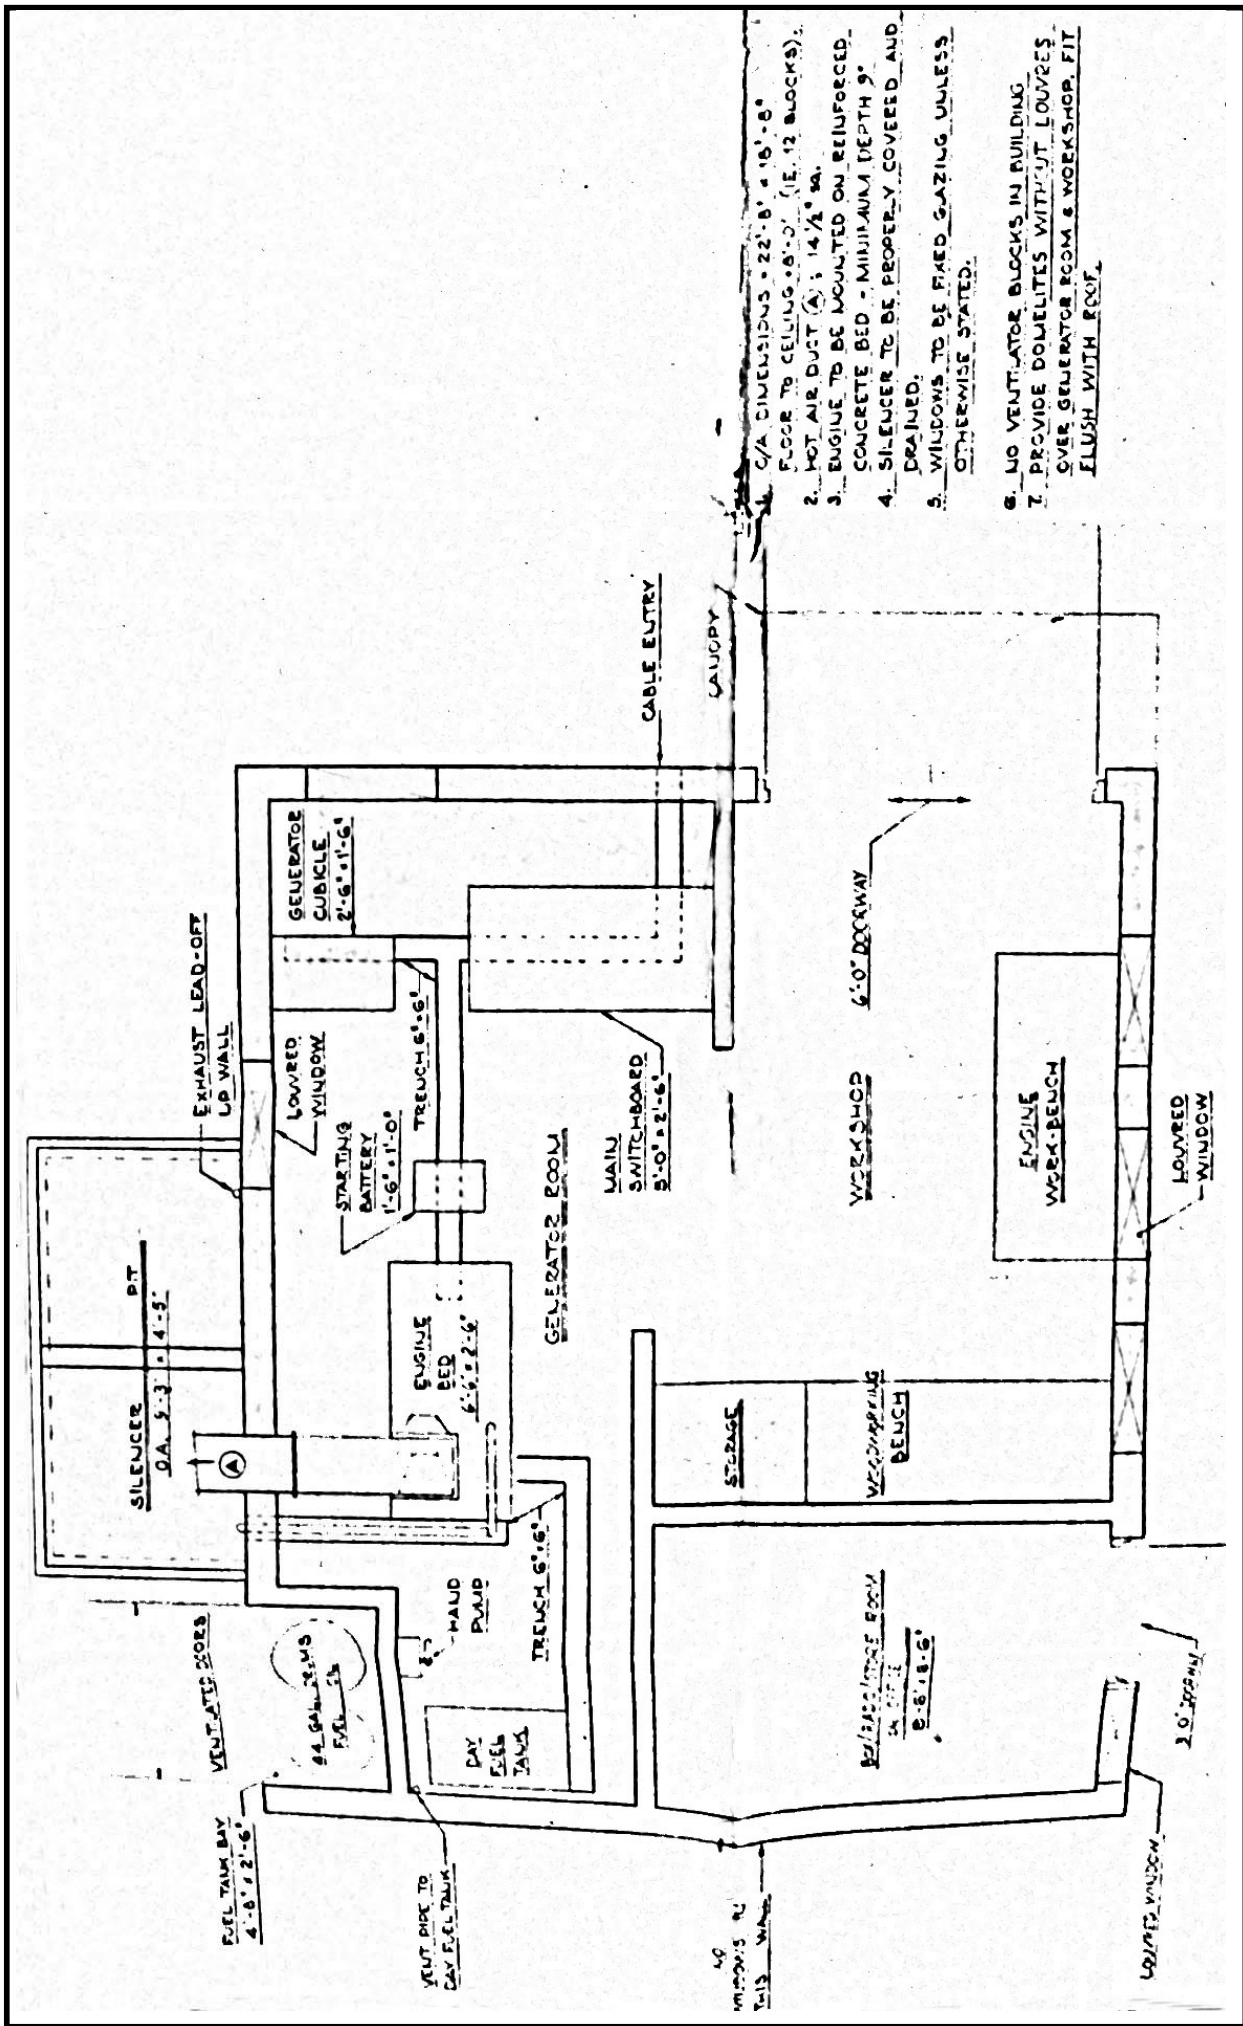
Figure 75 - The layout for the standard single generator power house from December 1969.
