3.0 Setting

4.0 Fabric Description

LANDSBOROUGH RANGERS HUT

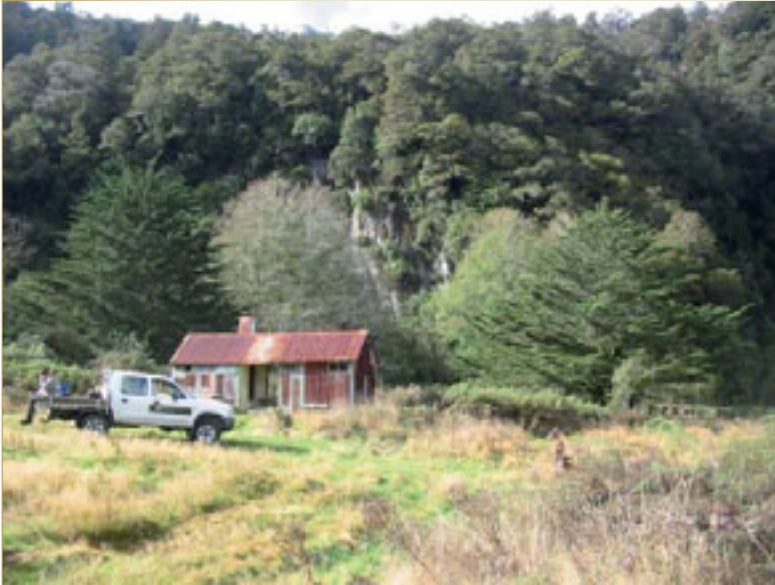
Photo 11: View looking east across to the Rangers Hut and the exotic trees behind it. J. BREEN, DOC, MAY 2006.

There is a range of exotic trees present on the flats to the east of the Rangers Hut (see site sketch plan on page 23). The most notable of these are three macrocarpa trees near the hut, and the nine alders that occur along the edge of the bush line. The alders probably mark the perimeter of the old horse paddocks.

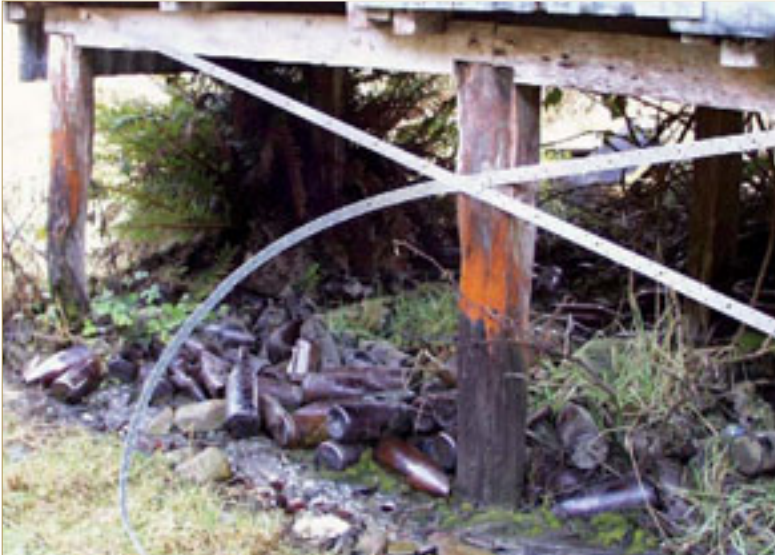
Piles of tin, metal drums and bottles are in the vicinity, as well as some flat iron, and a bottle dump in the regenerating bush near the small macrocarpa tree (see site plan). There is also a bottle dump under the south room of the hut. Remains of a small iron drum are situated in a creek running along the bluffs to the north of the site.

Photo 12: Bottle dump under the Rangers Hut. J. BREEN, DOC, MAY 2006.

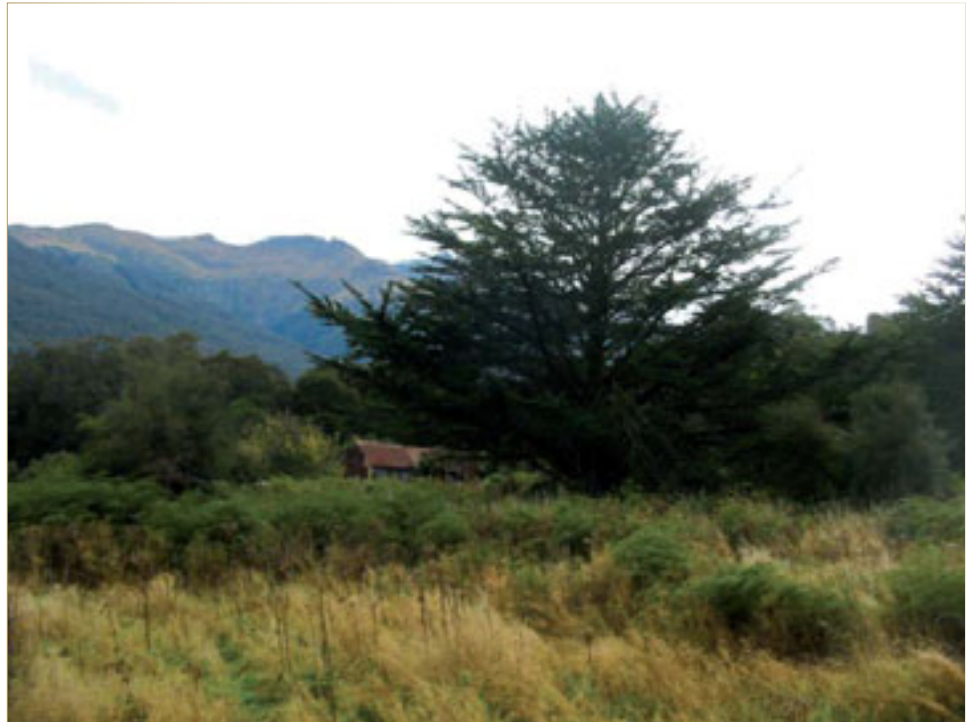
Photo 13: View across the old horse paddock of the large macrocarpa tree to the east of the Hut.
J. BREEN, DOC, MAY 2006

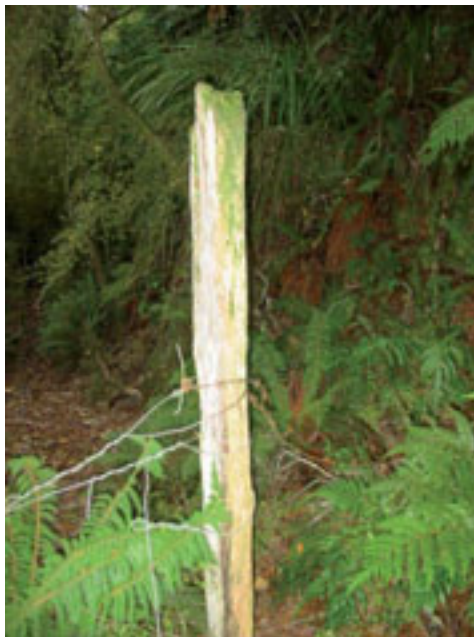
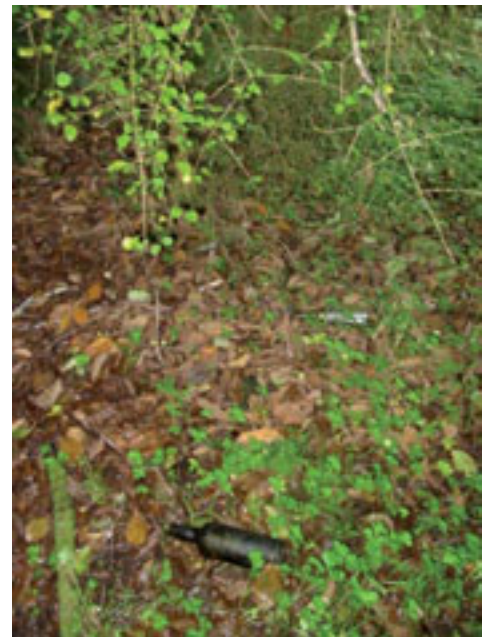
A few hand cut posts from an old fence line were also found. Searching in the adjacent area did not discover any more. A wire rope has been strung from the bluff behind the hut that was purportedly for slinging loads of firewood down to the hut.

Photo 14: Fence post near the cliff face.
Photo 15: Bottle dump in east of hut.
J. BREEN, DOC, MAY 2006

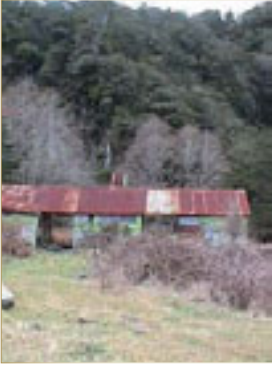
Photo 16: View of the Hut
in the late 1990s.
VAMS IMAGE.

Until the last few years, the Rangers Hut had three rooms - a central room with a large fireplace flanked by what were presumably bunk rooms (see image left and the plan drawing on the following page).

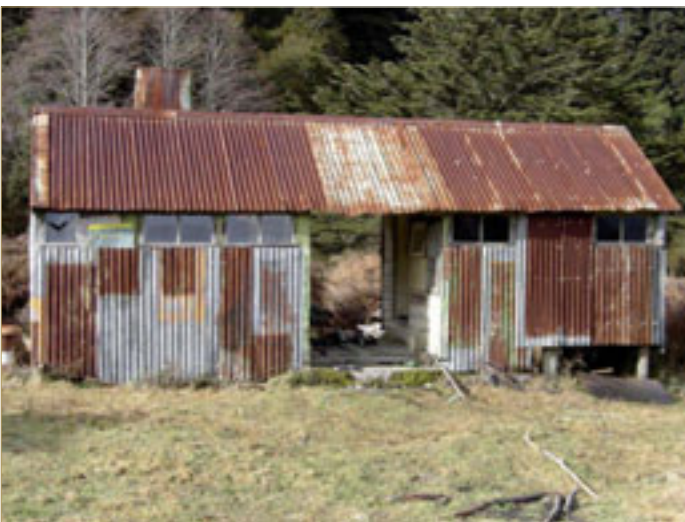
Photo 17: Ranger Hut view
looking east.
J. BREEN, DOC, 2005.

There are the remains of a few rock slabs running to the north from a patch of concrete at the north-west corner of the middle room. These slabs are probably the remains of a step up to the porch between the middle room and the north room. The patch of concrete has a 1947 penny set into it but it is unclear if this has any correlation to the date the third room was added (hf).

Cladding: The hut is currently clad in corrugated iron (nhf). This is a recent addition added to the hut to weather-proof it.⁴²

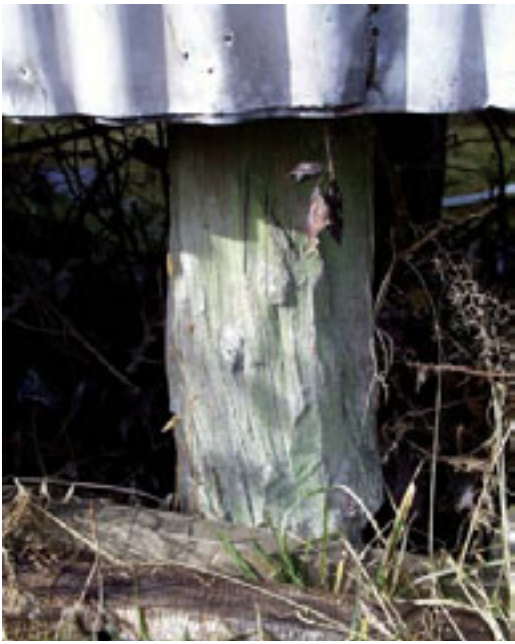
Photo 18: Detail of a pile cut from the bush.
J. BREEN, DOC, 2005.

Sub-floor framing and piles: The sub floor consists of both joists and bearers (hf) that sit on piles that

have been cut from bush timber and shaped by hand adzing (hf). The sub-floor framing and piles in the middle room are in relatively poor condition when compared to that of the south room. This is largely due to the rooms' respective height from the ground. The joists have slots cut out of them that rest in tongues of wood on the bearers. No nails are used (hf). A couple of lengths of zinc coated metal strapping have been nailed in a criss-crossed manner between the piles on the western side of the south room (see photo 12 p.21 - nhf).

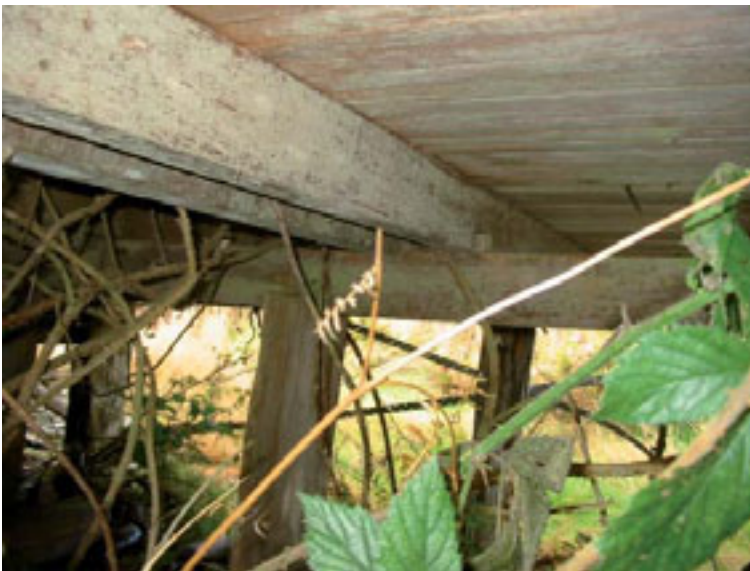
Photo 19: Detail of sub floor framing, south room. J. BREEN, DOC, 2005.

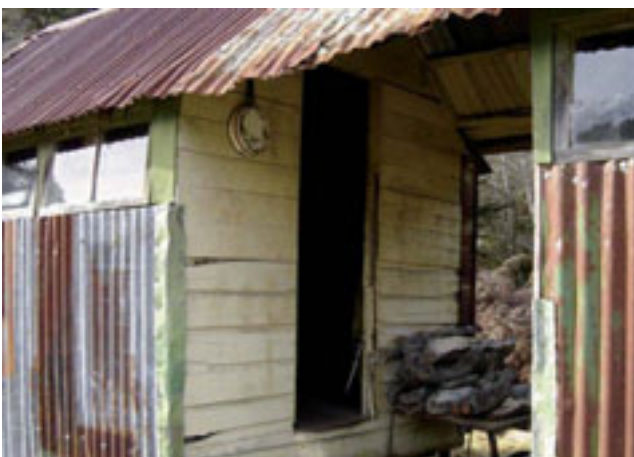
Porch: The porch is an addition, put in when the huts were re-built at Rangers Flat in 1941 (hf).

Photo 20: Porch looking north. J. BREEN, DOC, 2005.

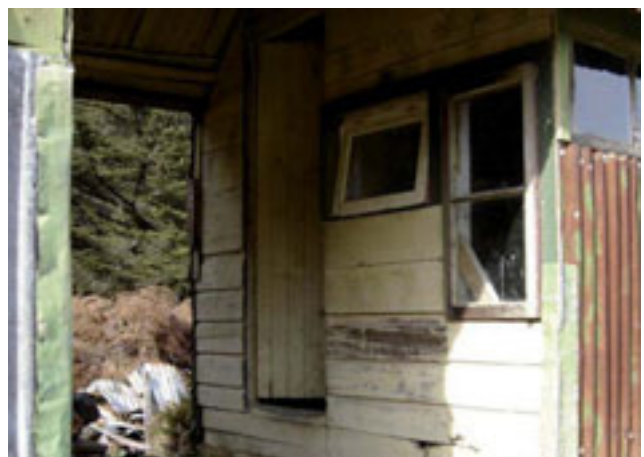
Photo 21: Porch looking south. J. BREEN, DOC, 2005.

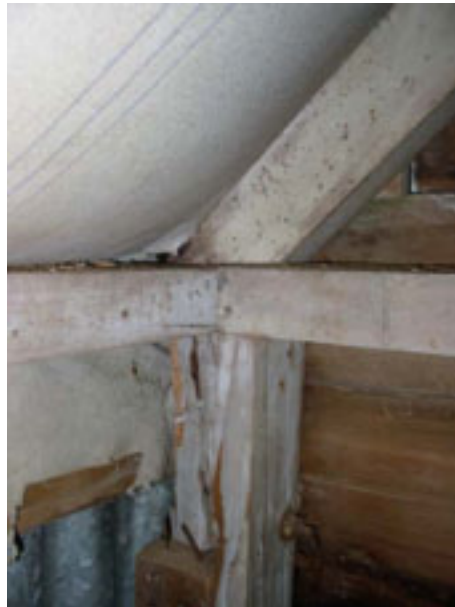
Photo 25 (left): Detail of corner joins.
N FREER, DOC, MAY 2006.

The corner studs are bolted together as per the original tent frame hut specification (see photo 25).

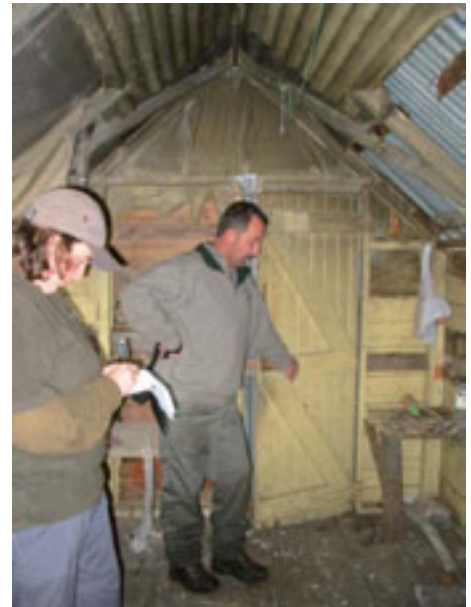
Originally cladding was rusticated weather boards. The remains of these can still be seen on the interior of the hut (hf - see 1996 photos 20 & 21).

Photo 26 (right): General view in the south room looking north. Note the tent still present in patches, and the weatherboard cladding underneath.
N FREER, DOC, MAY 2006.

The original tent lining is still apparent in some places, but it is in poor condition (hf).

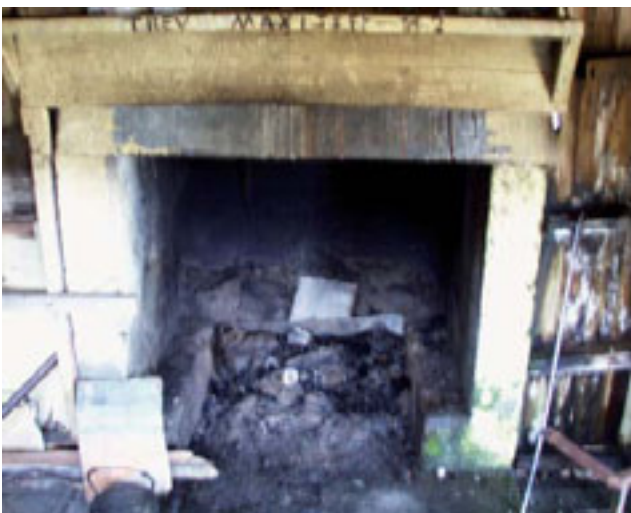
Photo 27: Fire place in the middle room. N. Freer, DOC 2006.

Fireplace: There is one fire place in the middle room of the hut. The fire place consists of a large concrete hearth, with a mantle (hf).

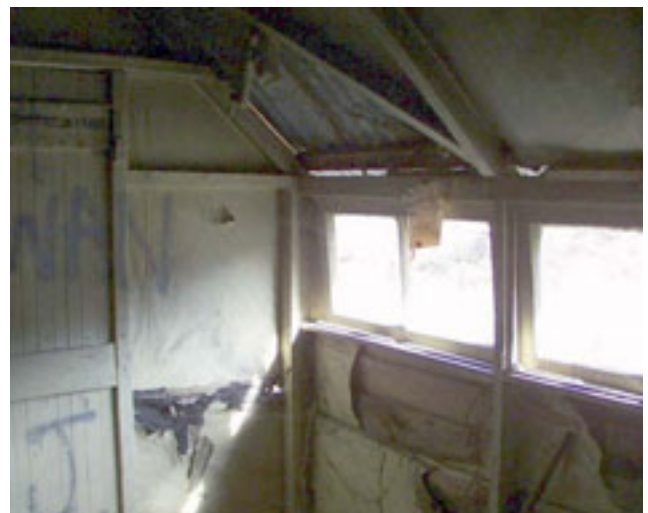
Photo 28: Interior view of the middle room, looking south.
J. Breen, DOC, 2005..

consistent with later plans.⁴³ A significant proportion of the framing on the east wall of the middle room is in poor condition. This room has been partially lined with T&G lining, as well as with silver sisalisation/building paper (hf). The middle room has also been painted.

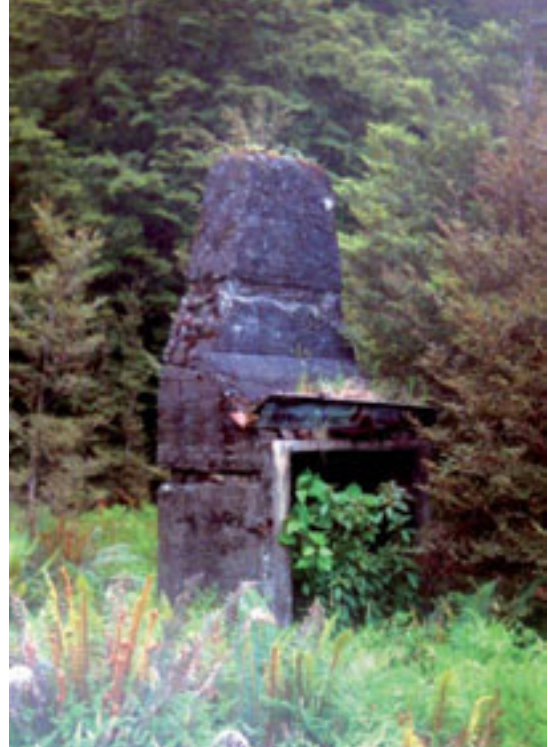
Chimney base from Rough Creek Hut.
MARK MARTINI DOC, DECEMBER 1996.
