Snoozing

"Rust never sleeps"

Comparison of two metal stabilisation systems used by DOC

- 1. Vulcan steam log hauler, Sheridan Creek, Otaki Forks = Hand clean, Shell Ensis Fluid's SDC and V.
- Davidson steam logging locomotive,
 Deadman Creek picnic area, Grey Valley = abrasion blasting and electro-zinc plating.
 Two pot epoxy coating

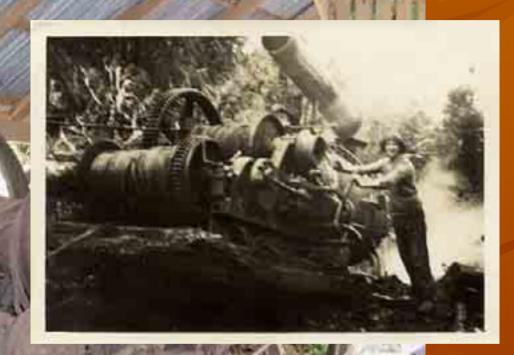
Vulcan steam log hauler

Mechanically sound

Sheet metal wasting

Wire rope a problem

Encroaching forest

Ponding of water

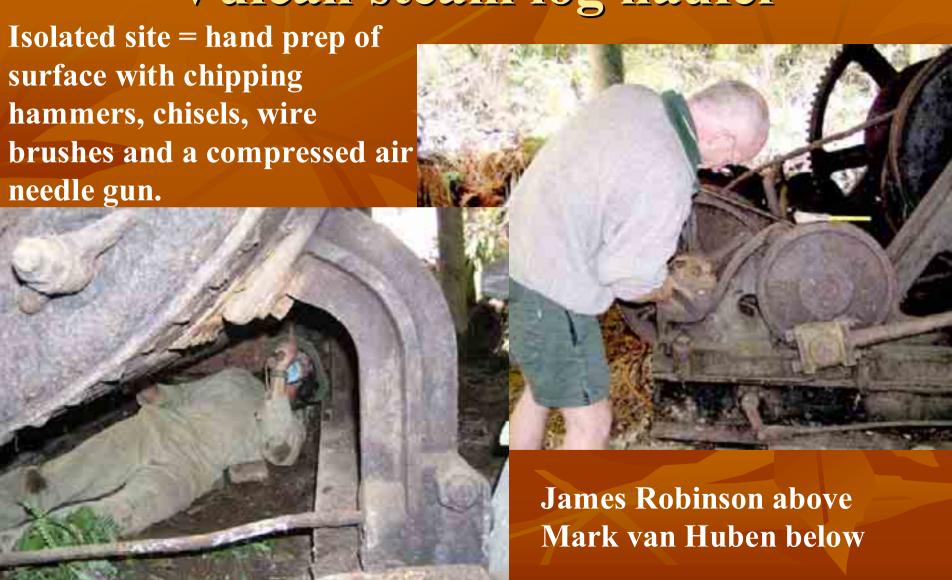
Vulcan steam log hauler

- Preparation of surface = 59 hours in total.
- Hauler weighs in at approx 8 tonne.
- Used chipping hammers, wire brushes, cold chisels and nail punches, compressed air needle gun, scrapers and engineers bars.
- Flew in air compressor, generator and other equipment.
- Unable to move major parts for cleaning down.
- No dismantling of minor parts

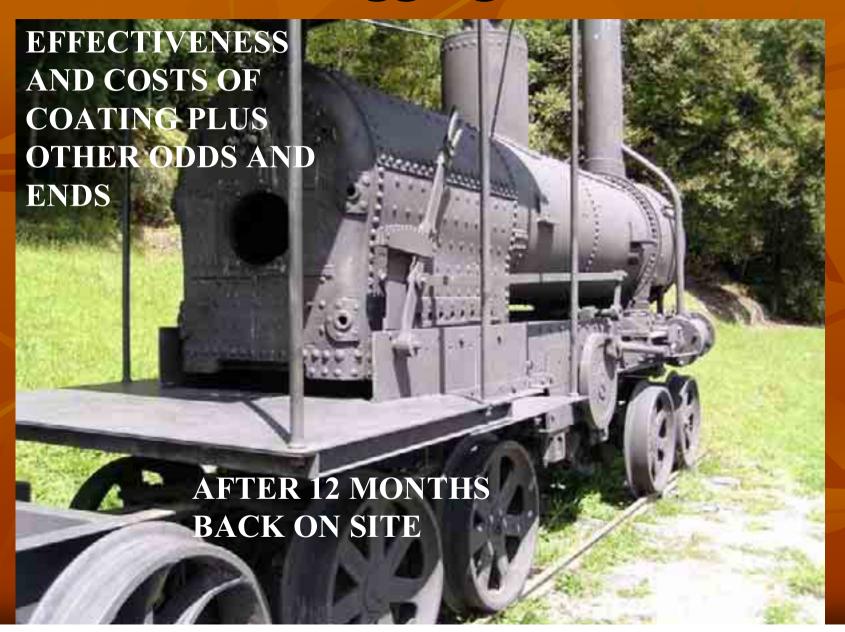
Davidson logging locomotive

- Basic costs:
- Consent for abrasion blasting, covered by the contractor but included in overall pricing.
- Removal off site to contractors yard, craneage and trucking \$1240, (18km to yard)
- Dismantle, abrasion blast components to 75 microns, thermo-zinc plate to 75 microns,
 fill joints, prime with Altex Ultra Prime 450. top coat with Altex 236 = \$8,000
 Total cost for replacement/repair \$36,804

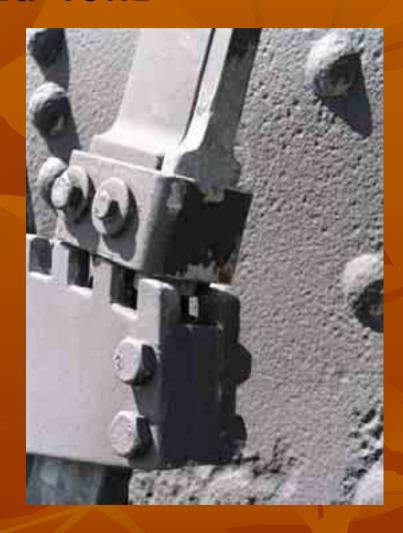
The only moveable object, back to zinc surface

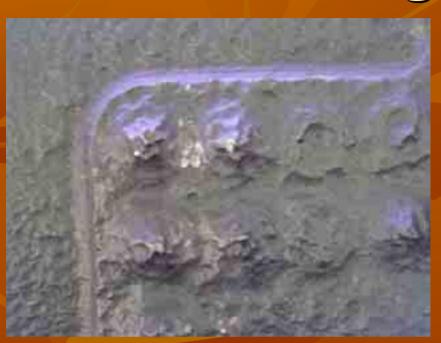
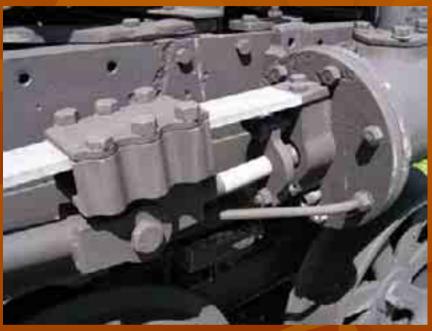
Shifting damage

Lifting chain damage to coating

Shifting on truck deck damage

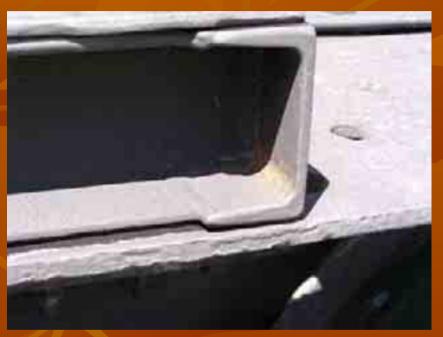
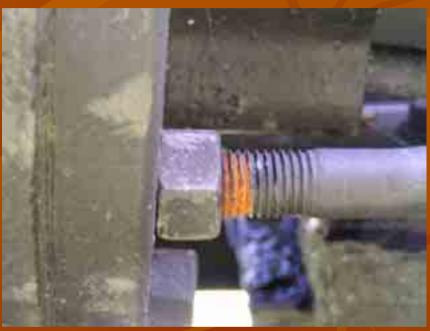
Odds and ends

Missed a bit?

Forgot about doing up the nut!
