Conservation of Ellis Hut

A practical workshop on conservation skills

By Pam Bain, Department of Conservation

Ellis Hut was built in 1884 in the Ruahine Ranges, Hawke's Bay, for mustering and wild animal control. A feature is hand-made tongue & groove interior lining. This report records a 1995 on-site workshop planning the hut's restoration.

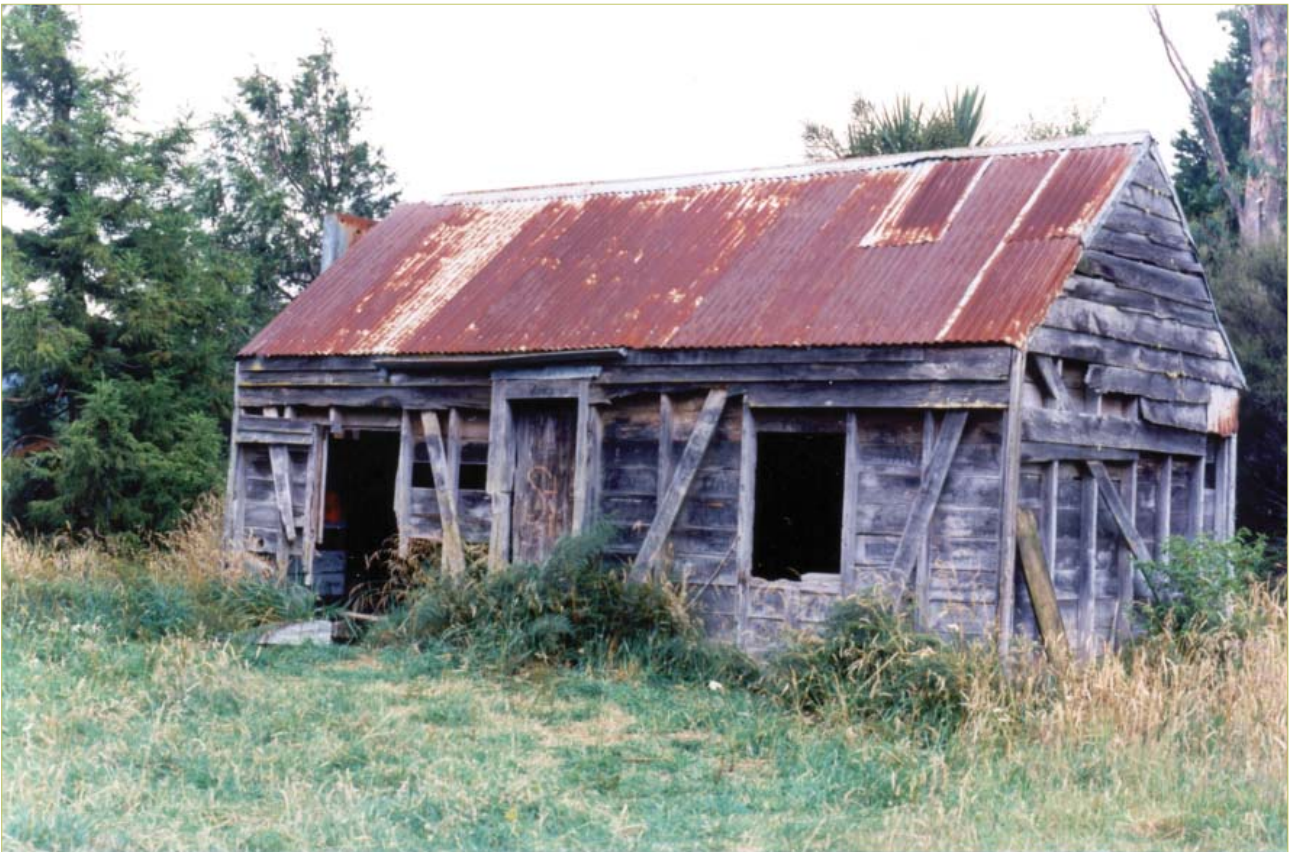
FIGURE 5: ELLIS HUT BEFORE CONSERVATION

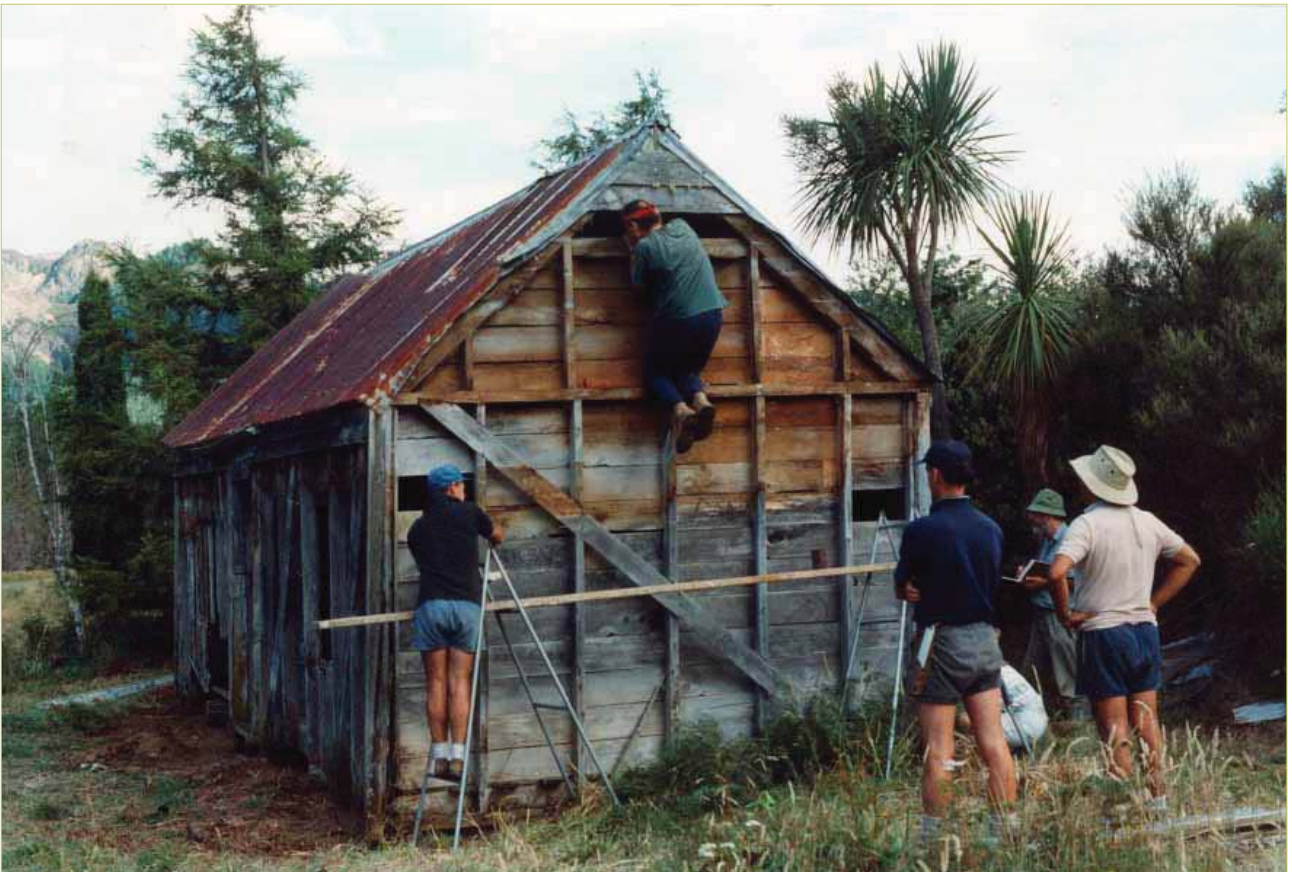
FIGURE 7: BUILDING TECHNOLOGY TEAM AT WORK ON THE WEST WALL

Chris Cochran and Jim Staton compiled a detailed analysis of the building technology of the hut (Appendix 3). They conclude “although it is not uncommon to find examples of pit-sawn timber in some of our early buildings, Ellis Hut must stand out as a building where we know that the whole of the structure, cladding and lining was pit-sawn, and where most of the finishing work was by hand” (Fig 7, 8).

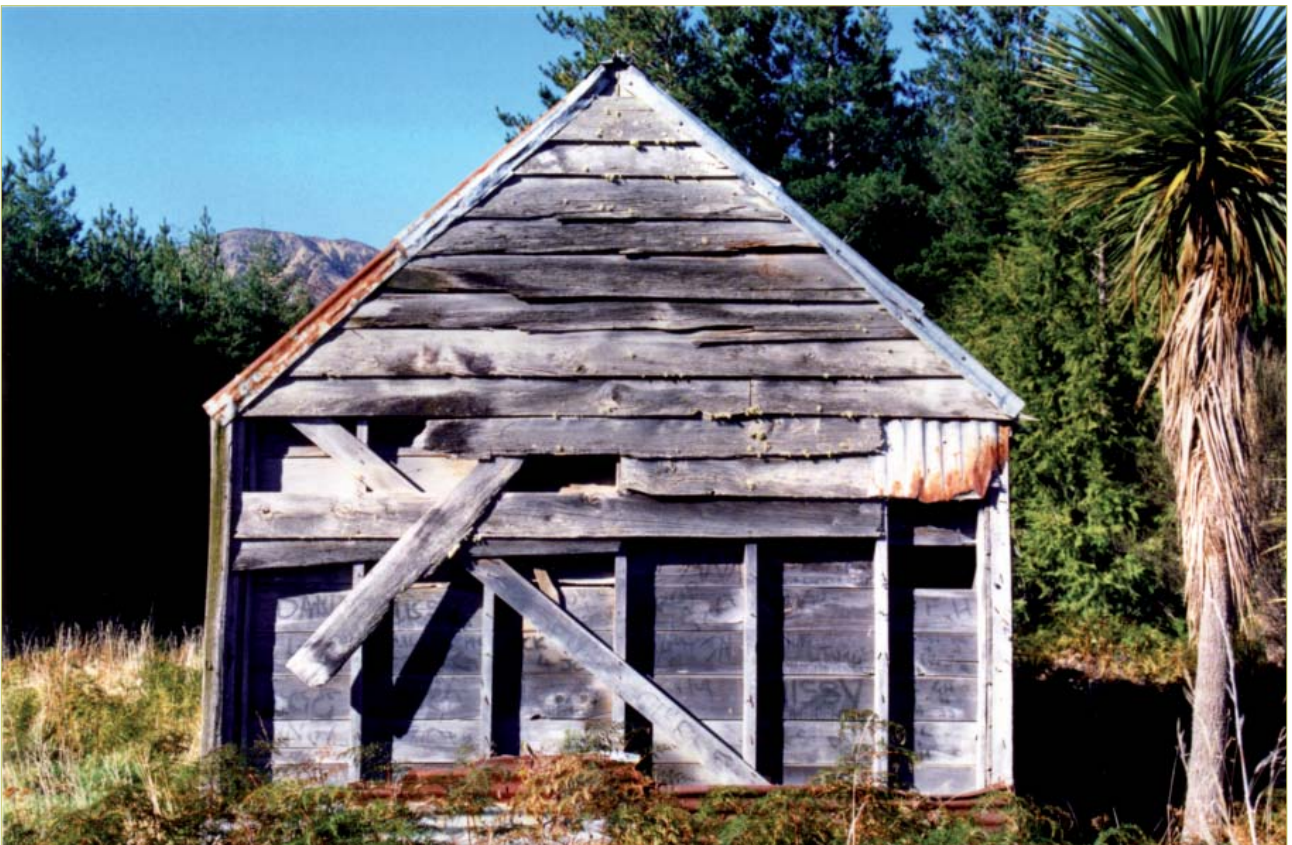
FIGURE 8: DETAIL OF WEST WALL CONSTRUCTION (SEE APP. 3: SITE DRAWING 10)

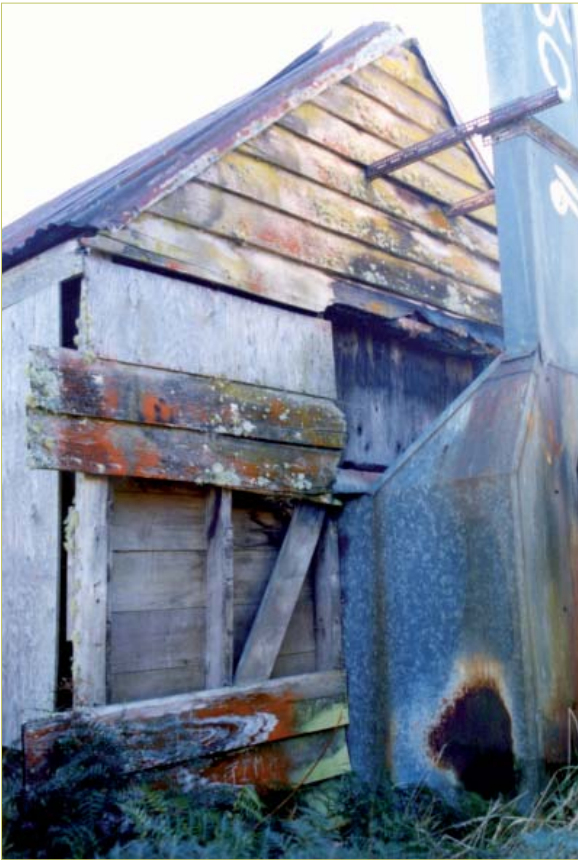
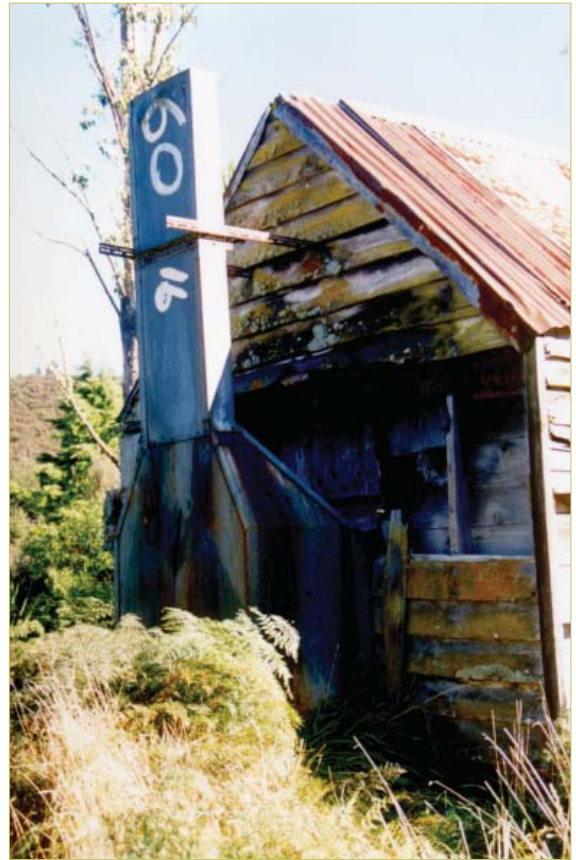
FIGURE 10: EAST WALL ELLIS HUT BEFORE CONSERVATION

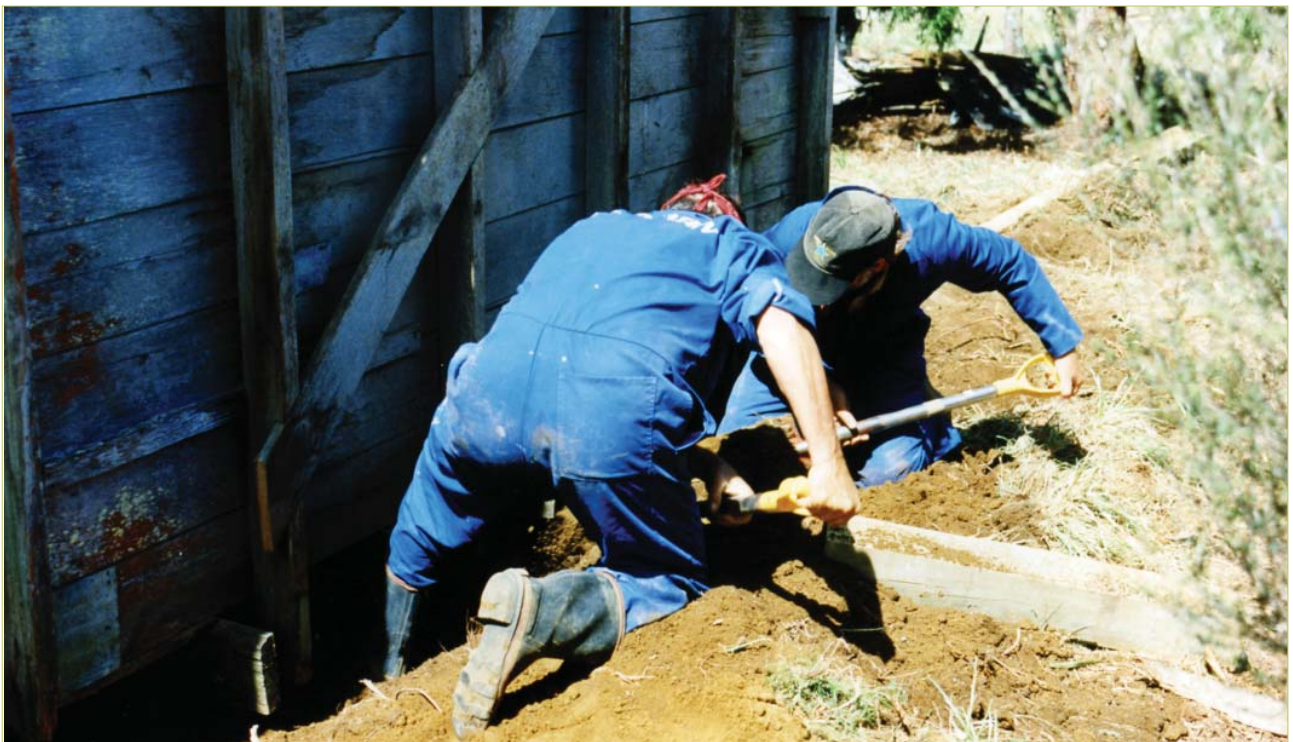
FIGURE 11: HUT BEING LEVELLED

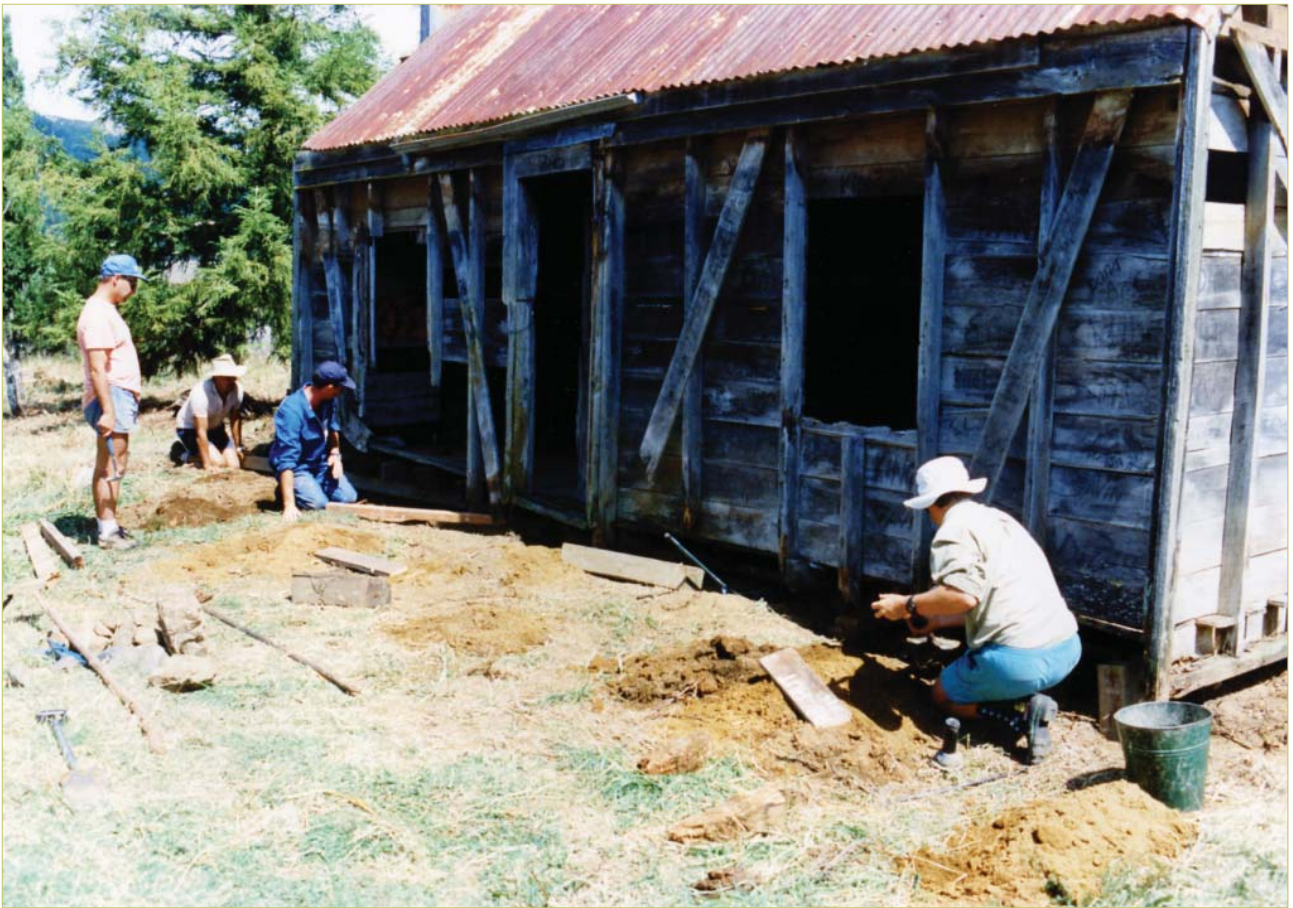
FIGURE 12: REPILING NORTH WALL

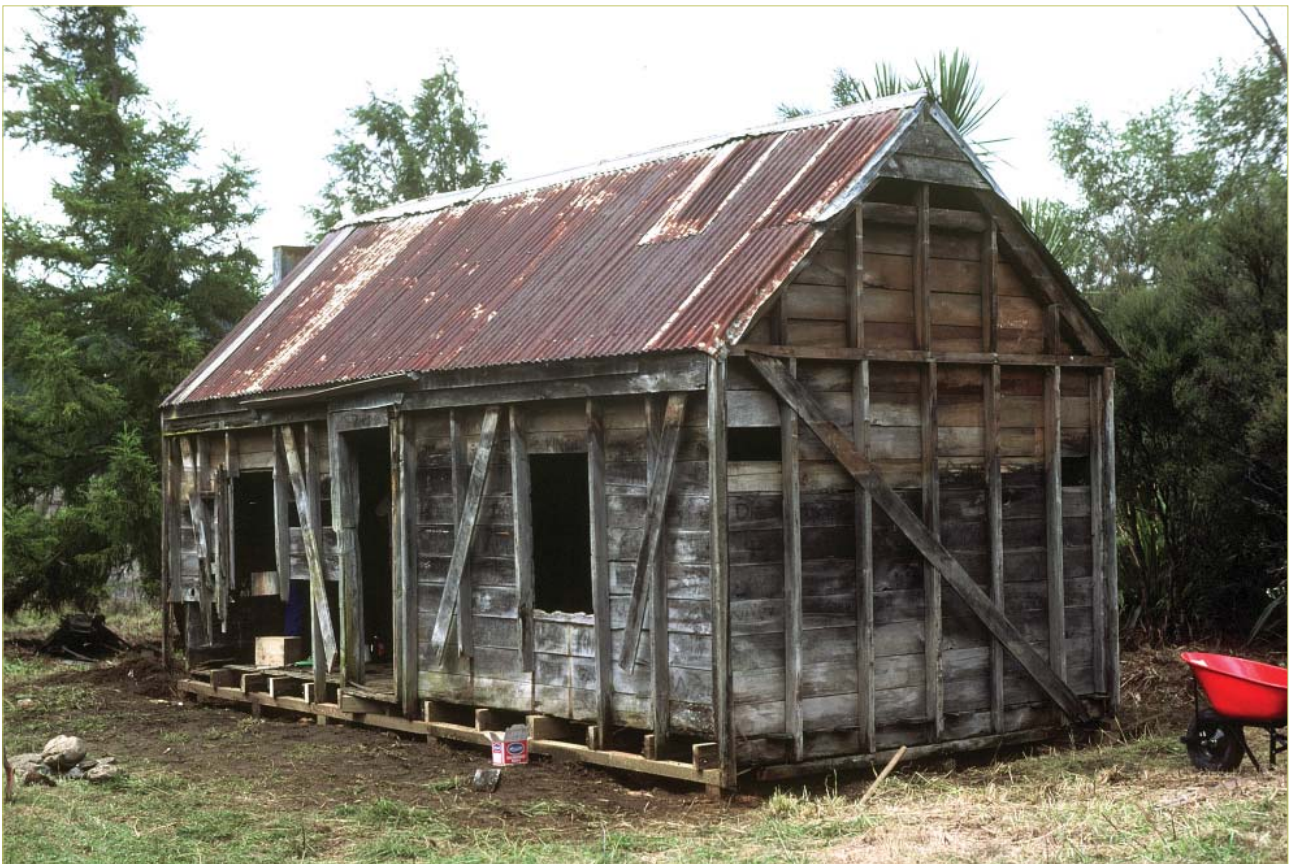
FIGURE 13: REPILING COMPLETED

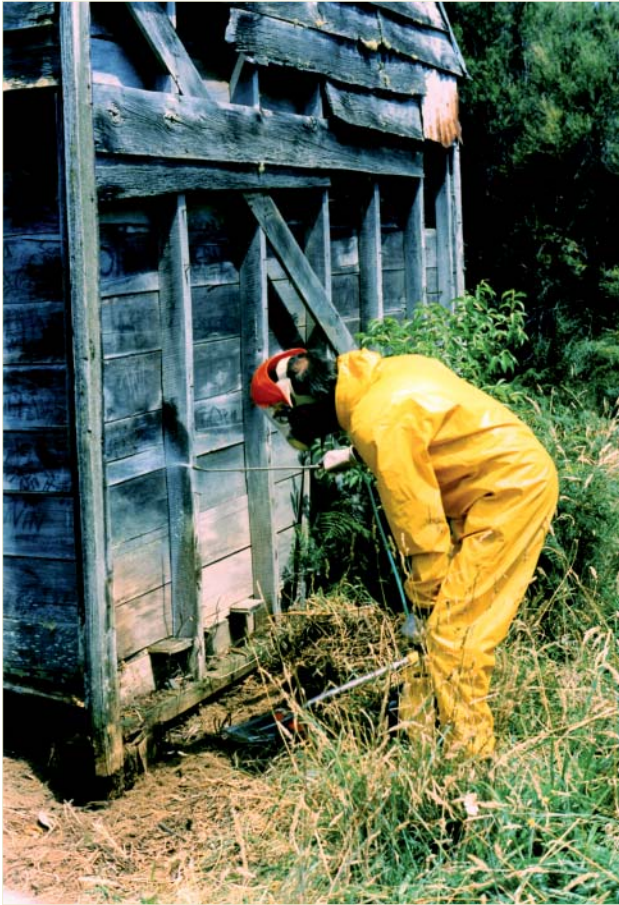
FIGURE 14: CHEMICAL TREATMENT OF WOOD

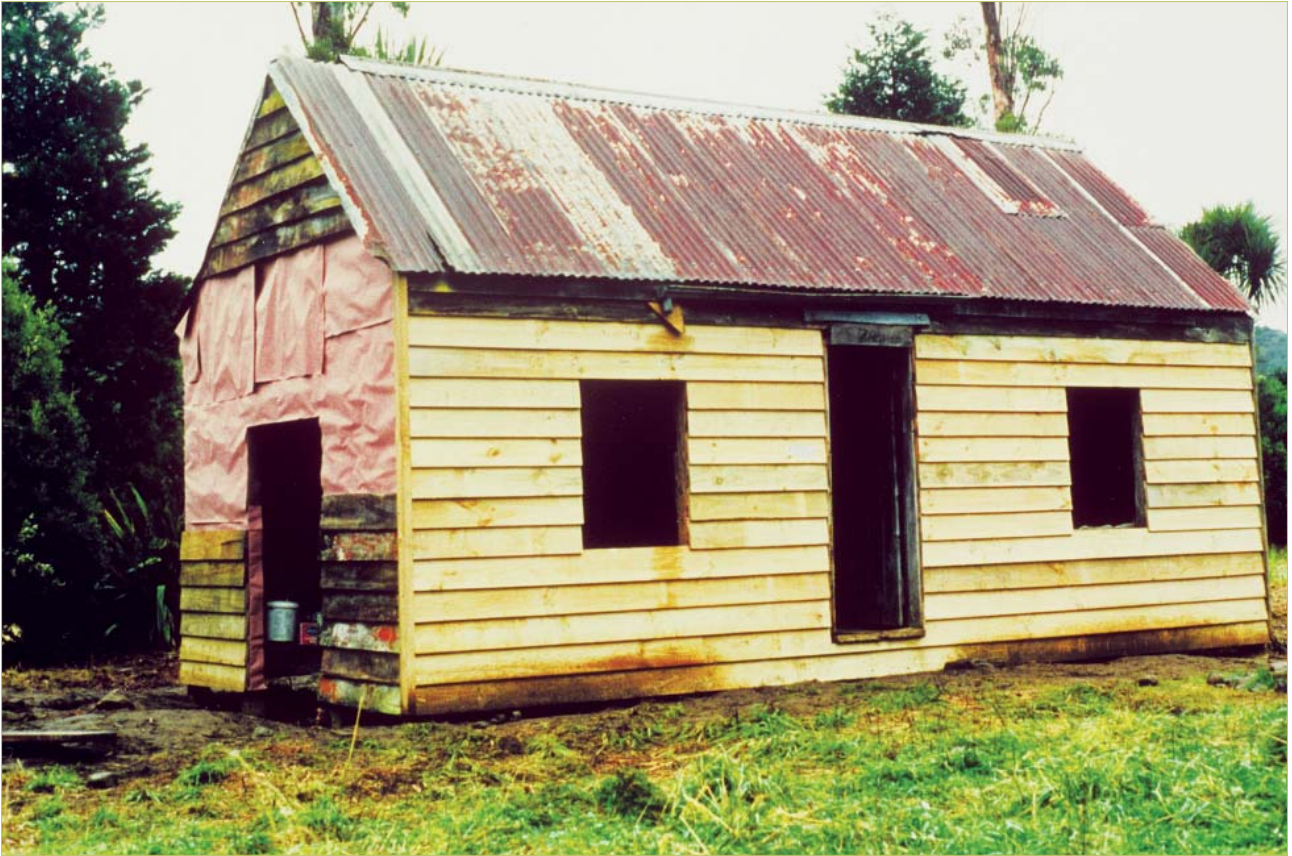
FIGURE 16: PINE CLADDING ON NORTH AND EAST WALLS

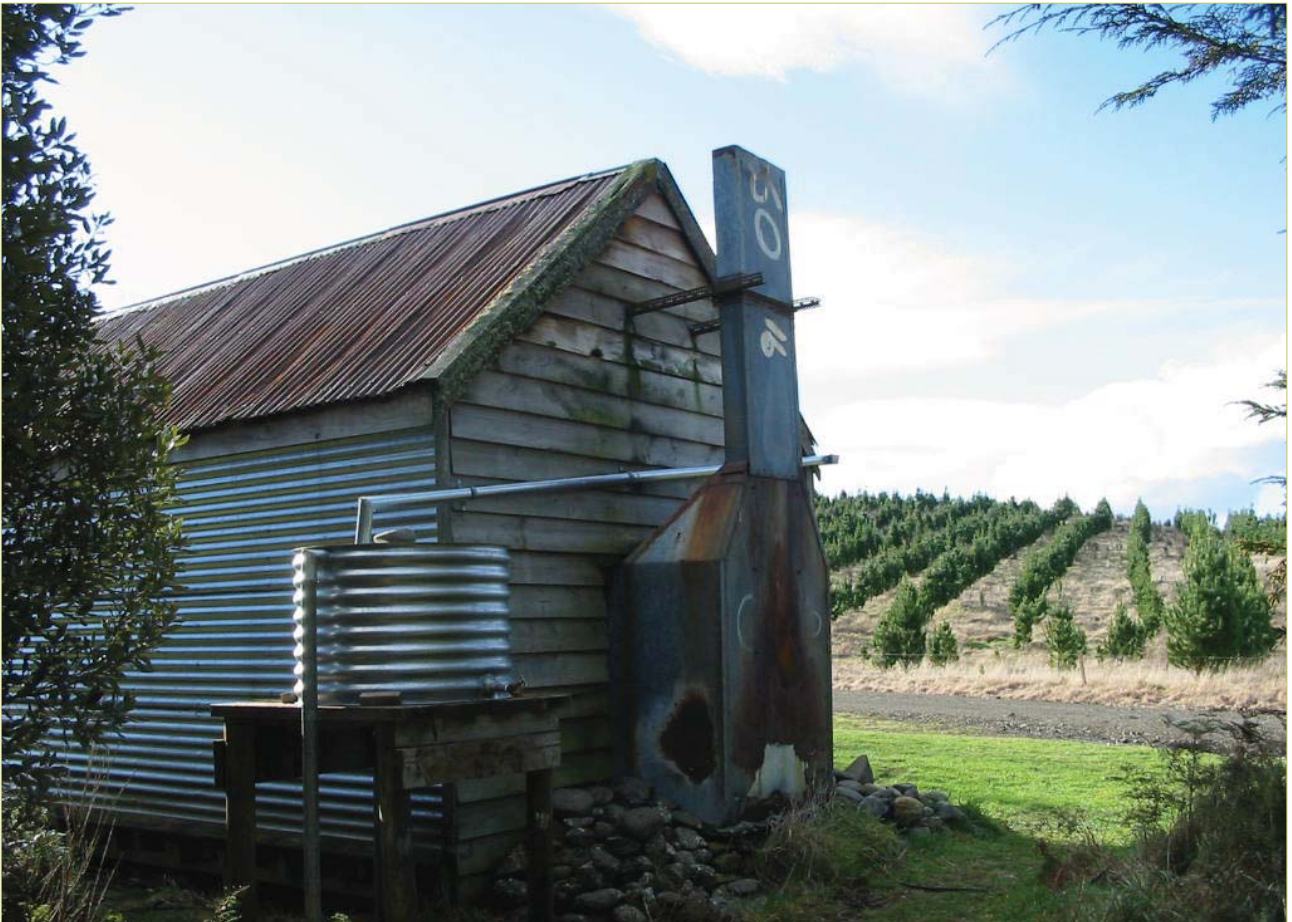
FIGURE 17: NEW WATER TANK AND REPAIRED CLADDING ON EAST AND SOUTH WALLS

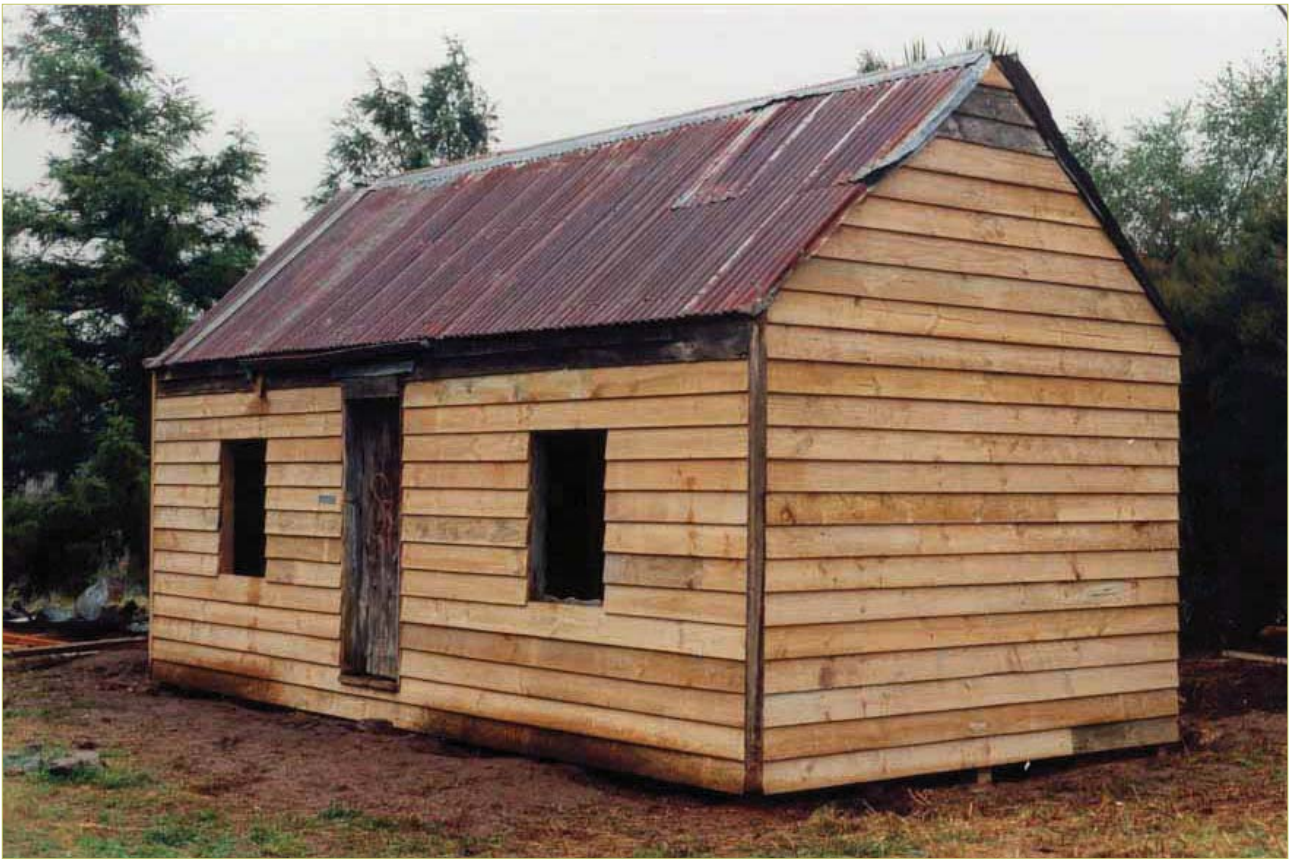
FIGURE 18: PINE CLADDING ON NORTH AND WEST WALLS

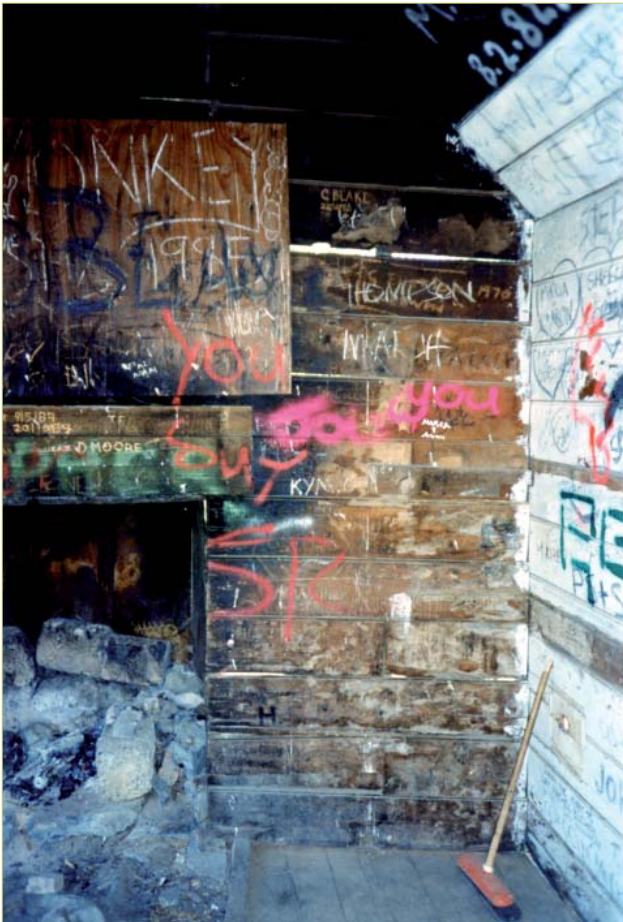
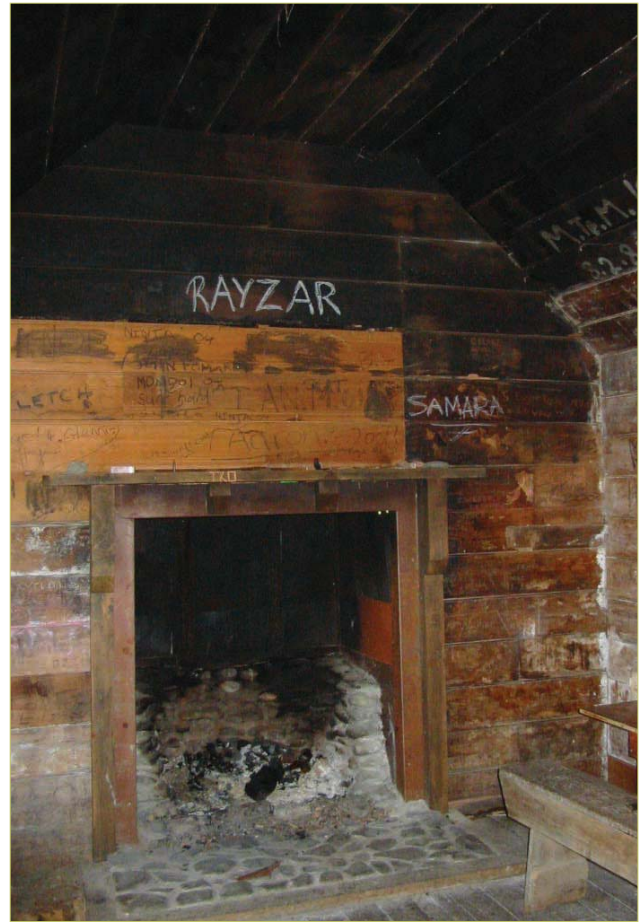
FIGURE 19: DETAIL OF CONSERVATION WORK (BEFORE AND AFTER)

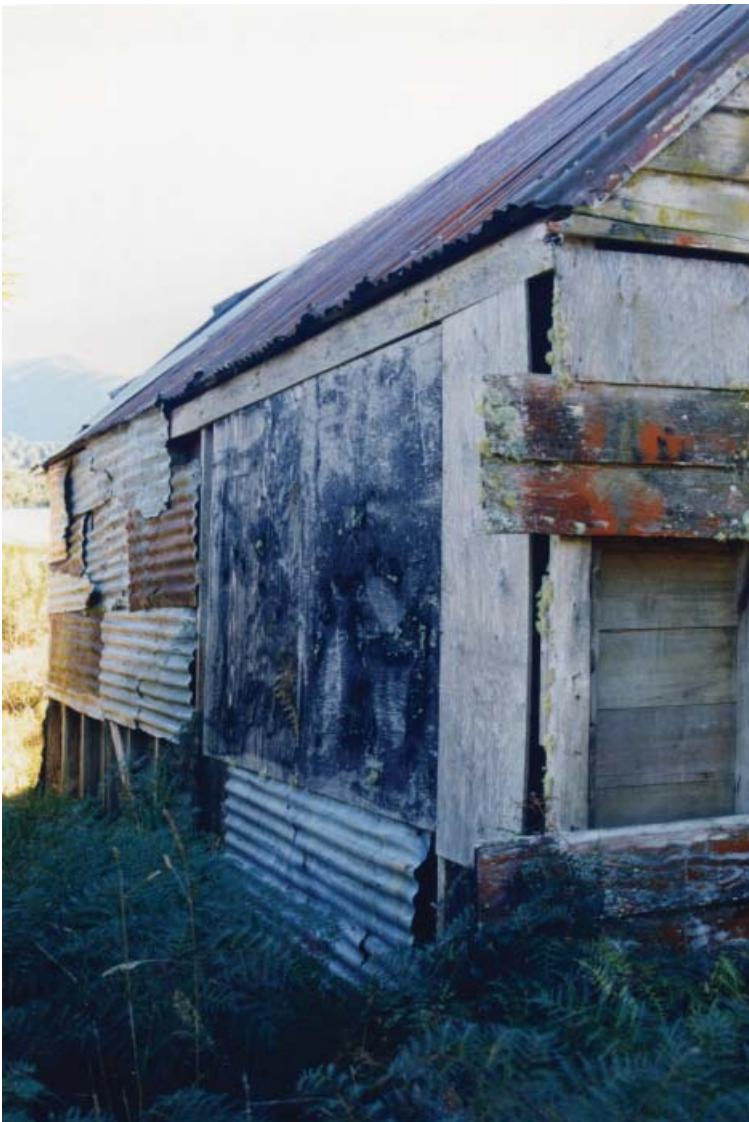
Rear (south-west) elevation. No weather-boarding remains on this wall.

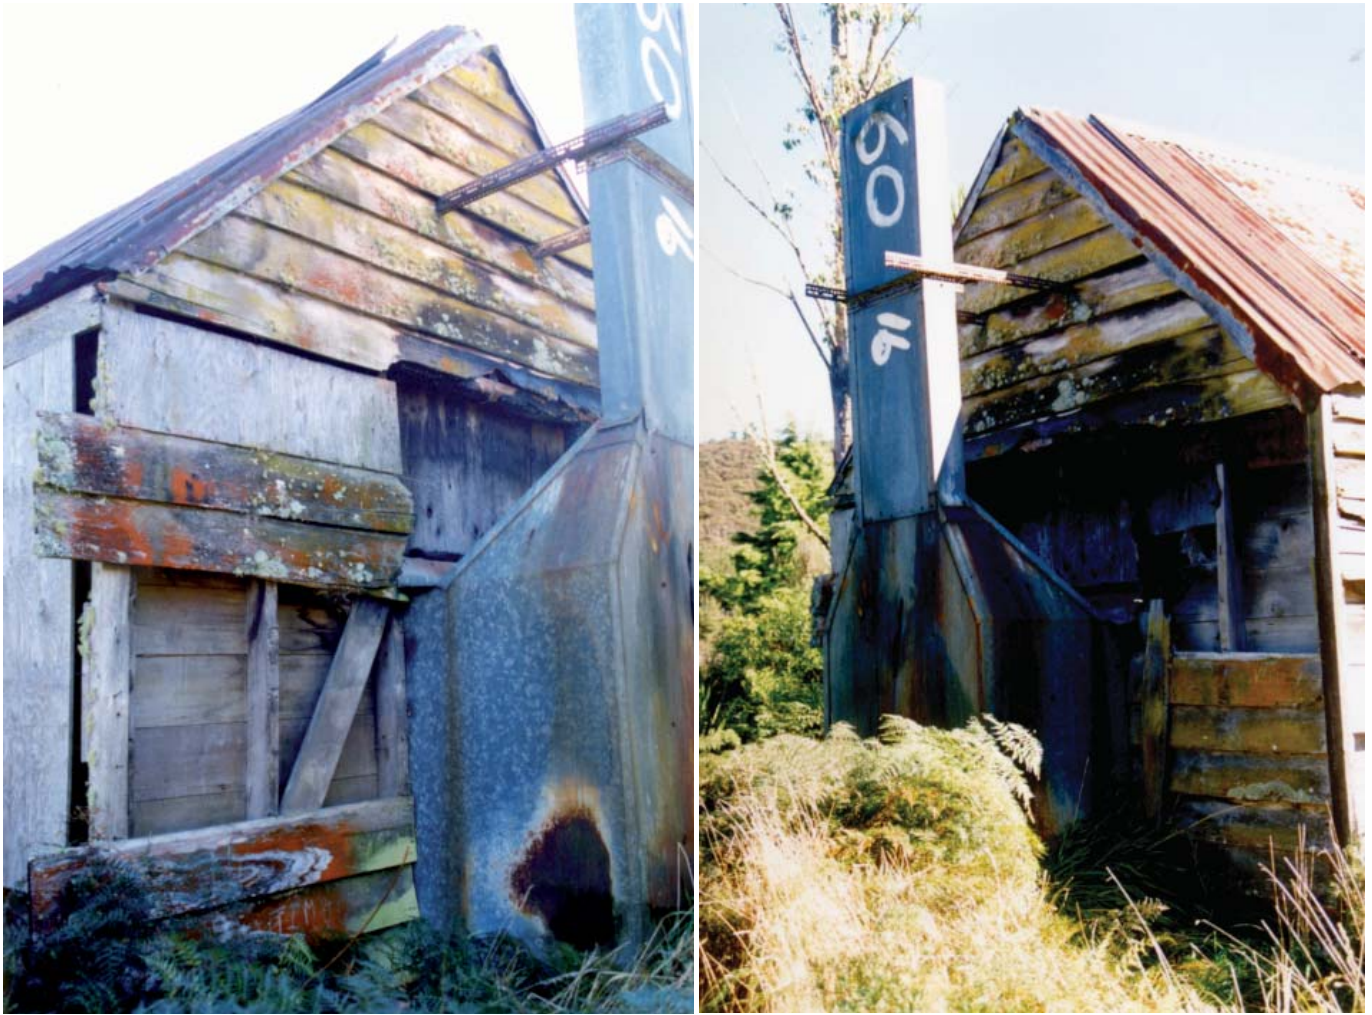
South-east elevation. Weatherboarding in the gable can be retained; other short lengths should be salvaged for possible re-use.

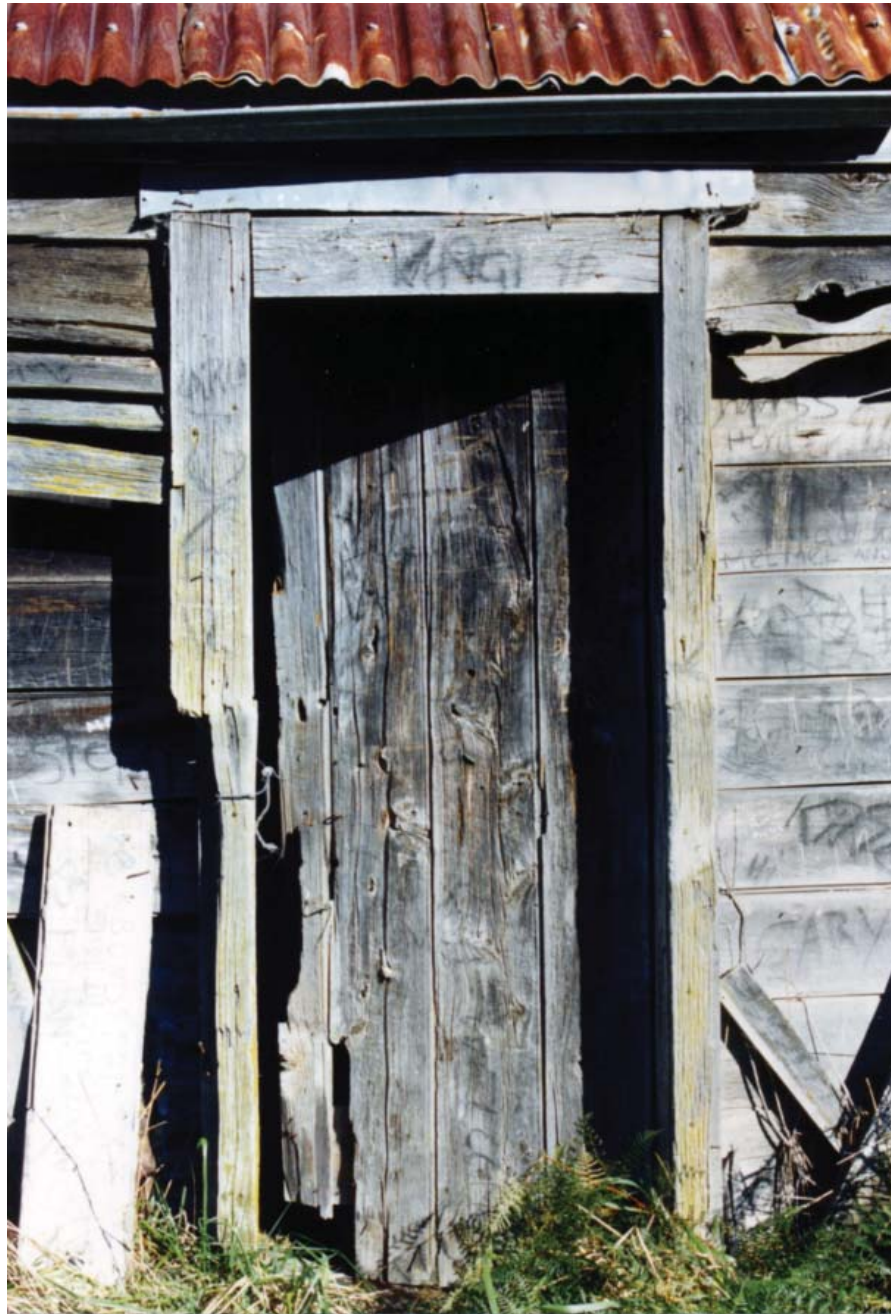
Detail of front door. Replace board on latch edge of door only.

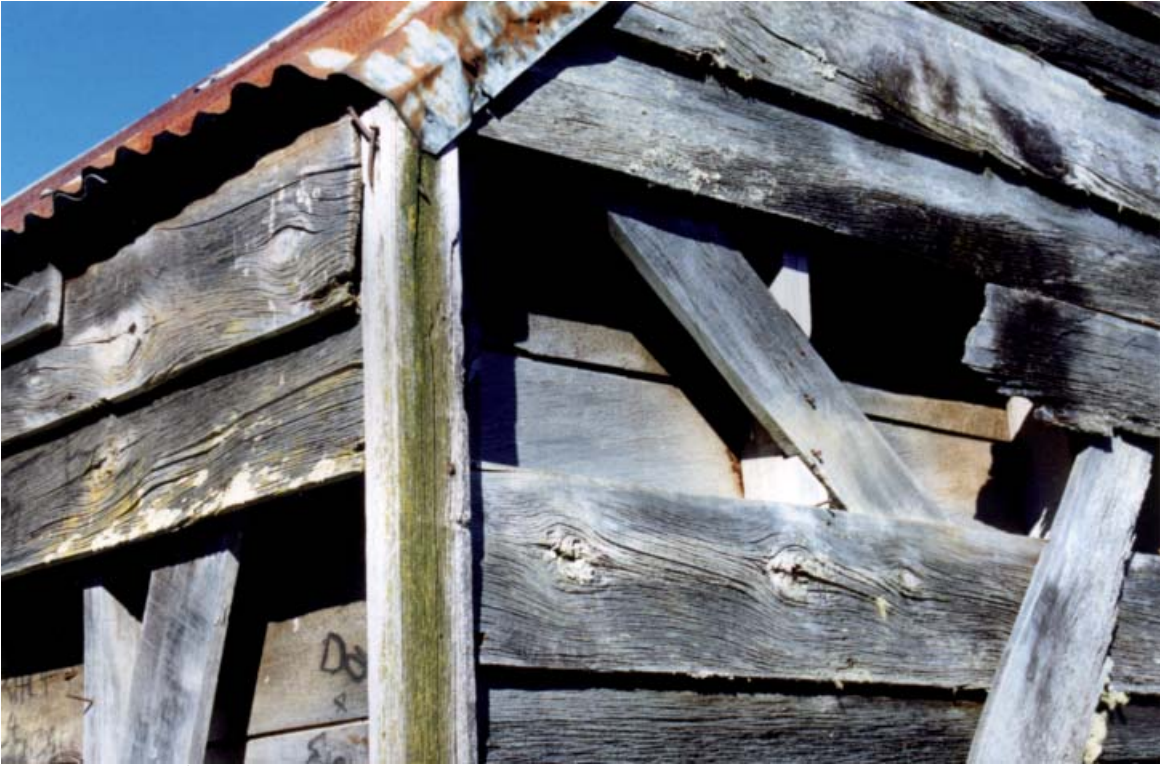
Detail of solid corner stop, north corner.

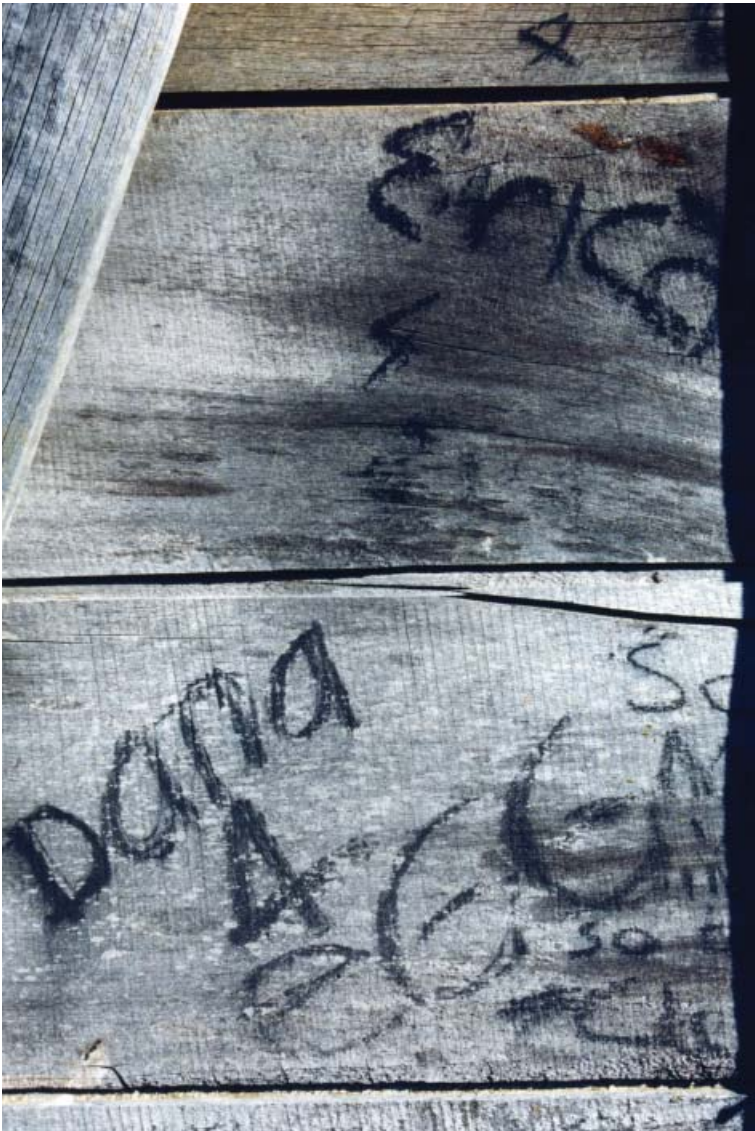
Detail showing pit-saw marks on inside face of tongue & groove boarding.

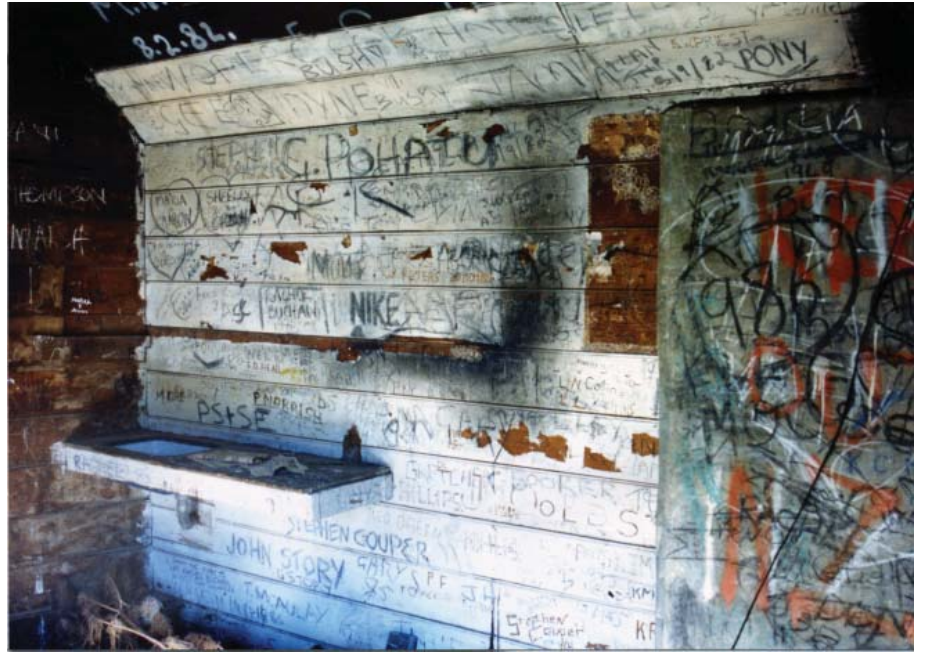
1 Interior, main room. Fireplace on left, sink bench in the middle & safe on the right. (See Plan for location of photos.)

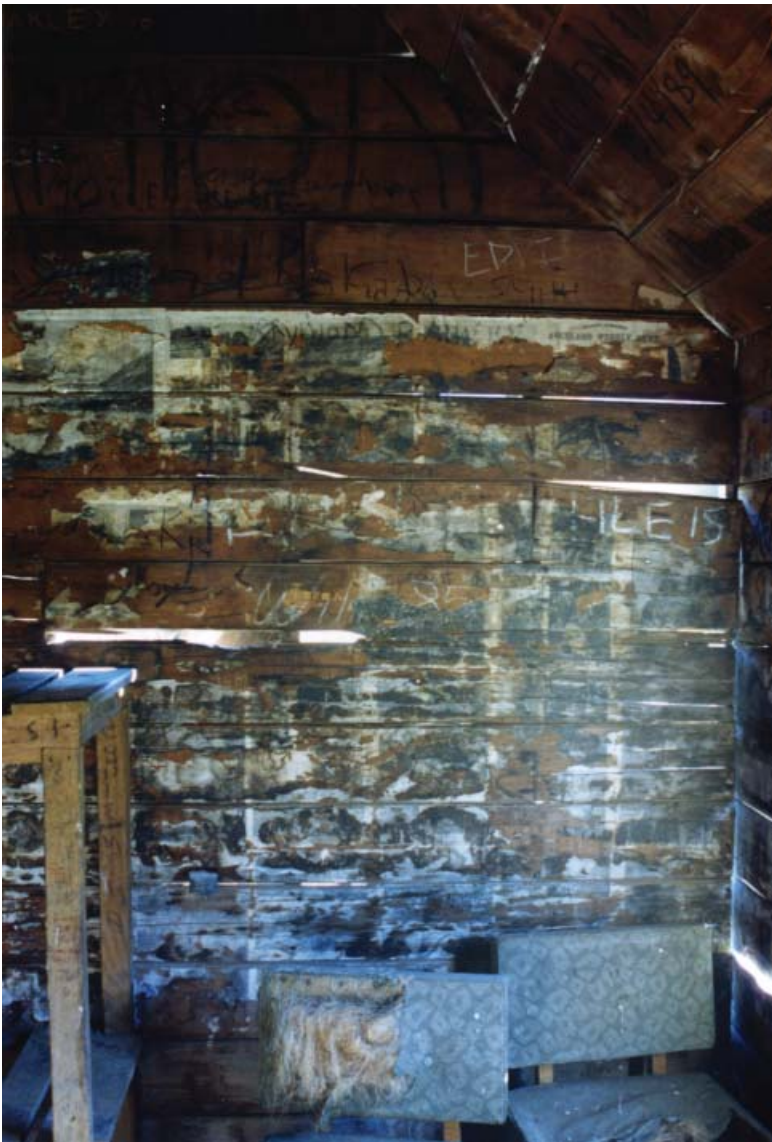
← Detail of boarding
in bunk room.
4

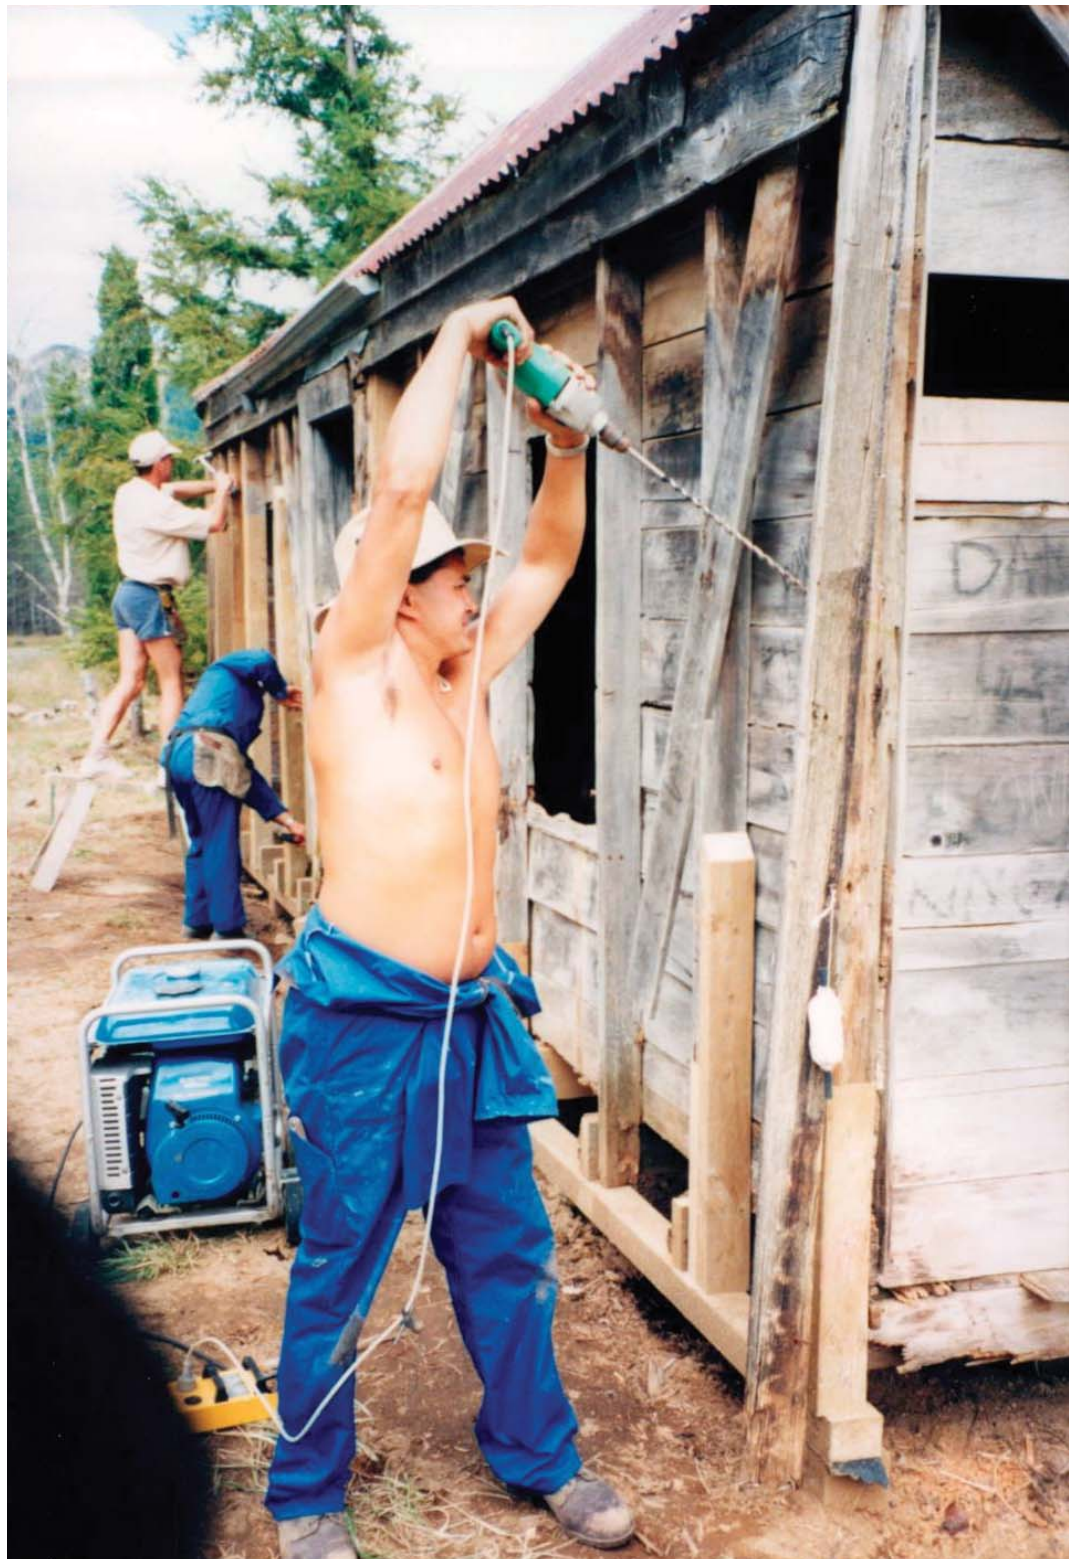
Taranaki conservation officer Dave Rogers drills holes in the original timber of the hut before preservative is pumped in. Behind him is carpenter Roger Elliott who works at the Rimutaka Forest Park for the Department of Conservation, and Peter Dandy, centre, from the department's Ongaonga field centre.
