Biodiversity Huts, Fiordland

Historic Heritage Assessment

Michael Kelly, Heritage Consultant

SOUTHLAND CONSERVANCY, MARCH 2010

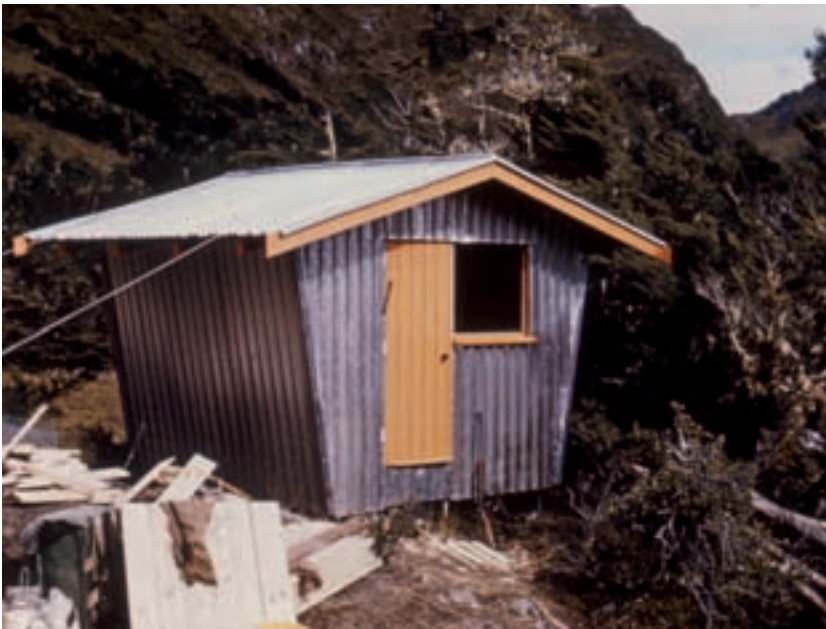
Wisely Hut nearing completion in 1961, with the leftover timbers and iron lying around the site. The hut's distinctive flared walls are easy to see without the later (1976) addition.

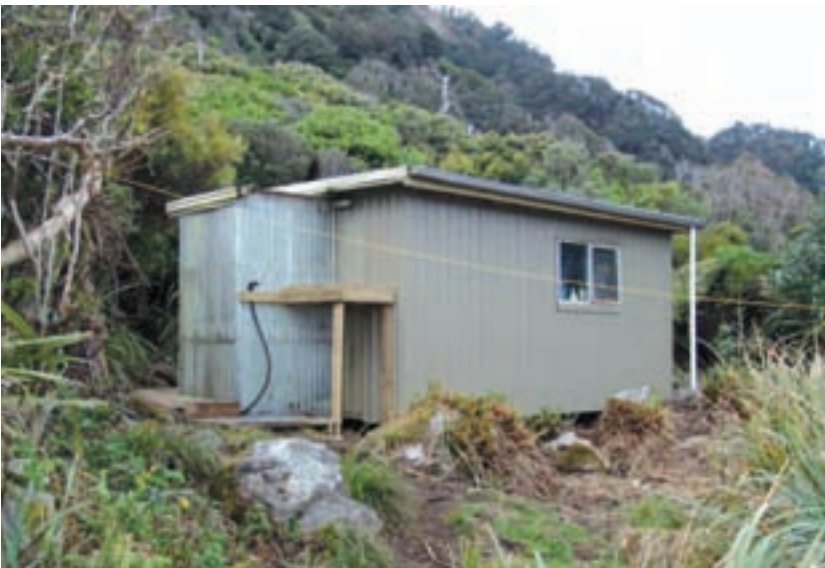
Stanley Burn Hut in the late 1970s, soon after its construction. (SOUTHLAND CONSERVANCY, DOC)

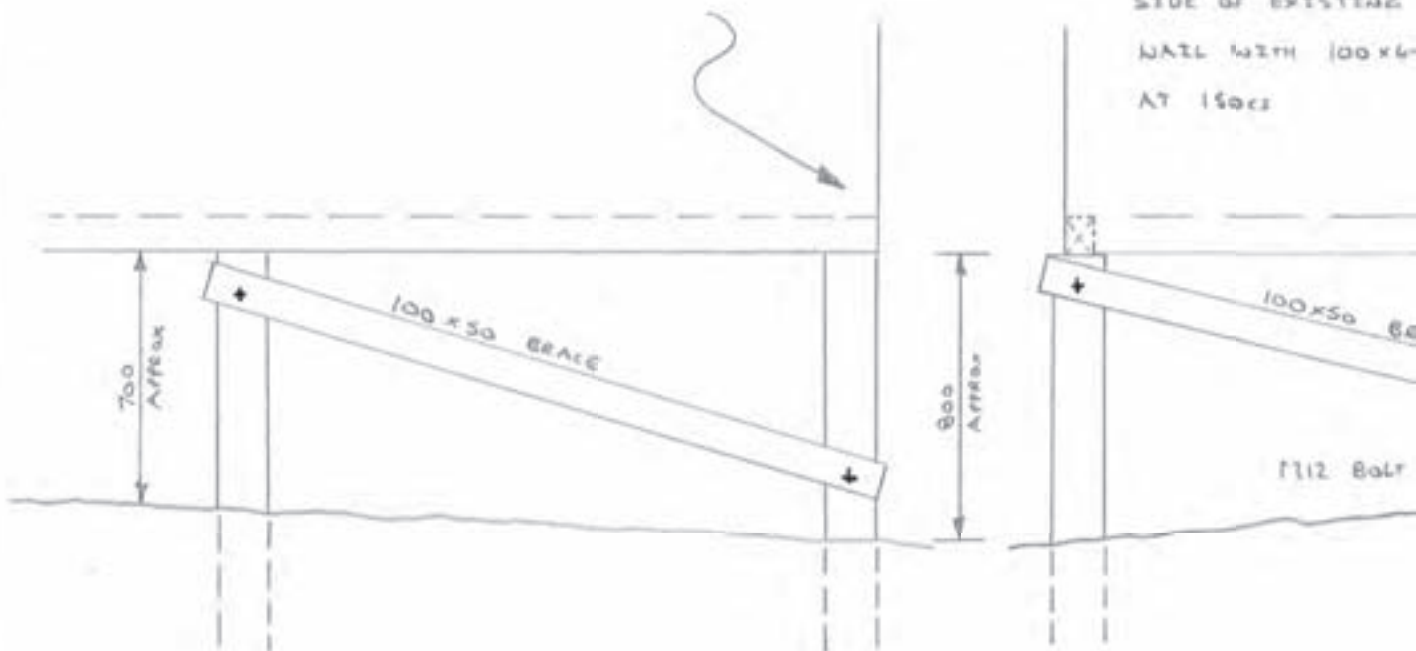
Aurora Point Hut foundation plan, 2004. (DOC)

ADDITIONAL 100X50
 SIDE OF EXISTING
 WALL WITH 100X6
 AT 150cs

ELEVATION 1 (1:20)

FOUNDATION PLAN (1:50)

3 BEARS EACH
CENTRE BEARER
6 FH WALLS

HUT TO BE JACKED UP APPROX
120 mm THIS HEIGHT TO LEVEL
FLOOR

TE ANAU AUA Southland Conservancy		
Project AUREA POINT HUT FOUNDATION UPGRADE		
Drawing Name RE-PIILING & BRACING DETAILS		
Scale	Date	Approved
Struct	27/11/04	T. Cross
Site No.	Asset No.	Drawing No.
627	47021	1
