Intertidal habitat enhancement on the lower Waikato River

Enhancement took place at the intertidal riparian section of the lower Whauwhautahi Stream, a tributary of the lower Waikato River.

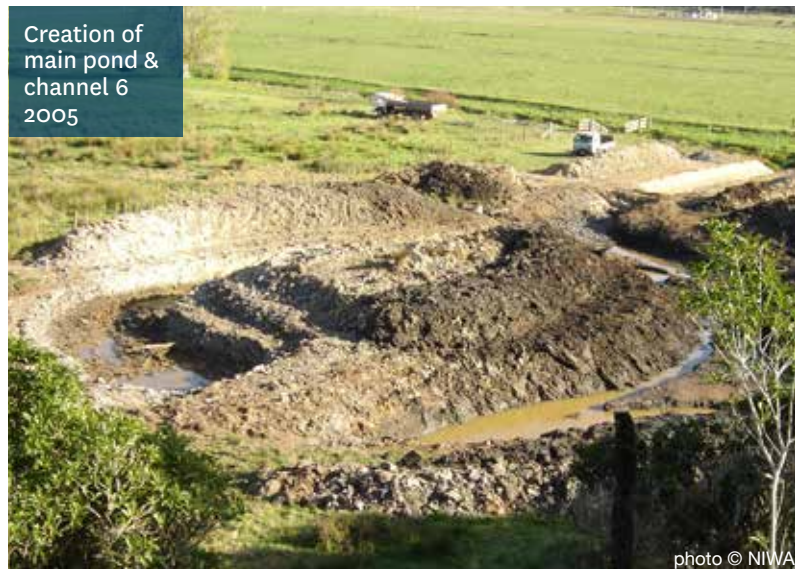
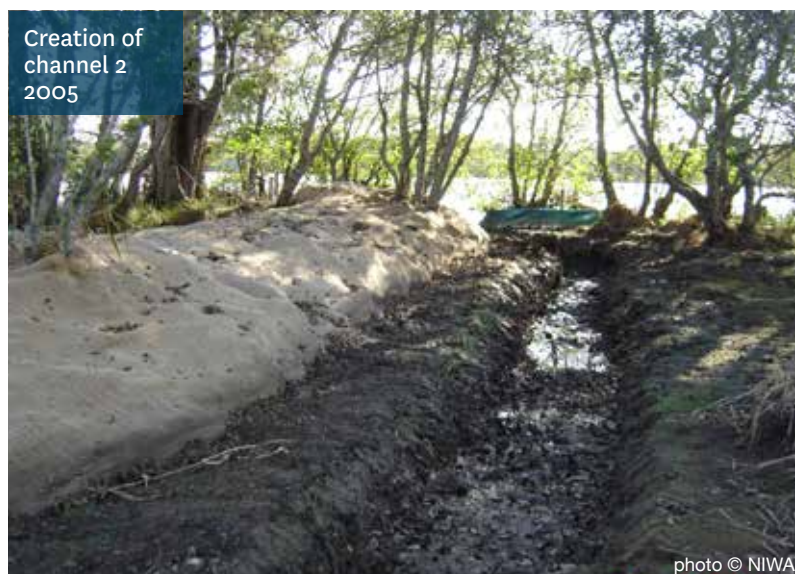
1. The area was fenced so that any īnanga eggs deposited on site would not be trampled by cattle.
2. Indigenous trees, shrubs and grasses were replanted to provide cover and food for fish.
3. Channels and ponding areas were created to increase fish habitat and improve access to spawning and feeding areas on the tide-flooded river margin (see map on front page).
4. Sloping banks were created to provide areas where īnanga could once again spawn.
5. Weeds were removed, eventually to be replaced by indigenous plants.
7. Annual maintenance of the spawning grounds was undertaken between 2005 and 2012 to ensure the habitat remained suitable for īnanga spawning and rearing. Maintenance consisted of weed control (chemically and by hand), inspection of fences, possum control, minor vegetation removal, staking and tying of plants as necessary, and replacement planting.

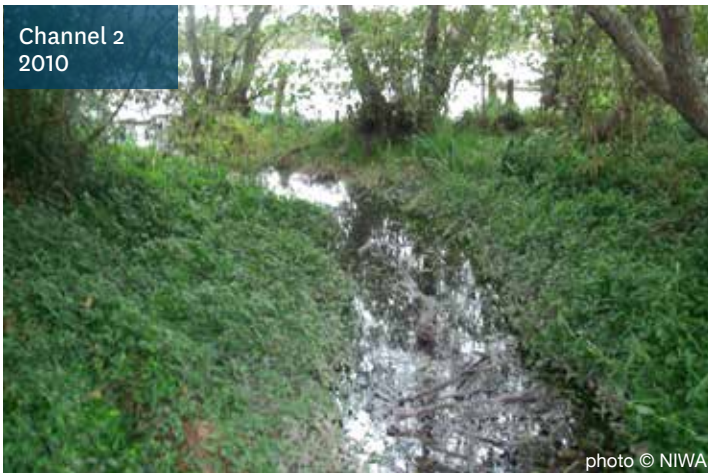
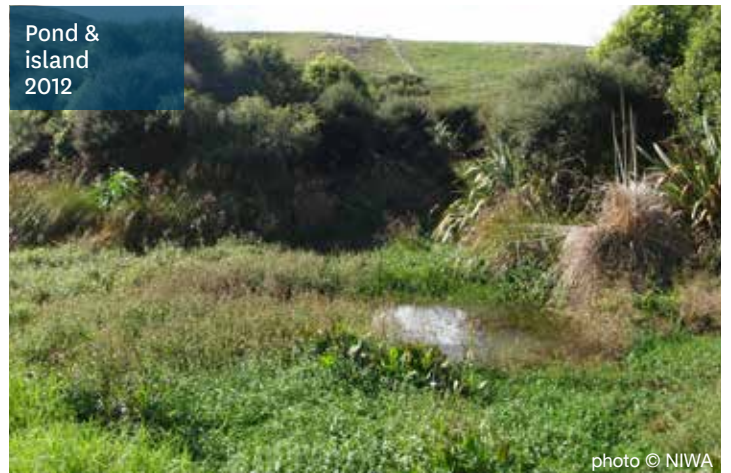
The initial assessments in 2006 and 2008 indicated that the channels and the pond were utilised by īnanga, with evidence of spawning found along the margins of channels 1 and 2 during autumn 2008 (Baker et al. 2010). In 2009 and 2010, large numbers of ripe īnanga were present at the site, with īnanga eggs located along the margins of channel 2 during autumn 2010. Between 2011 and 2014, no further spawning was evident at the site.

In assessing the vegetation along the channel margins, channel 2 was considered to provide the best spawning habitat within the enhanced area and was the main channel utilised by īnanga in 2008 and 2010. The spawning habitat was provided by a blanket growth of wandering willie (*Tradescantia fluminensis*). The native plantings of grasses and sedges alongside the channels proved difficult to maintain and may have been shaded out in summer by willows and elders as they were quickly out competed by wandering willie.

Patches of exotic vegetation were also deemed suitable for spawning along channels 1, 3 and 4. However, erosion was evident at channel 1, which had led to steep sided channels. As such, inundation of suitable spawning habitat was limited to high river levels and high spring tides.

Rank grasses were the dominant riparian plant along both channels 5 and 6. Although rank grasses can provide good īnanga spawning habitat, evidence of chemical control was apparent and the grasses were sparse along the intertidal margins of the channels. Therefore the habitat was not considered suitable for īnanga spawning and no evidence of spawning was found along these channels in any survey.
