13. South Island and Chatham Island

SOUTH ISLAND

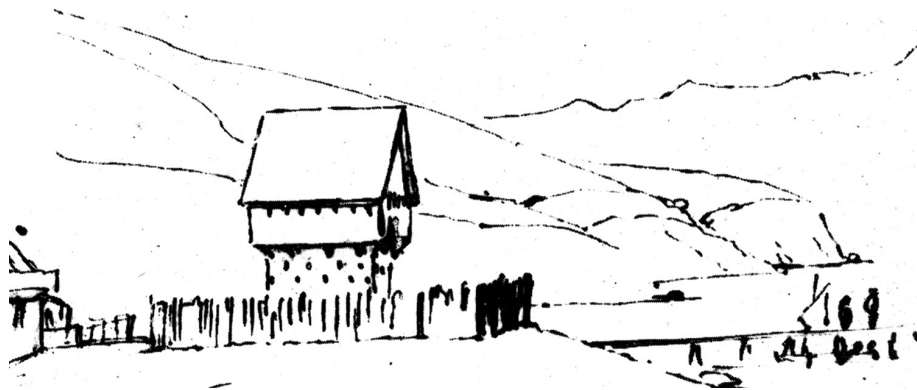
Figure 128. English Blockhouse, Akaroa, 1843. *W.B.D. Mantell sketch, in Hight & Straubel 1957: Fig. 14.*

A two-storey loopholed blockhouse, with the upper storey extending out from the lower, and surrounded by a rectangular stockade.

Under foreshore road and/or adjacent buildings; largely or completely destroyed.

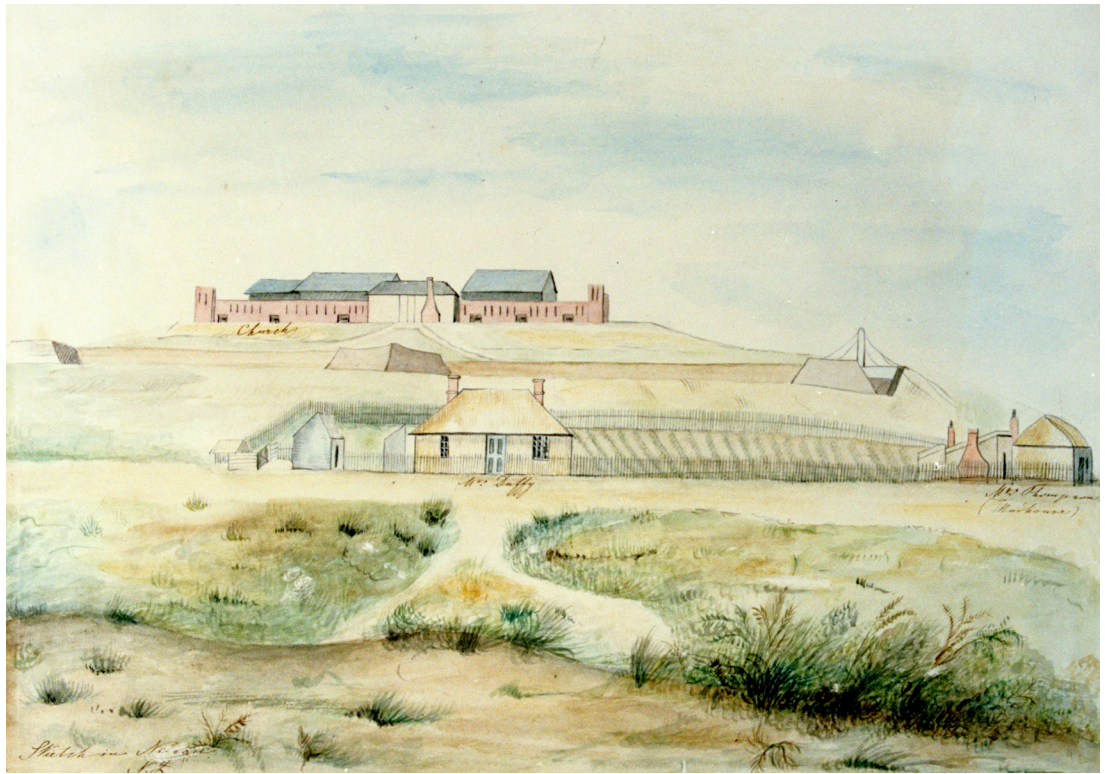
Figure 129. Fort Arthur, Nelson, 1845. 'Sketch in Nelson, N.Z.', Miss Longueville, Nelson Provincial Museum, Bett Loan Collection, AC844.

An initial timber and earthwork fort was later altered to a five-sided, bastioned earthwork at the top of the hill, enclosing more than an acre (.4 ha) of ground. Within the earthwork, a 47.5 × 15 m stockade was loopholed for muskets, with artillery comprising 18-pounder carronades (a type of mortar).

A bronze plaque marks the remains of an earthwork bastion a few metres from the cathedral's main door; other subsurface earthworks may survive in the gardens. Any remains of the stockade inside the earthworks were probably destroyed when the top of the hill was cut down for the cathedral.

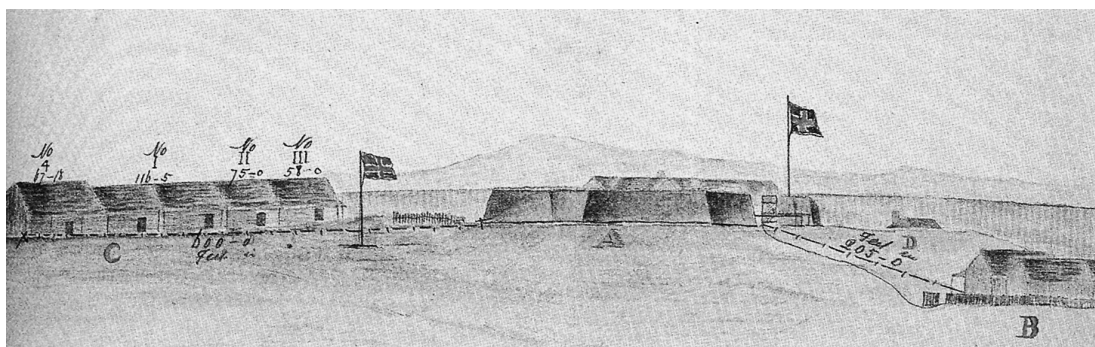
Figure 130. Waitangi Redoubt, Chatham Island. *Papers relating to Maori Prisoners of War and their guards on the Chatham Islands, Archives New Zealand, The Department of Internal Affairs Te Tari Taiwhenua, AD 31 3/15.*

Contemporary pictures show a rectangular work, c. 35 × 20 m, with sod walls and bastions at the northeast and southwest angles covering all sides. Largely filled with ponga and flax buildings. Contained a square magazine in the central courtyard (see also Cowan 1983 II: 227).

Present condition not known.
