# CONCESSION APPLICATION

Waka Kotahi NZ Transport Agency  
Homer Tunnel Avalanche & Rockfall Protection Structure and  
Associated Works

State Highway 94 and Fiordland National Park

3 JUNE 2022

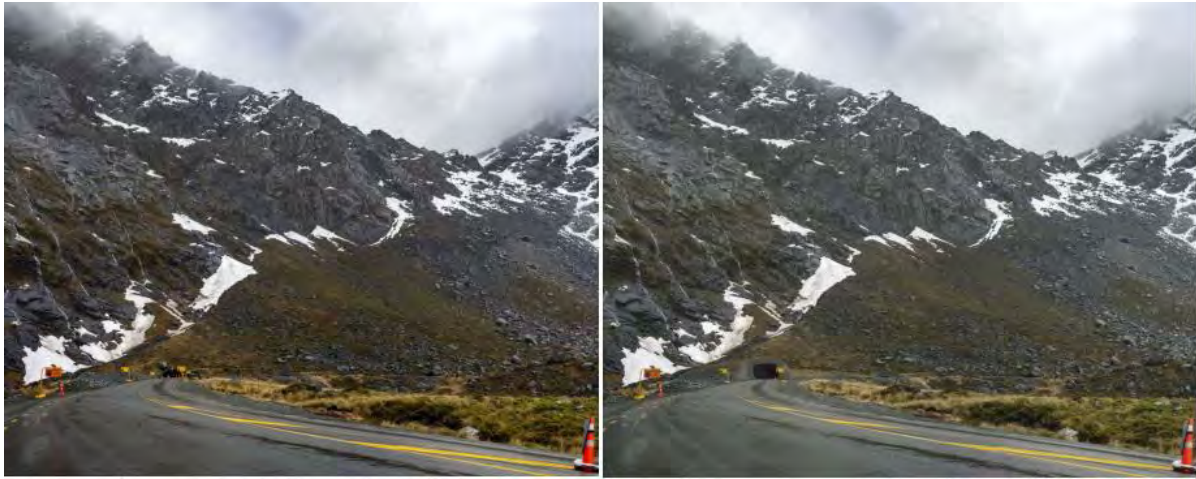
*Figure 8-1 Viewpoint 1 - Existing Protection Structure Left & Proposed Protection Structure Right*

Due to the increased length of the proposed structure, the new structure will appear 45m (based on an 80m structure) closer to the viewer at this point and thus, the full extent of the replacement structure will be the most obvious change. Notwithstanding this, the degree of visual effect will be reduced by a combination of distance and the large scale of the enclosing alpine landscape, and the limited number of motorists stopped at this particular viewpoint who have a line of sight. Additionally, the use of colour, texture and pattern in the concrete of the entrance façade will assist in blending in with the landscape.

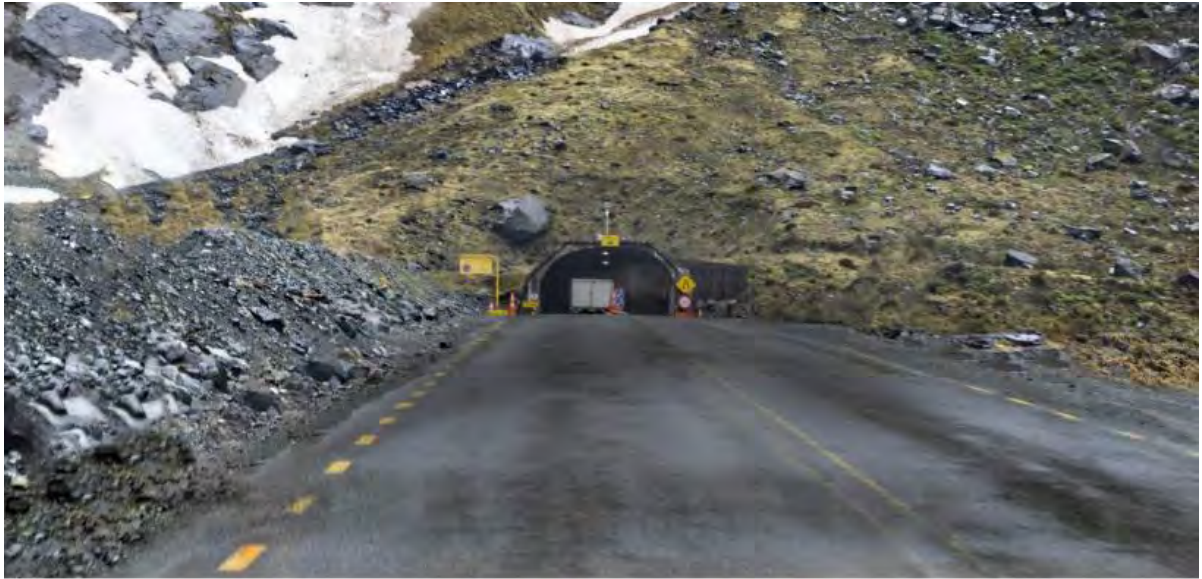
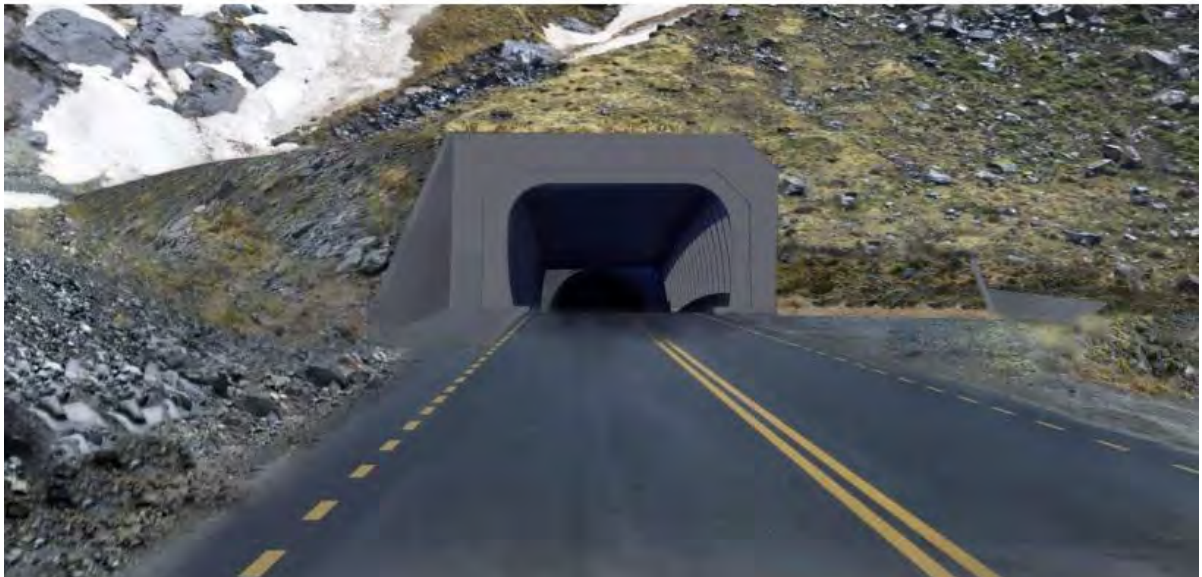
*Figure 8-2 Viewpoint 2 - Existing Protection Structure Top & Proposed Protection Structure Bottom*

Similarly, to Viewpoint 1, the new structure will create a distinct change in the landscape as it extends beyond the existing avalanche shelter. However, given the closer proximity of Viewpoint 2, the adverse visual effects will be greater. There are however, several positive attributes that will contribute to the motorist's overall view that act as mitigating factors to a visually larger structure. The experience of descending into a primeval void that is dark and long, carved out of native rock is not found anywhere else on the New Zealand highway network and is a highlight of travelling on the Milford Road, which is an experience in its own right. Further, the large scale of the enclosing alpine landscape, the viewer being in motion and therefore the short duration of the view all act to reduce the visual effects to an acceptable level at Viewpoint 2.

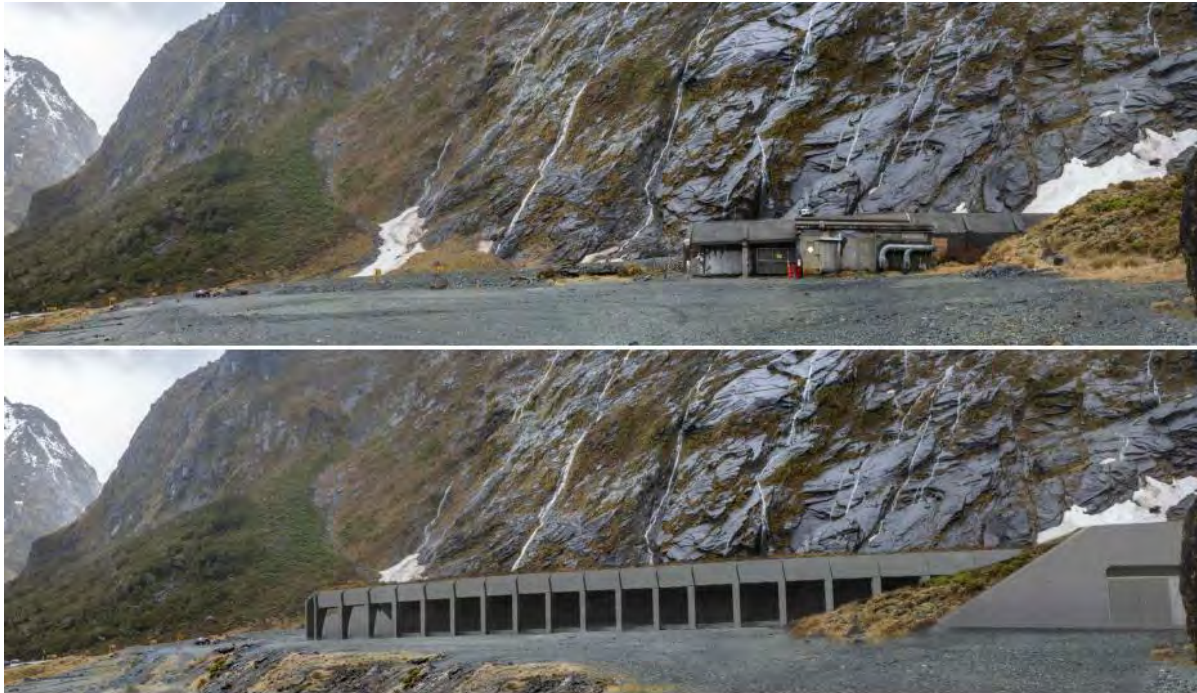
*Figure 8-3 Viewpoint 5 - Existing Protection Structure Top & Proposed Protection Structure Bottom*

Viewpoint 5 (refer Figure 8-3) is formed from the northwest aspect of the closed carpark from a point on the informal track leading up the Homer Saddle. The extent of the structure, its section pillars and openings that make up the northern wall of the shelter will be obvious.

The northern façade has been designed as 'open' which will assist in breaking up the visual bulk of the shelter, while the use of sympathetic and local colour tones, texturing and patterns in the concrete of the beams and pillars will assist in absorbing the structure into the landscape while creating visual interest. Removal of the carpark 'plateau' area will also

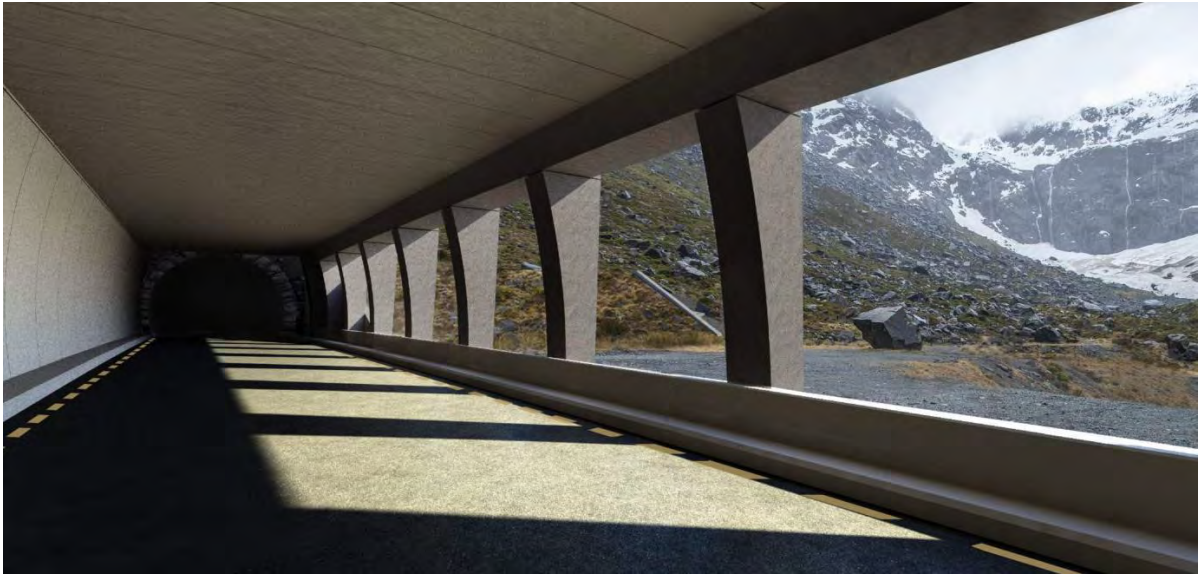
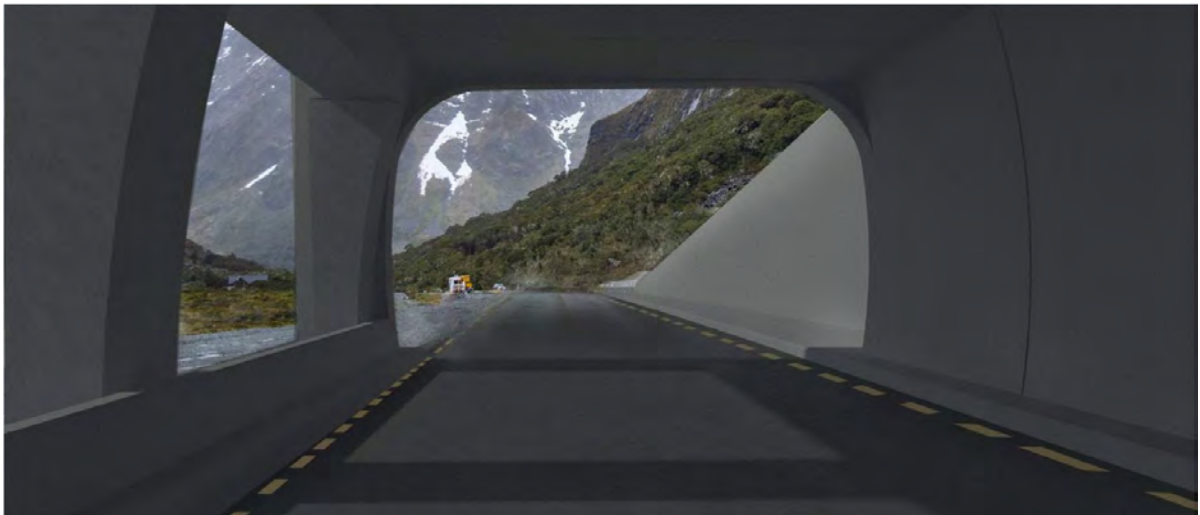
*Figure 8-4 Proposed Protection Structure at Viewpoint 3 Top & Viewpoint 4 Bottom*

Viewpoints 3 and 4 (refer Figure 8-4) are from entering the shelter toward the tunnel and exiting the shelter toward the Hollyford Valley respectively.

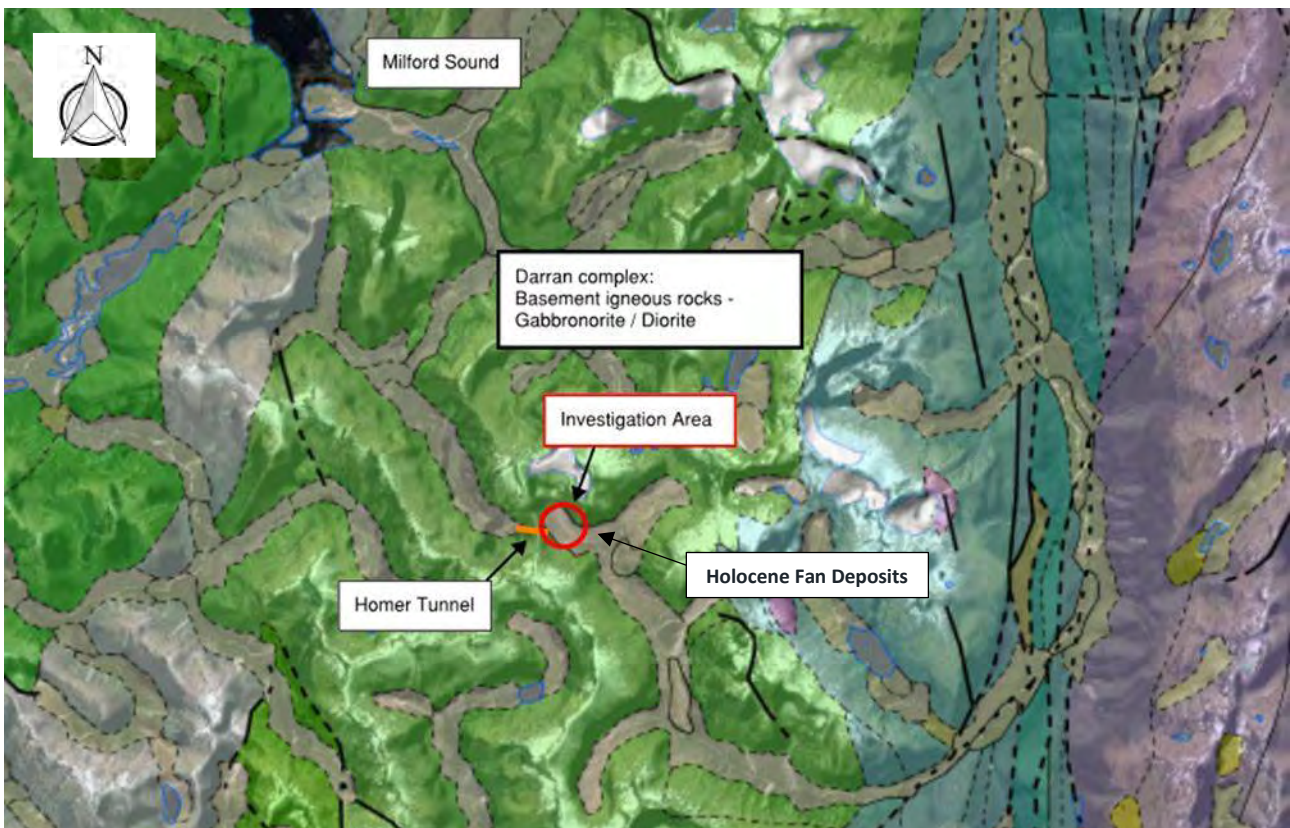
Figure 3: Geological Map of the area (GNS Geological Webmap extract)

The Institute of Geological and Nuclear Sciences Geological Web Map indicates that much of the site is situated on Holocene fan deposits comprising angular boulders, gravel, sand and silt. These include debris flow and avalanche deposits, refer to Figure 3.

The dominant rock type at the Homer Tunnel is an un-weathered biotite leucogabbro. This is dissected by south-west oriented intrusive pegmatite veins and diorite dykes which reflect past tectonic stresses. Hydrothermal veins within these volcanic rocks have introduced minerals of varying geochemistry, which have subsequently been eroded and weathered.

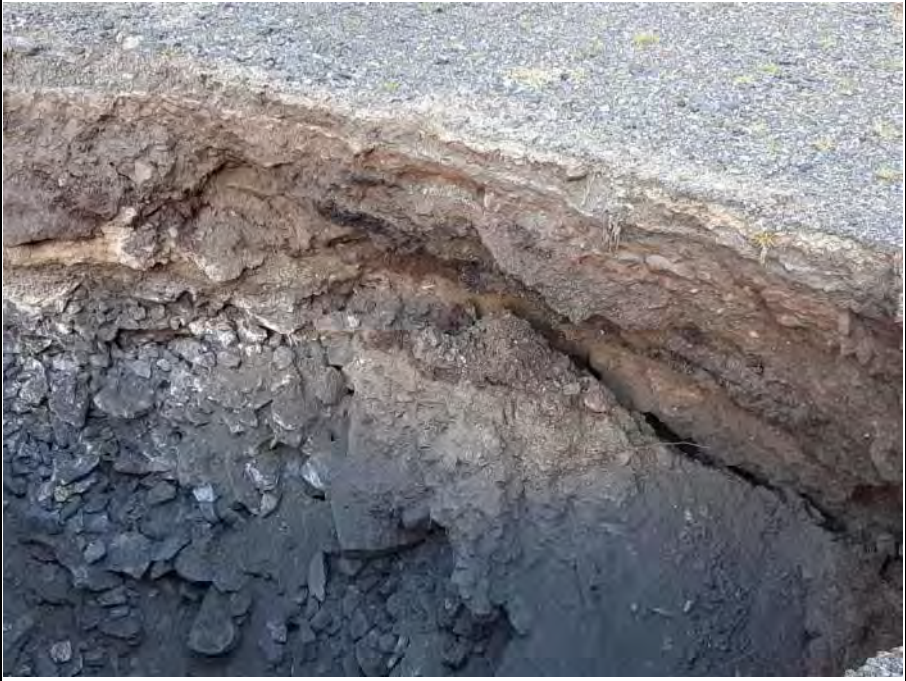
<b>Description</b> TP02, asphalt can be seen within the side wall of the pit that has been historically buried.

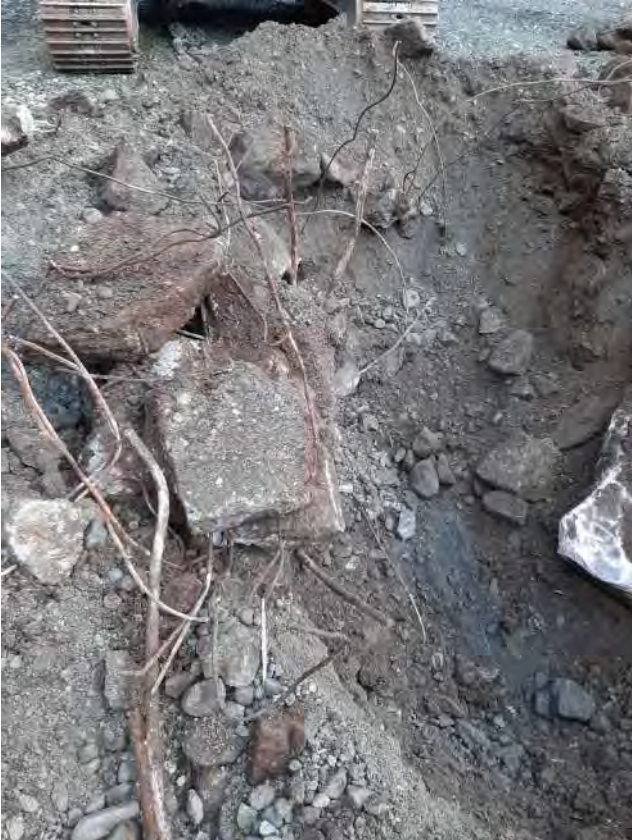
5	12 April 2022	
<b>Description</b> TP03, showing remnants of the destroyed avalanche shelter.

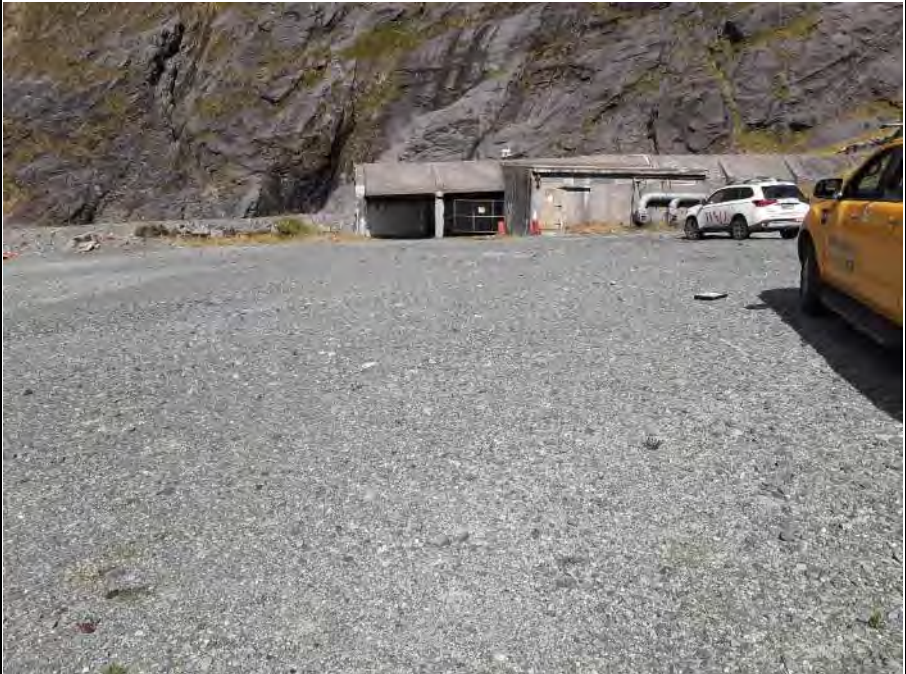
<b>Description</b> The existing portal structure proposed to be demolished.

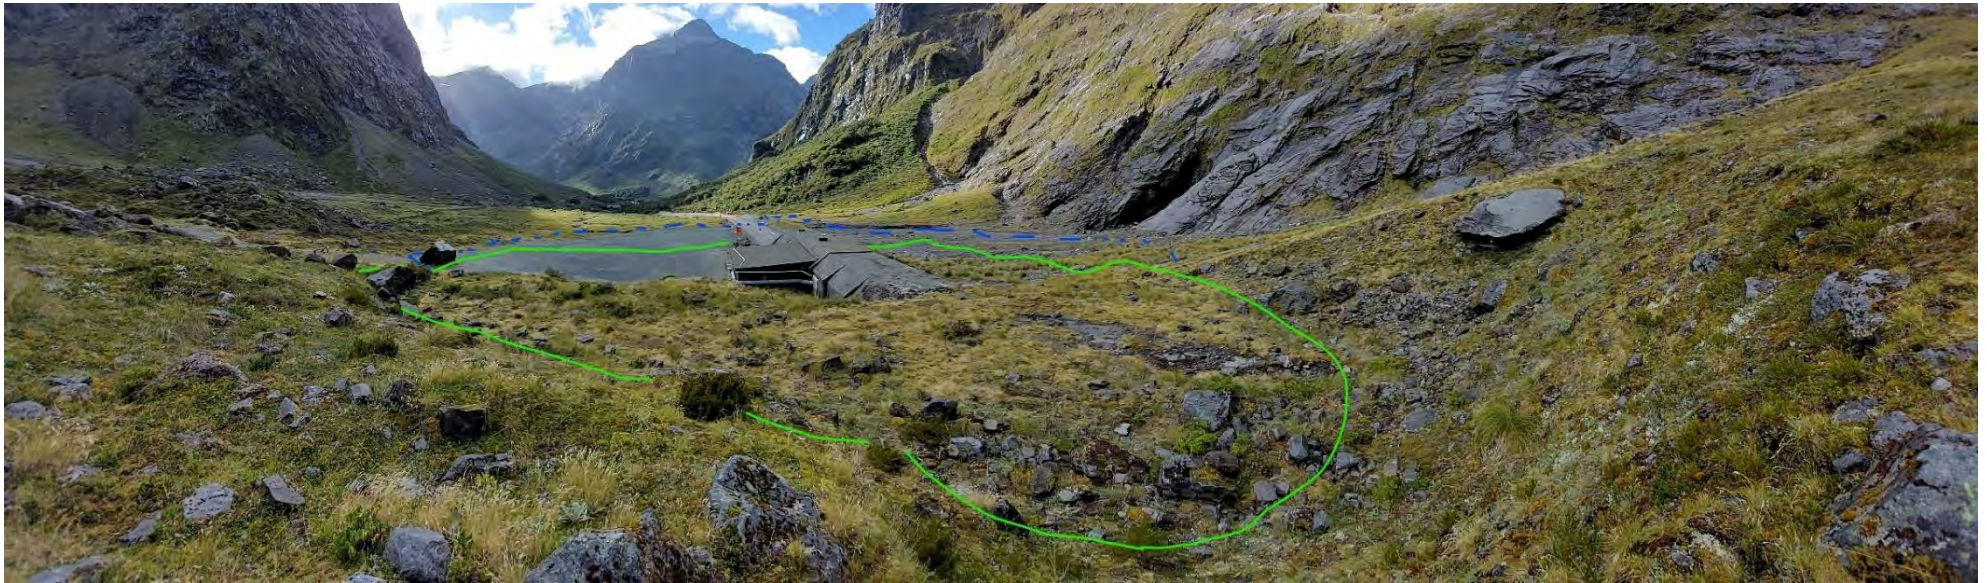
**Photo 1.** View of the footprints of Phases 1 and 2 SH94 Homer Tunnel Avalanche Shelter Project from the west. The approximate margins of Phase 1 are shown by the solid green line and Phase 2 by the dashed blue line.

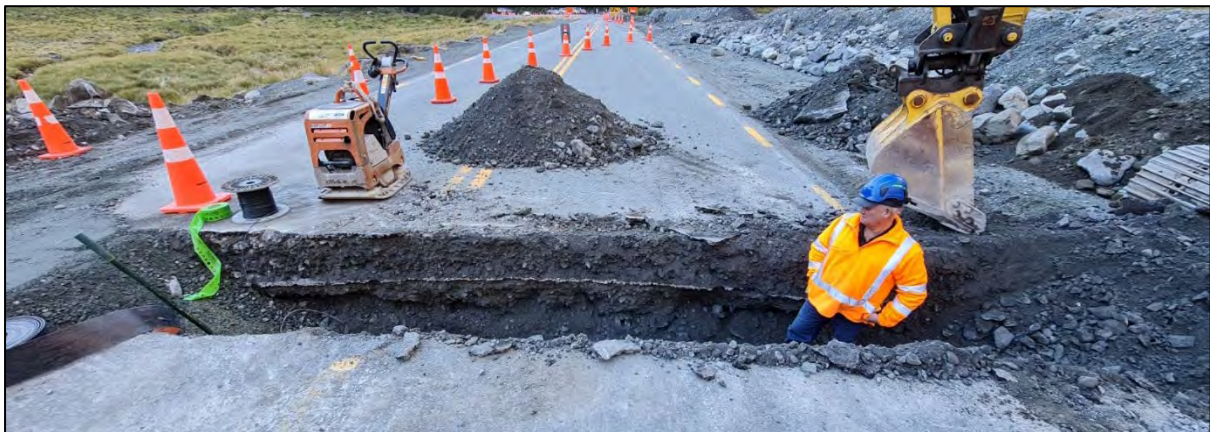
Figure 20. Trenching across the road during the Phase 1 work, looking east.

The first layer is the current road surface (20-30mm), followed by the mix of gravel and loose stones for about 47-500mm, no archaeological material was discovered in this layer. The third layer is the older road surface about 2cm thick then followed by about 50mm of gravel and loose stones, this layer contained a few elongated metal fragments that may have been the remains of either drill bits or reinforcing bars from the former avalanche shelter. The fourth layer and the base of the trench was made of concrete and is likely the remains of the previous structure. Approximately 100mm of concrete was exposed. The excavation also

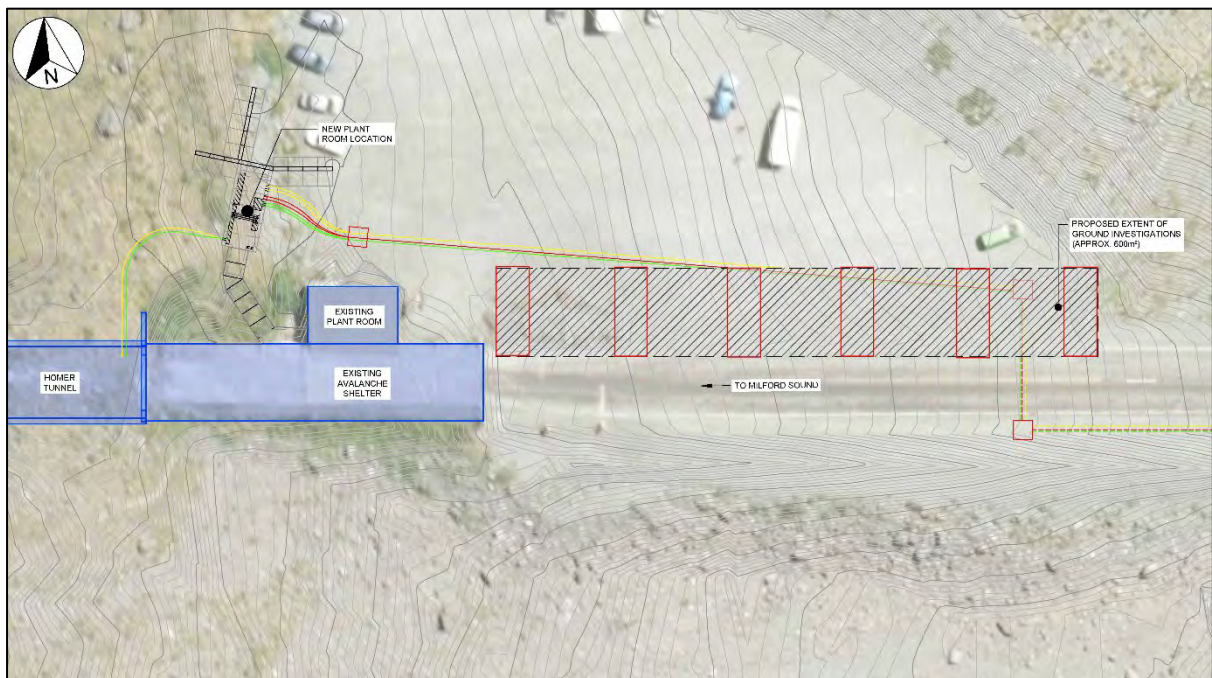
Figure 28. Design drawing showing the proposed exploratory excavation area (hatched in black, not to scale).<sup>60</sup>

There is also the option to expand these excavations to a larger, approx.600m<sup>2</sup> area (black hatched area, Figure 28) to full investigate any ground conditions or avalanche shelter that might be encountered.

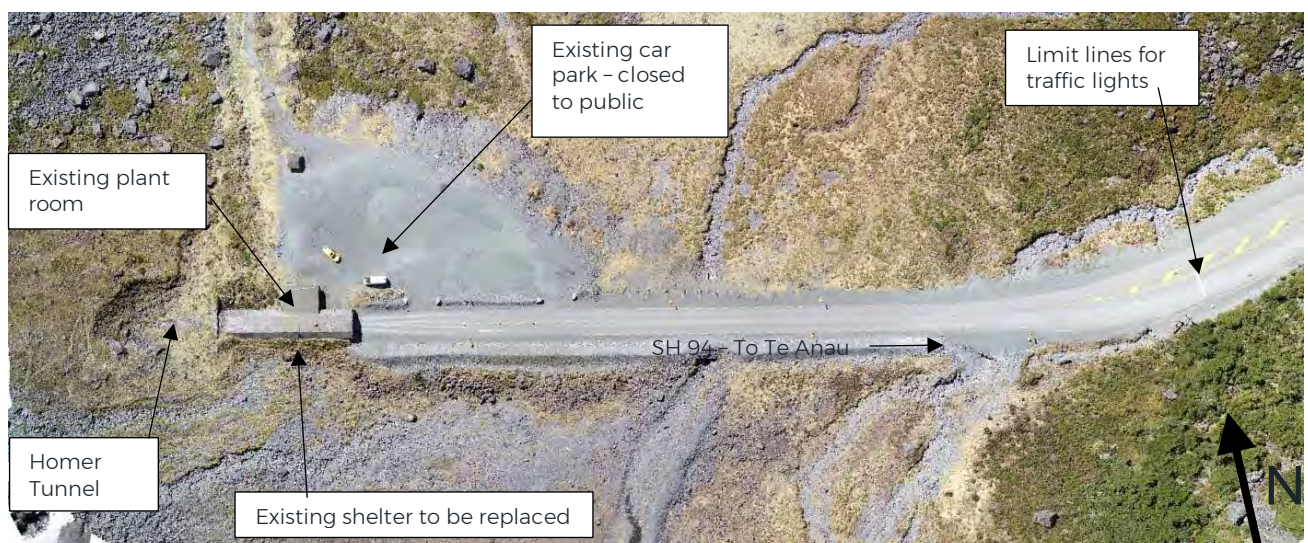
*The stretch of road in the hazard zone of the East Homer avalanche track extends from the tunnel portal to near to the limit lines for the traffic lights on the eastern approach (see Figure 3-1)*

Figure 3-1: Plan showing eastern approach to Homer Tunnel

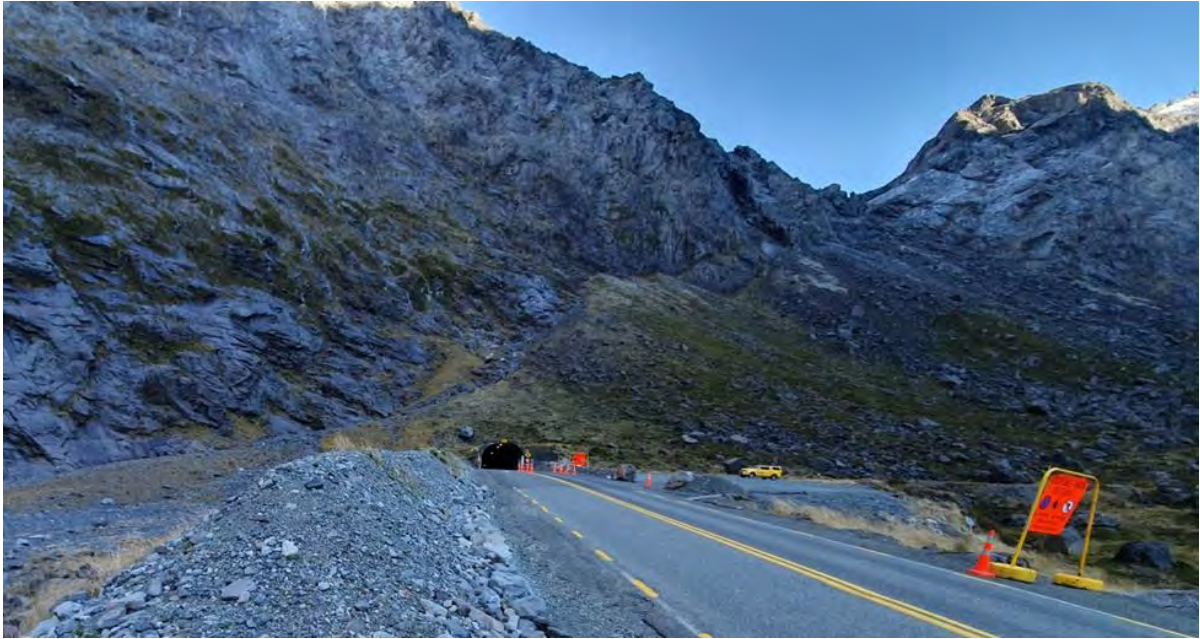
*Figure 3-3: Approaching the eastern portal and the existing avalanche shelter, with the dark coloured concrete, existing plant room immediately to the right of the tunnel entrance. There are earth bunds either side of the carriageway. On the left side, the bund provides rockfall protection and the bund on the right side prevents access to the now-closed car park*

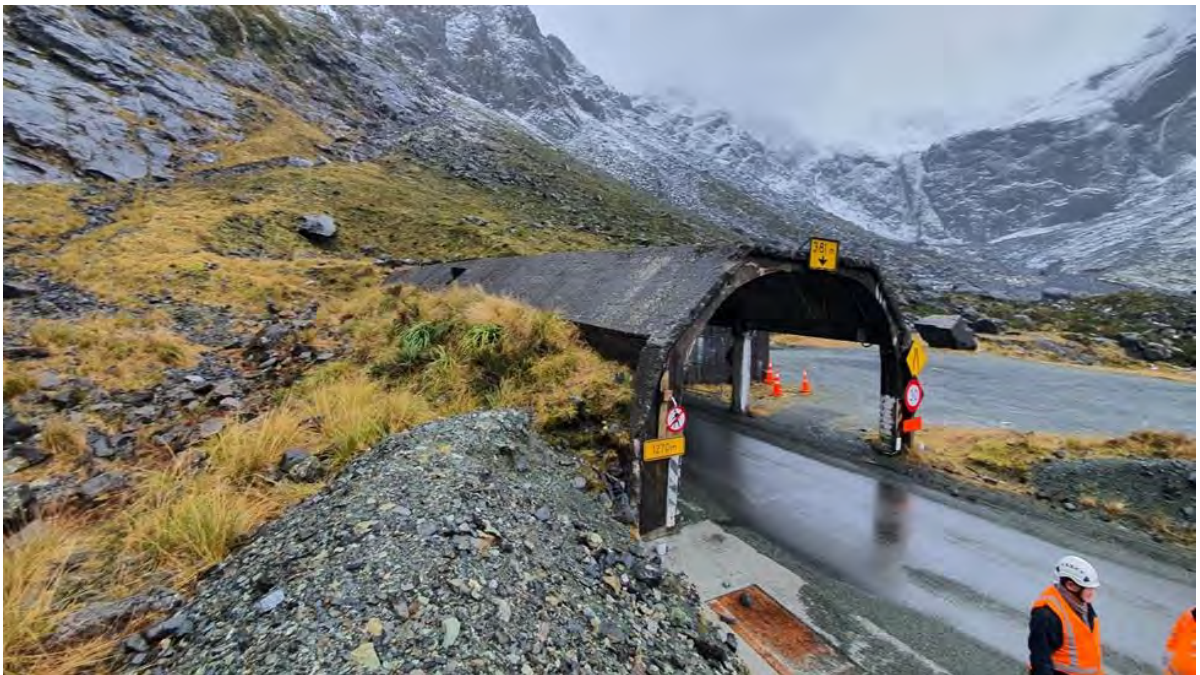
*Figure 3-4: View of existing avalanche shelter entrance*

As can be seen in Figures 3-4 to 3-7, the concrete of the existing avalanche shelter is weathered and quite dark in colour; presumably as the aggregate for the concrete was won from locally occurring rock and gravels. As the sections of the replacement avalanche shelter will be pre-cast at a site outside the national park, all the exposed concrete work will be pigmented to an equivalent dark colour.

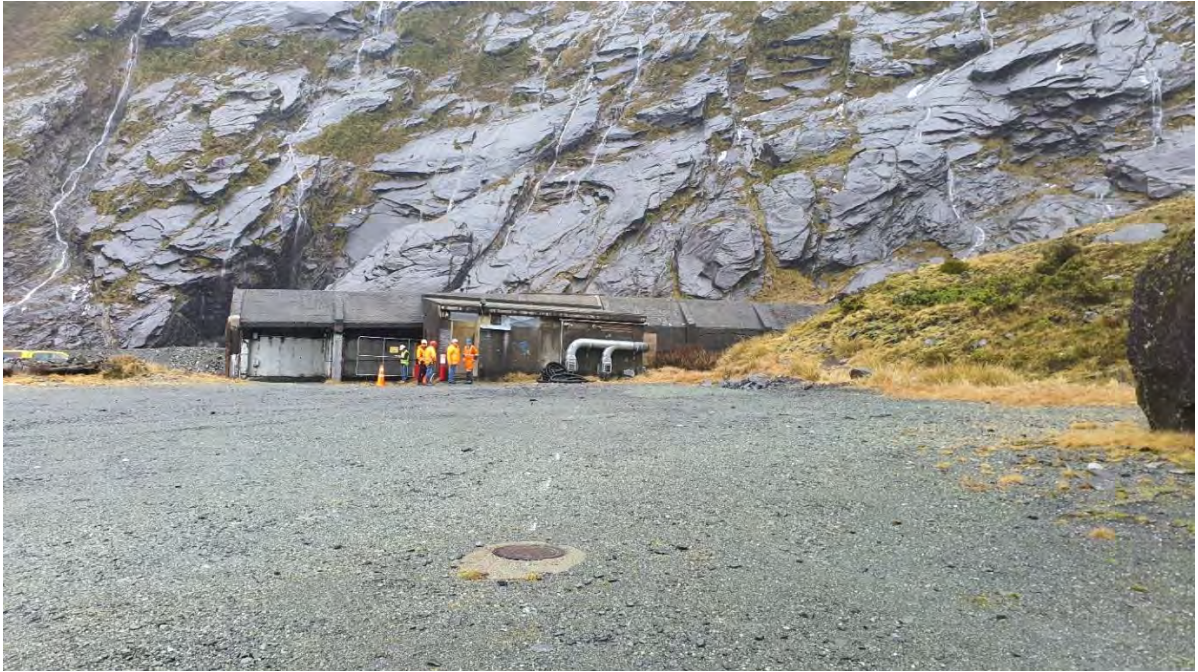
Figure 3-5: Existing avalanche shelter, plant room and talus slope viewed from car park

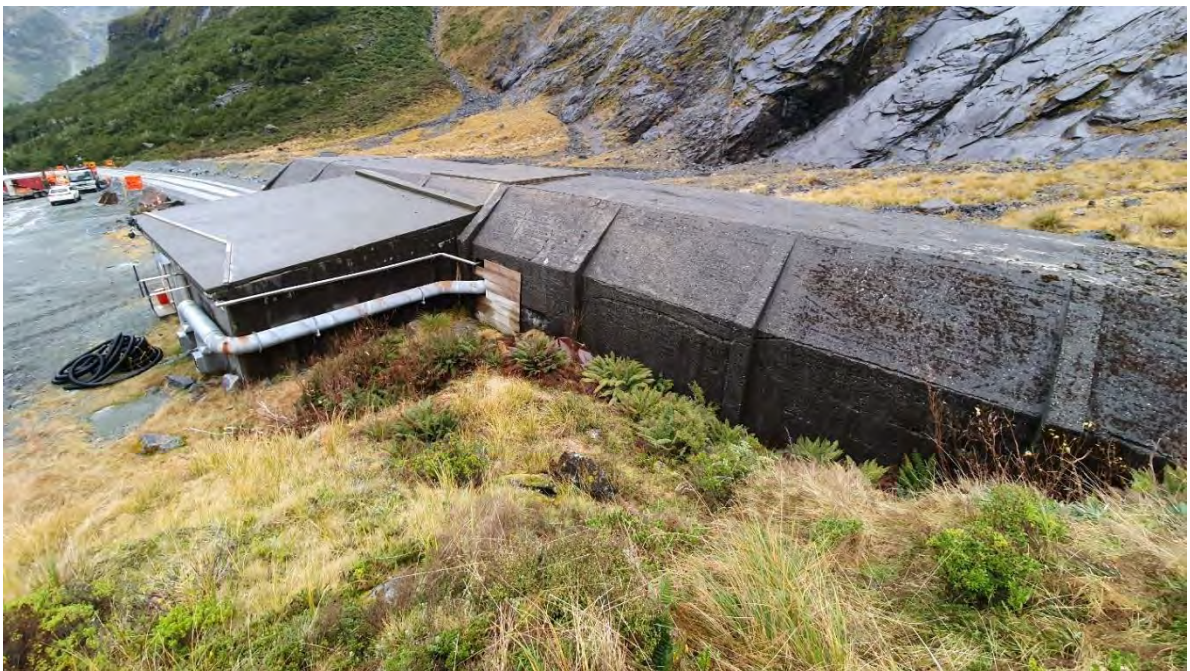
Figure 3-6: Existing avalanche shelter and plant room viewed from talus slope above

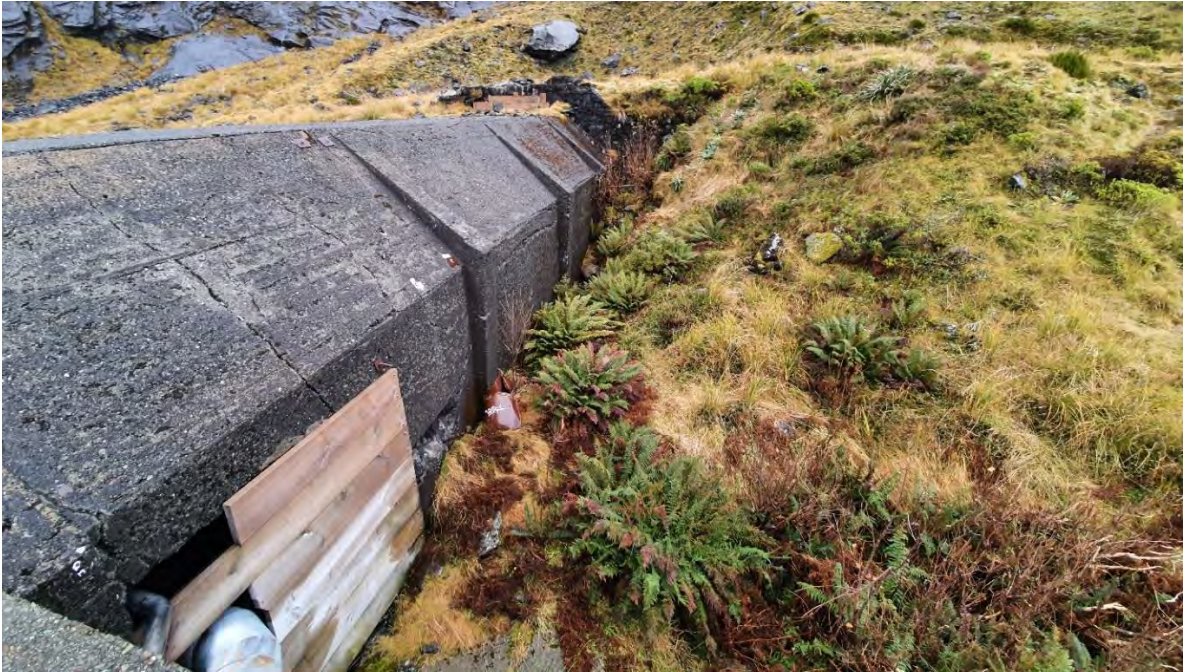
Figure 3-7: Existing avalanche shelter viewed from above existing plant room looking towards stone-faced wingwall at portal entrance

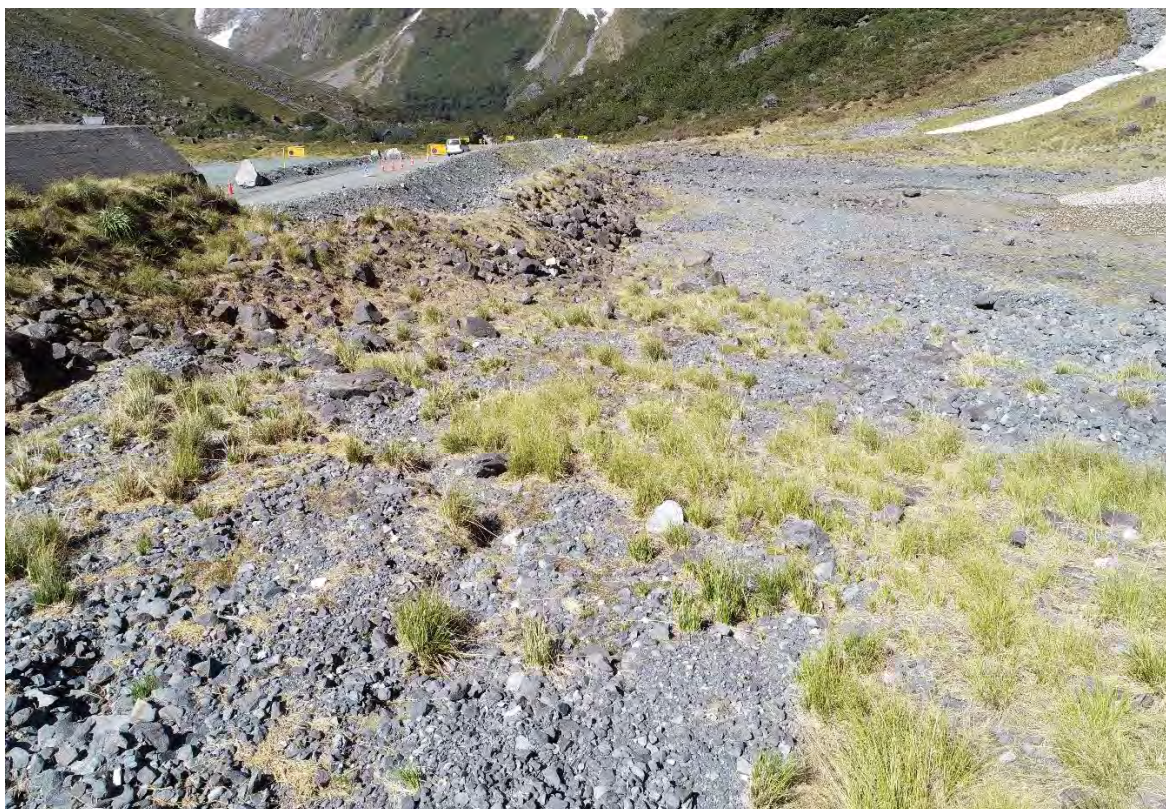
*Figure 7-1: Existing vegetation and both lichen-covered rocks and fresh rocks and gravel avalanche and waterborne debris on south side of the existing avalanche shelter.*

Figure 7-1 is typical of the vegetation and mixed rock cover on the talus slope to the immediate south of the existing avalanche shelter, an area that is frequently impacted by avalanches during the avalanche season. This area has naturally revegetated since the original construction of the tunnel. The localised presence of vegetation along the embankment on the flank of the existing shelter is likely attributable to snow drift accumulation during the winter months providing protection to the scouring effects of subsequent avalanches. This is not the case relative to the more expansive valley floor to the east away from the shelter, which is also impacted by surface water runoff. Figure 3.1 also shows this difference of vegetation cover in an aerial view.

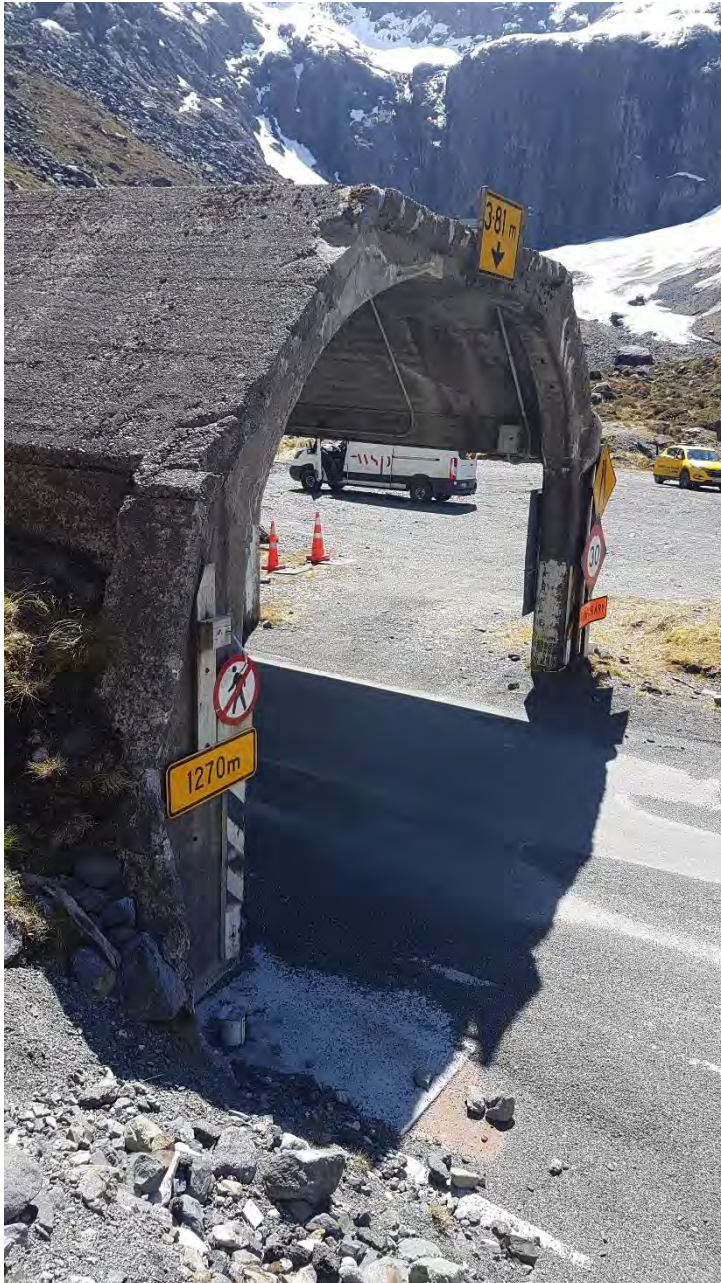
Figure 8-1 approximates the 'Existing Situation' photo for Viewpoint 3 and is somewhat dated in that there are no longer traffic lights at the entrance to the existing avalanche shelter nor are vehicles allowed to park close to the tunnel. However, the structure remains as shown in this photo with two openings in the north wall of the shelter. Beyond this into what the public would consider 'the mouth of the tunnel', the shelter is enclosed on both sides.

Figure 8-1: Homer Tunnel existing avalanche shelter road entrance

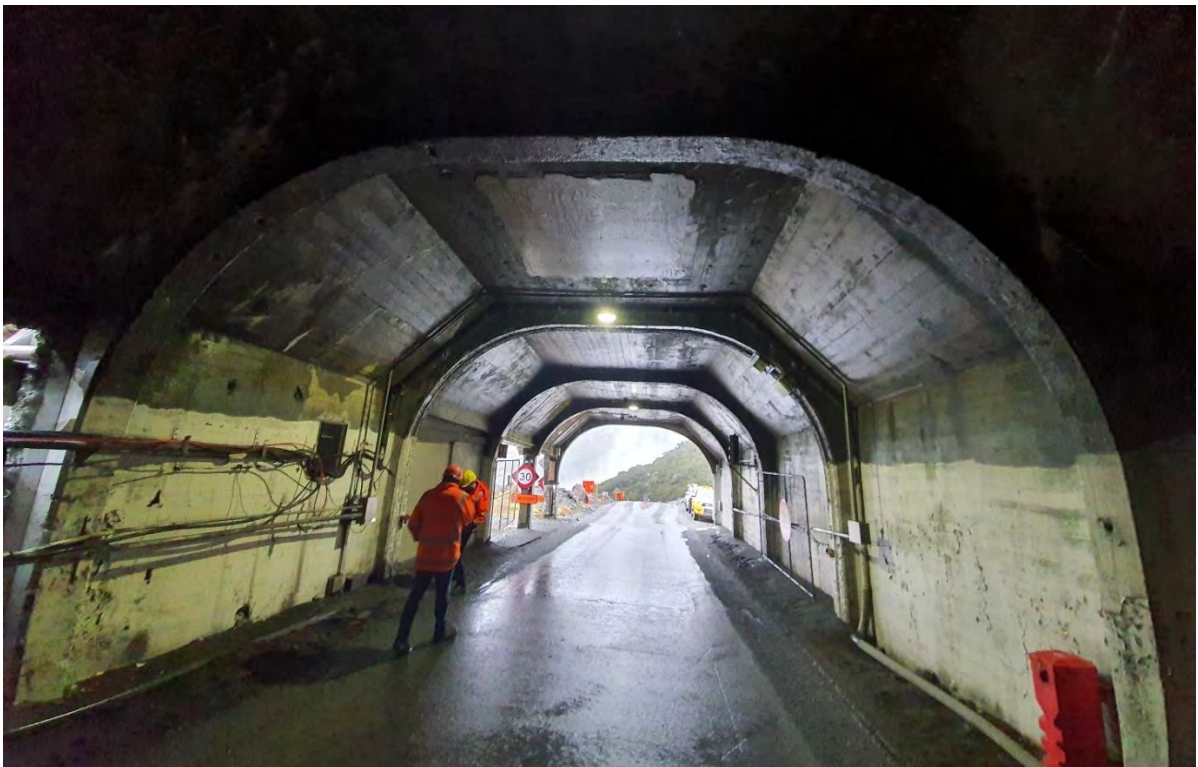
Figure 8-2 approximates the 'Existing Situation' photo for Viewpoint 4 and shows the view from within the inner section of the existing avalanche shelter looking out to the short, flat section of SH94 that is the eastern approach to the tunnel with the Hollyford Valley visible beyond. On the immediate left there is a small opening in the shelter wall containing ducting, followed by two sections of solid wall that relate to the existing plant room followed two openings in the north wall of the shelter. The latter allows for glimpses of the Upper Hollyford Valley as the motorists exit the tunnel.

Figure 8-2: Homer Tunnel existing avalanche shelter road entrance as seen from within the shelter.

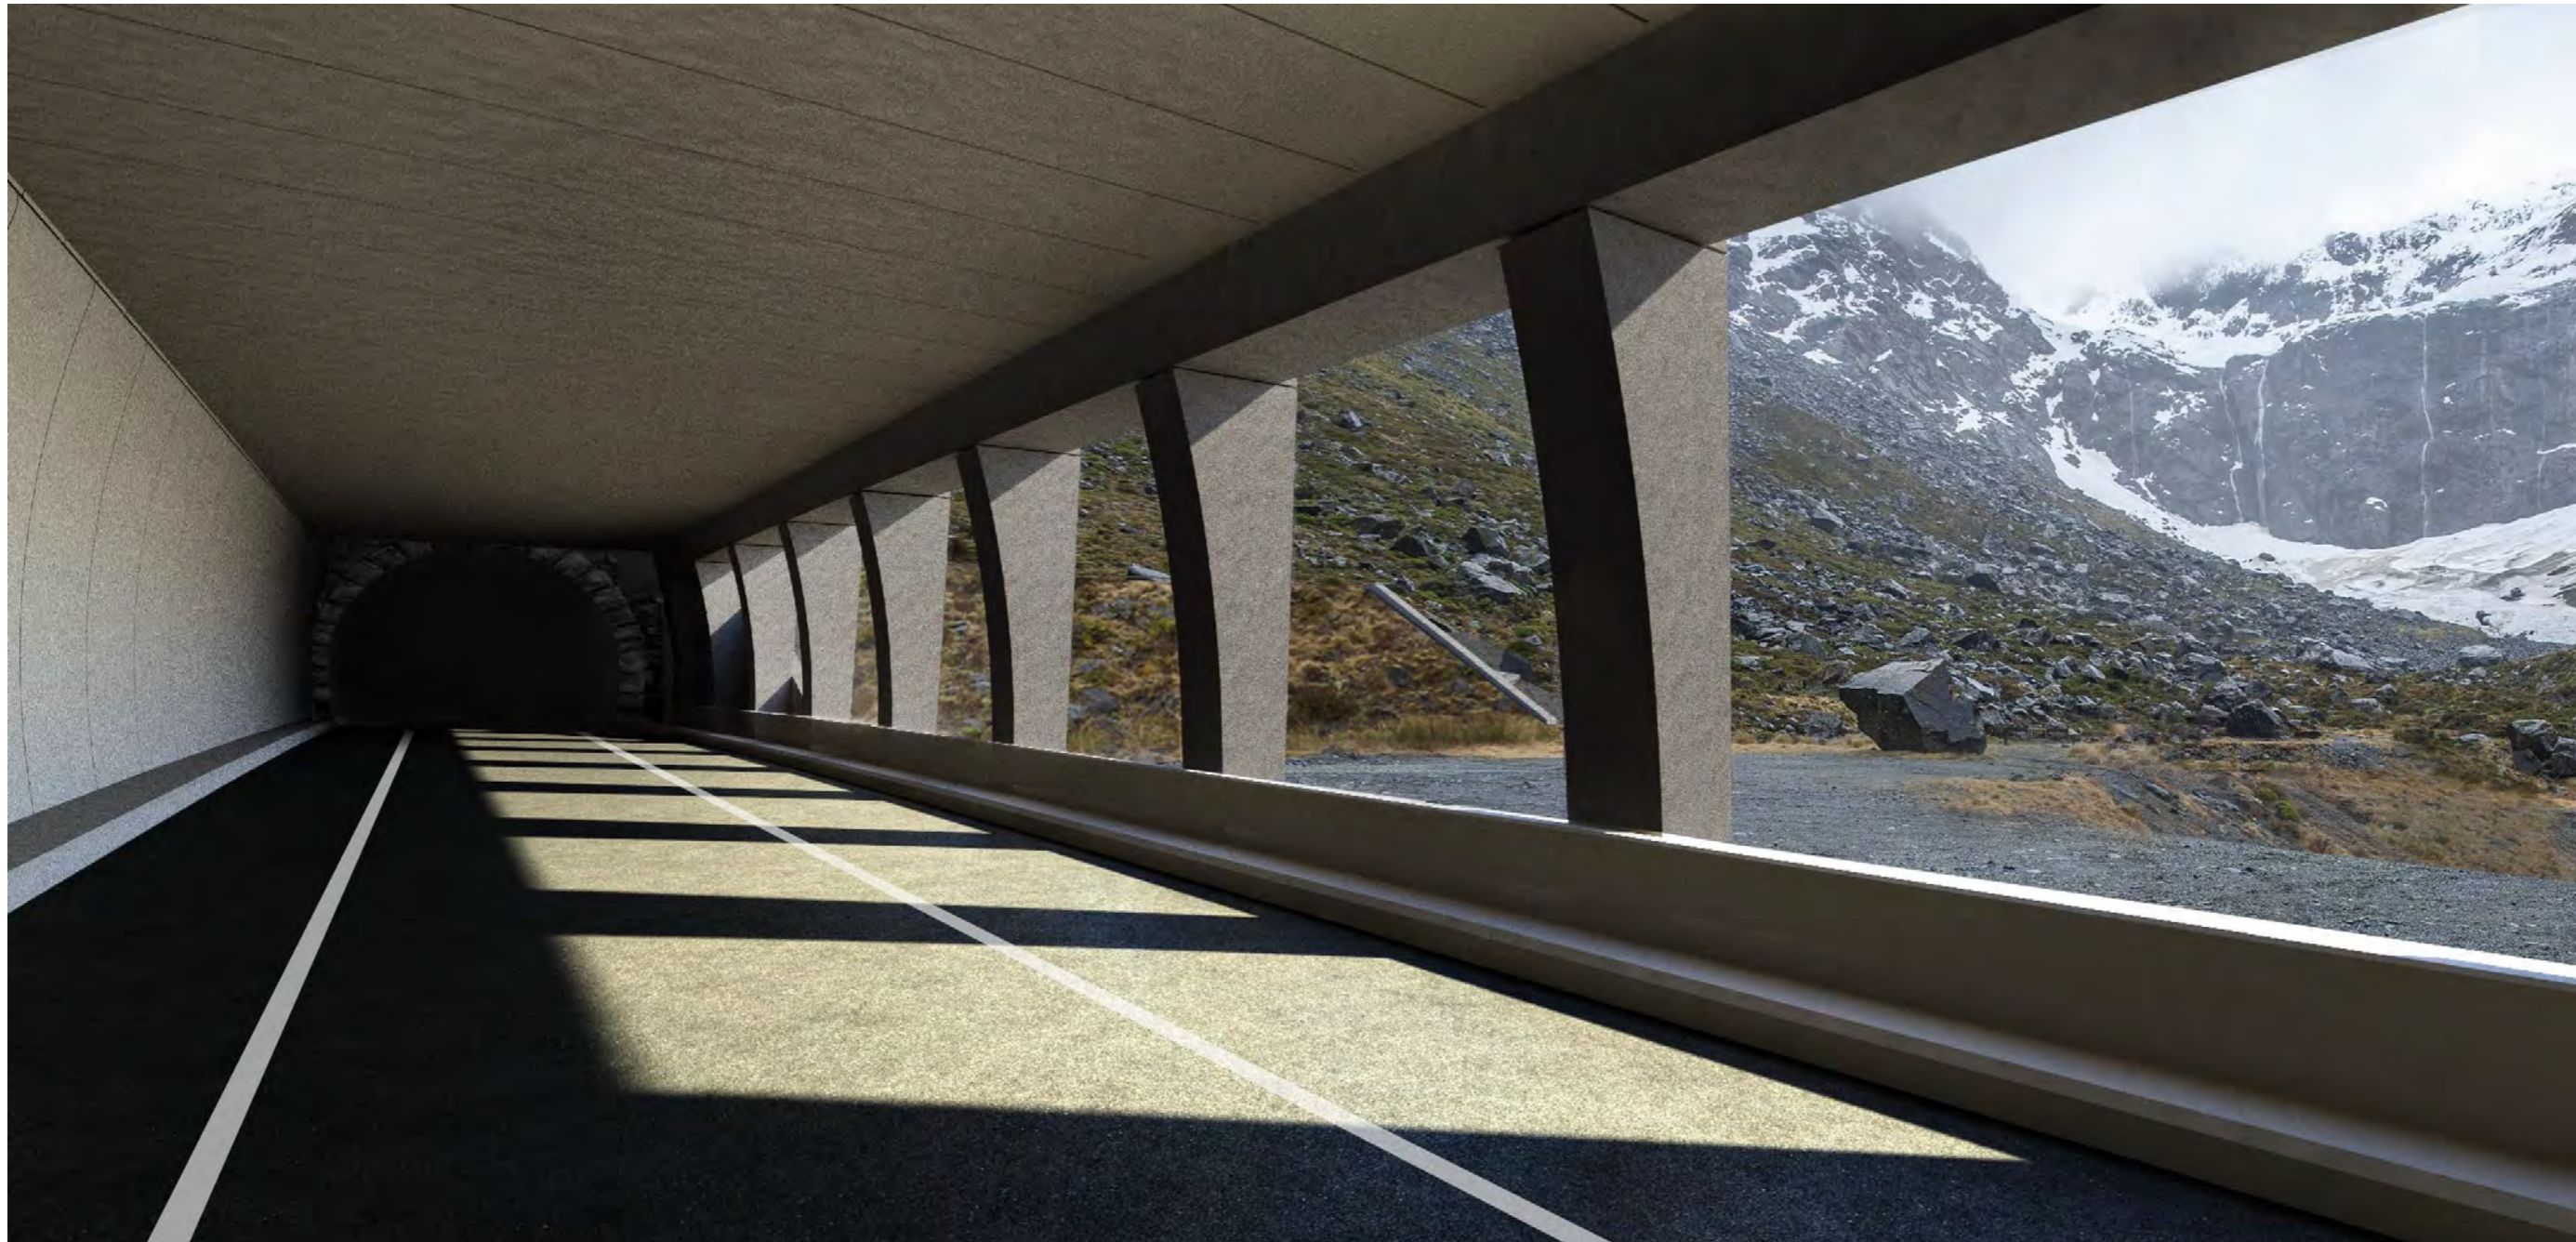
ATTACHMENT 1 | VIEWPOINT 3 | ENTERING SHELTER TOWARD TUNNEL

The 'Project Completed' image for Viewpoint 3 is based on a computer model of what would be seen driving through and looking out through the openings in the north wall of the replacement avalanche shelter towards the Homer Saddle and the head of the Hollyford Valley. These openings are the inner seven of a potential total of sixteen in the north wall of the proposed shelter. This will be a transient view as the motorist is about to descend into the tunnel with the openings and their pillars flicking past.
