# CONCESSION APPLICATION

Waka Kotahi NZ Transport Agency  
Homer Tunnel Avalanche & Rockfall Protection Structure and  
Associated Works

State Highway 94 and Fiordland National Park

3 JUNE 2022

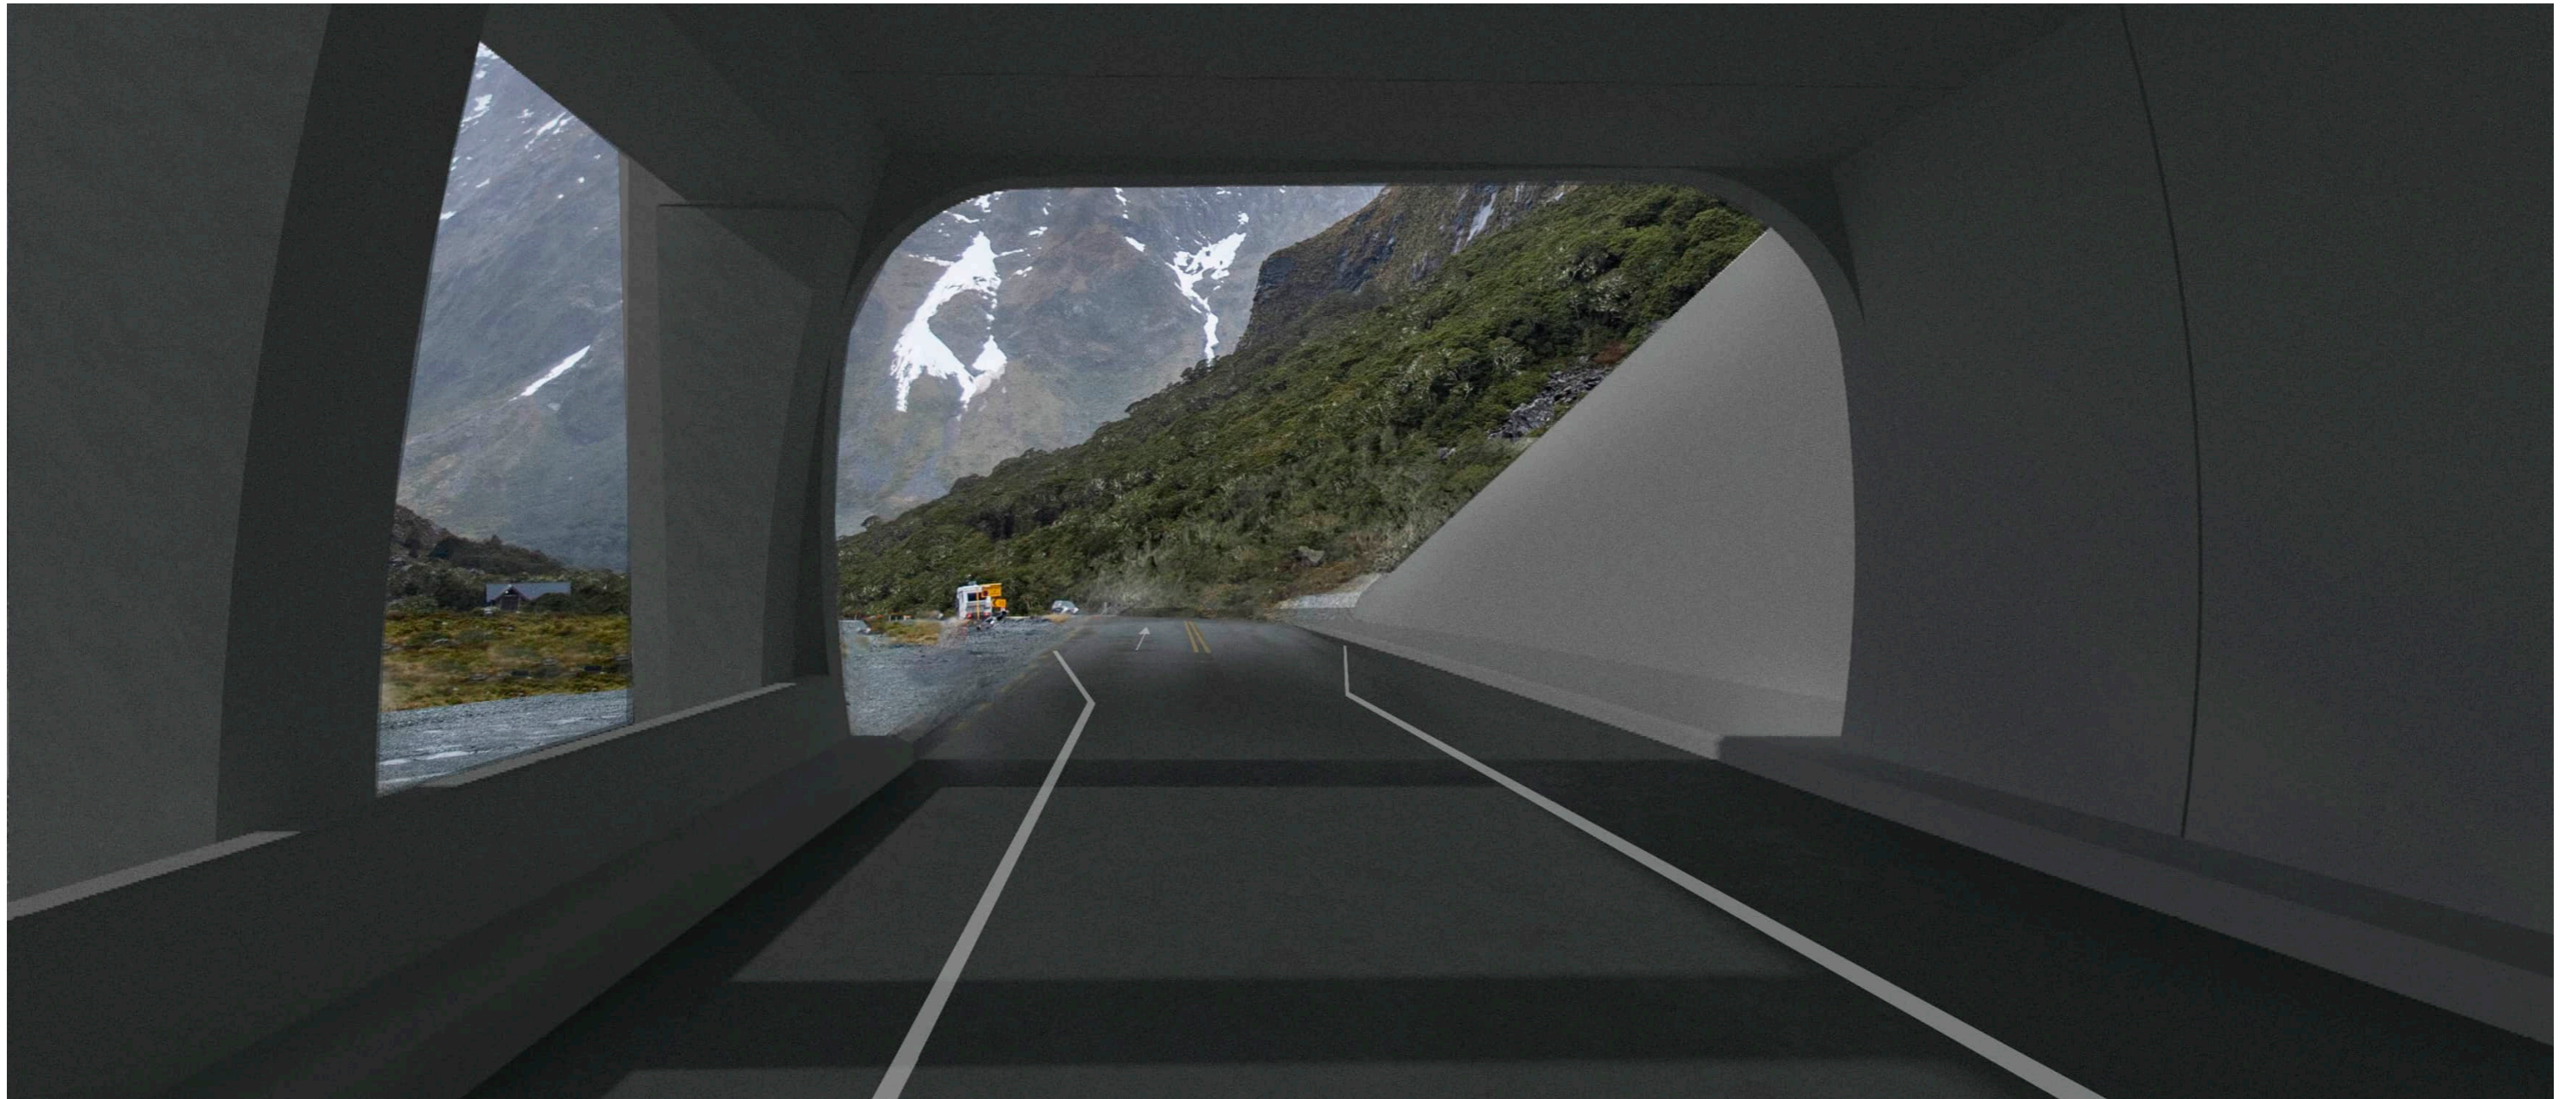
ATTACHMENT 1 | VIEWPOINT 4 | EXITING SHELTER TOWARD HOLLYFORD VALLEY

The 'Project Completed' image for Viewpoint 4 is also based on a computer model of what would be seen looking out through the final opening in the north wall of the replacement avalanche shelter and the shelter entrance towards the Hollyford Valley. This will be a transient view as the motorist is about to descend from the tunnel into the valley with a quick succession of openings and pillars flicking past.
