Applicant Information Form 1a Notified or Non-notified Process

CONSERVATION PLAN

Kilbride Homestead, Mason Bay, Stewart Island

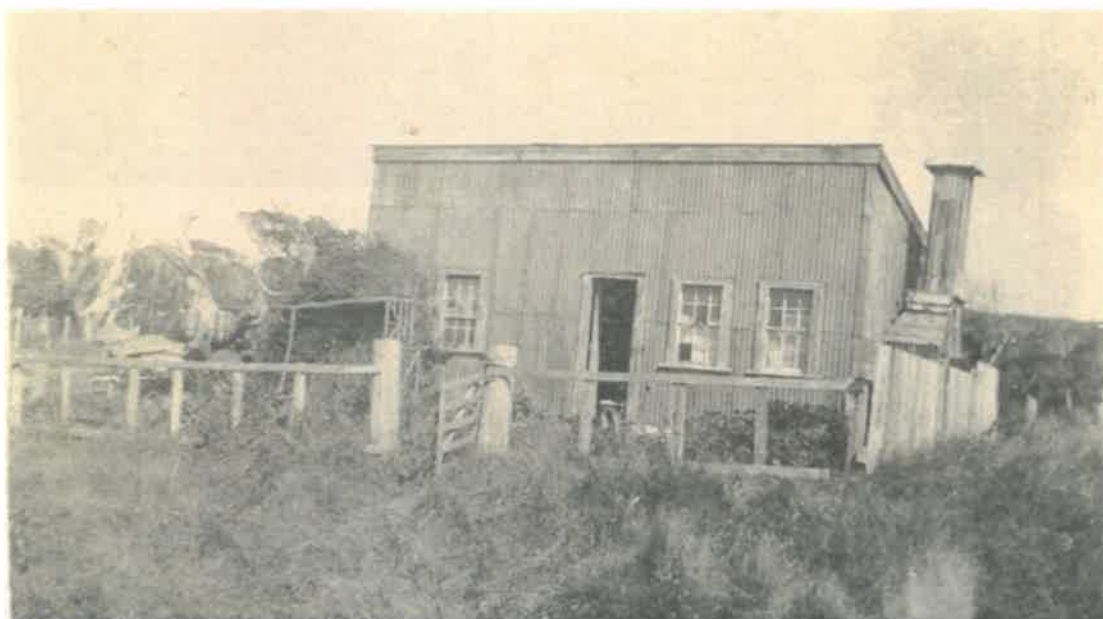
The second Kilbride Homestead in 1924, after the Leasks took over the run and before they built the present house. Note the multi-pane, double-hung sash windows, some of which may have been reused in the present house. (E.A. Willa, Stewart Island Museum)

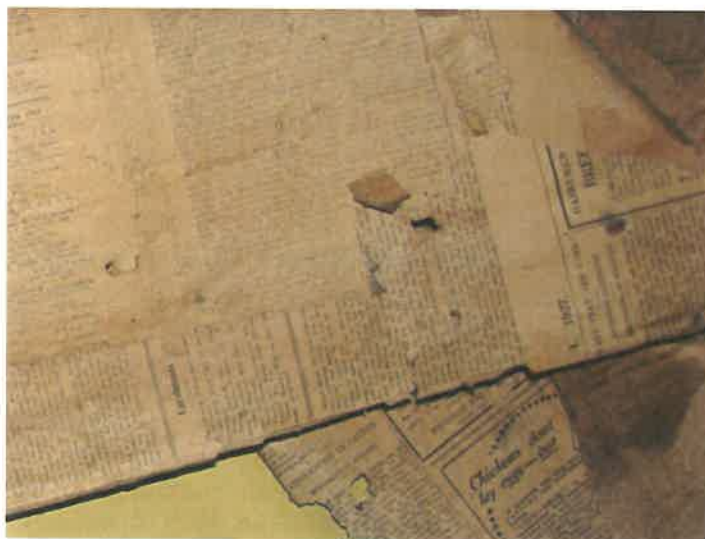
The newspapers used as lining behind the wallpaper are an unidentified paper of 1927 in the front bedroom and an *Otago Witness* of 16 January 1929 in the back bedroom; the presence of these papers in this situation strongly suggest the building was constructed in 1927 or shortly thereafter.

The weatherboards are lapped, in bungalow style, rather than rusticated (the latter being the favoured building cladding of the late 19th and early 20th centuries). The weatherboards are machine-cut but not bevel-backed; they were likely to have come from a mill, probably on the Island as this would have been the most accessible source of good timber.

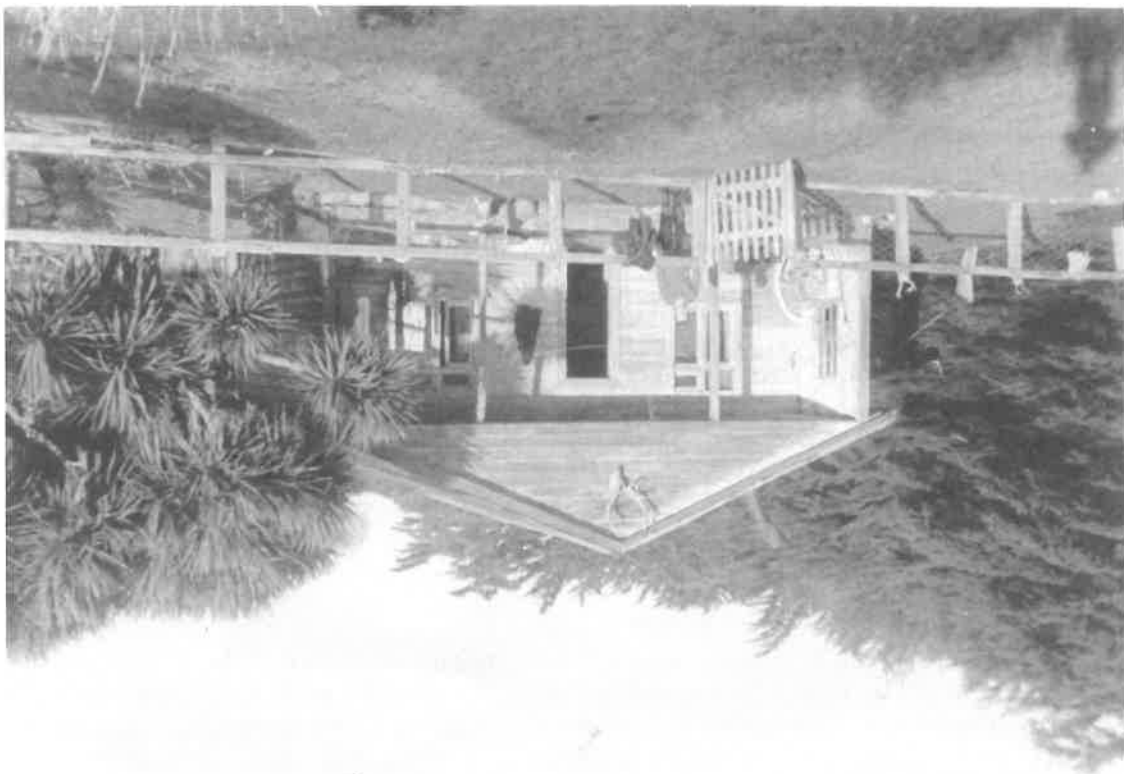
Kilbride Homestead in the 1960s. The cabbage tree to the left (now gone) was a small plant in the 1920s' image. Note the window in the verandah wall, later removed. (Joy Knowles Collection)

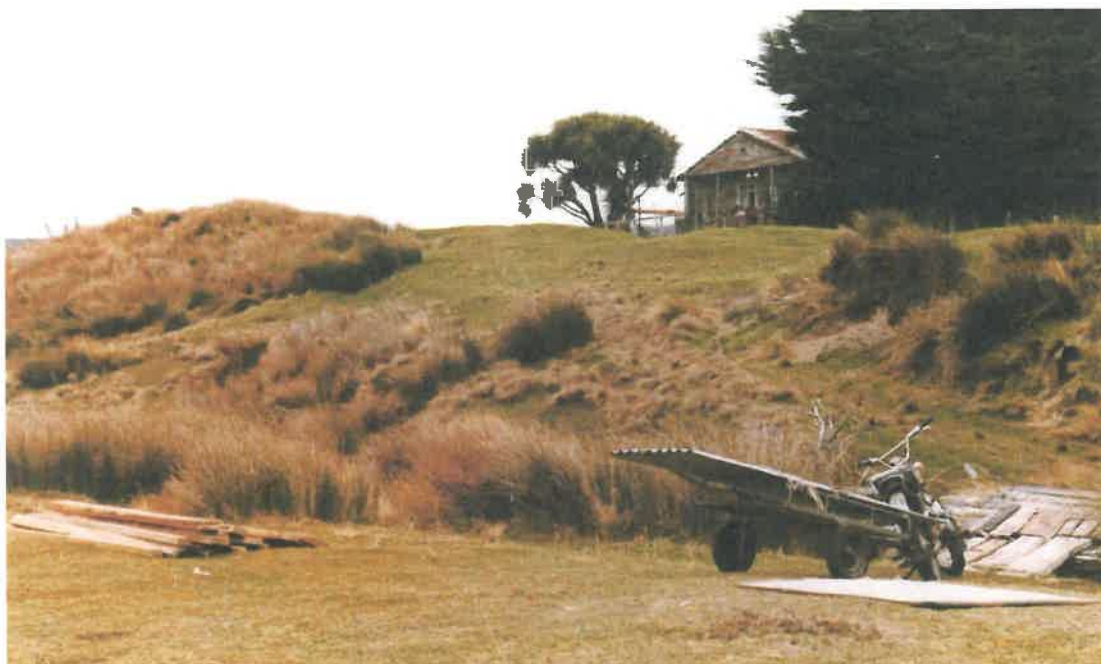
Re-roofing of Kilbride underway, ca.1980s. (Paul Duston Collection)

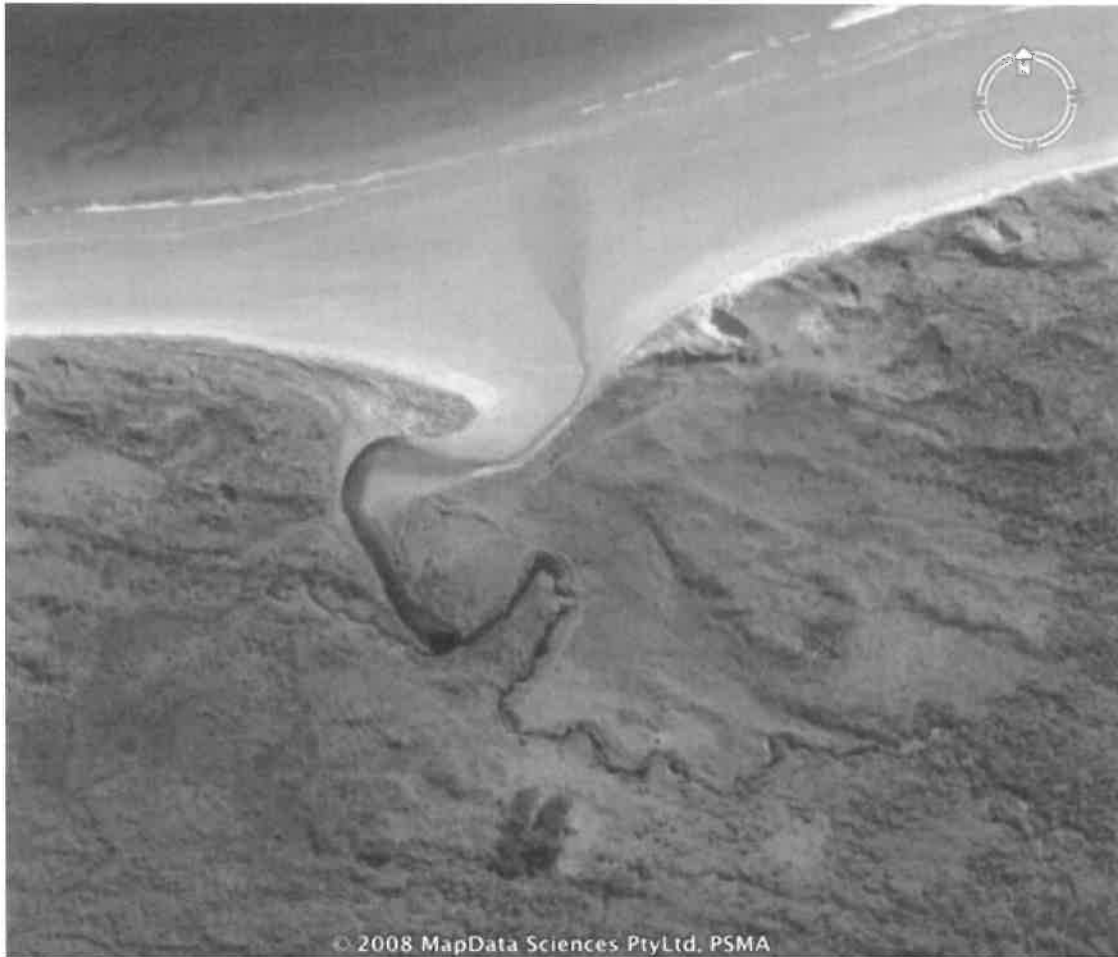
Kilbride Homestead and its surroundings, pictured from the air. Note Leask Creek, bridge and tractor shed, and the regenerating coastal scrub. (Google Earth, 2008)

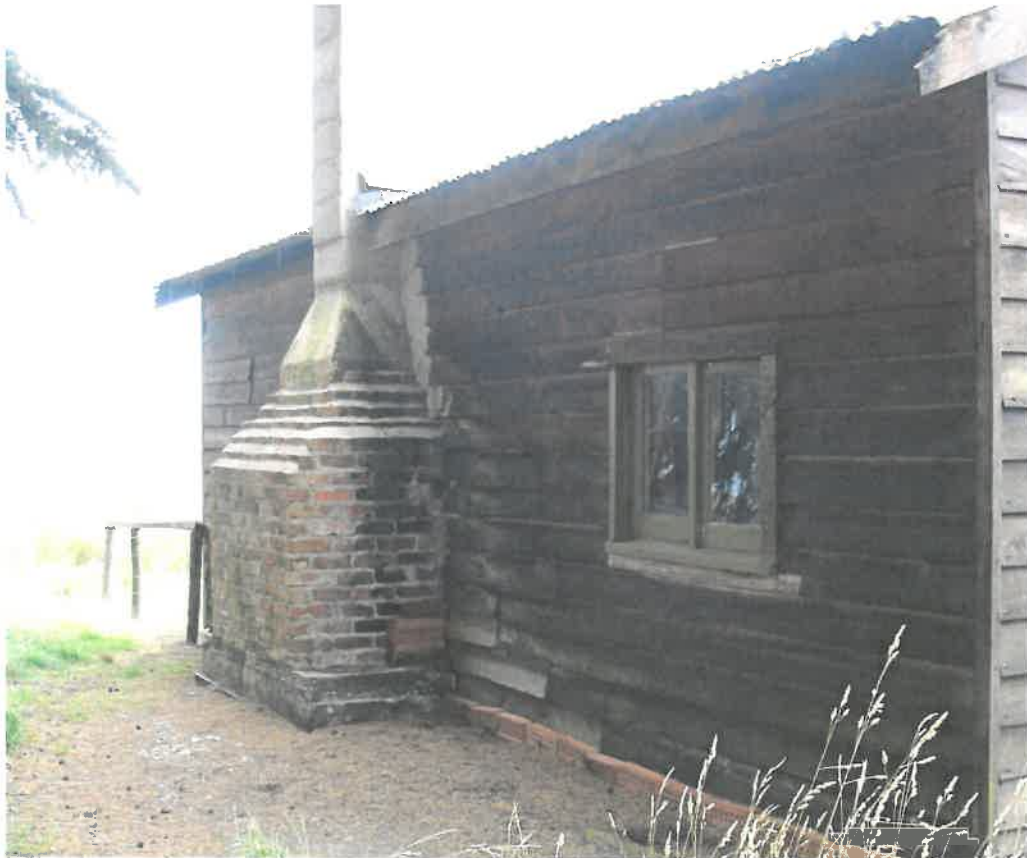
West elevation (R Murray)

The large brick chimney base is the main feature on the west elevation. The chimney was partially re-built in 1993 with a concrete block flue and crude cement weathering to the house. There is also an odd casement window to the back bedroom. By the shape of the repairs made to the wall (most visible from the interior), the latter appears to be a replacement for a previous double-hung window. At the south, the small lean-to projects from the main body of the house. This is partly clad in profiled metal weatherboard-style cladding and partly in vertical clear corrugated acrylic sheet at the back porch. A short run of spouting discharges water from this roof to ground. The building's main spouting is on the east elevation; this feeds the two water tanks, one in corrugated iron, which sit on a timber stand at the south-eastern corner of the house. Adjoining the stand is the kitchen window – changes to the cladding here show that a door once occupied this position.

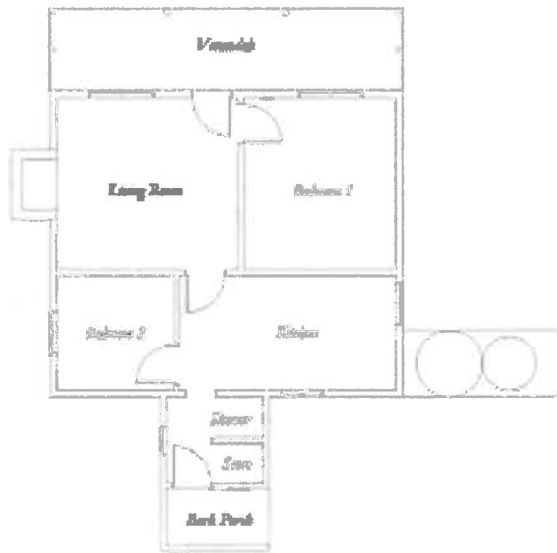
Key plan

The house has a compact plan of just 80 m² including the verandah and back porch and is a model of efficient and economical use of space. There are four main rooms: two bedrooms, a

living room and a kitchen. The small lean-to contains a shower and storage area and lets on to the back porch. There is a minimal amount of circulation space with no halls or passages.

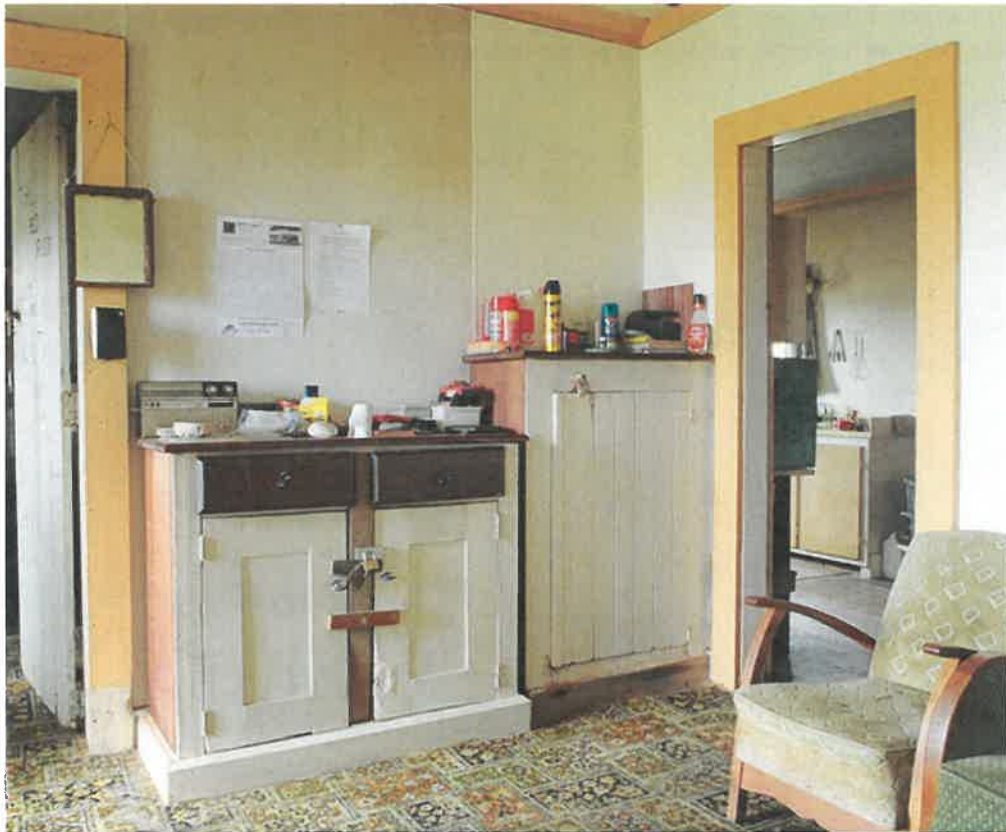
Living room/ dining room – original built-in cabinetry (R Murray)

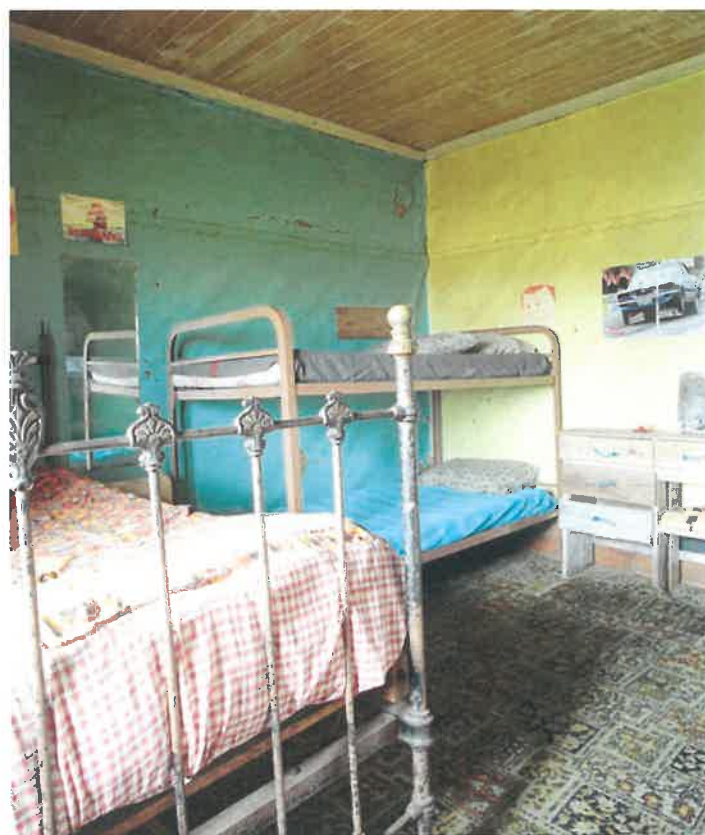
Front bedroom (R Murray)

The door to the front bedroom is a ledged tg&v door, apparently found on the beach. This room has been little altered over time. It has a fine matchlined timber ceiling, unpainted, with a simple cornice, and papered walls. The paper, in fair to poor condition generally, has been painted in yellow and aqua and gives the room a lively appearance. The paper is backed on old newspapers (dating to 1927) over scrim on sarking and these give an indication of the house's age.. The room is furnished with an interesting cast iron four-poster bed under the window, a pair of bunks and a simple home-made cabinet built from material off the beach. The timber window is clear finished on the inside.

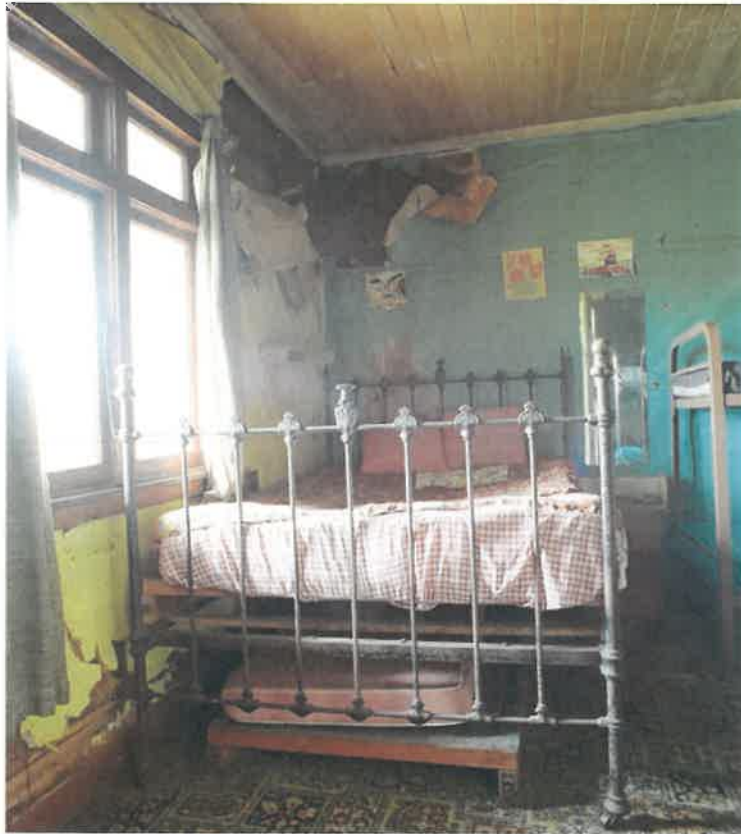
Front bedroom – note condition of wallpaper (R Murray)

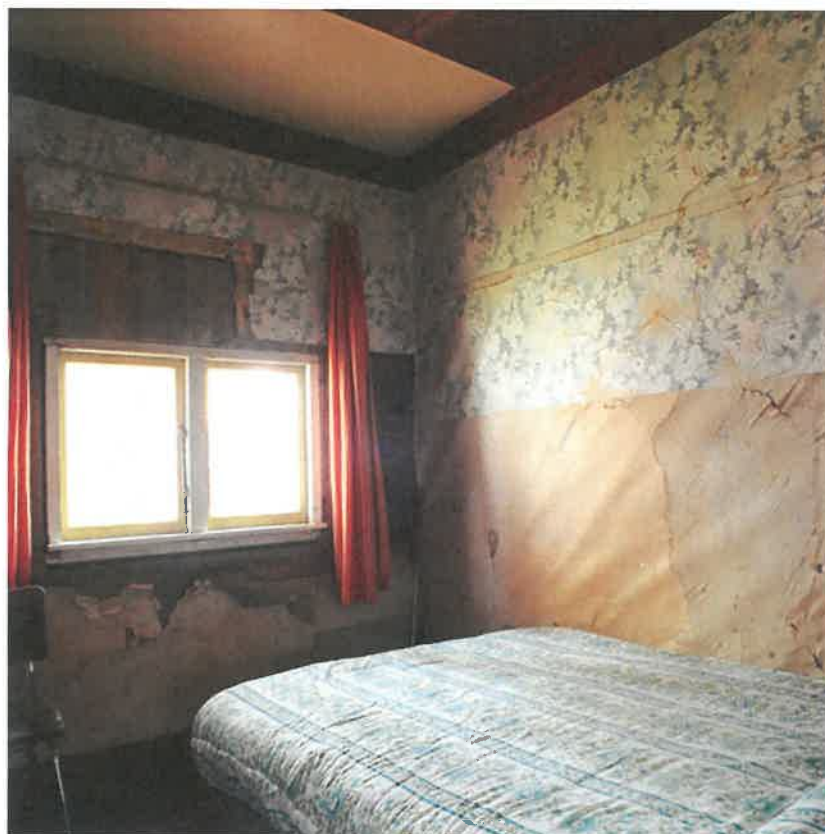
The back bedroom is accessed off the kitchen through a painted four-panel door. This is a dark space, due to the small window looking out under the macrocarpa shelter belt, the dark ceiling (mainly stained plywood) and the dark furnishings. This room is finished similarly to the front bedroom, with wallpaper backed on newspapers (a paper from 1929 is visible near the window) over scrim on the wall sarking and lining and contains a double bed.

Back bedroom – note condition of wallpaper (R Murray)

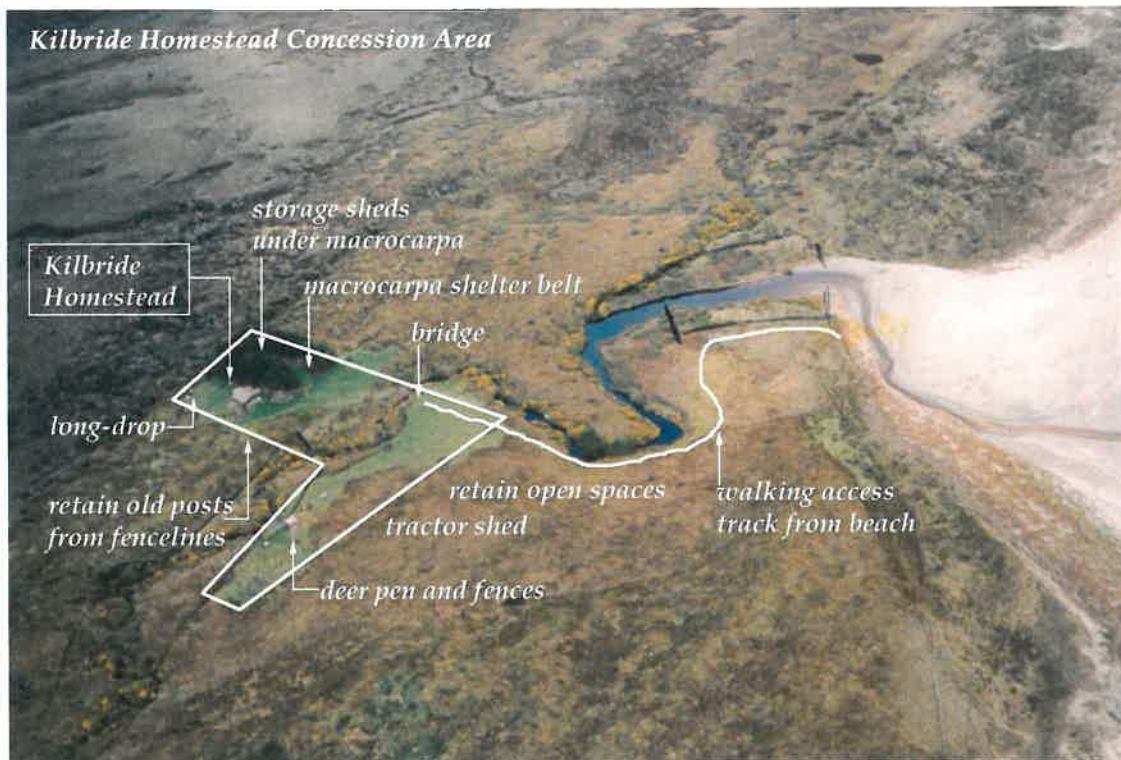
Indicative curtilage for concession area (based on diagram prepared by L. Grace)

The immediate setting of the house, including the existing open area, shed and long-drop toilet, should be protected from encroaching vegetation to the full extent of any curtilage agreed in the concession. The macrocarpa shelter belt and mint patch should be maintained concurrently with this immediate setting. The bridge, tractor shed, deer paddock and associated fences are important adjuncts to the homestead and should be protected and maintained within the terms of the concession (the fence wires can be removed, but the posts should remain).
