**ACCESS ARRANGEMENT APPLICATION- SUGARLOAF QUARRY**

# DEPARTMENT OF CONSERVATION ACCESS AGREEMENT APPLICATION & ASSESSMENT OF ENVIRONMENTAL EFFECTS

## KOKIRI LIME COMPANY LIMITED SUGARLOAF QUARRY

REPORT: SQD620

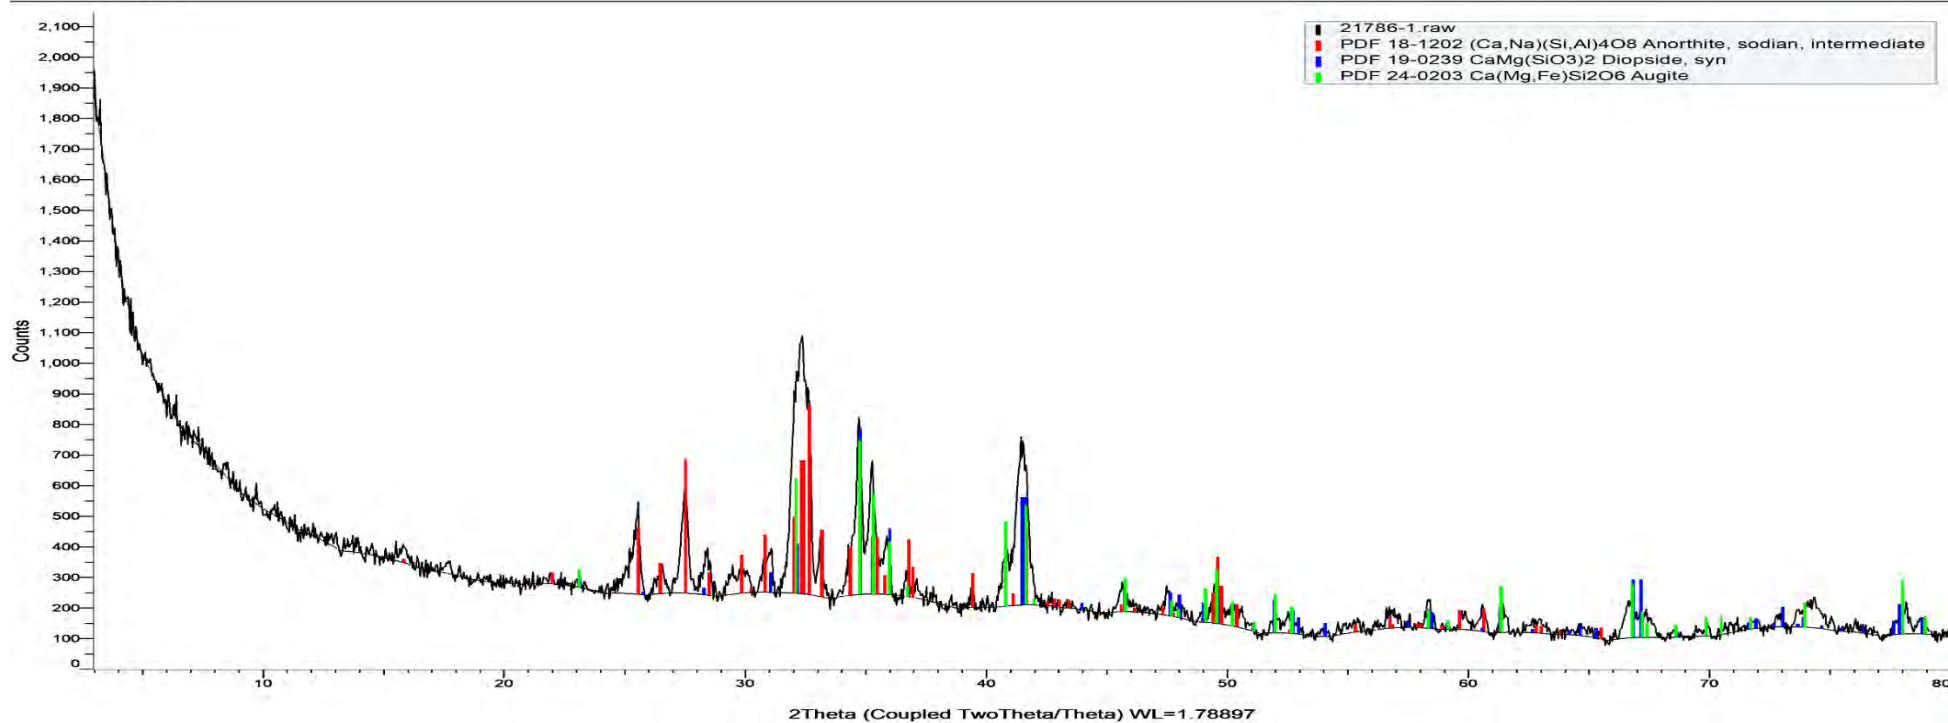
SA21786-A

Phase Name	Phase Formula	Weight %
Anorthite	$(Ca,Na)(Si,Al)_4O_8$	58
Diopside	$CaMg(SiO_3)_2$	26
Augite	$Ca(Mg,Fe)Si_2O_6$	16

These minerals are all pretty much interchangeable - realistically it's just a mix of feldspars.

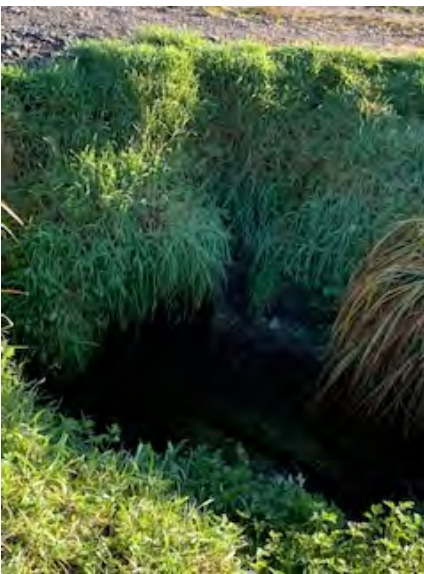
Sugarloaf access road culvert no 1 inlet from deep drain

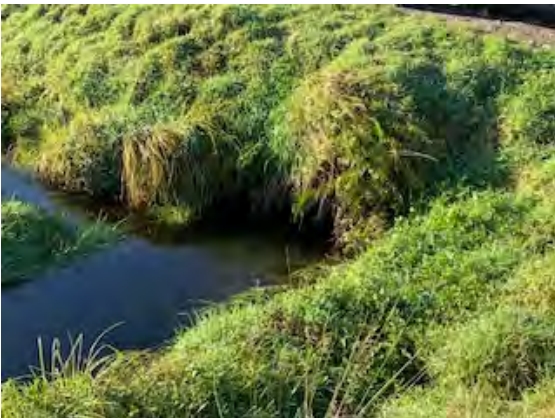
Sugarloaf access road culvert no 1 outlet from deep drain

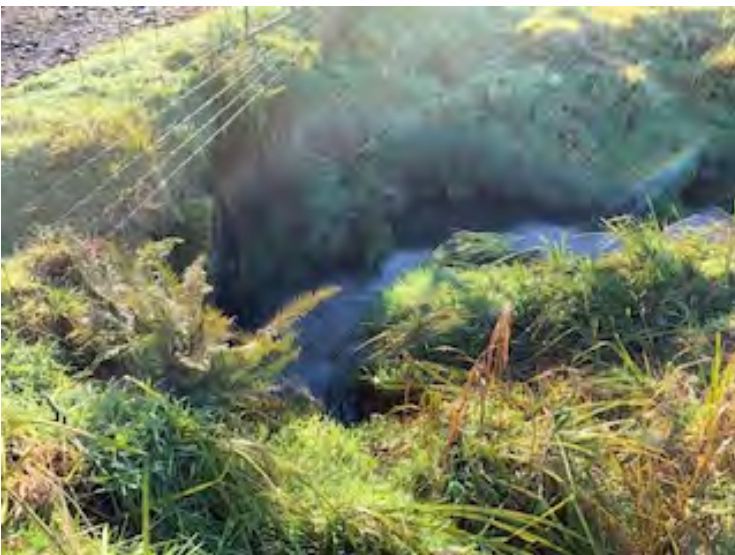
Scotts's Creek culvet no 2  
inlet

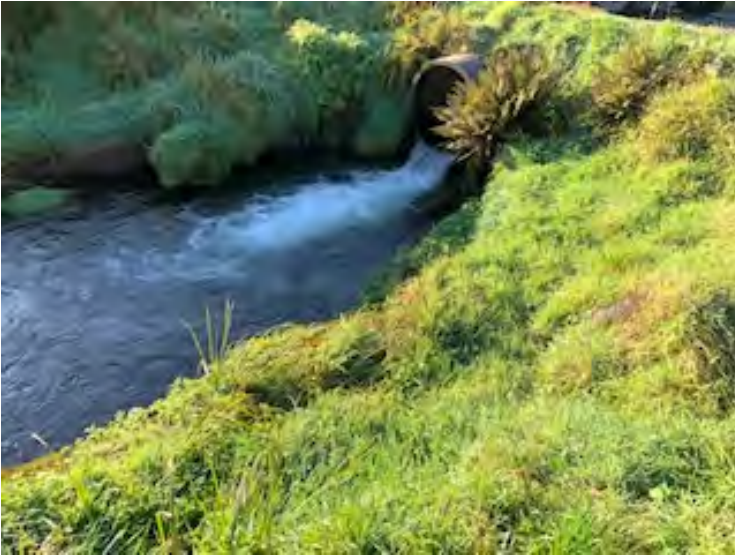
Scotts Creek- Culvert 2 Access road- Outlet

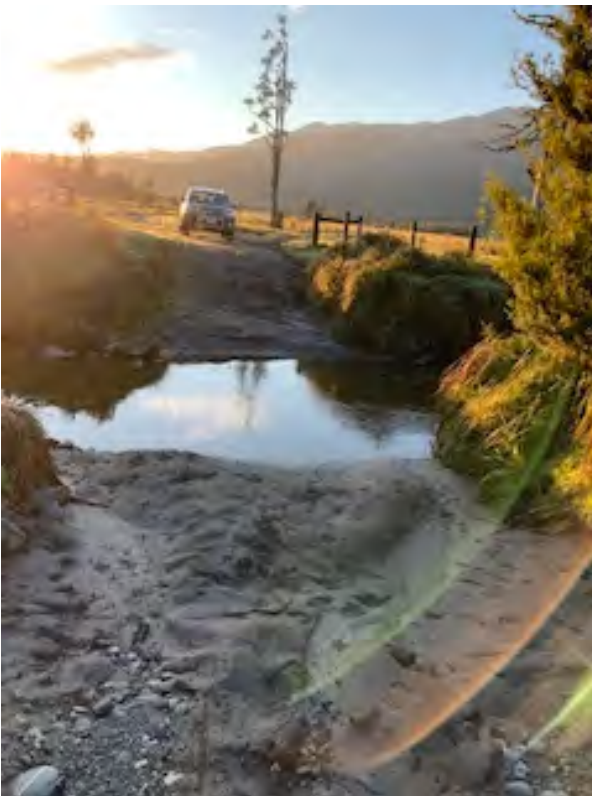
Border Creek- Culvert 3 Access road- Crossing point- looking north west, new culvert installation required

As mentioned in Section 1.10.2 the MoW bridge is not economically feasible to repair, so needs to be removed and a new culvert structure needs to replace it. A suitable steel culvert design will be undertaken to accommodate Border Creek catchment flows. A steel culvert/option is sought for the following reasons;

The culvert installation will require a temporary ford to be constructed across Border Creek for access. Grade of ford will be 1:5 and be temporary until culverts are installed. The installation will also require a dewatered site, so suitable rock / aggregate (pit run) raft foundations can be installed. In order to undertake this we propose installing a gravel cofferdam 10 meters upstream and downstream of the current bridge location. On a favourable fine weather forecast we will then use one 8/6 inch high head dewatering pumps with 6 meter suction lines and a fish screen rose head to over pump Border Creek flows. 6 inch HD PVC lay flat will be used for the discharge line. This over pumped water should be relatively sediment free.

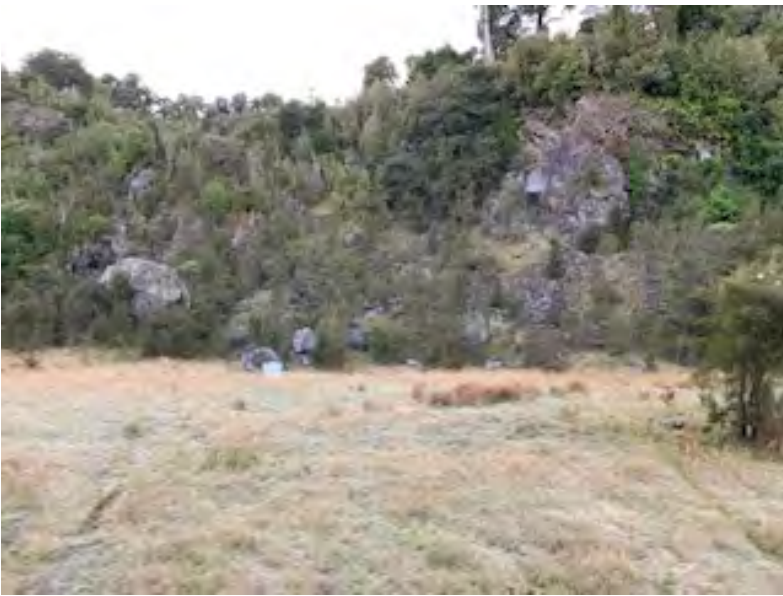
Existing Quarry Floor and Face

Currently the quarry floor is covered in grass / moss / lichens and requires stripping down to hard. We intend to scape the quarry floor, providing a hard, all weather surface. This is for quality and environmental control purposes and will reduce sediment run off in inclement weather conditions.

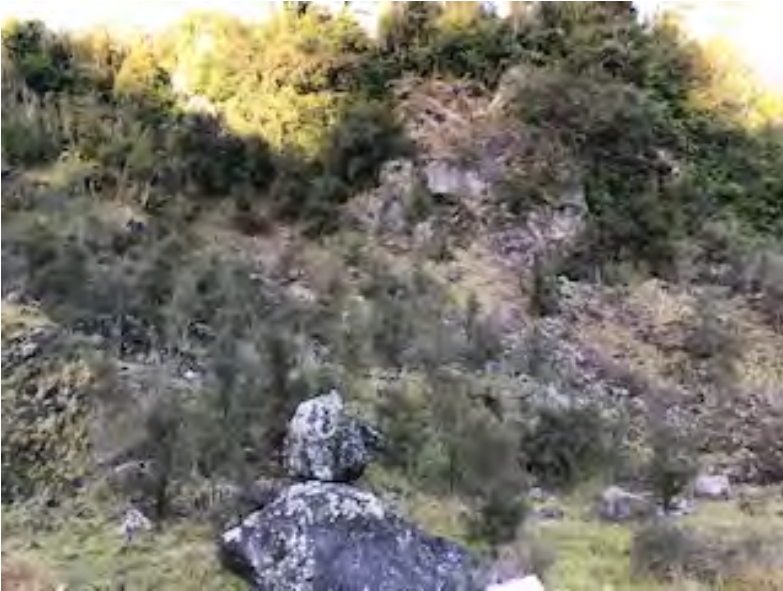
Existing Quarry Face, rubble and rock remains from previous quarrying

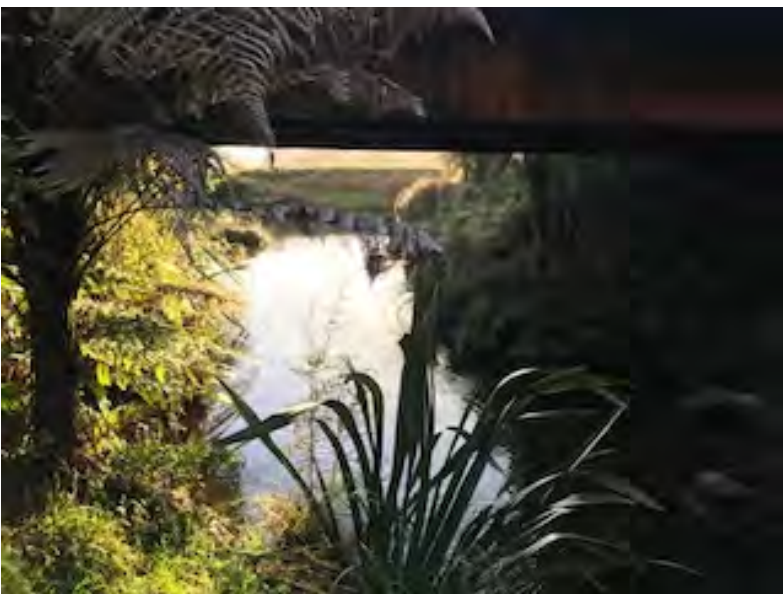
Border Creek under MoW Bridge

Border creek velocity of flow at the MoW bridge is deemed stagnant. Water has a dark patina caused by dissolved organic matter, typical of swampy areas that drain into Border creek.

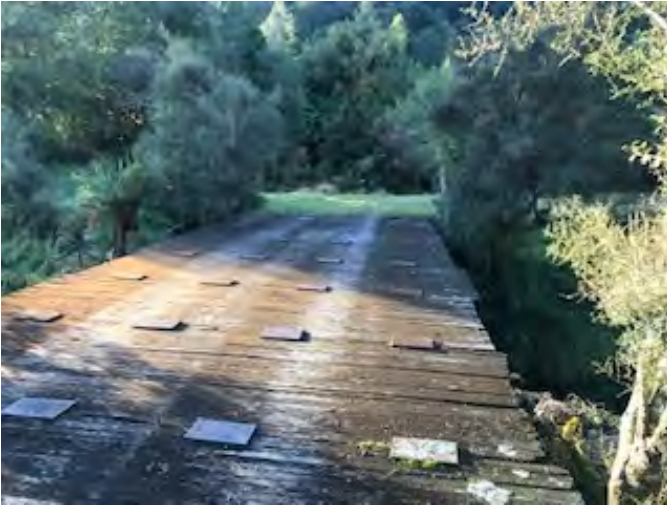
MoW Bridge, looking north into quarry floor

WDC had intentions to remove the bridge and Kokiri had asked for time to conduct an economic feasibility study on the MoW bridge. We have since had a structural engineer determine that the bridge is not feasible to repair. According to the WDC will continue with the bridge removal so we can replace it with a suitably designed culvert / bridge structure.

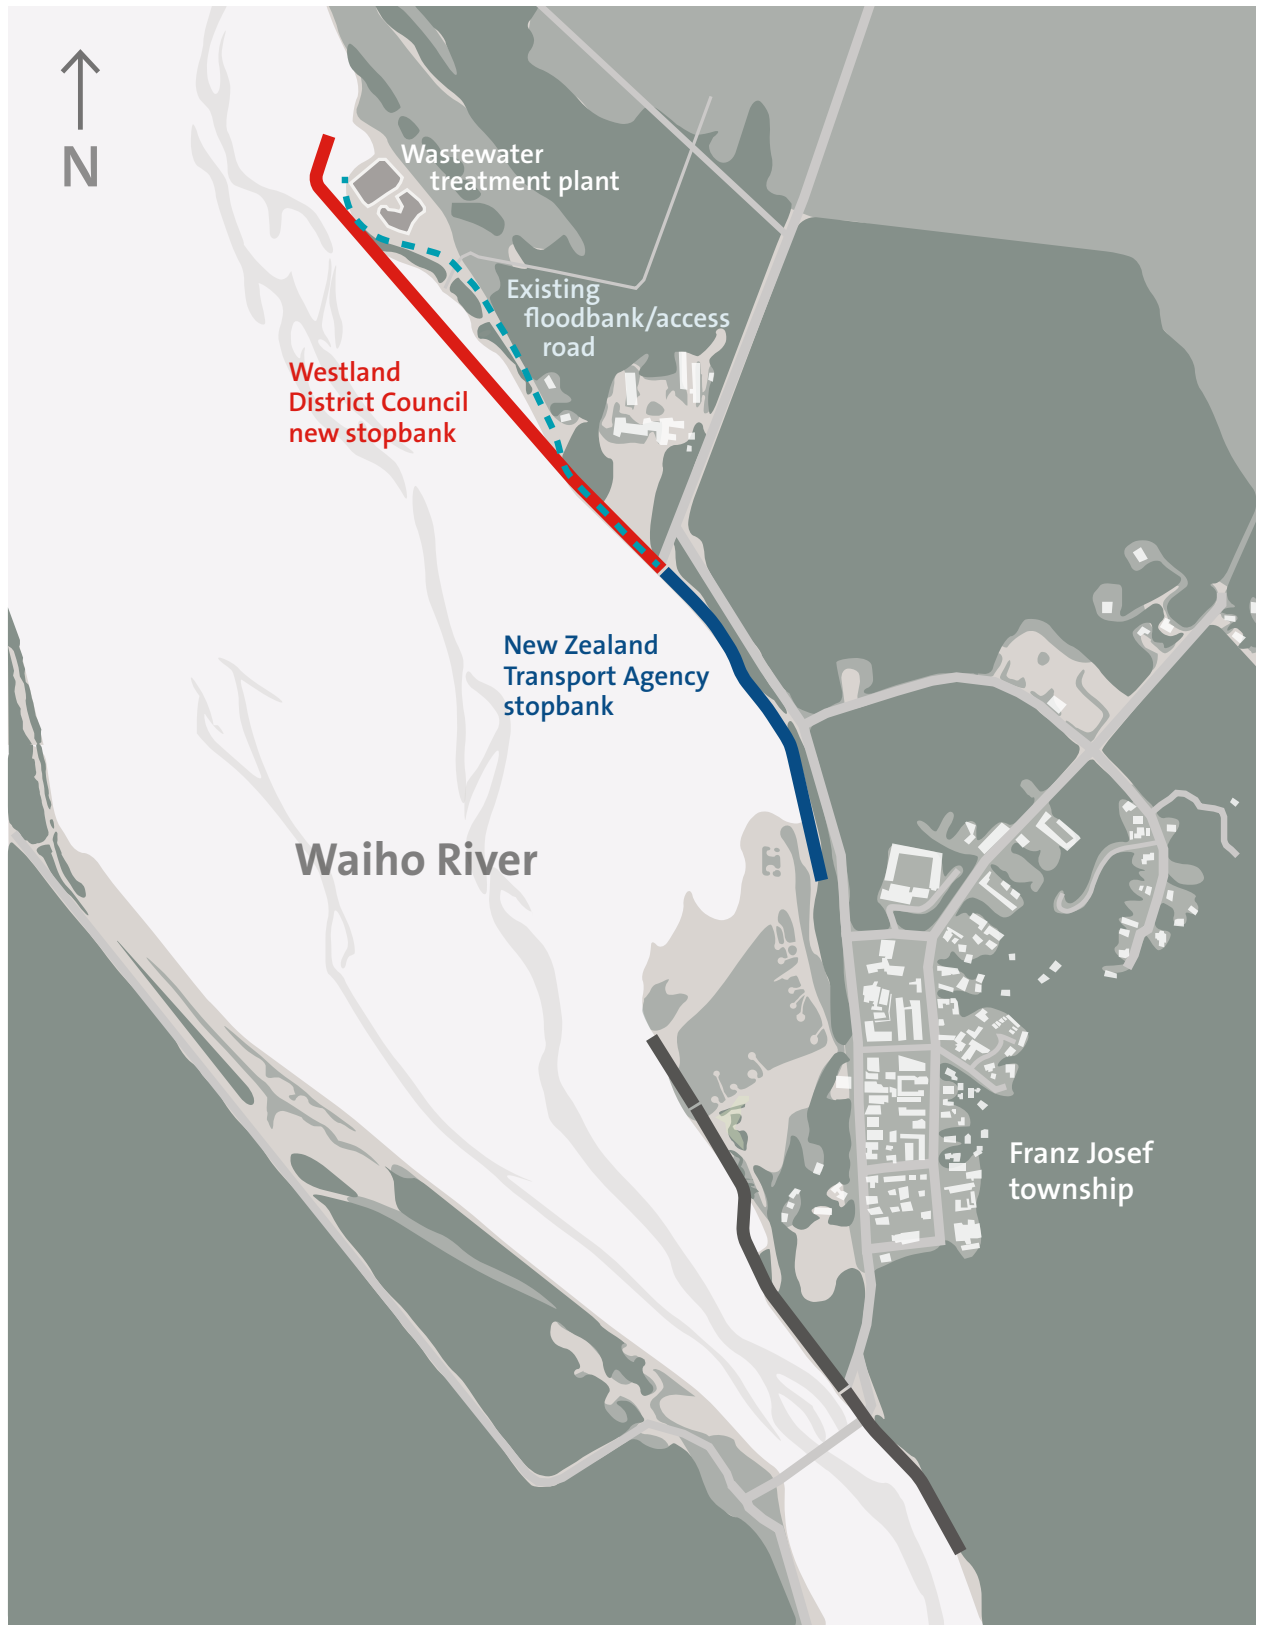
## Westland District Council's new stopbank along the Waiho River

This map shows the new stopbank that Westland District Council built, which is next to the existing New Zealand Transport Agency stopbank.
