# Lahars from Mt Ruapehu

## Tongariro/Taupo

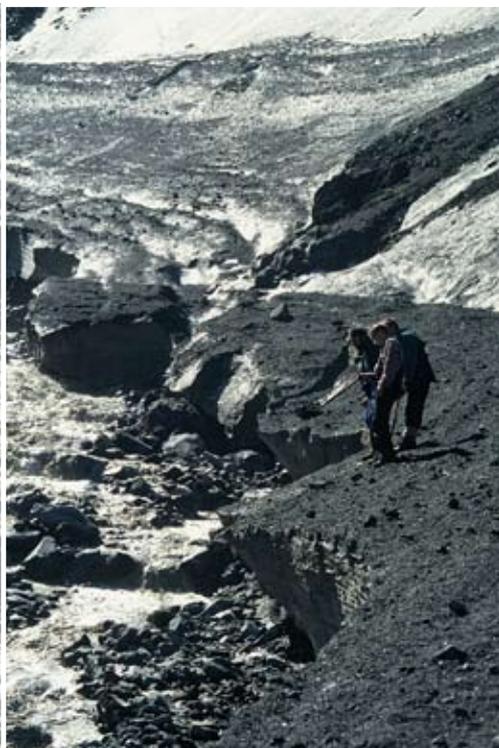
Ruapehu lahar debris from the 1995 eruption  
K. Williams

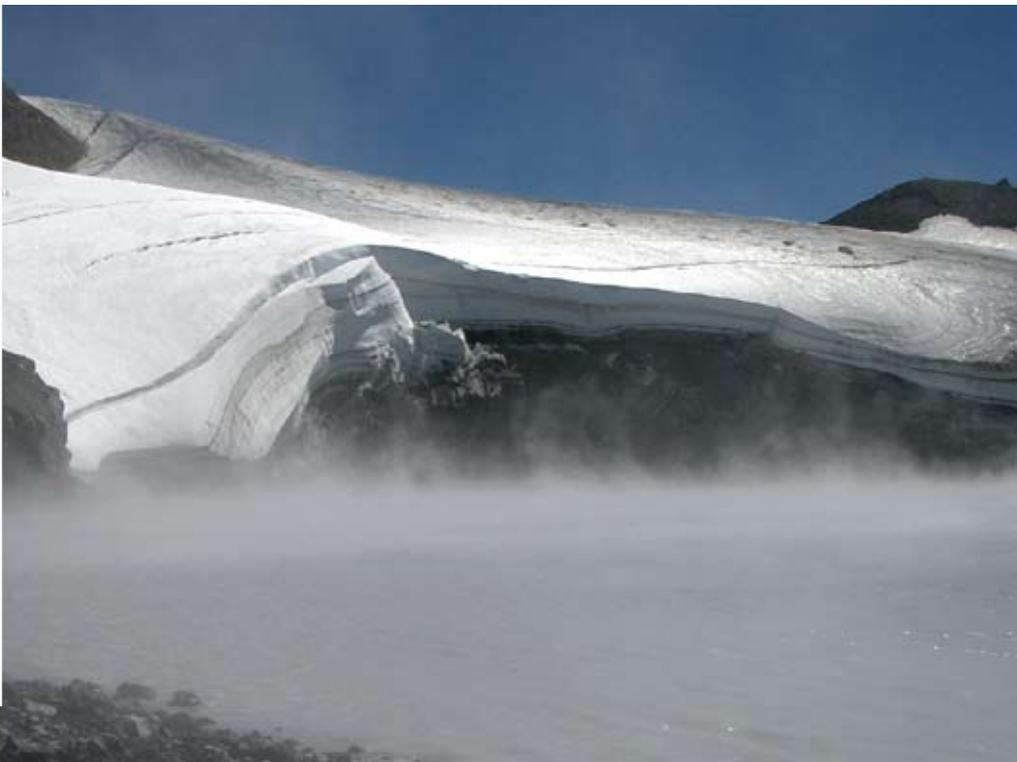
Ice cliff at crater lake Harry J. R. Keys

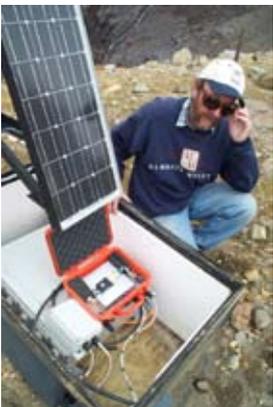
Lahar alarm warning equipment H. Christophers

- A public consultation process has been carried out with scientific input and risk assessments.
- Reliable early warning and emergency response systems have been set up. Sensors have been installed in the upper lahar path, and in the event of a lahar alarms are automatically sent to police, rail and road authorities and other agencies. This

system should give at least 40 minutes warning of a lahar at the Desert Road and two hours' warning at Tangiwai. This alarm system is called the Eastern Ruapehu Lahar Alarm Warning System (ERLAWS).
