Heritage Assessment: Kohukohu Historic Reserve Former Kohukohu School

Heritage Assessment: Former Kohukohu School

Kaitaia Area Office

2011

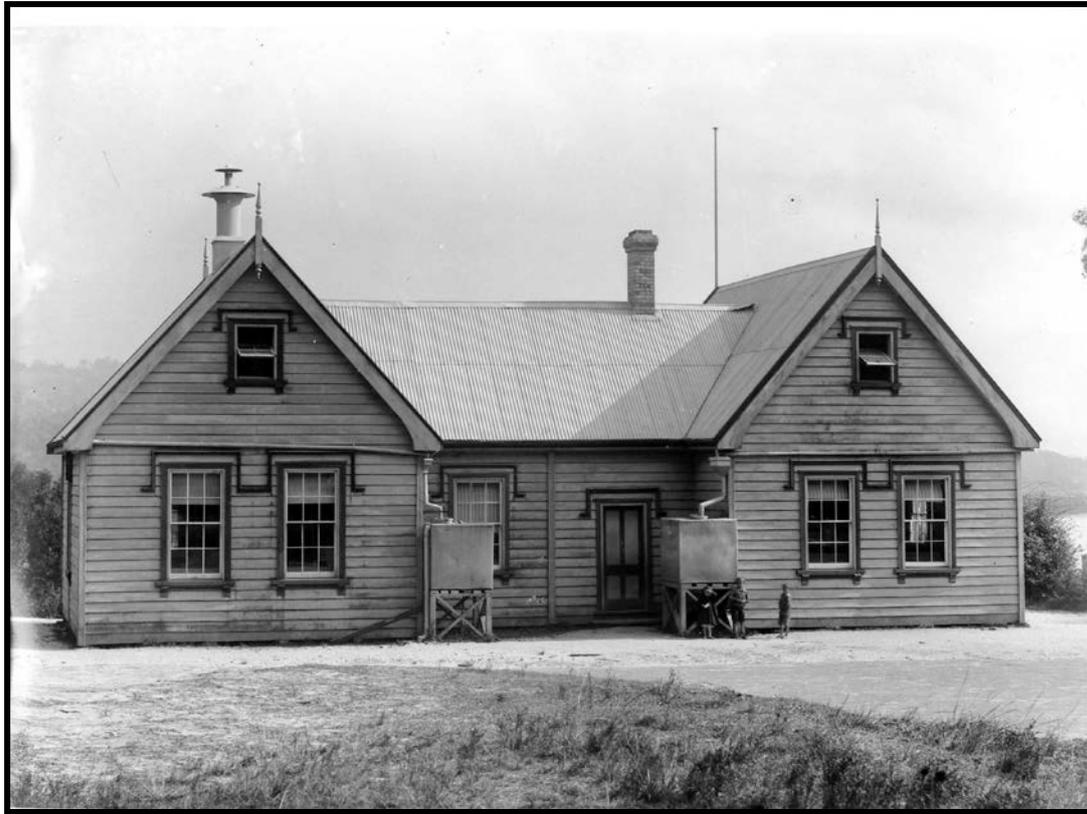
Figure 1: Kohukohu School after the second classroom had been built in 1892 (photo courtesy of Home Comforts, Kaitaia).

The question was ridiculous, and the board proceeded immediately to build the new room in full confidence of receiving the grant to pay for it. When they were notified that the money was available, they were able to reply by return mail that the building had already been completed.

Kohukohu was fortunate in getting its third room before the war tightened the Governments purse strings, the additions were completed in August 1915. Kohukohu was never cramped for room space again.²

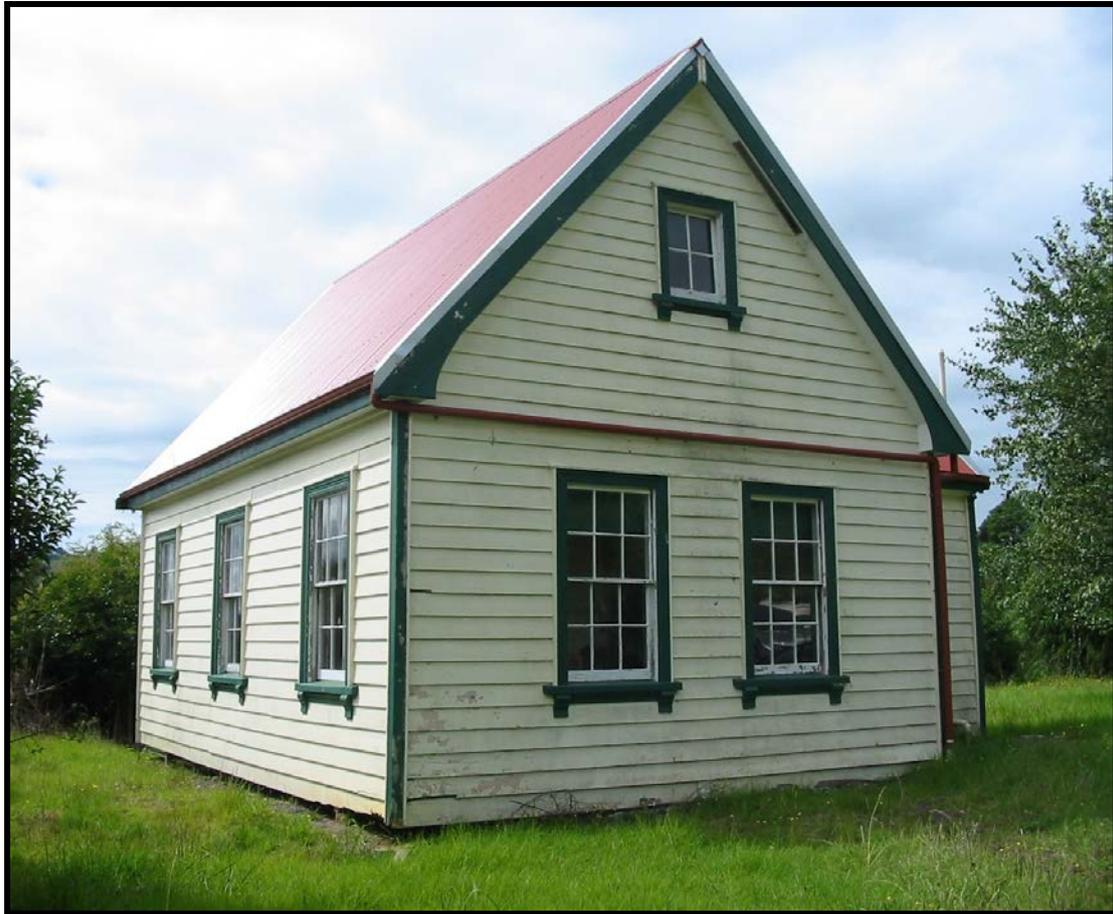
Figure 2: School building circa 2007 after new roof (image: A Macrae).

The Kohukohu School is a single story kauri timber structure with attractive multi-pane windows. It is a simple utilitarian design typical of buildings of its day with high studs, a steep pitched roof and ceilings. It had a wooden shingle roof which at some point was replaced with corrugated iron. Originally it did have some decorative mouldings outside above the windows, but none of these remain. It began as a single classroom and was extended twice finally ending up as a three classroom school. A more detailed description of the fabric can be found in the Appendices.

- 2006:** The roof replacement bid is successful (\$12,600).
- 2007:** (June) Roof is replaced.

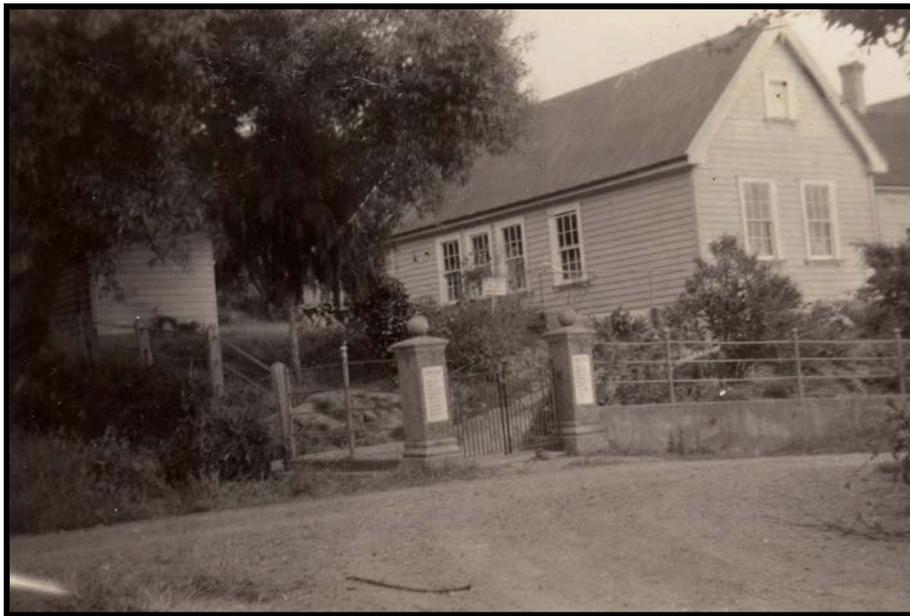
Figure 3:: Memorial gates as they were in 1940. (photo credit Francie Wilson)

The Old Kohukohu School is also the site of the remains of a set of World War I Memorial gates. The gate posts have been re-sited at the new Kohukohu School but the iron pipe railing fence that was attached to the gate posts still remain at the school. The War Memorial gates are a Category II Historic Place Register No 9526.¹¹ The remaining iron pipe railing fence is registered along with the school as a Historic Place.

The school was once the location of a set of Memorial Gates honouring the eighteen former school pupils who died in World War One. These gates were probably installed in the 1920s¹³ and then moved to the new school in the 1970s.¹⁴ Stuart Park of the NZ Historic Places Trust:

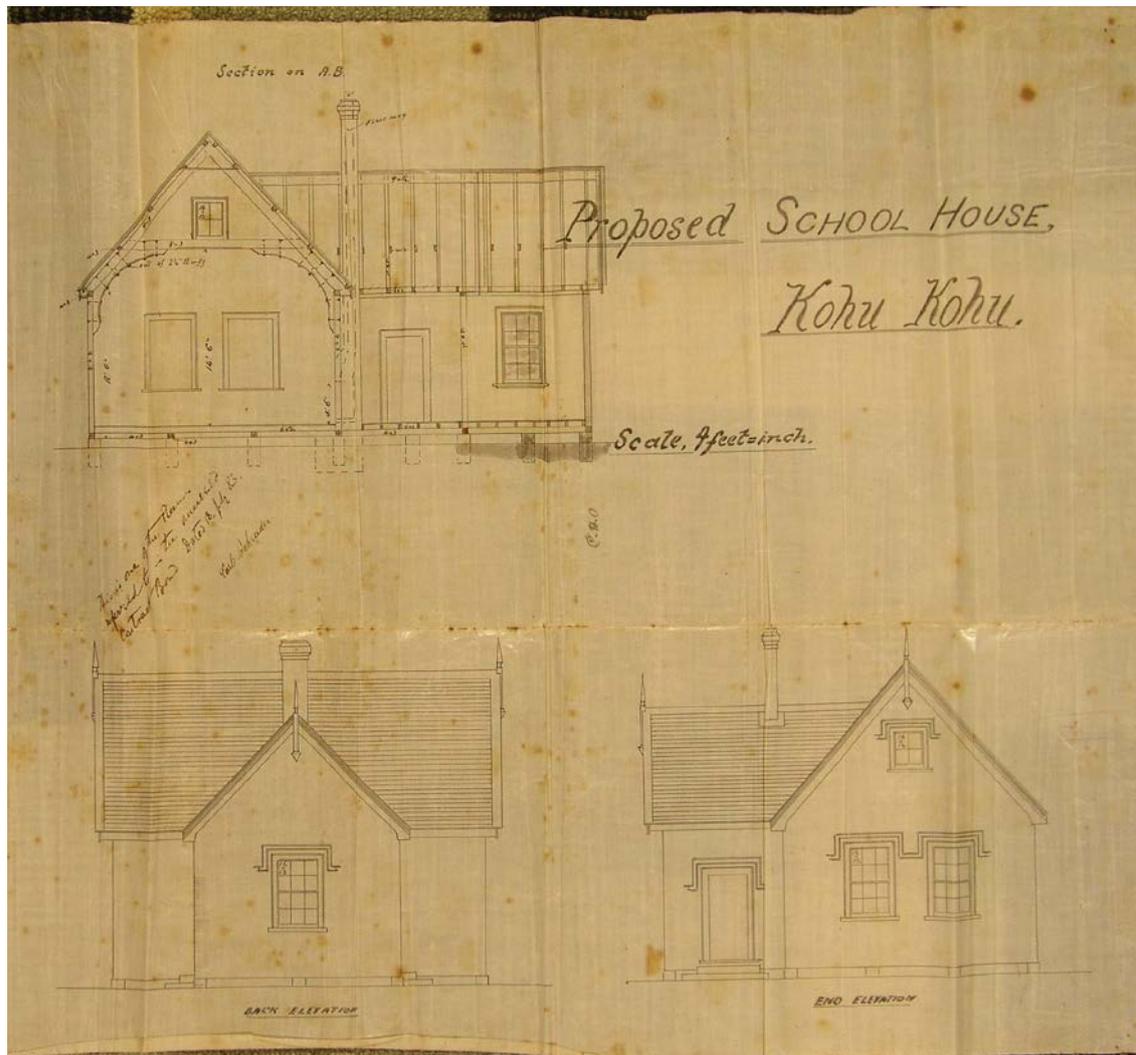
Figure D1: Copy of original drawings for first classroom built in 1883. Plans from Archive New Zealand (Archives reference YCBD A688 1650/d).

*‘The school was erected in 1883 on a site purchased three years earlier. It had a shingle roof, one large room and a porch and was expected to accommodate 60 students. From a photograph and an old architects drawing, it appears that the school porch was extended to twice the original size, probably during the 1890’s. The extra space would have been used as a temporary classroom to accommodate the schools rapidly increasing population.’*¹

The building consists of one large classroom (9.2m x 6.2m, 57.04sqm) and an annex (3.0m x 5.0m 15sqm) which contains a kitchen and a toilet. The stud height is approx 3m and a 45 degree pitch gable end roof runs length wise along the classroom. A secondary gable end roof covers the annex and intersects the main roof at right angles
