Historic concrete structures in New Zealand

Overview, maintenance and management

Peter Reed, Kate Schoonees and Jeremy Salmond

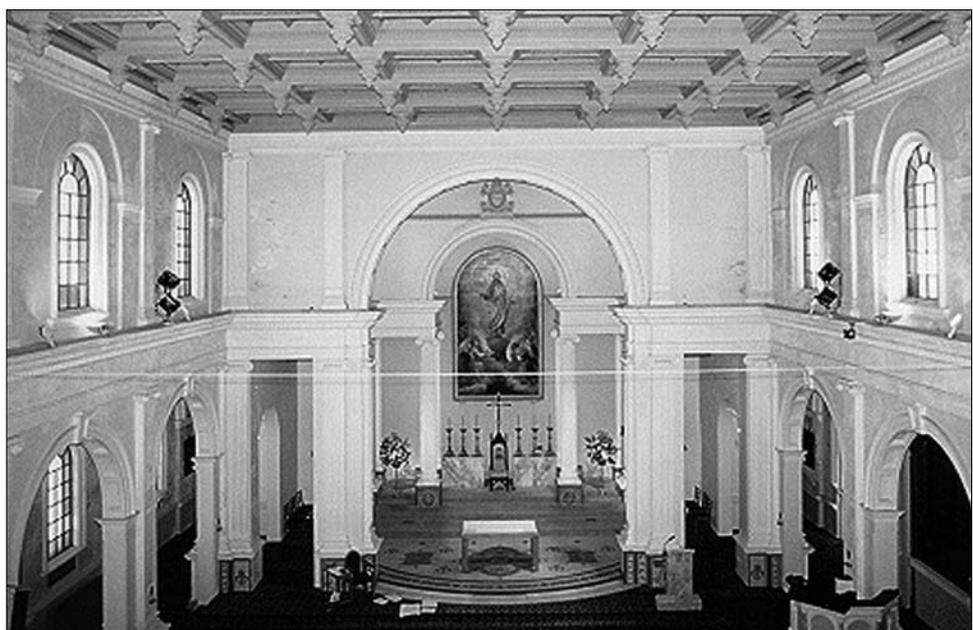
Figure 7. Sacred Heart Cathedral, Wellington. Conventional stone and brick masonry, with a core of reinforced concrete.

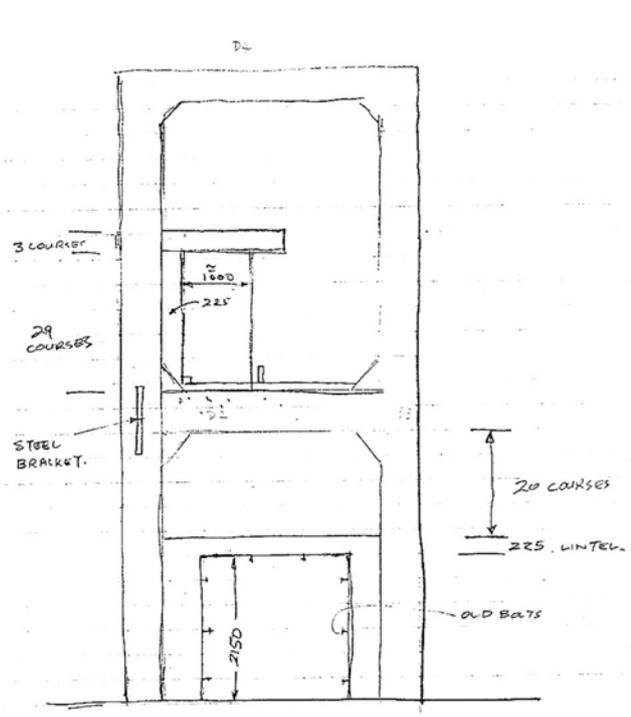
Figure A1.3. North elevation of water tank, Motuihe Island.
