Summary of monitoring of the
Ohakune Old Coach Road shared
walking and cycle track – Tongariro
District

November 2019 P Mahoney & N Wood.

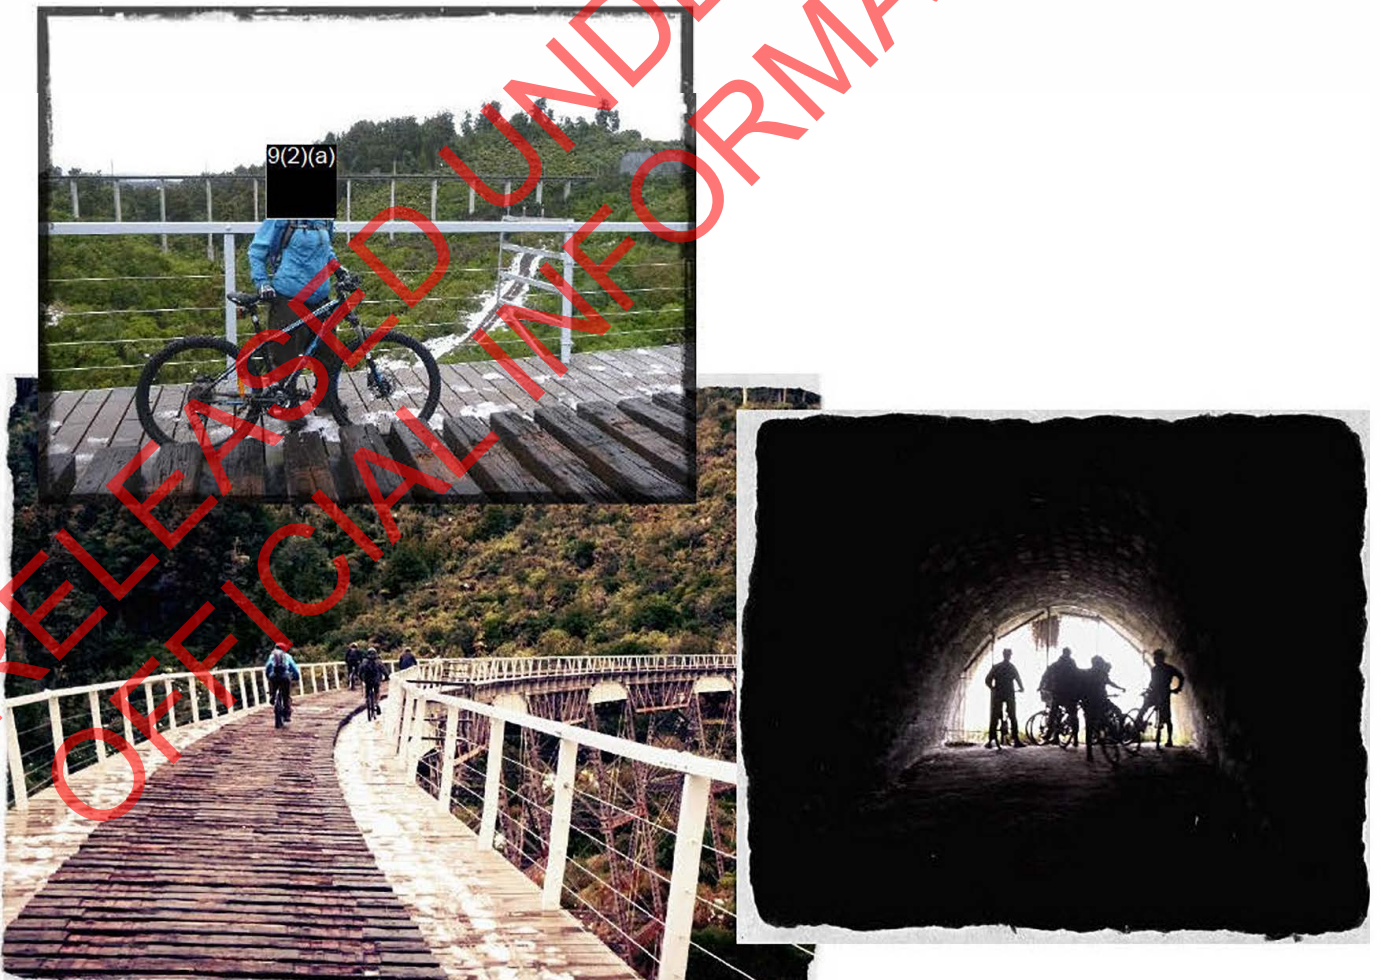
Figure 3: Cyclists on the Ohakune Old Coach Road.

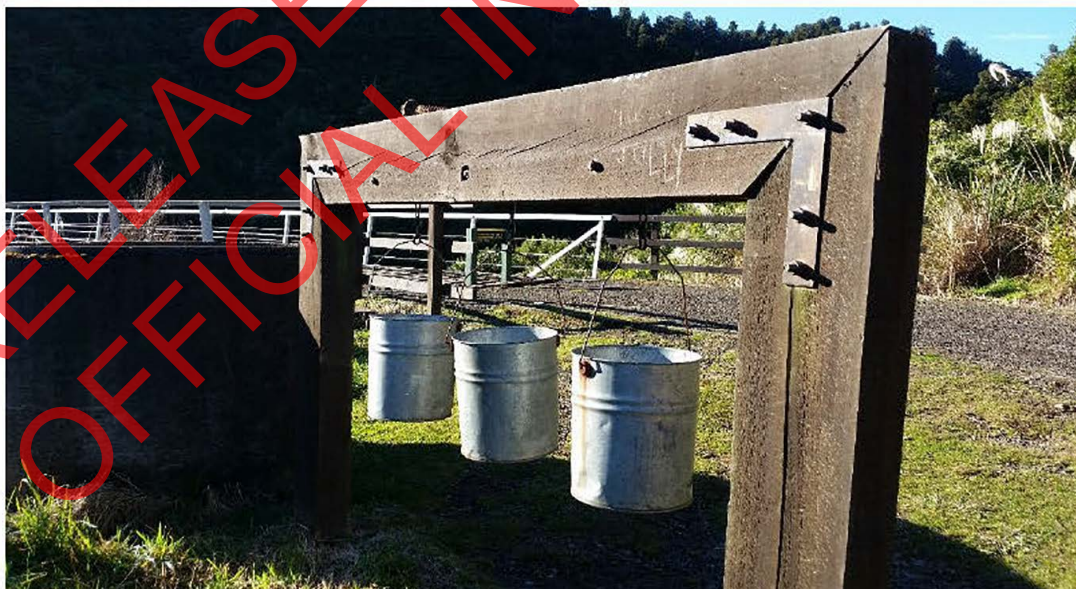
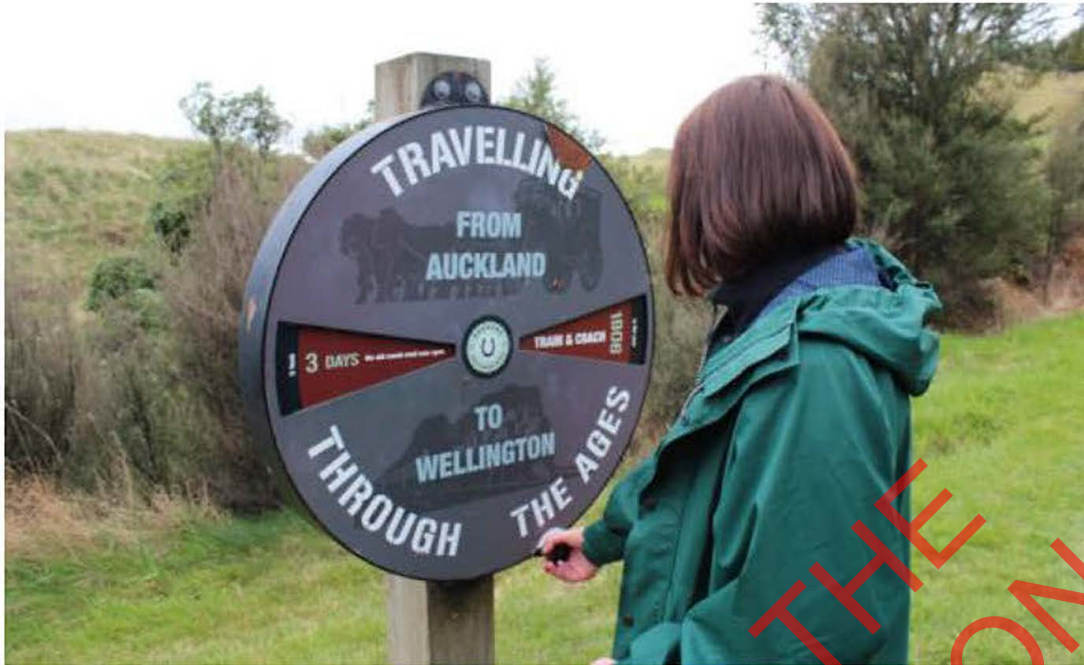
Figure 7: Old Coach Road interpretation.

As part of the restoration project interpretation signs, explaining historical values, have been installed along the track. These have been installed imaginatively, and include a range of different structures such as fire buckets, wheels, spades and sculptures (see Figure 6). The social monitoring and engagement quantifies high visitor interest at these interpretation structures.

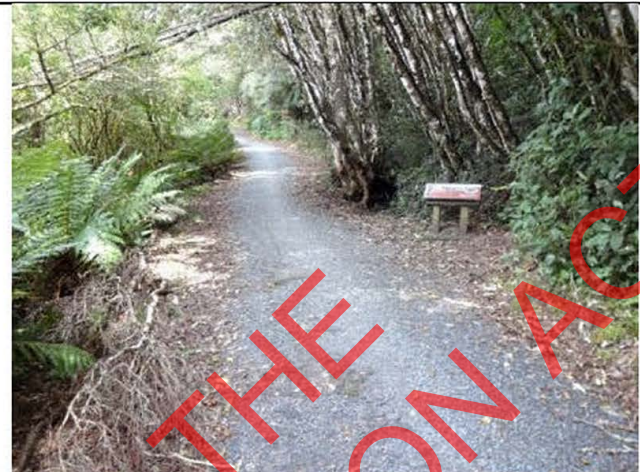
Future showcase section.

This 100m level section of road south of Taonui is proposed as the best candidate to designate to showcase the original cobble surface, bumpy and uncomfortable as it is. The section shows no sign of impact as cyclists move slowly along here, recovering from hill climbs.

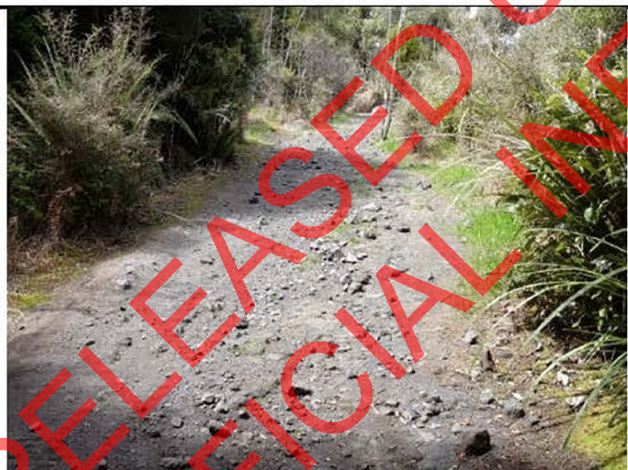
Success of protective surface

The 1.5km long trial of protective surface is a great success tested over its first five years. In a careful inspection by foot not one loose cobble was found. This surface also maintains the heritage character of the road. It should now be progressively applied to the whole road.

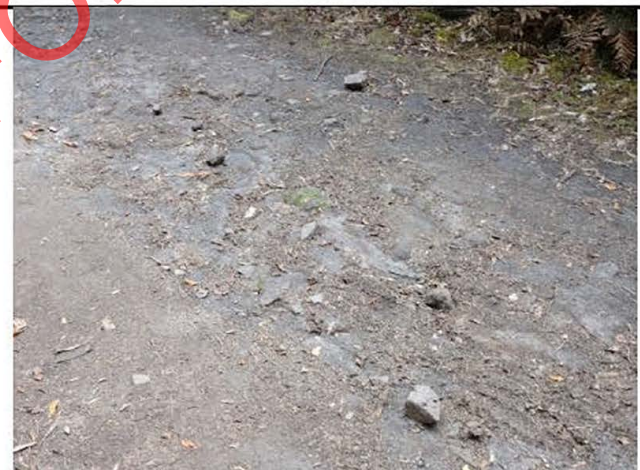
Large scale of impacts

This is a section of road that does not yet have protective surfacing. Cobblestones are being dislodged by cyclists: an example of the active damage that has started in two zones totalling 100m and involving hundreds of stones being loosened. Even from a track asset viewpoint, DOC should protect this original a high-quality track base.

- Apply protective surfacing to two sections of road, each around 50 m long, have started showing severe impact that is not acceptable for a registered archaeological site.
- On the section of road already with protective surfacing (~1.5km), repair the surfacing at stress points

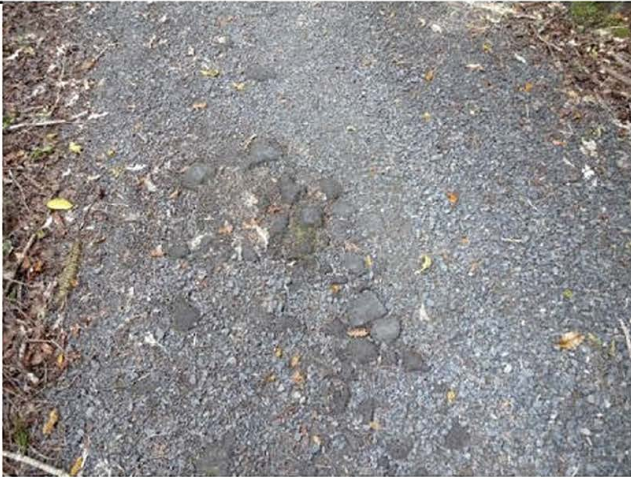
Irreversible nature of impacts

The archaeological agreement with Heritage NZ requires DOC to monitor road user impacts and to remedy them swiftly. Stones once loosened are not able to be replaced and are quickly swept to the side and lost. Adjacent stones then become weakened and soon pop out. DOC must stop this damage happening, but it is not a big job and the surface protection material is available.

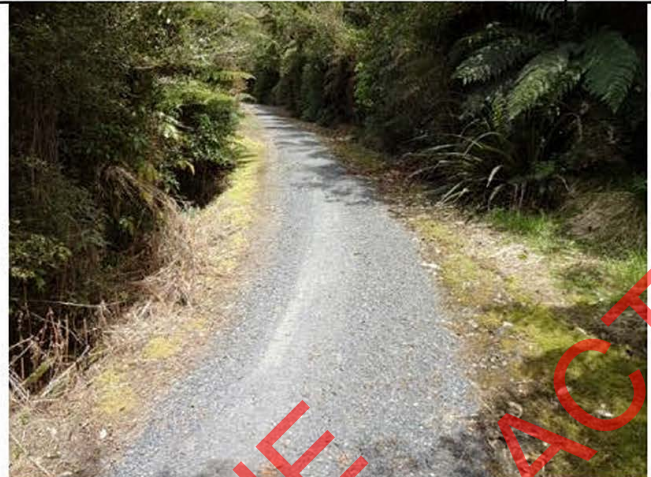
Example of where surfacing top-up is required.

The protective surfacing trial has been a great success. After 4 years less than 1% of the length treated requires attention. In a few places like this, apply and compact a "25mm surface top up" to ensure these exposed cobbles are not loosened and lost.

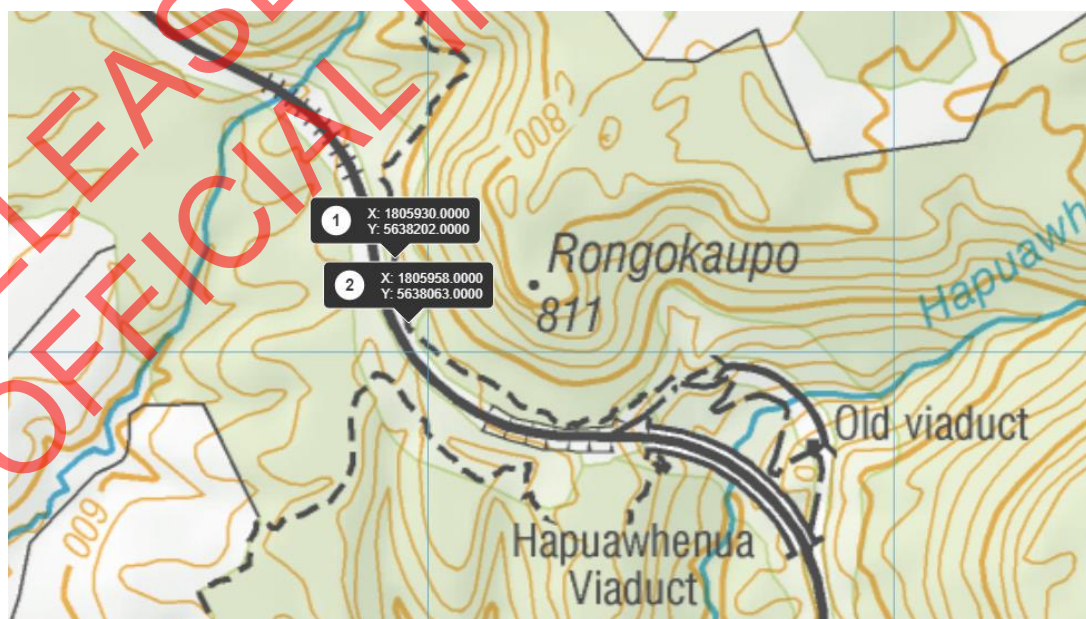
145.1m – new surface

DOC staff resurfaced the remaining unmetalled section at the bottom of skyline, as well as re-surfacing a short piece from the end of the unmetalled section to the bush section (Hapuawhenua North link) which was still historic and had metal on it previously, but had worn out from bicycles over time going around the corner.
