Brunner Suspension Bridge, 1876

Prepared by Colin Perfect
and Paul Mahoney
Department of Conservation
for the
Brunner Industrial Site
Co-ordinating Committee.

2nd June 2004

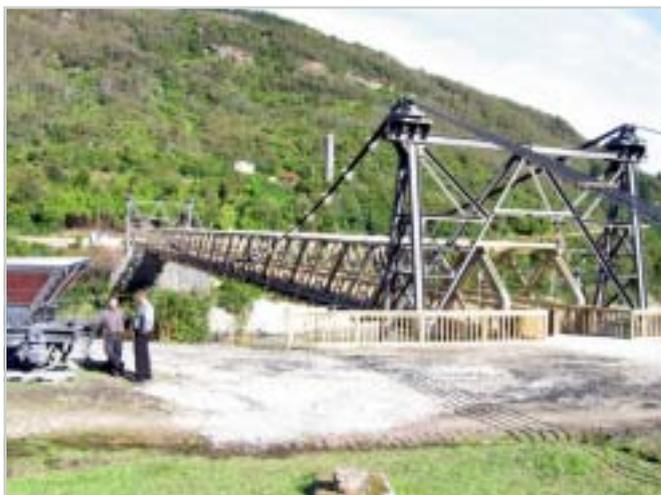
The restored Brunner Bridge in 2004 from the Brunner mine site. A Q class coal wagon is shown to the left; horses pulled these across the bridge. Tyneside with its chimney is depicted across the river. Photograph: David Chung

The reconstructed bridge of 2004 retains the 1964 steel towers. It reintroduces the 'box girder truss' which is a close copy of the version opened in 1876 but scaled down 10%. Although now in its sixth incarnation, the Bridge tower positions and key dimensions remain essentially unchanged.

The successful tender was from Works Infrastructure Limited for \$585,000. The 2003-04 work began with the complete disassembly of the bridge including the steel towers. Restoration commenced with the re-erection of the rebuilt towers followed by the stringing and fixing of the new suspension cables. The treated radiata pine box girder trusses were prefabricated and reinstated in sections. The first two sections were hung from the cables on the Taylorville side of the river with the assistance of a mobile crane. The remaining sections were winched out from the Tyneside side of the river. Sections were progressively bolted together when the cross bracing was correctly aligned. Bolted connections were used for the main timber structural joints. The foundations, 2 steel towers, 8 timber transoms and some cable clamps survive from the earlier bridges, all other components are new material.
