MEMORANDUM

Attention: Nigel Binks, Department of Conservation

RE: 230067.3-001Rev0: Amur Carp Surveillance and Culvert Assessment Completion Memo

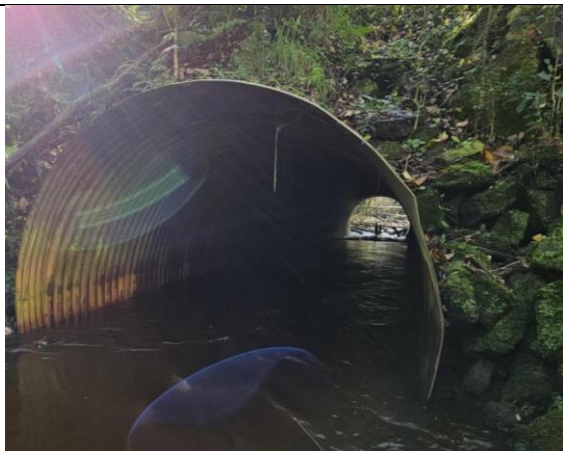
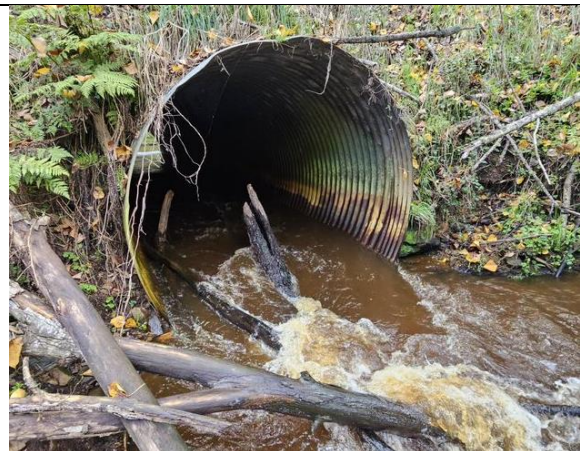
CULVERT 1	Location: Unnamed Road (Mystery Creek Catchment)		Coordinates: -37.866790, 175.343537		
Type of culvert: round metal culvert		Length: c. 23.5 m			
		Width: 2.9 m			
Wetted width of stream:		Upstream: 2.4 m			
		Downstream: n/a			
Velocity⁴ of the stream:	Upstream:	d1 = 540	d2 = 588	d2 – d1 = 48 mm	
	Downstream:	d1 = n/a	d2 = n/a	d2 – d1 = n/a	
Upstream Observations: <ul style="list-style-type: none">• Top 75% of culvert is sunken at least 25%• Culvert is at least 50% smaller than upstream bank width• Lower velocity upstream of culvert than downstream (by observation)					
Downstream Observations: <ul style="list-style-type: none">• Culvert is over 75% smaller than the downstream bank width• Ledge present in the culvert approximately 75% of the way downstream, potentially due to the culvert sinking in the structure, creating heterogeneity in flow dynamics.					
Fish Passage: <ul style="list-style-type: none">• Fish passage obstruction likely for weak swimming species, but no impediment for stronger swimming species.• Does not comply with NPS⁵ freshwater regulations

Figure 3: Photo taken from upstream end of Culvert 1.

Figure 4: Photo taken from downstream end of Culvert 1.

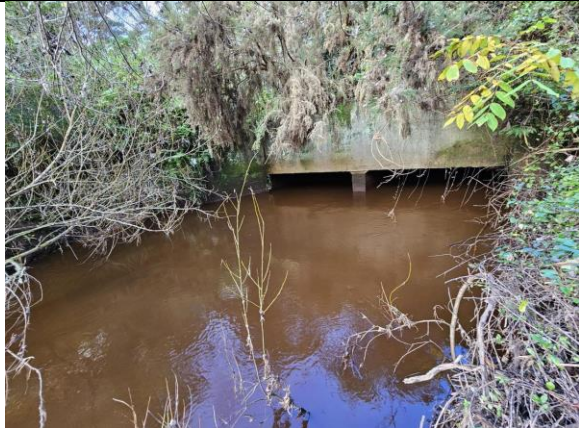
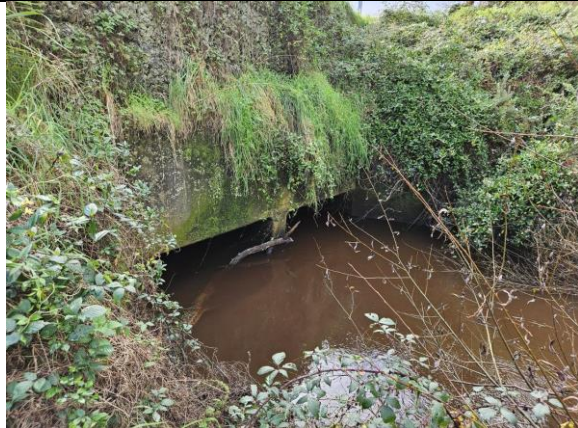
CULVERT 2	Location: Mystery Creek Road Culvert (Mystery Creek Catchment)		Coordinates: -37.870368, 175.339997		
Type of culvert: double concrete box culvert with double wing wall and apron		Length: n/a			
		Width: c. 5 m			
Wetted width of stream:		Upstream: n/a			
		Downstream: n/a			
Velocity⁶ of the stream:	Upstream:	d1 = n/a	d2 = n/a	d2 – d1 = n/a	
	Downstream:	d1 = n/a	d2 = n/a	d2 – d1 = n/a	
Upstream Observations: <ul style="list-style-type: none">• Water velocity unable to be measured due to limited accessibility, but appears slow to moderate with no obstructions• Culvert appears sunken (unknown depth)• Water level is consistent throughout the culvert• Culvert width is in line with stream wetted width					
Downstream Observations: <ul style="list-style-type: none">• Culvert width is in line with stream wetted width					
Fish Passage: <ul style="list-style-type: none">• No fish passage obstruction

Figure 5: Photo taken from upstream end of Culvert 2.

Figure 6: Photo taken from downstream end of Culvert 2.

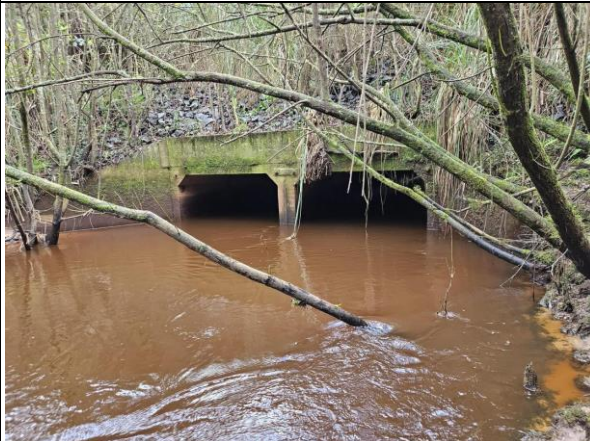
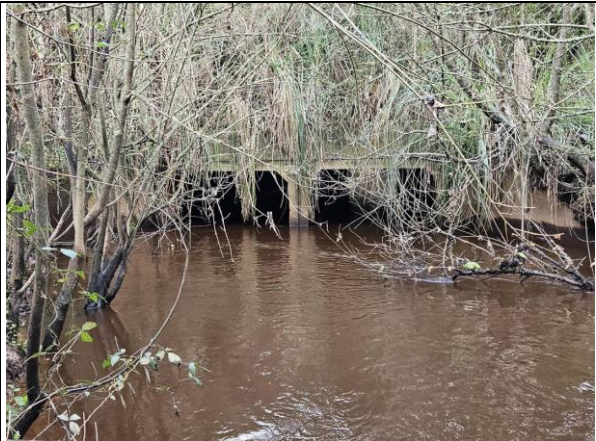
CULVERT 3	Location: John Roberts Contracting (Mystery Creek Catchment)		Coordinates: -37.877472, 175.333808		
Type of culvert: double concrete box culvert with double wing wall and apron		Length: c. 20 m			
		Width: 4.3 m			
Wetted width of stream:		Upstream: 5.3 m			
		Downstream: 5.6 m			
Velocity⁷ of the stream:	Upstream:	d1 = 580	d2 = 589	d2 – d1 = 9	
	Downstream:	d1 = 580	d2 = 600	d2 – d1 = 20	
Upstream Observations: <ul style="list-style-type: none">• box culver is significantly sunken (25-40%)• stream angles right by 45 degrees when it reaches the culvert• velocity is relatively uniform upstream and downstream• culvert is smaller than wetted width, possibly influenced by the angling of the stream					
Downstream Observations: <ul style="list-style-type: none">• Similar width between culvert to streambank widths upstream and downstream.					
Fish Passage: <ul style="list-style-type: none">• No fish passage obstruction

Figure 7: Photo taken from upstream end of Culvert 3.

Figure 8: Photo taken from downstream end of Culvert 3.

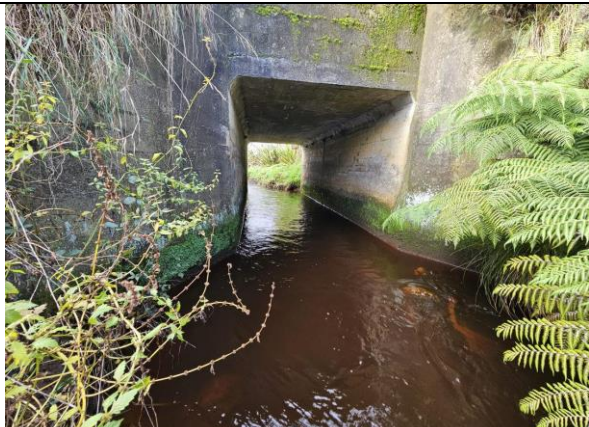
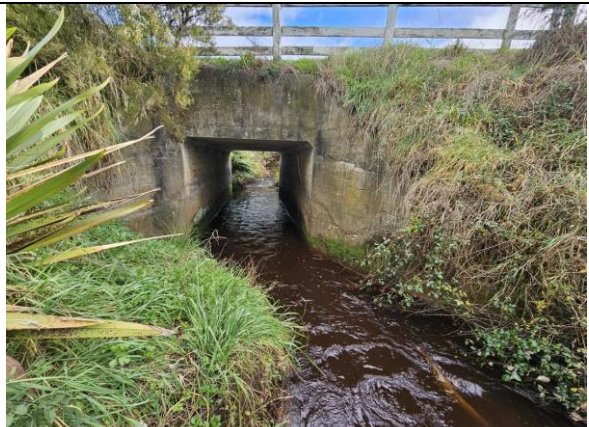
CULVERT 4		Location: Forkett Road Culvert (Mangaotama Catchment)		Coordinates: -37.933365, 175.260295					
Type of culvert: single concrete box culvert with wing walls and apron		Length: 15 m		Width: 2.5 m					
		Upstream: 2.55 m		Downstream: 2 m					
Wetted width of stream:		Upstream:		d1 = 284	d2 = 315				
		Downstream:		d1 = 280	d2 = 294				
				d2 – d1 = 31					
				d2 – d1 = 14					
Upstream Observations:									
<ul style="list-style-type: none">Concrete bottom is present at entrance to culvertNo instream sediment depositionNot in line with the natural flow path of the watercourse, offset to the left looking downstreamCulvert width is in line with the wetted width of the stream									
Downstream Observations:									
<ul style="list-style-type: none">Just past the edge of the concrete apron there is undercutting and pooling, causing initial stages of a fish barrier.Faster velocity at the end of the apron, creating bank incision and undercuttingSlip on the true right downstream bank

Fish Passage:									
<ul style="list-style-type: none">No fish passage obstruction									
<div><div>

<p>Figure 9: Photo taken from upstream end of Culvert 4.</p></div><div>

<p>Figure 10: Photo taken from downstream end of Culvert 4.</p></div></div>

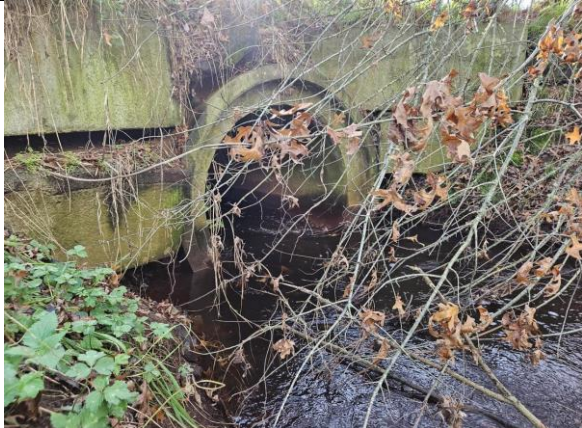
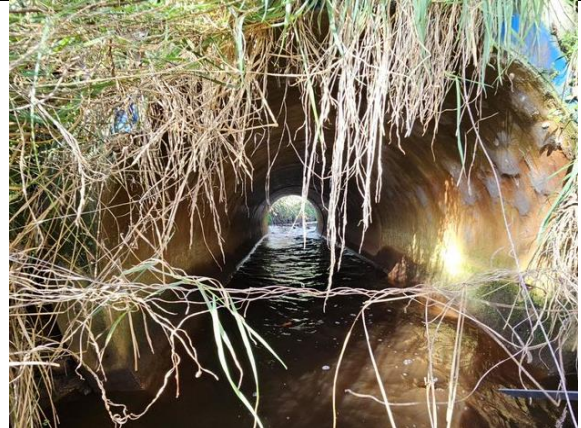
CULVERT 5		Location: 530 Ryburn Road Culvert (Mangaotama Catchment)		Coordinates: -37.931236, 175.253571	
Type of culvert: piped culvert			Length: 12 m		
			Width: 1.6 m		
Wetted width of stream:			Upstream: 3.1 m		
			Downstream: 3.6 m		
Velocity⁹ of the stream:		Upstream:	d1 =	d2 =	d2 – d1 =
		Downstream:	d1 = 650	d2 = 690	d2 – d1 = 40
Upstream Observations: <ul style="list-style-type: none">• Culvert is situated above the streambed• Stream width is significantly wider than the culvert (~1.5 m).• High nutrient levels in the stream (periphyton present)					
Downstream Observations: <ul style="list-style-type: none">• No evidence of embeddedness or sorting and deposition processes within the culvert.					
Fish Passage: <ul style="list-style-type: none">• Moderate impediment to fish passage• Adverse impact to weak swimming species• Does not comply with NPS¹⁰ freshwater regulations• Koi burst swimming would likely overcome this during regular flow conditions

Figure 11: Photo taken from upstream end of Culvert 5.			Figure 12: Photo taken from upstream end of Culvert 5.
