# Technical Report on Vegetation Status in Waituna Lagoon: 2009–2025

This report was commissioned by the Department of Conservation (DOC) and based on work under Project DOC20203.

NIWA – National Institute of Water & Atmospheric Research Ltd  
PO Box 11115  
Hamilton 3251  
Phone +64 7 856 7026

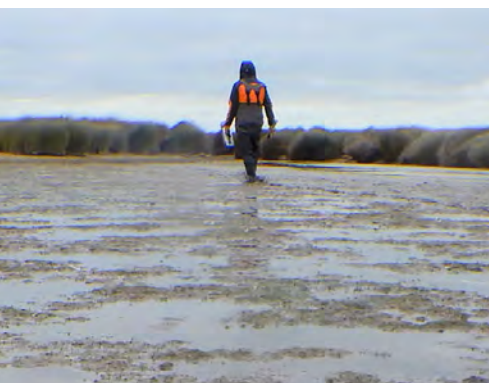
Figure 1: Diverging bar plot showing the number of months for which Waituna Lagoon was open or closed prior to monitoring (as indicated by the y axis). The dotted line indicates the ecological target of three months of lagoon closure before monitoring.

By the time of the annual summer monitoring in January 2025 (20-22 January 2025) the lagoon had been open to the sea for 117 days (Figure 1, Figure 2). Therefore, the target of three months of closed conditions prior to vegetation monitoring (Lagoon Technical Group 2013) was not achieved in 2025 (Figure 1, Figure 2). Nor was it achieved previously in 2024 (Figure 1, Figure 2), although vegetation monitoring in that year was delayed until April by the presence of a toxic algal bloom.

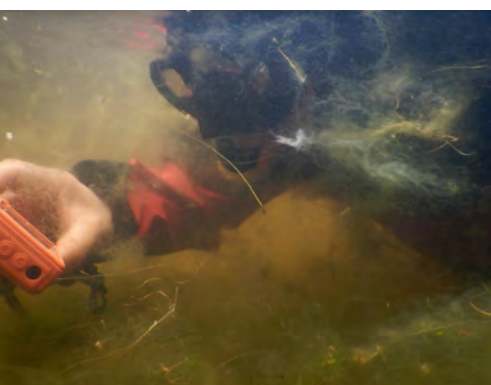
Figure 3: a) Time series of temperature and salinity, b) Chlorophyll-*a* (Chl-*a*), total phosphorus (TP), and total nitrogen (TN), and c) Total suspended solids (TSS) and turbidity at the lagoon centre sampled over 2009 to 2025.

Although a high peak of Chl-*a* (>0.035 mg l<sup>-1</sup>) had been seen previously in winter 2020, a cluster of values that approached or exceeded this value were recorded from July 2023, including a record Chl-*a* value of 0.316 mg l<sup>-1</sup> in January 2024 (Figure 3b). The latter was the algal bloom that precipitated an emergency opening of the lagoon. Chl-*a* declined after the opening but had climbed briefly to 0.042 mg l<sup>-1</sup> by late June 2024 before the September 2024 opening (Figure 3b). Average Chl-*a* values had reduced by the September 2024 to January 2025 period but were higher than the same period for 2020 to 2023.

High nutrient concentrations, particularly TN, were apparent over winter 2023 immediately before the algal bloom but showed ongoing declines following the two lagoon openings in 2024 (Figure 3b). TN levels over spring/summer before the 2025 vegetation monitoring were less than for the same period in the previous five years.

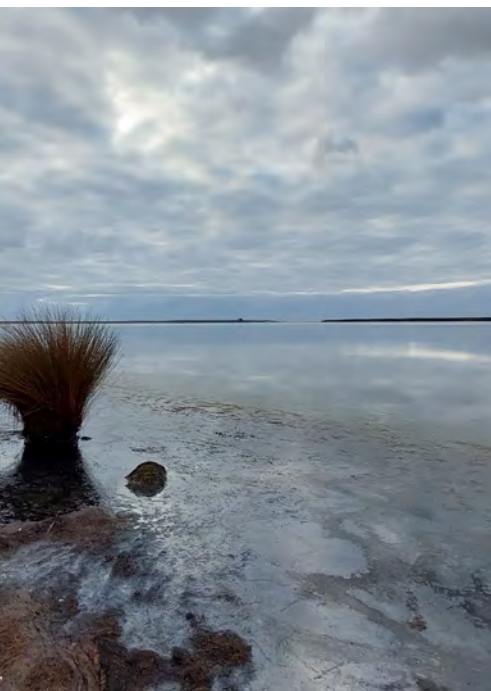
Figure 4: Monitoring sites in Waituna Lagoon. Transects are numbered from 1 to 10 from East to West. The numbers of each transect were allocated on ascending order from North to South. Site T8–9 has been removed due to migration of the coastal barrier.

The location of 47-48 monitoring sites are shown in Figure 4. (One site could not be sampled due to the migration of the coastal spit from 2014 onwards).

The importance of the eastern end of the lagoon as either a refuge for *Ruppia* or a more suitable area for recovery, was apparent again in 2025 as had been noted in previous years. In contrast, 29% of the eastern sites recorded *Ruppia* in 2024, compared to 47% of sites in the west from T6 (Figure 4). The difference between years may have been due to the location of the opening site, which was in the vicinity of Site 2.3 in 2024 when usually the lagoon is opened just west of site 7.7 (Figure 4).

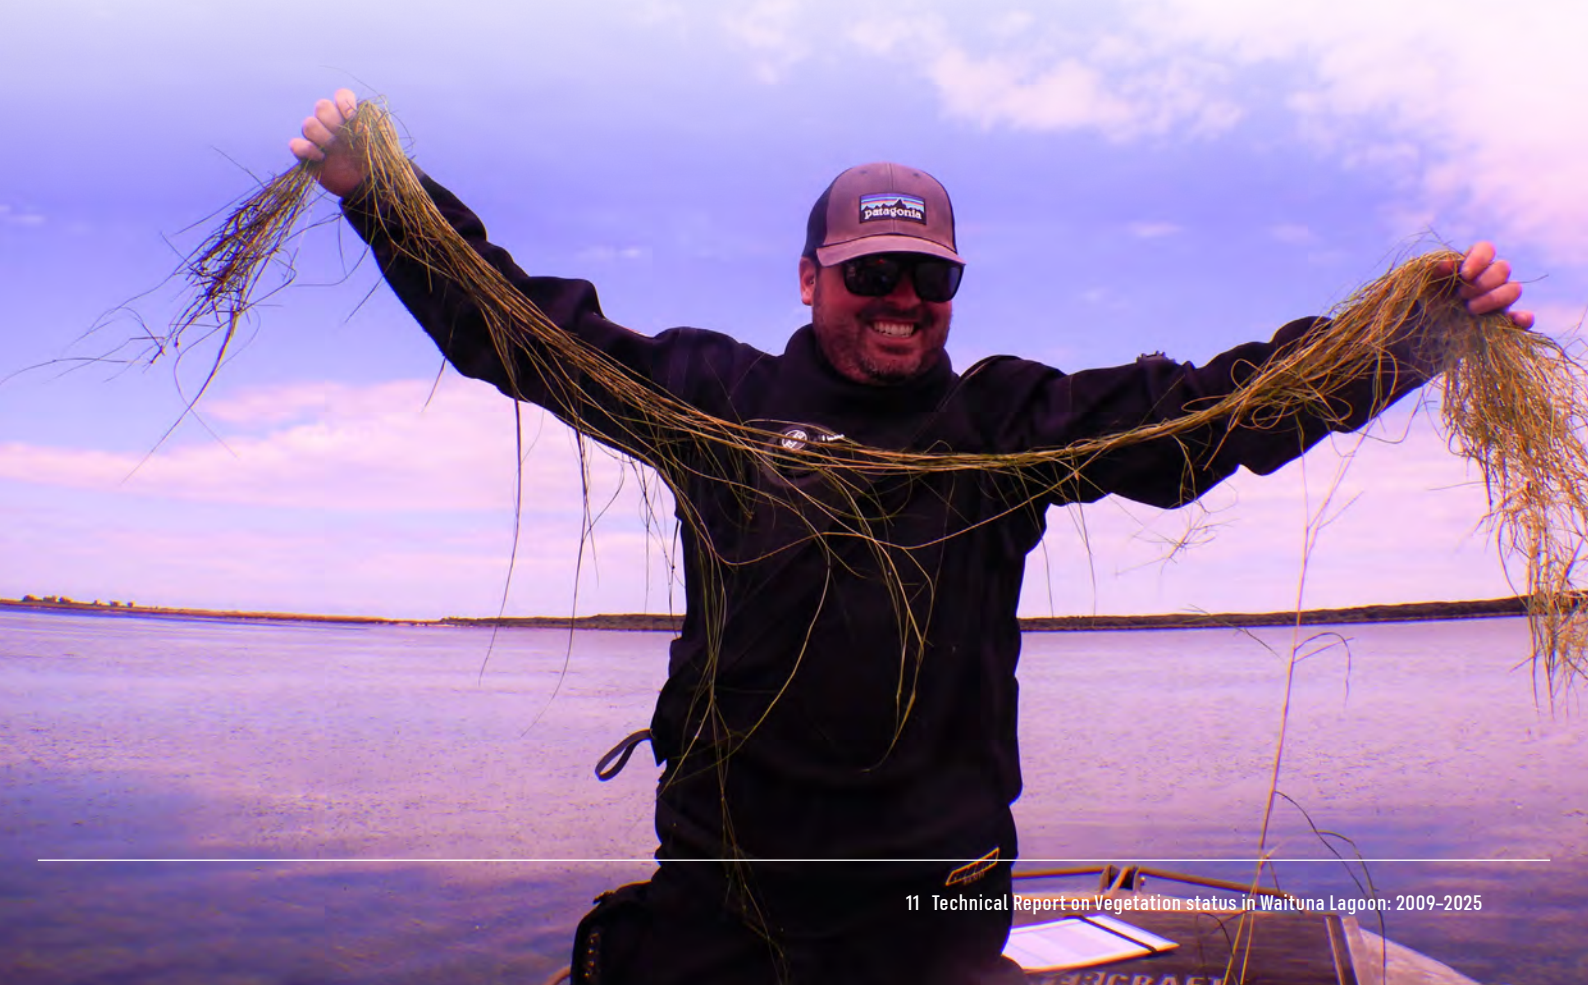
Figure 5: Box and whisker plots of salinity (top), depth (middle) and temperature (bottom) over all monitoring years. (n = 48 or 47).

At the time of the 2025 monitoring, salinity was generally high in the lagoon (average 27.9 PSU) due to the open status that had persisted for almost four months (Figure 5). Higher salinity (average >15 PSU) was observed when the lagoon was open to the sea in 2011, 2014, 2020 and 2021, but an open lagoon in 2013 was associated with low salinity. The year 2024 had intermediate salinity, as the lagoon had been closed for only 15 days at the time of monitoring.

In 2025, the lagoon was open to the sea and was tidal (Figure 2). Water quality parameters could not be recorded at twenty-two sites because they were dry. The average depth of the other sites was 0.45 m. Water depth in 2025 was similar to monitoring during the years 2011, 2013, 2014, and 2021 when the lagoon was also open to the sea (Figure 5). In 2024, all monitored sites were submerged, and their average depth was 0.84 m.

The average water temperature during monitoring in 2025 was 19.6°C, which is the highest value recorded, although a relatively wide range of values was recorded (Figure 5). An average of 16°C to 18°C has been recorded for most monitoring years (Figure 5). In 2024, average monitored water temperature at 11.8°C was substantially lower than the other years (Figure 5) but this was due to monitoring being delayed until April after the earlier presence of a toxic algal bloom.

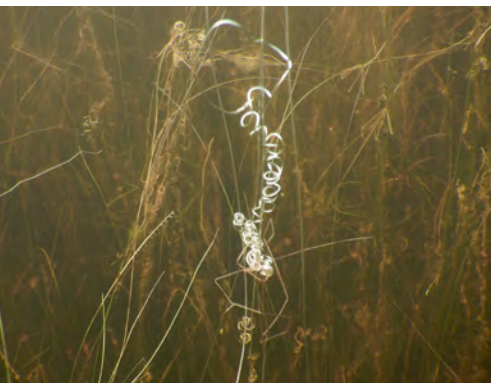
Figure 8: Vegetation composition shown as relative frequency of occurrence (sites recorded) for species or vegetation groups.

In 2025, 38% of sites did not record any vegetation (Figure 8), with the majority of these being dry under the low water level and tidal range of the open lagoon. *Ruppia polycarpa* was recorded at 36% of sites, but *Ruppia megacarpa* was not recorded. *Ruppia polycarpa* was recorded at over half of the sites east to Transect 5, but only 23% of the sites from Transect 6 to the west. Monitored occurrence of *Ruppia polycarpa* in 2025 had decreased slightly from in 2024, this being the second consecutive year that the lagoon was open during the spring-summer growth season.

Macroalgae were relatively common at sites in 2025 (45%) despite the number of dry sites (Figure 8). Green filamentous algae (*Cladophora* species and/or *Rhizoclonium* species) were the dominant macroalgae (43% of sites). *Ulva intestinalis* was recorded at 9% of sites, all within the western half of the lagoon. Other minor macroalgae included the marine brown filamentous *Ectocarpus* species, and green filamentous *Stigeoclonium* species.

Macroalgal occurrence in 2025 had increased since monitored in 2024 following a toxic algal bloom (Figure 8). However, macroalgal occurrence during monitoring over the last three years have been lower than recorded over 2015–2017 and 2019–2022 (Figure 8). Although hoe samples are known to incompletely sample macroalgae, wider *in situ* observations by divers (section ‘Macroalgal cover’) confirm macroalgal results.

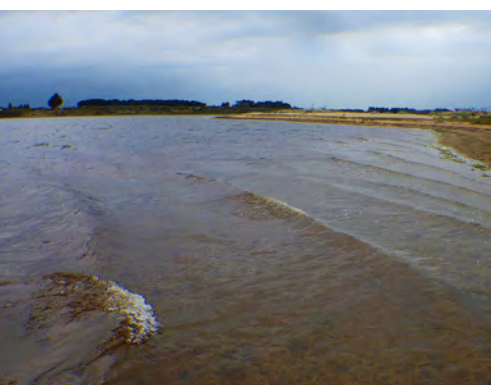
Figure 11: Life-stage category of *Ruppia* species across monitoring years as a proportion of records.

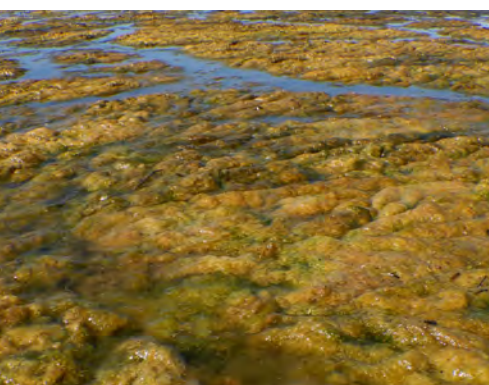
Figure 12: Box and whisker plots of macroalgae cover over monitoring years as an average of hoe measurements at monitoring sites ( $n = 48$  or  $47$ ).

In 2025, the average macroalgal cover recorded in the hoe samples was 15%. This value is intermediate to average cover values of c. 60% recorded during monitoring in 2019 and 2022 and  $\leq 5\%$  recorded in the years 2009–2012, 2014, 2018 and 2023–2024 (Figure 12). Previously in 2016, 2017, 2019 and 2022, macroalgae covers at individual sites have exceeded 100% on occasion (Figure 12), where different macroalgae types formed overlying layers (e.g., benthic mats and surface mats).
