Vegetation Status in Waituna Lagoon: Summer 2025

This report was commissioned by The Department of Conservation (DOC) and based on work under Project DOC24203.

DOC commissioned NIWA to undertake the 2025 summertime Waituna Lagoon survey to document the health of submerged vegetation and to provide an inter-annual comparison of its condition. This report summarises the key findings to guide further ecological management of the lagoon.

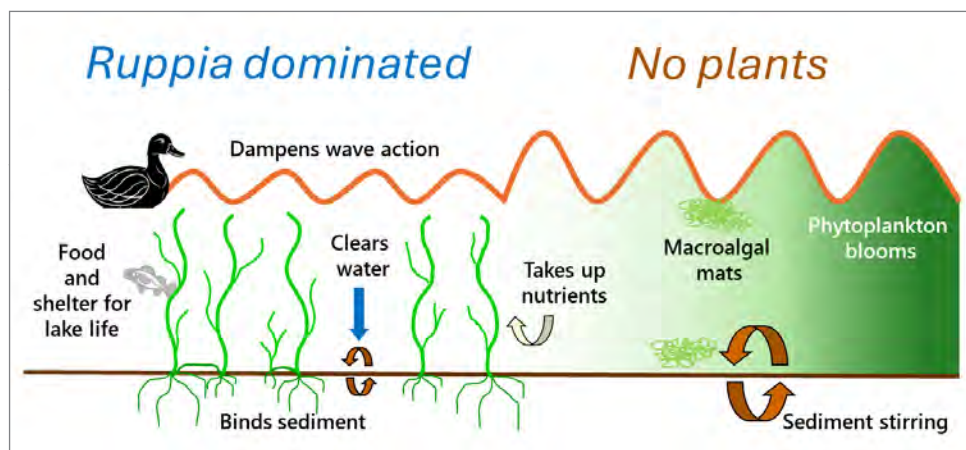
Figure 1: *Ruppia* vegetation can safeguard water quality in the lagoon compared to a system with no plants.

Submerged plants have an important role in keeping shallow lakes and lagoons clean and healthy (Figure 1). If submerged plant communities become too stressed, they can collapse. The lake or lagoon then enters a new, dirty water state, with high levels of resuspended sediment and development of macroalgal mats or phytoplankton blooms instead of plants. The submerged native plant species of *Ruppia* (horse's mane) safeguard water quality in Waituna Lagoon. *Ruppia* tolerates fluctuating levels of saltwater in lagoons better than other submerged plants, but does not occur in the sea. Other plants, including a nationally rare, salinity-tolerant charophyte, also occur at Waituna Lagoon.

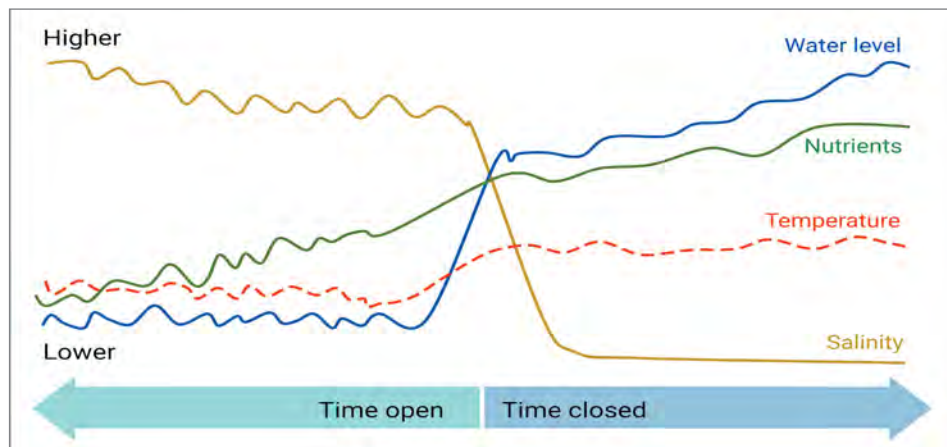
Figure 2: Key changes in the waters of Waituna Lagoon with time after opening or closing to the sea.

Monitoring of the waters of Waituna Lagoon over time⁵ has built up a picture of the key changes caused by opening events⁶. Water level is lower and salinity higher when the lagoon is open and temperature and nutrient concentrations are both reduced with flushing by the sea (Figure 2). These changes and their duration influence the vegetation of Waituna Lagoon.

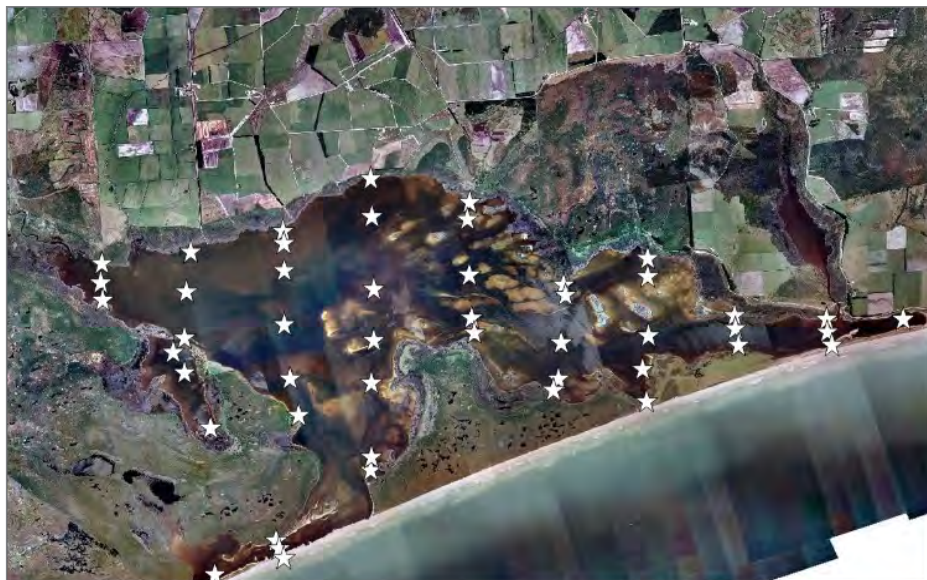
Figure 3a: Map showing the location of sampling sites (47-48).

The lagoon is monitored each year in late summer at 47-48 sites (Figure 3a). At each site, an assessment of environmental quality includes depth and water quality measurements (Figure 3b). Substrate characteristics are measured in four samples of the lagoon bed retrieved using a garden hoe, and the composition and abundance of vegetation is also described, including *Ruppia* life-stage as flowering or vegetative. Submerged native plants and dominant macroalgae are shown in Figure 4.

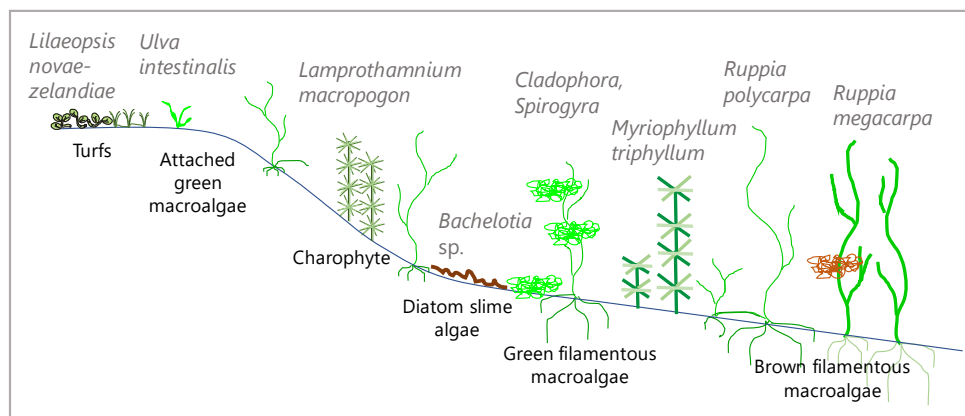
Figure 4: Common submerged plants and macroalgae types in Waituna Lagoon.

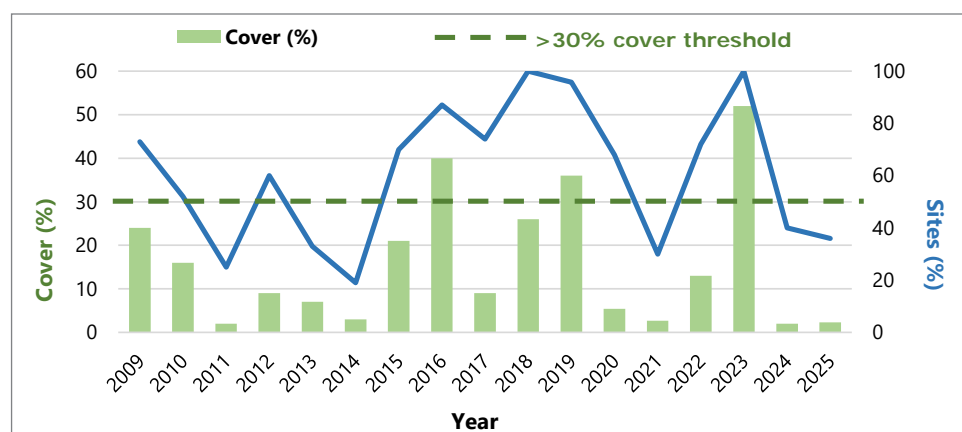
Figure 5: Lagoon-wide cover of *Ruppia* is shown as green bars and percentage of sites at which *Ruppia* was present as a blue line.

The lagoon-wide cover of *Ruppia* in 2025 was 2% (Table 2) and did not meet the ecological target. Plants of *Ruppia* species were recorded at fewer than half of the monitoring sites and *Ruppia* cover did not exceed an average cover of 30% at any monitoring site.

The occasions when the *Ruppia* cover target has been met are shown as bold, in highlighted cells in Table 2. The years 2016, 2019 and 2023 that met this target (Table 2, Figure 5) were the second of two consecutive years of lagoon closure during the critical spring-summer growth period for *Ruppia*.

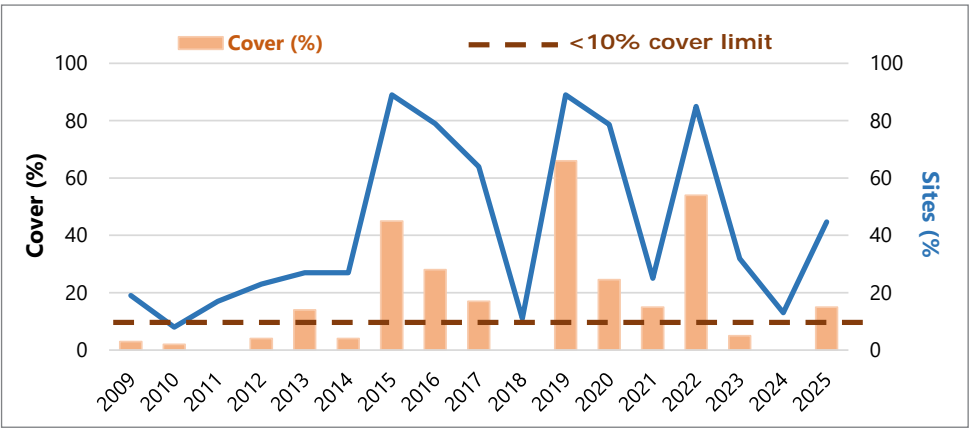
Figure 6: Lagoon-wide cover of macroalgae is shown as orange bars and percentage of sites at which macroalgae was present as a blue line.

The target for macroalgae cover was not met in 2025 (Table 4, Figure 6). The lagoon-wide cover of 15% occurred when the lagoon was open to the sea during monitoring. Macroalgal development at the time of monitoring (Table 4) does not strongly reflect the status of the lagoon closure target (Table 1). However, macroalgae abundance is known to respond quickly to favourable short-term conditions such as high water temperature and still conditions.
