Vegetation Status in Waituna Lagoon: Summer 2020

This report was commissioned by The Department of Conservation (DOC) and based on work under Project DOC20203.

DOC commissioned NIWA to undertake the 2020 summer-time Waituna Lagoon survey to document the health of submerged vegetation and to provide an inter-annual comparison of its condition. This report summarises the key findings to guide further ecological management of the lagoon.

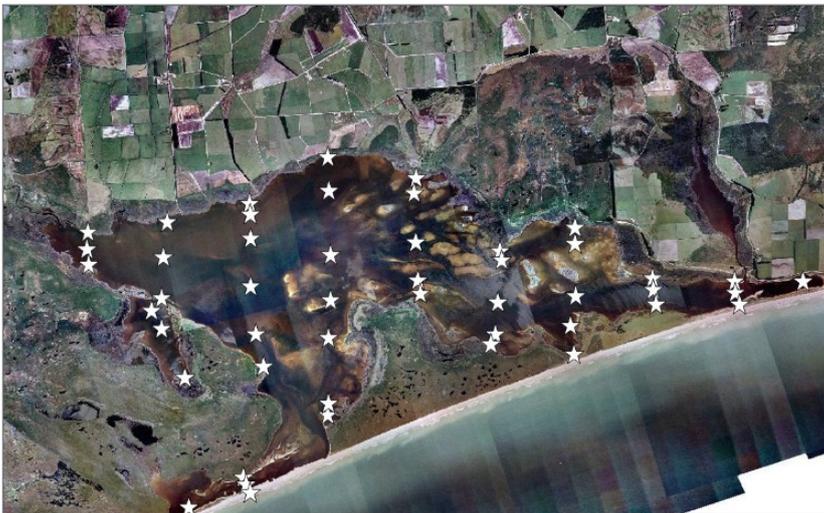
Figure 3a: Map showing the location of sampling sites (47-48).

The lagoon is monitored each year in late summer at 47-48 sites (Figure 3a). At each site, an assessment of environmental quality includes depth and water quality measurements (Figure 3b). Substrate characteristics are measured in four samples of the lagoon bed retrieved using a garden hoe, and the composition and abundance of vegetation is also described, including *Ruppia* life-stage as flowering or vegetative. Submerged native plants and dominant macroalgae are shown in (Figure 4).

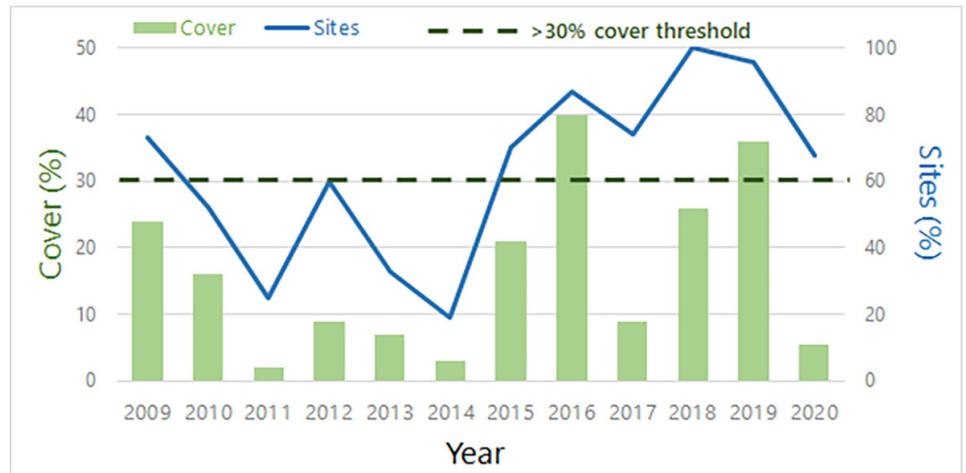
Figure 5: Lagoon-wide cover of *Ruppia* is shown as green bars and percentage of sites at which *Ruppia* was present as a blue line.

A healthy *Ruppia* community occupies a large habitat area in Waituna Lagoon. This is measured by calculating the percentage cover of *Ruppia* across all sites in the Lagoon. In 2020, the lagoon-wide average cover did not meet the ecological target (Box 1) of >30–60% (Table 2, Figure 5).
