Technical Report on Vegetation Status in Waituna Lagoon: 2009–2021

This report was commissioned by the Department of Conservation (DOC) and based on work under Project DOC20203.

Introduction

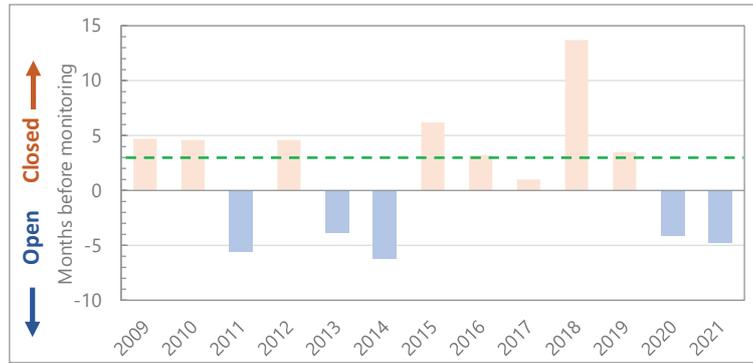
Figure 1: Diverging bar plot showing the number of months for which Waituna Lagoon was open or closed prior to monitoring (as indicated by the y axis). The dotted line indicates the ecological target of three months of lagoon closure before monitoring.

The lagoon was open to the sea for a period of almost 5 months (145 days) prior to the annual monitoring of vegetation in February 2021 (Figure 1, Figure 2). Therefore, the target of three months of closed conditions prior to vegetation monitoring (Lagoon Technical Group 2013) was not achieved in 2021. This target recognises that open lagoon conditions may be detrimental to *Ruppia* development if openings persist through the main spring-summer growth period for vegetation (September to February).

The lagoon has previously been open to the sea for similar spring-summer periods lasting 3.9 to 6.2 months prior to monitoring in 2011, 2013, 2014, 2017 and 2020 (Figure 1 negative axis, Figure 2).

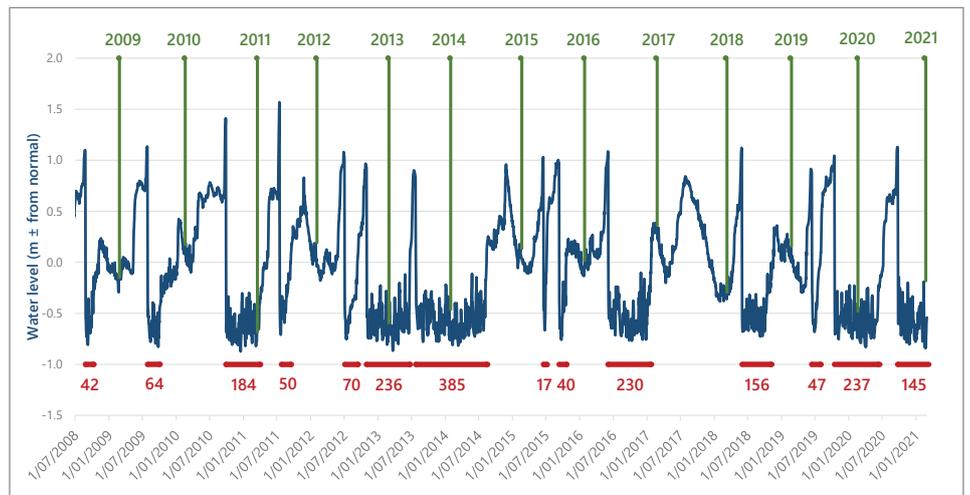
Figure 2: Plot showing the continuous water level time series for Waituna Lagoon, measured at Waghorns Road. Periods of lagoon opening are indicated by horizontal red lines. The number of days during which the lagoon was open correspond to the red numbers. Finally, the annual summer vegetation monitoring events are indicated by green vertical lines.

The lagoon was opened in late September 2020, after which the water level averaged 0.59 m less than normal up until the vegetation monitoring date (mid-February 2021), with oscillations around this value due to tidal exchanges and sea level (Figure 2).

The frequent artificial openings of Waituna Lagoon over the period of vegetation monitoring are very different from the natural situation (Hume et al. 2016). Usually, artificial openings are made on an annual or more frequent basis, for variable timeframes (Figure 2).

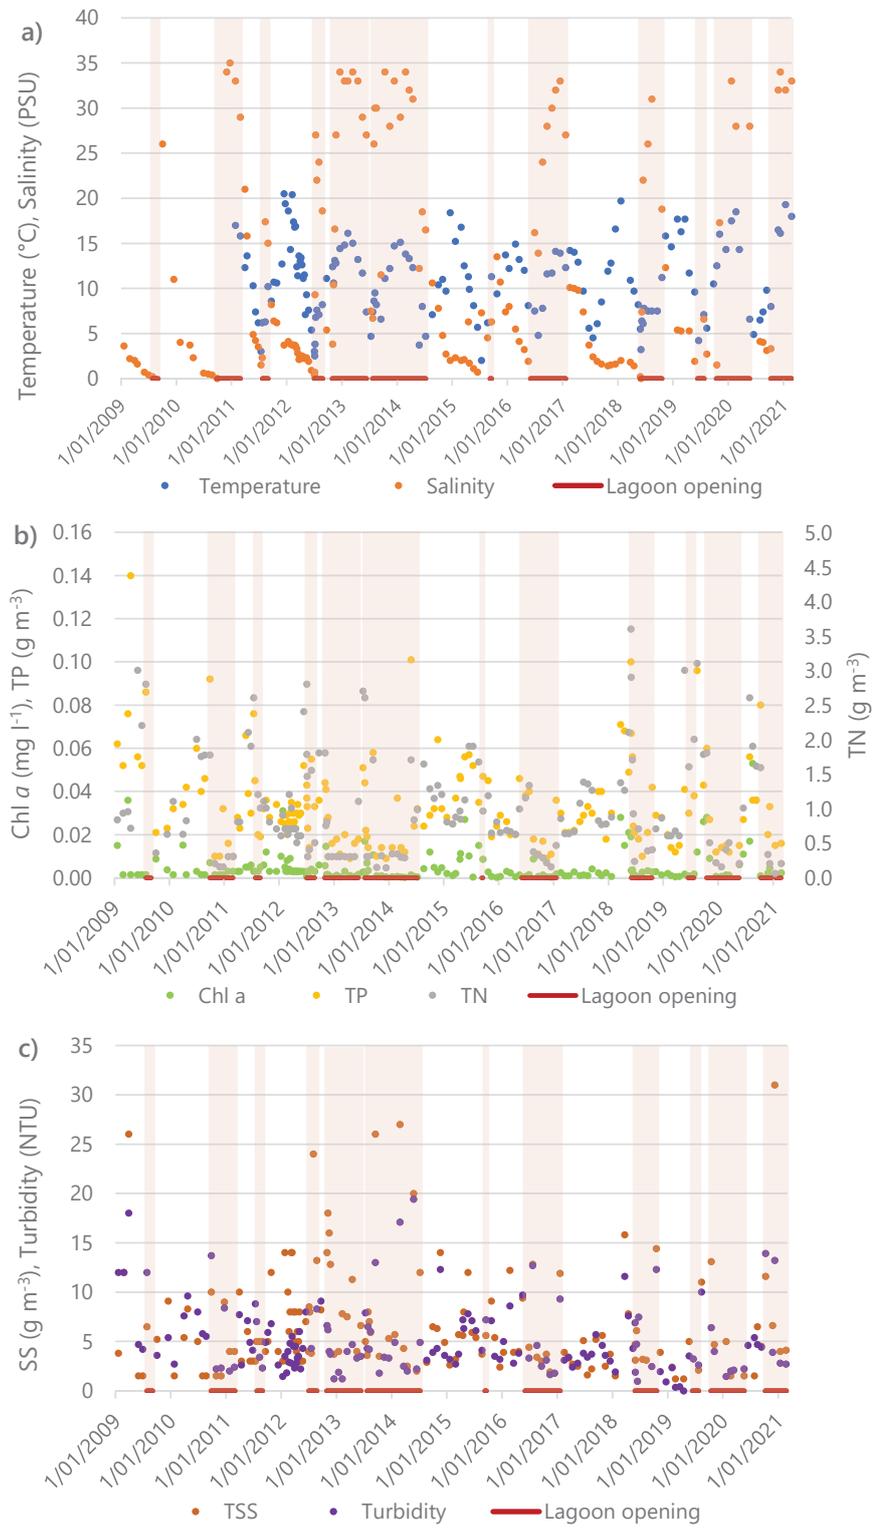
Figure 3: a) Time plots of temperature and salinity, b) Chlorophyll-*a* (Chl-*a*), total phosphorus (TP), and total nitrogen (TN), and c) Total suspended solids (TSS) and turbidity at the lagoon centre sampled over 2009 to 2021.

The open mouth conditions during the main 2020/21 spring/summer *Ruppia* growth season resulted in high (over 30 PSU) salinity levels recorded in the central lagoon (Figure 3a). Similar high salinities have only been recorded only when the lagoon is open. Over the 2020/21 spring/summer growth season, temperatures increased seasonally between 15 and 20°C, similar to the previous three years and reaching higher temperatures than were seen between 2016 to 2017, according to Environment Southland data (Figure 3a).

Following the September 2020 opening, the previously elevated nutrients (TP and TN) and chlorophyll-*a* concentrations (Chl-*a*) decrease, similar to patterns seen in 2018 and 2019 (Figure 3b). Peak nutrient levels recorded over the previous three years were greater than over 2016 and 2017. Measures of suspended solids and turbidity were variable following the most recent opening, in contrast to earlier decreases seen in 2019/20 (Figure 3c).

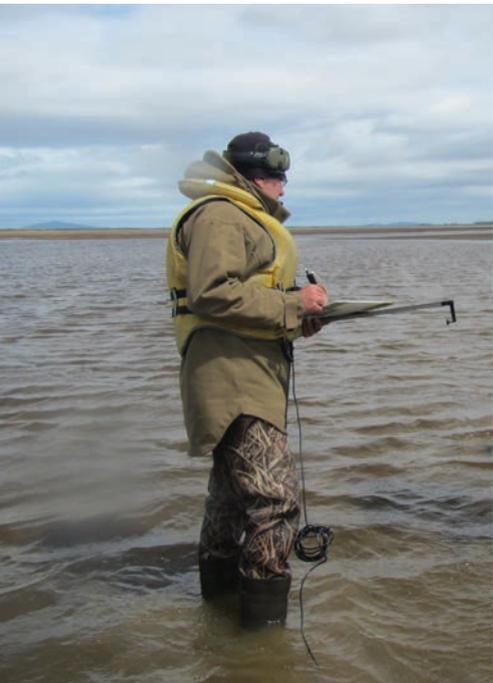
Figure 4: Monitoring sites in Waituna Lagoon. Transects are numbered from 1 to 10 from East to West. The numbers of each transect were allocated on ascending order from North to South.

The location of 47-48 monitoring sites is given in Figure 4. (One site could not be sampled due to the migration of the coastal spit from 2014 onwards).

Under the open lagoon conditions at the time of the February 2021 monitoring, the average salinity was 29 PSU. Salinity values were similar to levels recorded in 2011, 2014 and 2020 (Figure 5 top), all monitoring occasions timed when the lagoon had been open for over 4 months. Seventeen sites in 2021 recorded >30 PSU, all of which were located west of transect T5 (Figure 4).

Sixteen sites were dry at the time of the 2021 monitoring. Most of these sites (twelve) were along the northern margins of the lagoon but also included the shallow southern arm close to the lagoon opening site (Figure 4). Average depth at monitoring sites in February 2021 (0.27 m) was the lowest of all monitoring years, being less than values recorded during previous monitoring during open lagoon conditions in 2011, 2013, 2014 and 2020 (Figure 5 middle). The remainder of monitoring events were deeper due to closed lagoon conditions, although 2018 also had relatively low water levels (Figure 5 middle) due to a drought year in the region rather than open mouth status.

No vegetation (plants or macroalgae) was recorded at sixteen monitoring sites, based on the hoe samples in 2021 (Figure 9), with six of these sites being dry at the time of monitoring. The non-vegetated sites that were immersed were all in the south-western half of the lagoon (T 7.3–7.7, 8.3–8.5, 9.2 and 10.2, Figure 4). Sites without any vegetation were fewer than previous years when the lagoon had similarly been open for c. 4-6 months in 2011 (29 sites), 2013 (26 sites) and 2014 (32 sites). However, these years had a much lower contribution by macroalgae (Figure 9).

Ruppia polycarpa was the most widespread submerged plant recorded in the hoe samples in 2021 but was present at only eleven sites. *R. megacarpa* was recorded at three sites, none of which recorded *R. polycarpa* and were restricted to the eastern lagoon (T 1.1, 4.3 and 4.5, Figure 4). Overall sites with *Ruppia* comprised less than half the number recorded in 2020. Correspondingly, *Ruppia* species in 2021 together formed a lower contribution to vegetation composition than recent years of 2015 to 2020 and was similar to previous extended opening years of 2011 and 2014 (Figure 9).

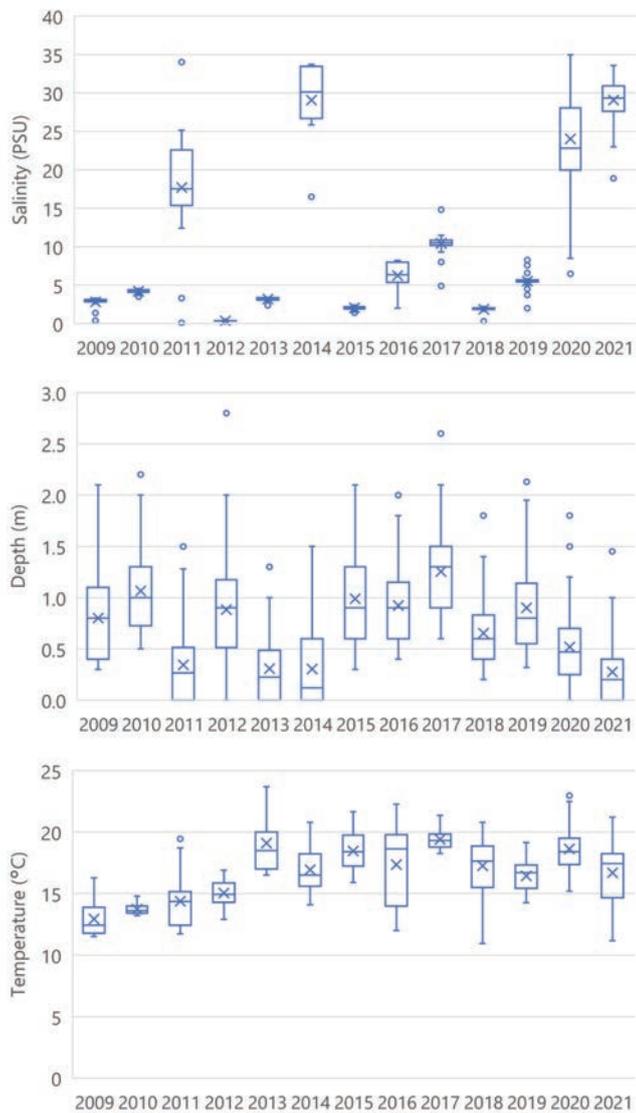
Figure 5: Box and whisker plots of salinity (top), depth (middle) and temperature (bottom) over all monitoring years. (n= 48 or 47).

Water temperatures recorded for lagoon waters during the 2021 monitoring event (average 16.7°C) were lower than recorded in 2013, 2015, 2017 and 2020 but higher than 2009 to 2012 (Figure 5 bottom).

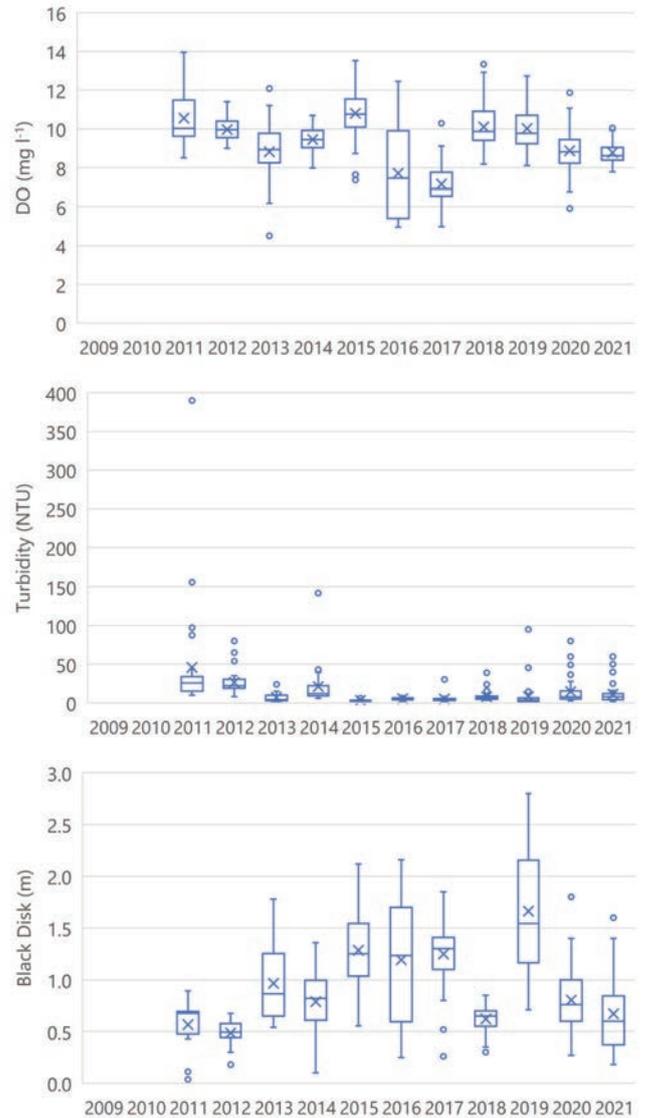
Figure 6: Box and whisker plots of DO (top), turbidity (middle) and black disk (bottom) at the monitoring sites (n= 48 or 47), from 2011 to 2021.

An average DO of 8.8 mg l⁻¹ recorded during monitoring in 2021 was similar to 2013, 2014 and 2020 (Figure 6 top). The 2021 minimum DO of 7.8 mg l⁻¹ was well above the threshold of 5 mg l⁻¹ that is considered necessary for healthy aquatic life. Over 75% of sites in 2021 recorded DO values >85%, which indicates well oxygenated conditions.

An average turbidity of 11.2 NTU during the 2021 monitoring, is similar to 2013 and 2015–2019 but lower than 2011, 2012, 2014 and 2020 (Figure 6 middle). However, the black disk measurement averaged only 0.67 m in 2021 and was amongst the lowest values recorded, similar to 2011, 2012, 2018 and 2020 (Figure 6 bottom). This may reflect the very shallow depths of many sites in 2021 and observed resuspension of sediment. Water colour (dissolved organic carbon) can also reduce water clarity. Also notable in 2021 was the occurrence of strong currents at some central sites (in keeping with low and tidally influenced lagoon levels) that resulted in observed re-suspension of macroalgae and other drift debris that would have contributed to low visual clarity (black disk). These influences would not necessarily be detected as turbidity (NTU).

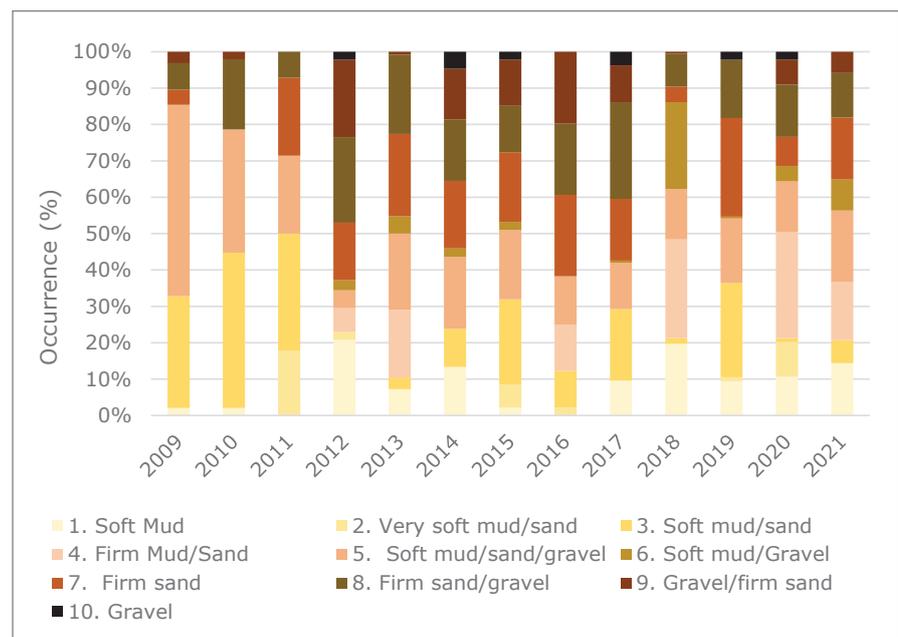
Figure 7: Bar plot illustrating the composition in substrate type (% occurrence), recorded during each of the annual monitoring surveys. Substrate types are numbered from softer to harder.

Sediment composition in 2021 showed a similar low proportion of softer/finer substrates (categories 1 to 3) to monitoring events recorded in 2012–2014, 2016, 2018 and 2020 (Figure 7). By contrast, substrates in 2009 to 2011, 2015, 2017 and 2019 were softer/finer (Figure 7). Substrates characterised by firm sand (categories 7 and 8, Figure 7), comprised a higher proportion (>30% samples) over 2012 to 2017, 2019 and 2021.

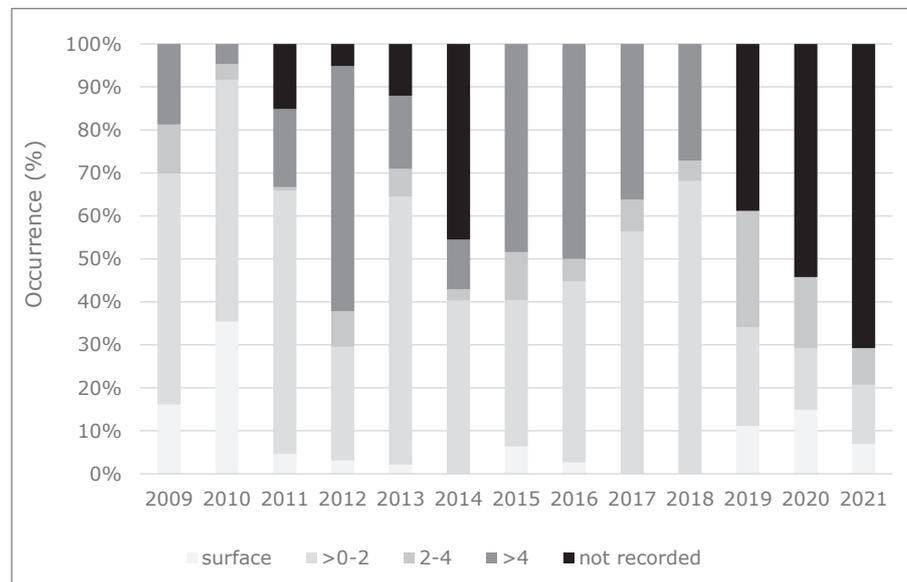
Figure 8: Substrate depth to a blackened layer shown as occurrence (% records) for five incremental depth categories.

Only 7% of substrate samples recorded a blackened layer at the surface in 2021 (Figure 8). Most of these samples comprised soft mud. By contrast, 71% of samples did not record a blackened layer as it was either not present or positioned deeper than the sample (4-6 cm). This absence of a blackened layer is similar to the 2014 results, which also followed an extended period of lagoon opening. As observed in 2020 (after an extended opening), a number of samples (11%) in 2021 had a mottled appearance where a distinct blackened layer could not be discerned.

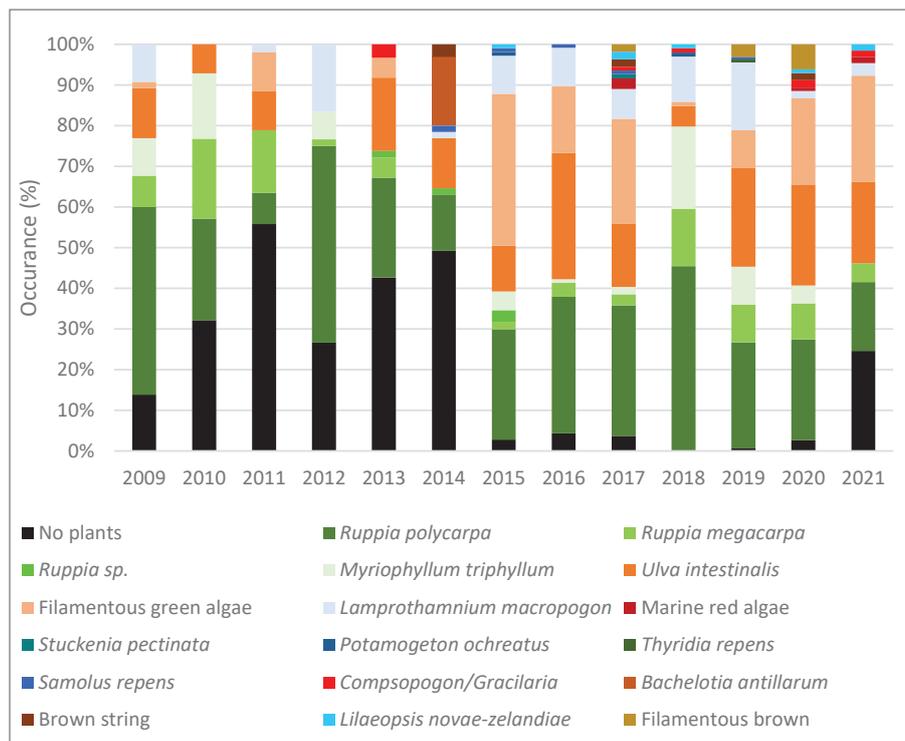
Figure 9: Vegetation composition shown as relative frequency of occurrence (sites recorded) for species or vegetation groups.

Recorded diversity of other submerged plants in the hoe samples was low in 2021, similar to 2020 (Figure 9). The charophyte *Lamprothamnium macropogon* was present at two sites in the eastern lagoon. This charophyte has been more conspicuous in the years that the lagoon has been closed including 2012, 2015-2016 and 2018-19 (Figure 9). The amphibious turf plant *Lilaeopsis novae-zelandiae* was recorded at one dry site in 2021 (Figure 9). The freshwater macrophyte *Myriophyllum triphyllum* was not recorded in 2021.

Macroalgae formed a major component of the vegetation in 2021 (Figure 9) but to a lesser extent than in 2020 based on hoe samples. Again, macroalgae were dominated by filamentous green species (17 sites) and *Ulva intestinalis* (13 sites), but overall species composition showed stronger brackish/marine associations than in 2020. Filamentous green algae were mainly comprised of the genus *Cladophora* but were sometimes co-dominated by *Rhizoclonium*, *Microspora* or cf. *Draparnaldia*.

The diatom *Bachelotia antillarum* has not been prominent since 2014 (Figure 9). In contrast to recent years, *Bachelotia* was noted as widespread in 2009 and 2010 (Robertson and Stevens 2009, Stevens and Robertson 2010). However, the hoe did not sample this alga successfully and results were not able to be adequately quantified or included in the results plotted in Figure 9.

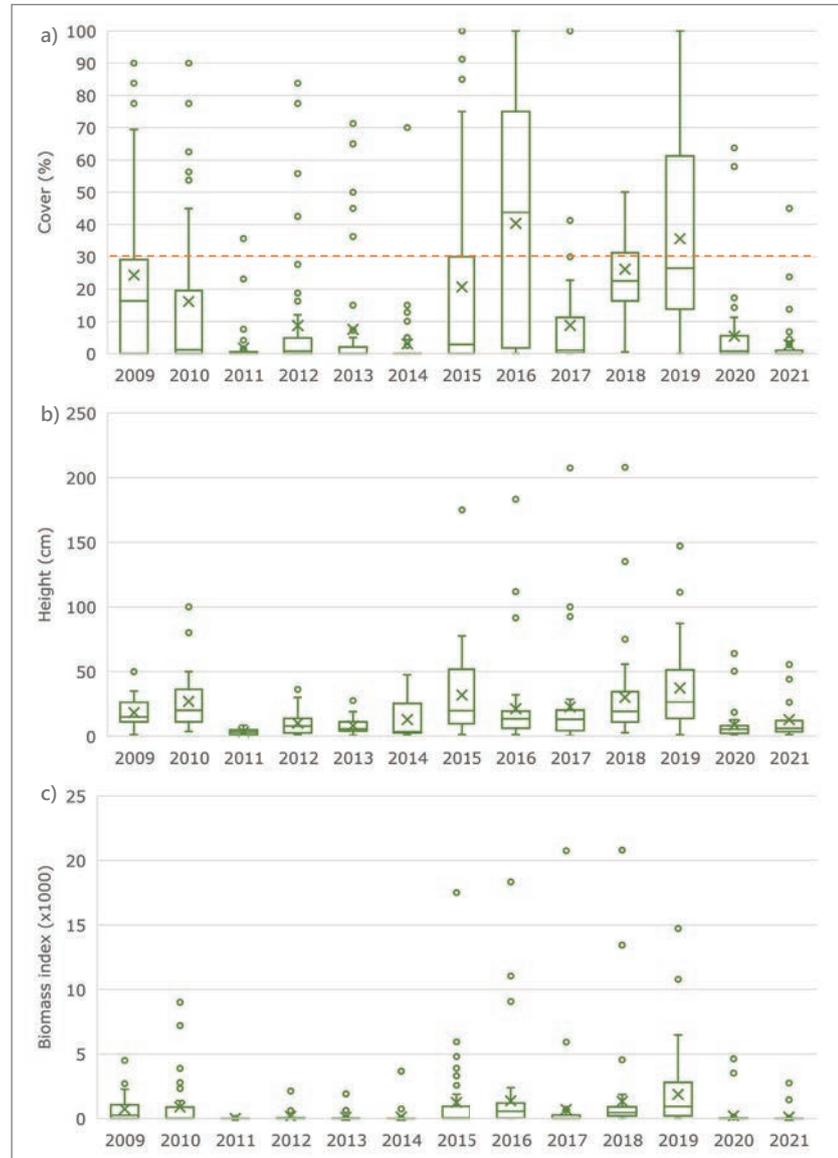
Figure 10: Box and whisker plots of *Ruppia* cover a), height b) and derived biomass index c) over monitoring years, as an average of measurements at monitoring sites (n= 48 or 47). Dotted line represents the lagoon-wide target for *Ruppia* cover of 30% identified by the Lagoon Technical Group (2013).

Average *Ruppia* covers measured by the hoe method in 2021 were 2.7%, which at <10% is amongst the lowest previously recorded years of 2011–2014, 2017 and 2020 (Figure 10a). The highest *Ruppia* covers of ≥ 20 -80% were exclusively associated with *R. megacarpa* in 2021. Previously, *R. megacarpa* was also disproportionately represented in hoe samples that recorded high covers ($\geq 80\%$).

The average height of *Ruppia* in 2021 measured from hoe samples was 12.8 cm. This is similar to the lowest previously recorded years of 2011–2014 and 2020. All recorded *Ruppia* heights over 20 cm were represented by *R. megacarpa* in 2021, which comprised the three taller outliers in the graph (Figure 10b). *Ruppia megacarpa* has been disproportionately represented amongst the taller height records in all monitoring events to date.

‘Biomass index’ is calculated as the product of average cover x height at sites using the hoe method and is a proxy for biomass in *Ruppia*. The average biomass index in 2021 at 103 was similar to 2011–2014, 2017 and 2020 (Figure 10c). In contrast, average biomass index exceeded 1000 in 2015–2016 and 2018–2019 (Figure 10c). As common in years before, high outliers for biomass index in 2021 represent sites with *R. megacarpa*.

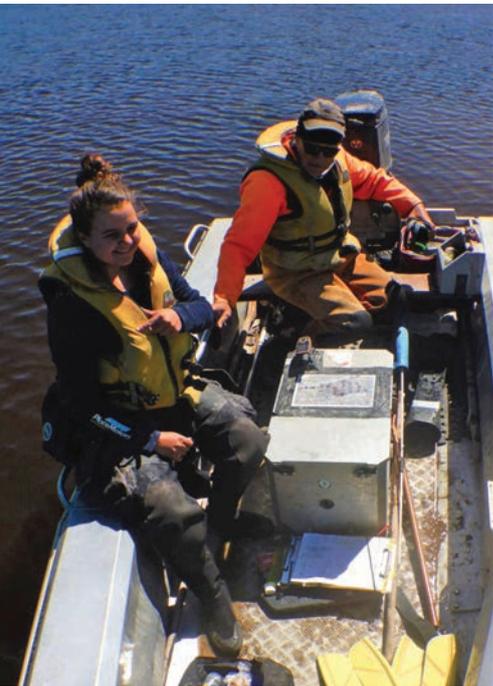
Figure 11: Relationship between *Ruppia* cover (top) and height (bottom) estimated from hoe samples and diver observations within a 10 m diameter area at each site.

Diver observations within a 10 m diameter area at each site show some correlation with *Ruppia* covers and heights sampled with the hoe method since 2013 (Figure 11 top). However, observations at the larger spatial scale were more likely to detect *Ruppia* where plant covers were low or patchy. In 2021, the average lagoon-wide cover of *Ruppia* estimated from diver observations was 4.3% (not much greater than the 2.7% cover measured using the hoe method). Diver observations similarly showed low average *Ruppia* covers of less than 12% for monitoring years 2013, 2014, 2017 and 2020, with covers exceeding 30% for the years 2015, 2016, 2018 and 2019. Average height of *Ruppia* estimated by divers in 2021 was 19.6 cm, compared to 12.8 cm measured using the hoe method, in keeping with diver method tendency to report taller plants over the larger assessed area (Figure 11 bottom).

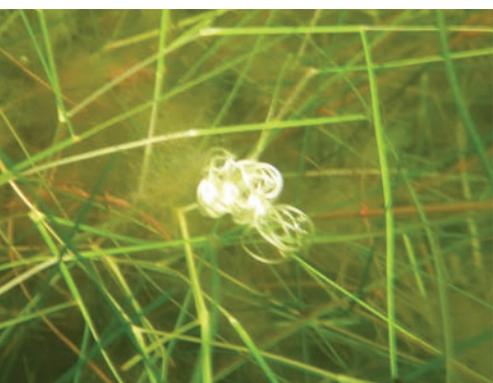
Figure 12: Life-stage category of *Ruppia* species across monitoring years as a proportion of records.

Only *R. megacarpa* was recorded as flowering or post flowering at two sites in 2021. This reproductive status at just 6% of hoe observations for *Ruppia* is amongst the lowest recorded, similar to 2011, 2013-2014, 2017 and 2020 (Figure 12) when the lagoon had also been open for much of the *Ruppia* spring-summer growth period.

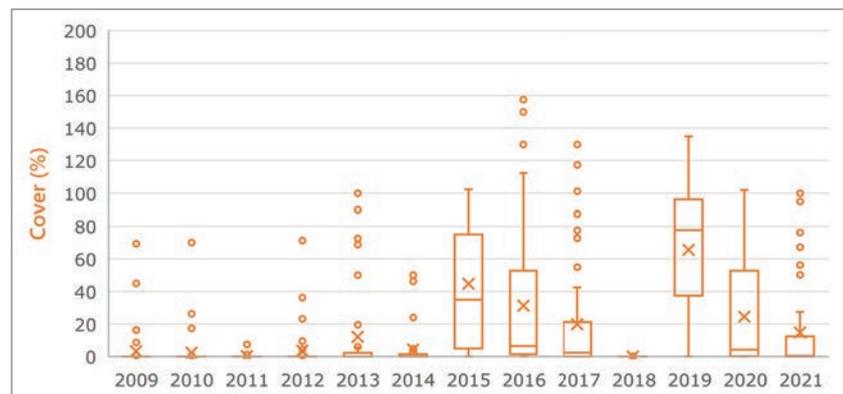
Figure 13: Box and whisker plots of macroalgae cover over monitoring years as an average of hoe measurements at monitoring sites (n= 48 or 47).

In 2021, the lagoon-wide average cover for macroalgae was 14.8% according to the hoe method (Figure 13). This was a lower macroalgae cover than the average values of 25–66% recorded over 2015–2016 and 2019–2020 (Figure 13). Macroalgae levels based on the hoe method in 2021 were substantially higher on average than recorded in 2009–2014 and 2018 (Figure 13). Notably in 2021, the highest macroalgal covers from the hoe method predominated amongst western lagoon sites (T8–T10), comprising six out of the seven sites that recorded average macroalgae covers >50%. Note that macroalgae could exceed 100% cover at some sites due to combinations of benthic, epiphytic, and floating growths of different algal types (Figure 13).

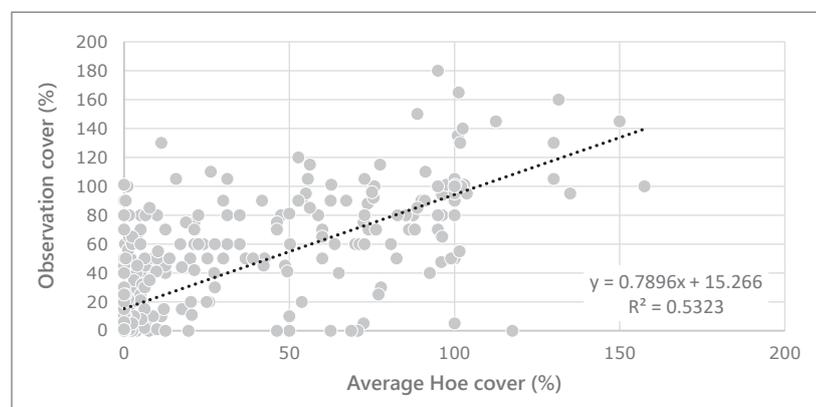
Figure 14: Relationship between macroalgal percentage cover estimated from hoe samples and diver observations within a 10 m diameter area at each site.

There remains a weak correlation (all monitoring years) between macroalgal cover estimate by hoe samples and overall covers observed by divers (Figure 14). Diver observations provided a higher lagoon-wide estimate of macroalgae cover, than the hoe method of 26.6% in 2021, but because of the issues with macroalgae drift, this was still likely to be an underestimate of macroalgal abundance in 2021.
