Lessons Learnt 003

Creation of rock weir and installation of culvert baffles to enable salmonid passage

December 2019 V2

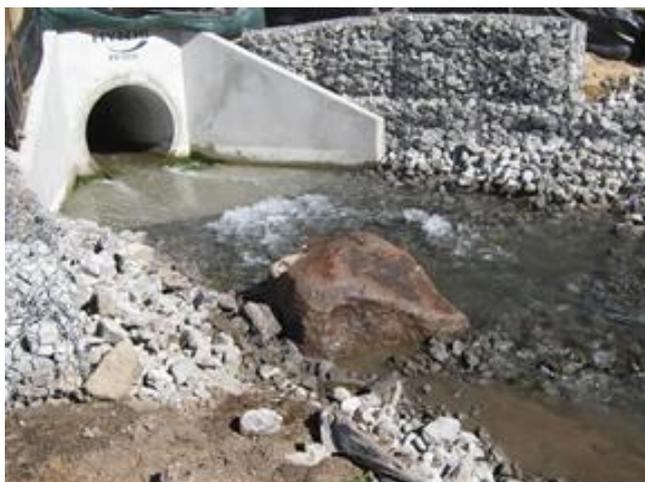
A 1200 mm diameter single barrel concrete road culvert was installed in Waiowhero Stream, Rotorua during a State Highway 5 road upgrade (Figure 1). This replaced an existing embedded culvert that provided effective fish passage. The new replacement culvert presented a problem for fish passage through being flush mounted, not embedded, and longer than the previous culvert; providing a lower water depth (i.e. 50 mm est.) and higher water velocities.

Figure1. New replacement culvert installed in Waiowhero Stream, Rotorua, early in remediation process showing shallow, high velocity water spilling from concrete apron.

Opus consultants cemented around 80 cobble baffles (100 mm x 150 mm approx.) spaced 50-70 cm apart along the culvert base in an irregularly staggered pattern to break the flow, slow water velocity, raise water level and provide resting areas for fish.

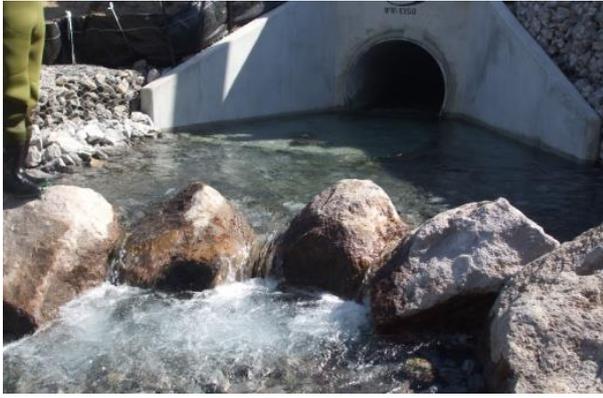
Figure 2. New replacement culvert installed in Waiowhero Stream, Rotorua, with the upstream facing 'V' weir downstream (March 2010. Photo: John Meikle)

Downstream of the culvert apron, the contractors under Fish & Game supervision placed 6 large boulders (largest available) in an upstream facing 'V' weir (Figures 2 & 3) to provide adequate conditions needed for passage including:

- An increase in the water level of about 100-150 mm across the apron and through the culvert.
- A decrease of the water velocity (not measured) through the culvert and over the 'wing wall' apron so that fish could negotiate the culvert.
- The formation of a pool immediately downstream of the culvert as a result of the increased water level of 100-150 mm. The pool allowed trout to negotiate the obstacle by jumping.

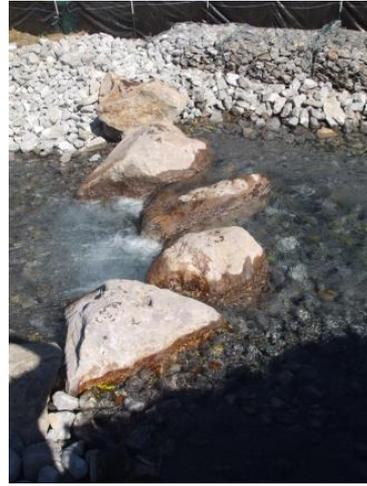
Figure 3. Side view of the upstream facing 'V' weir downstream of the culvert. (Photo: John Meikle)
