# Appendix I

### Proposed Plan Change 1 - Regional Coastal Plan

- Kermadec and Subantarctic Islands

### Vessel hull and niche area inspection - requirements, method and forms

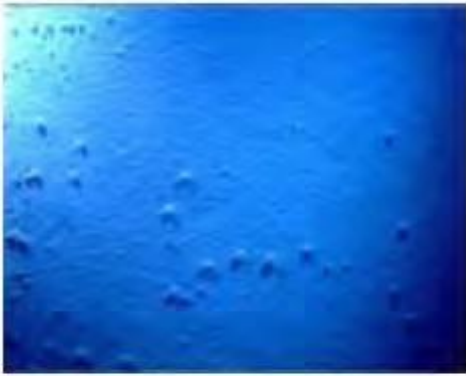
| LOF rank | Criteria |
|---|---|
| 0 | No visible biofouling. Hull entirely clean, <b>no slime fouling (biofilm)</b> on any visible submerged parts of the hull. |

Figure A4.3. Definition of the LOF ranks (ranging from 0 to 5) and example images of vessel hull surfaces of each of the different ranks (continued on next page).

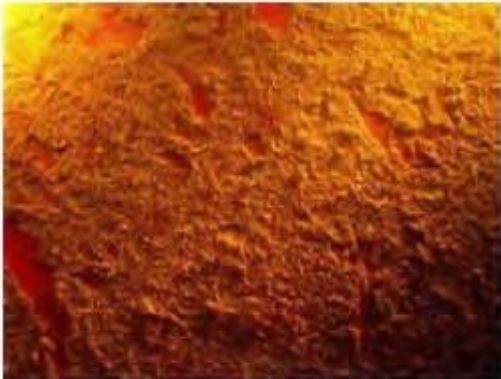
| LOF rank | Criteria |
|---|---|
| 1 | Hull partially or completely covered in slime fouling (biofilm). <b>Absence of any macrofouling.</b> |

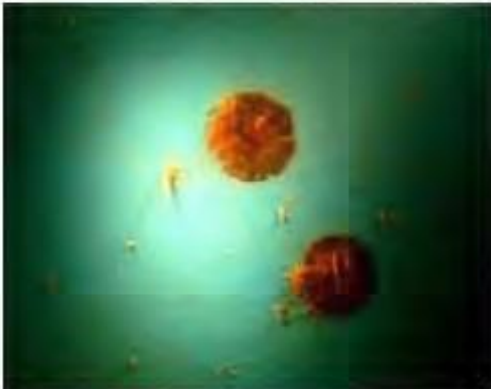
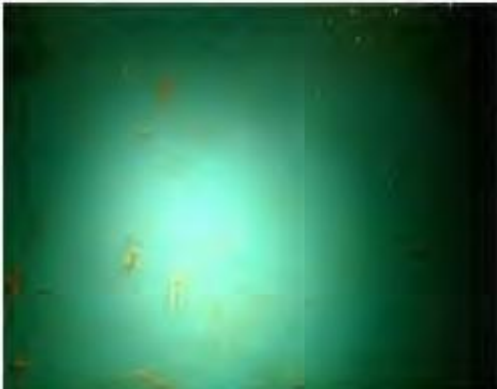
| LOF rank | Criteria |
|---|---|
| 2 | <b>Light biofouling.</b> 1–5% of visible surface covered by very patchy macrofouling. Remaining area often covered in slime. Examples below show presence vs. absence of fouling in two adjacent areas of a vessel hull. |

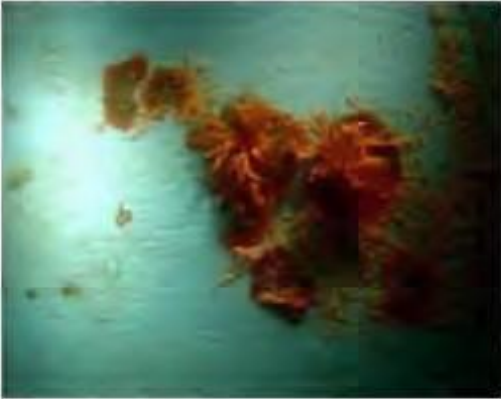
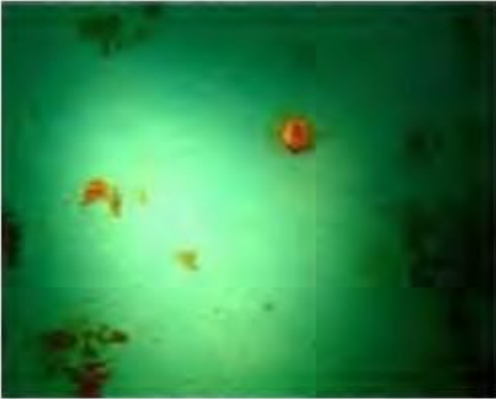
| LOF rank | Criteria |
|---|---|
| 3 | <p><b>Moderate biofouling.</b> Macrofouling clearly visible (usually &gt; 1 species) but still patchy. 6–15% of visible hull surface covered by macrofouling. Remaining area often covered in slime.</p> <div data-bbox="384 380 887 777"> </div> <div data-bbox="946 380 1444 777"> </div> |

Figure A4.3—continued.

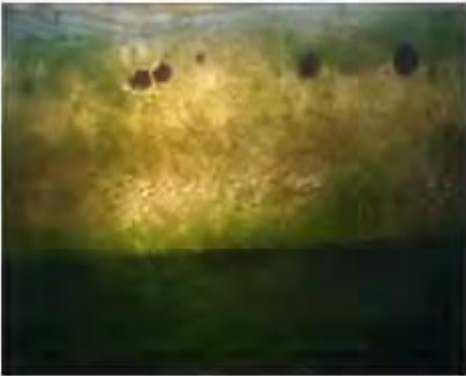
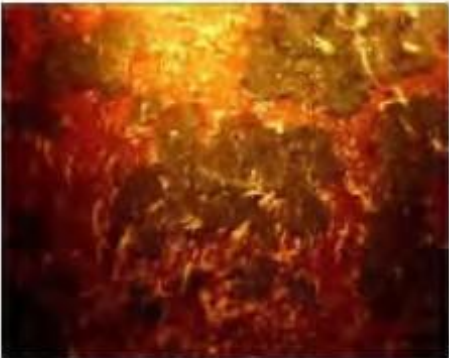
| LOF rank | Criteria |
|---|---|
| 4 | <p><b>Extensive fouling.</b> 16–40% of visible hull surface covered by macrofouling, generally with several distinct types of organisms. Remaining area often covered in slime.</p> <div data-bbox="384 934 852 1308"> </div> <div data-bbox="946 934 1396 1290"> </div> |

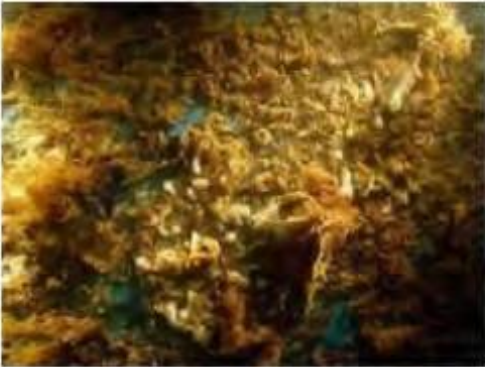
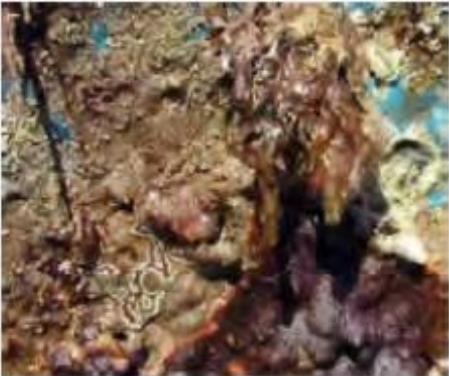
| LOF rank | Criteria |
|---|---|
| 5 | <p><b>Very heavy fouling.</b> 41–100% of visible hull surface covered by macrofouling, often with many distinct types of organisms. Remaining area often covered in slime.</p> <div data-bbox="384 1424 871 1789"> </div> <div data-bbox="946 1424 1396 1798"> </div> |

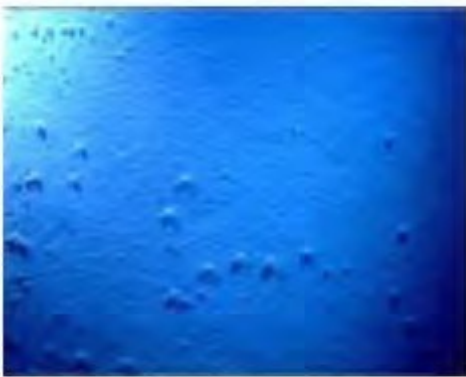
| LOF rank | Criteria |
|---|---|
| 0 | No visible biofouling. Hull entirely clean, <b>no slime fouling (biofilm)</b> on any visible submerged parts of the hull. |

Figure A4.3. Definition of the LOF ranks (ranging from 0 to 5) and example images of vessel hull surfaces of each of the different ranks (continued on next page).

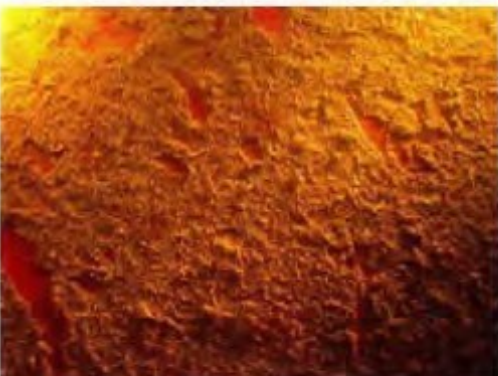
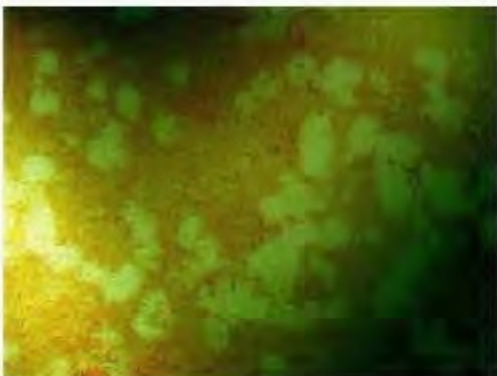
| LOF rank | Criteria |
|---|---|
| 1 | Hull partially or completely covered in slime fouling (biofilm). <b>Absence of any macrofouling.</b> |

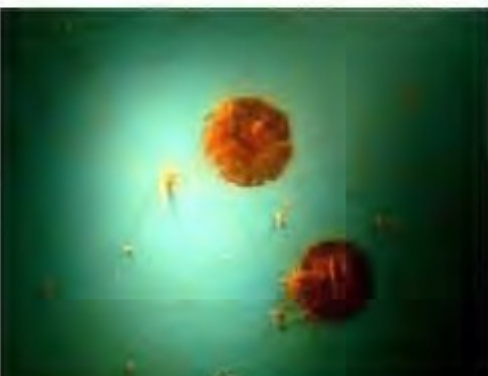
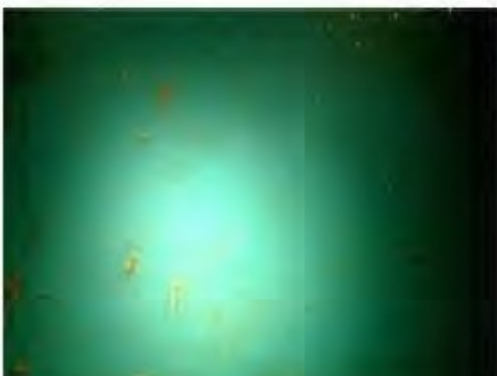
| LOF rank | Criteria |
|---|---|
| 2 | <b>Light biofouling.</b> 1–5% of visible surface covered by very patchy macrofouling. Remaining area often covered in slime. Examples below show presence vs. absence of fouling in two adjacent areas of a vessel hull. |

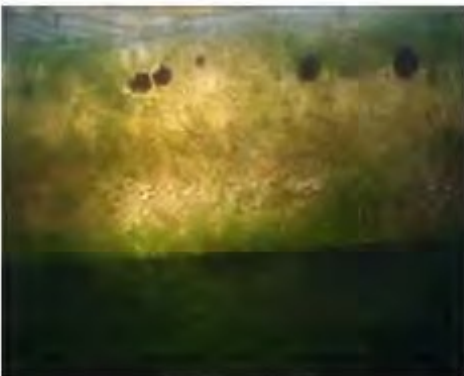
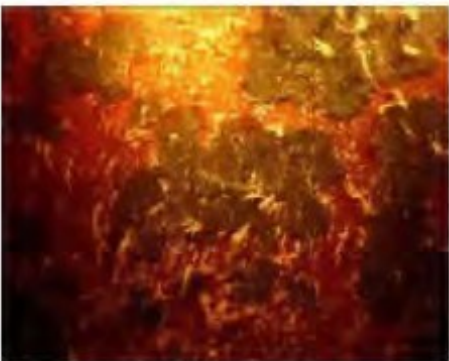
| LOF rank | Criteria |
|---|---|
| 4 | <b>Extensive fouling.</b> 16–40% of visible hull surface covered by macrofouling, generally with several distinct types of organisms. Remaining area often covered in slime. |

Figure A4.3—continued.

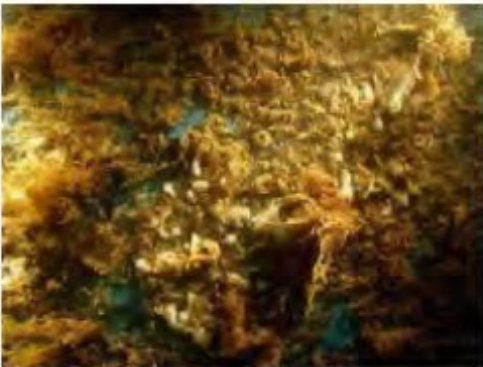
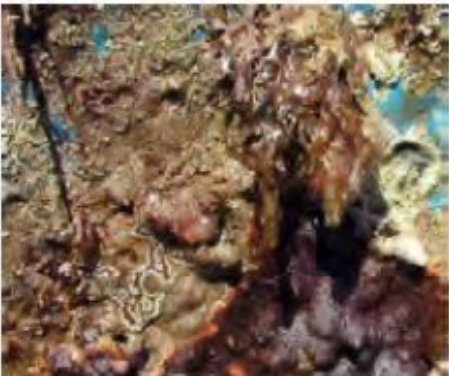
| LOF rank | Criteria |
|---|---|
| 5 | <b>Very heavy fouling.</b> 41–100% of visible hull surface covered by macrofouling, often with many distinct types of organisms. Remaining area often covered in slime. |
