Subject: Hahei Beach Short Walk Options Paper

1. This paper sets out the context and damage to Hahei Beach Short Walk (Hahei Walk), the intended reroute alignment, the assessment methodology used, the options considered, and recommendations for next steps.

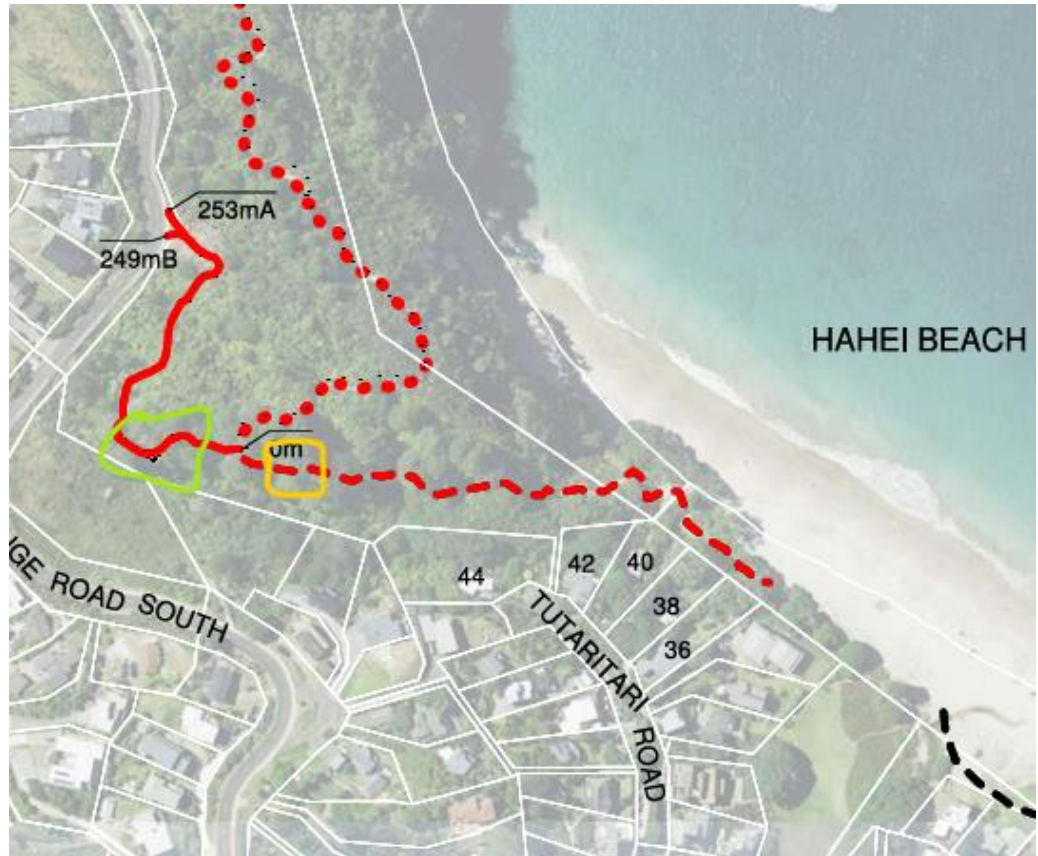
Figure 1: Landslide and track vulnerability on Hahei Beach Short walk section 1 that was to be retained (yellow) and proposed reroute (green)

23. Fallen tree trunks have exacerbated the land instability. Figure 1 highlights in yellow the new slip affecting the Hahei Beach Short Walk. This section was to be kept as part of the new track alignment. The slip would prevent end-to-end access, meaning the track would remain closed even if the reroute proceeded. This reinforces the ongoing vulnerability of the track to slip events.

24. The green square marks a section of the proposed reroute where three fallen trees are obstructing the alignment. Their root balls encroach onto the track, and the cut trunk sections remain upslope. Over time, these pose an ongoing risk as they may rot, shift, and potentially slip onto the track. Removal was not feasible within budget and relocating the material downslope risked damage to adjacent private property. There are another 50-plus tree trunks above the track expected to cause further instability over time. No other track alignments were considered practical.

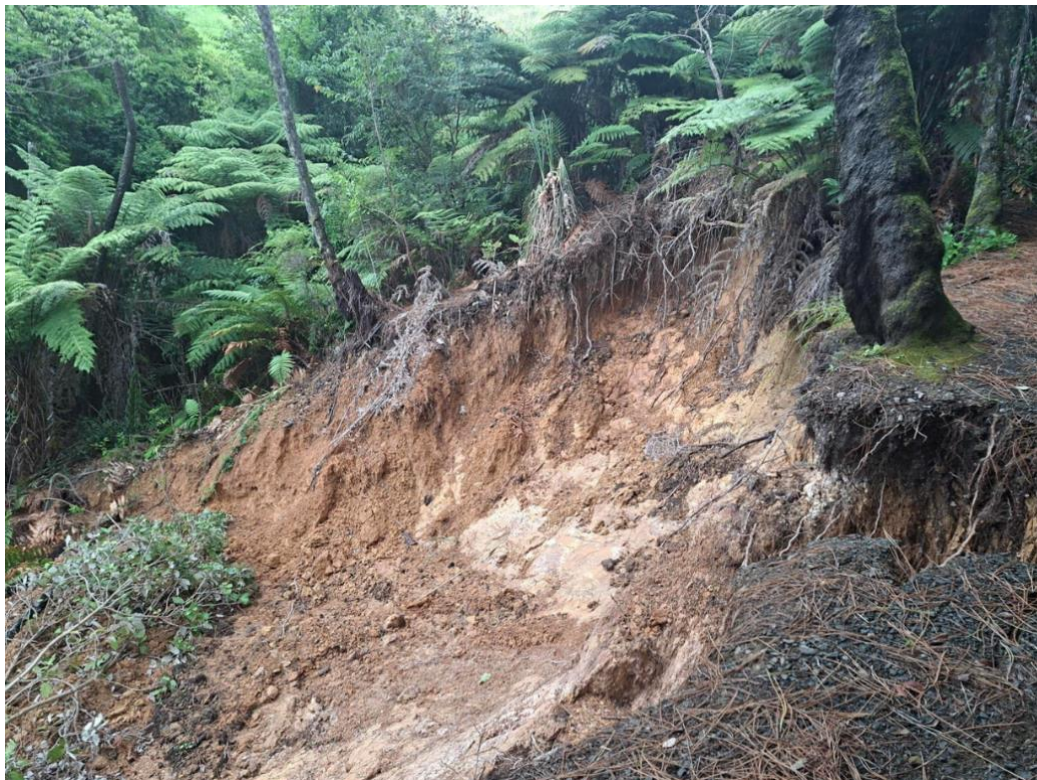
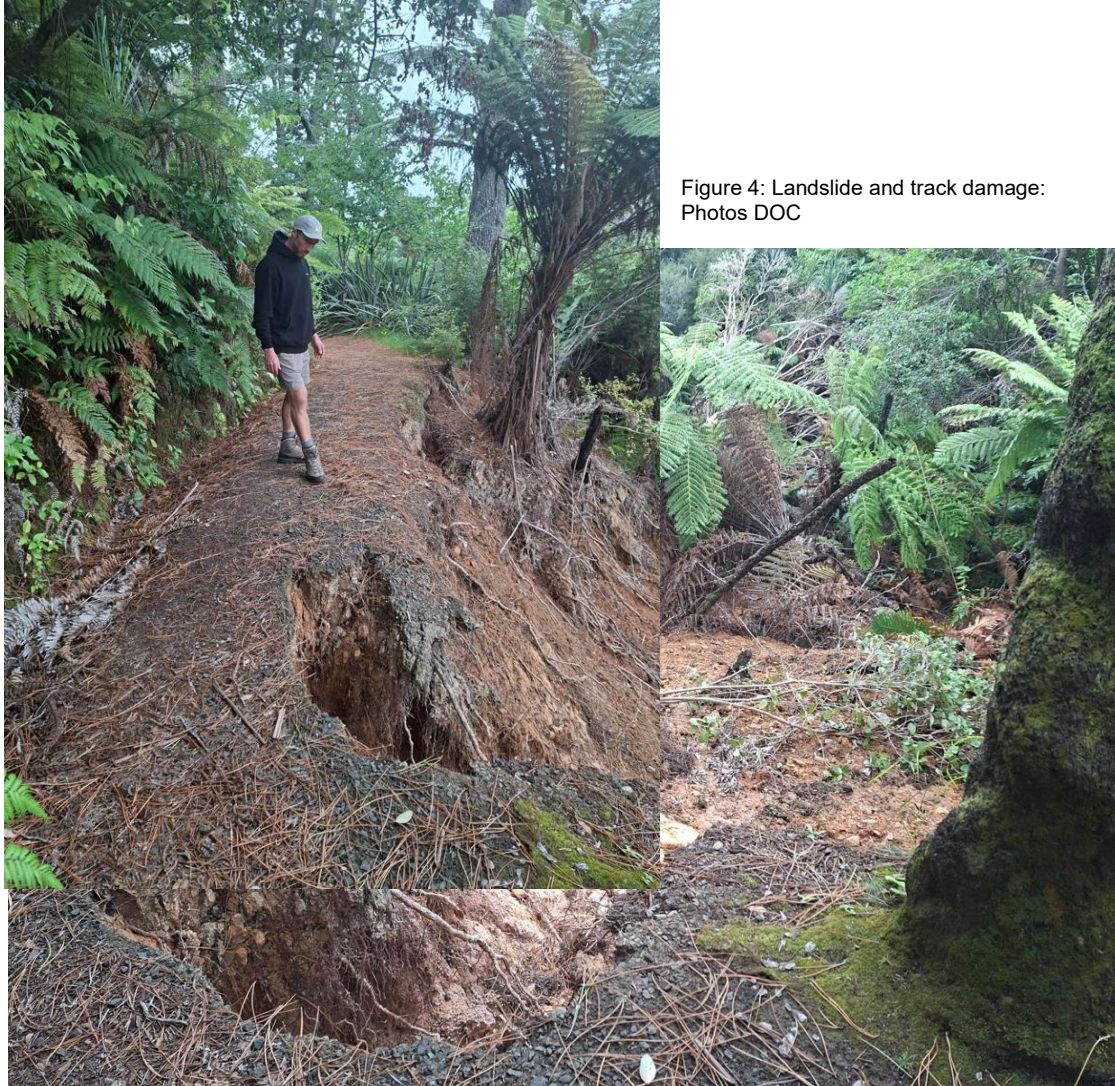
Figures 2 & 3: Landslide and track damage: Photos DOC

21. Table 1 shows the decision-making process flow chart⁶ used to guide this assessment. The first step was to understand the risk/damage.
22. The Project Manager for the track reroute and construction experts undertook damage assessments in January and February 2026. The assessment undertaken was based on operational and constructability expertise and informed by existing geotechnical reporting for the area as well as direct observation of current site conditions. Damage assessments confirmed two landslides, one on a section of the existing track which needed to be retained for the reroute; and one on a section the new reroute would have crossed, where water is pooling and there is evidence of further instability.

25. This site damage was assessed as major, with repair requiring funding beyond the district budget⁷. It was confirmed there is no funding available to undertake the works required to repair this new slip area. This aligns with DOC prioritising limited capital investment toward resilient, high value assets and core visitor experiences, while reducing exposure to assets that are vulnerable, high maintenance, or unlikely to deliver reliable outcomes.
26. The next step of the assessment is to consider visitor site criteria, importance of the site and climate change and natural hazard risk modelling.
27. The Hahei Walk has known geological instability confirmed by geotechnical reports. Previously bridges have been placed to cross historic landslides. These were assessed as needing replacement due to foundation issues.
